***HASELOR and WALCOTE***

***Conservation Area Review***

***Draft Report - October 1997***

***for Stratford on Avon District Council***

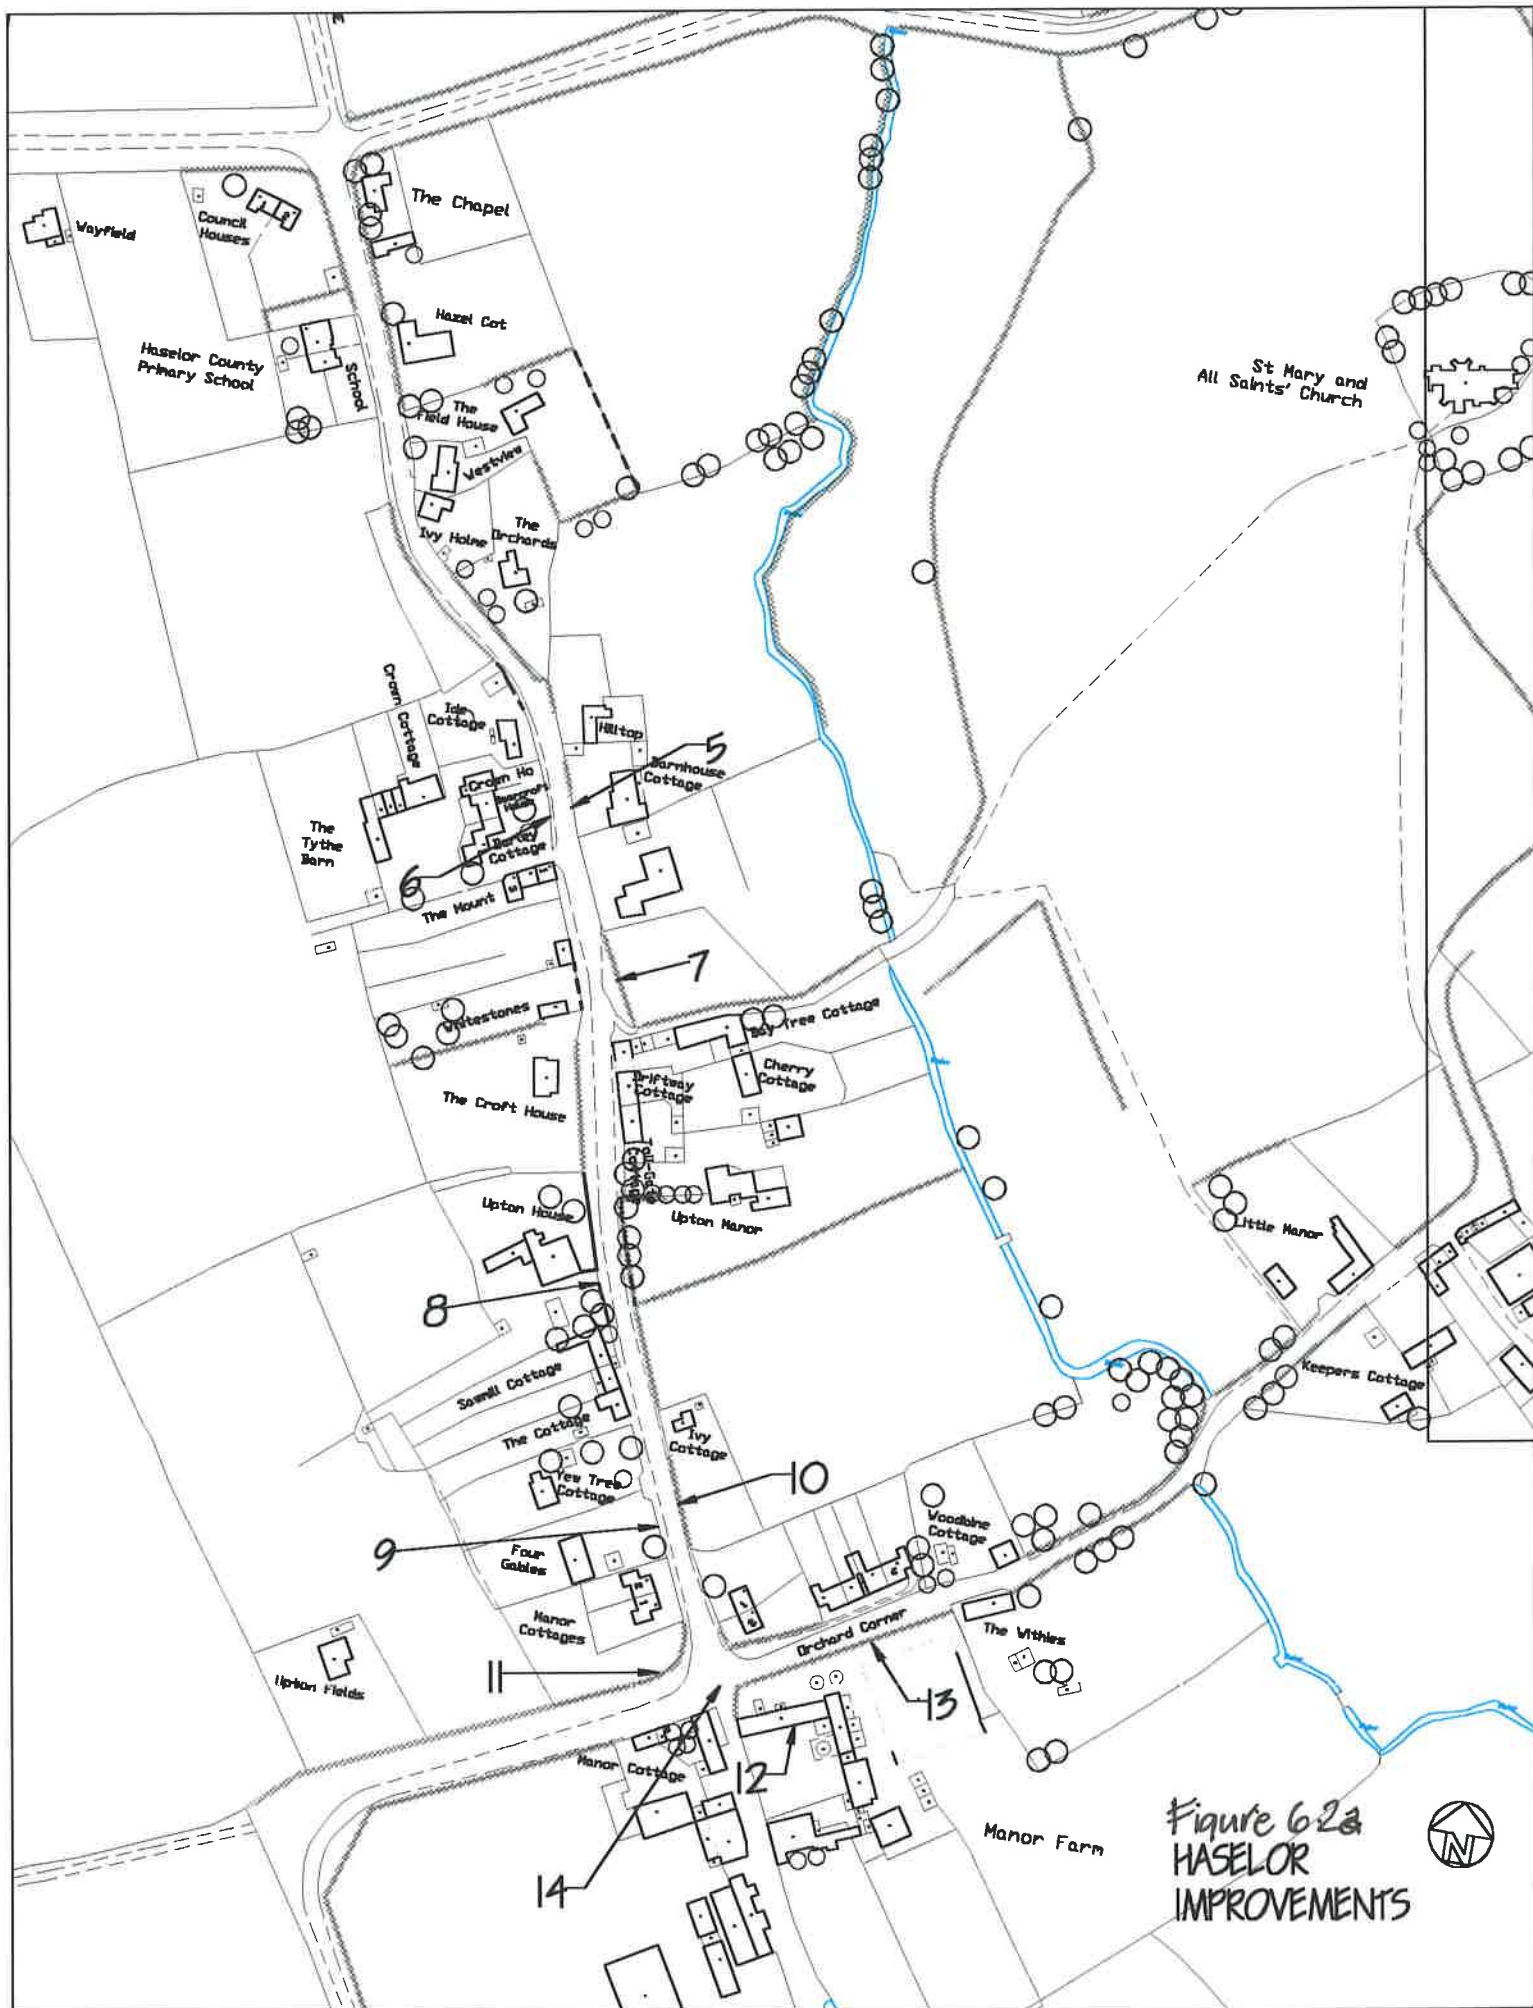
Figure 6.2a  
**HASELOR  
 IMPROVEMENTS**

1. Rebuilding of cottages has left the area in front of them open and suburban looking: define the front boundary with a wall or hedge.
2. Small red brick garage is notable in view from Mill Lane, but overgrown: tidy up.
3. Attractive Victorian cart shed, requiring re-use to preserve it.

4. Yard adjacent to 3 with original pavings and surrounded by attractive walls: requires renovation.
5. Inappropriate hedge species, inappropriate building form (Barnhouse Cottage): encourage planting of more substantial native hedge.

6. Renovated housing left with open, suburban looking front gardens: wall or native hedge required to define street.
7. Upton Green: hedges make access indirect and obscure wider views over valley to church. Consider landscape schemes to open up the green and bring it more into the village scene.

8. Some clearance of overgrown multi-stemmed trees required.
9. "Suburban" garden requiring better definition of front boundary, in keeping with other parts of Main Street.

10. Long, dull Leylandii hedge on top of stone retaining wall. Replacement with native species would be better long term.
11. Tidying up and strengthening of hedgerows and old orchard at entrance to village.

12. Manor Farm yard and buildings in urgent need of repair / renovation / re-use.
13. Untidy hedge and adjacent paddock and farm buildings. Management would improve outlook of Orchard Corner.

14. Street surfaces: tighter definition of carriageway with kerb setts and footpath paving could help appearance at entry to village.
