# ***LADBROKE***

## ***Conservation Area Review***

*December 1997*

**ROGER EVANS ASSOCIATES**

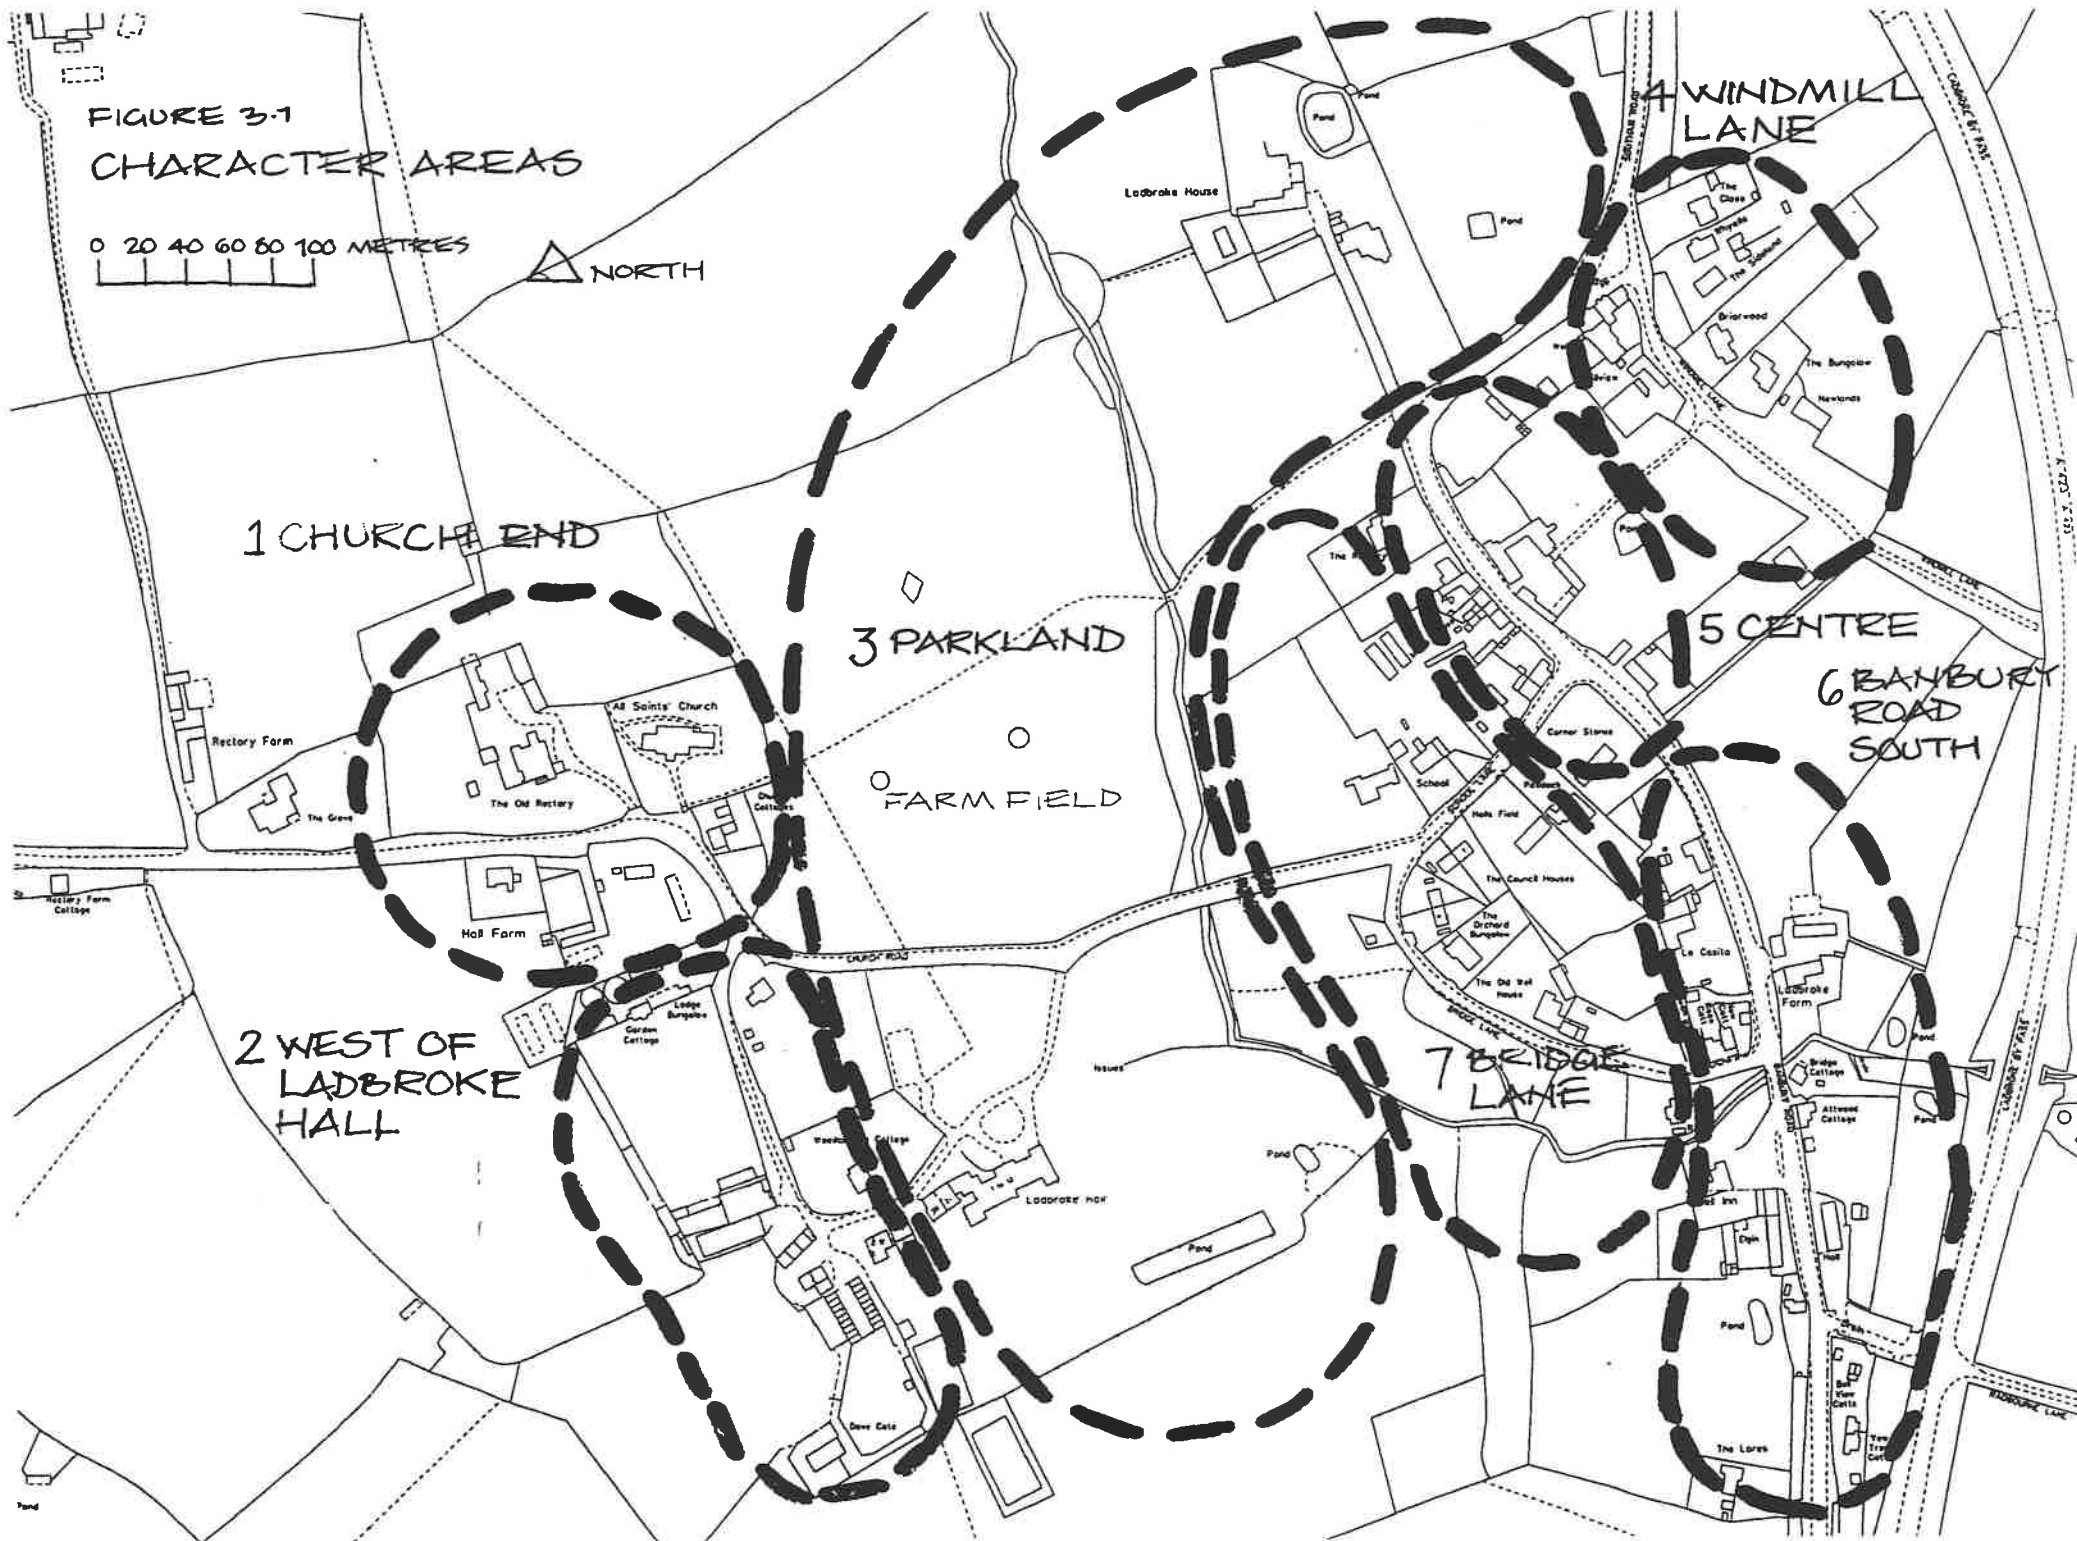
FIGURE 3-1  
CHARACTER AREAS

History has split Ladbroke into two distinct village areas, separated by a broad belt of parkland. Even within this general division, the character of the village is quite fragmented. At the church end the immediate environment at the entrance to the village is good, but between Hall Farm and Ladbroke Hall there are some very untidy elements. On the east side, the buildings at Windmill Lane form a quite separate group at the Southam Road approach, and Banbury Road has a clearly different character north and south of School Lane. Bridge Lane is a quiet leafy backwater. Figure 3.1 shows these different areas, which are described below.

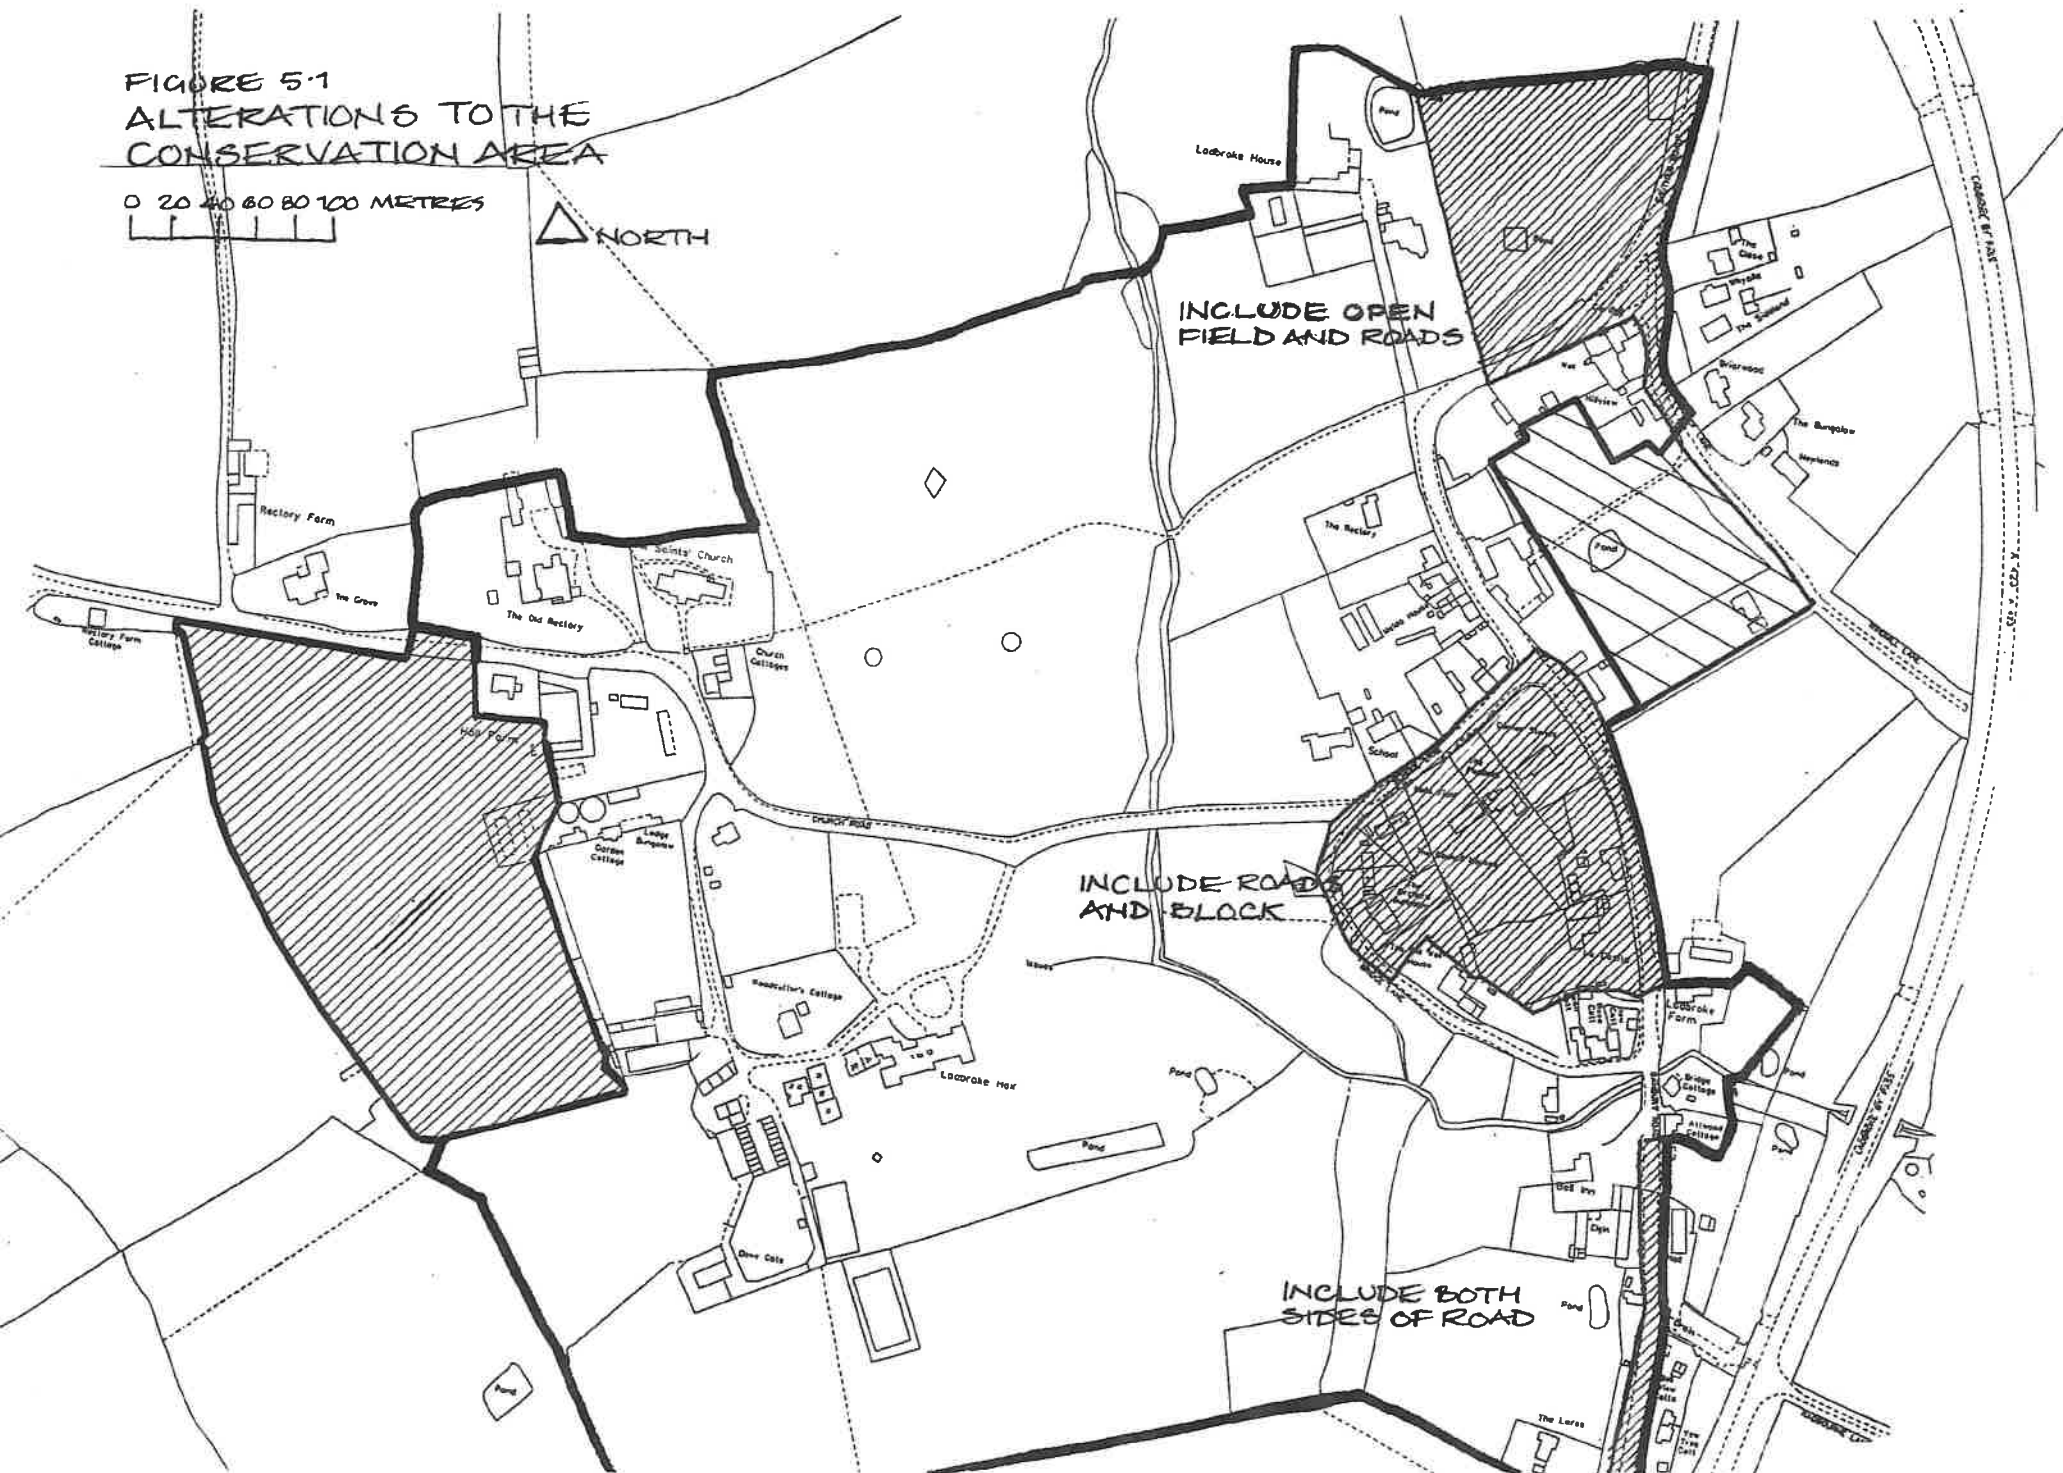
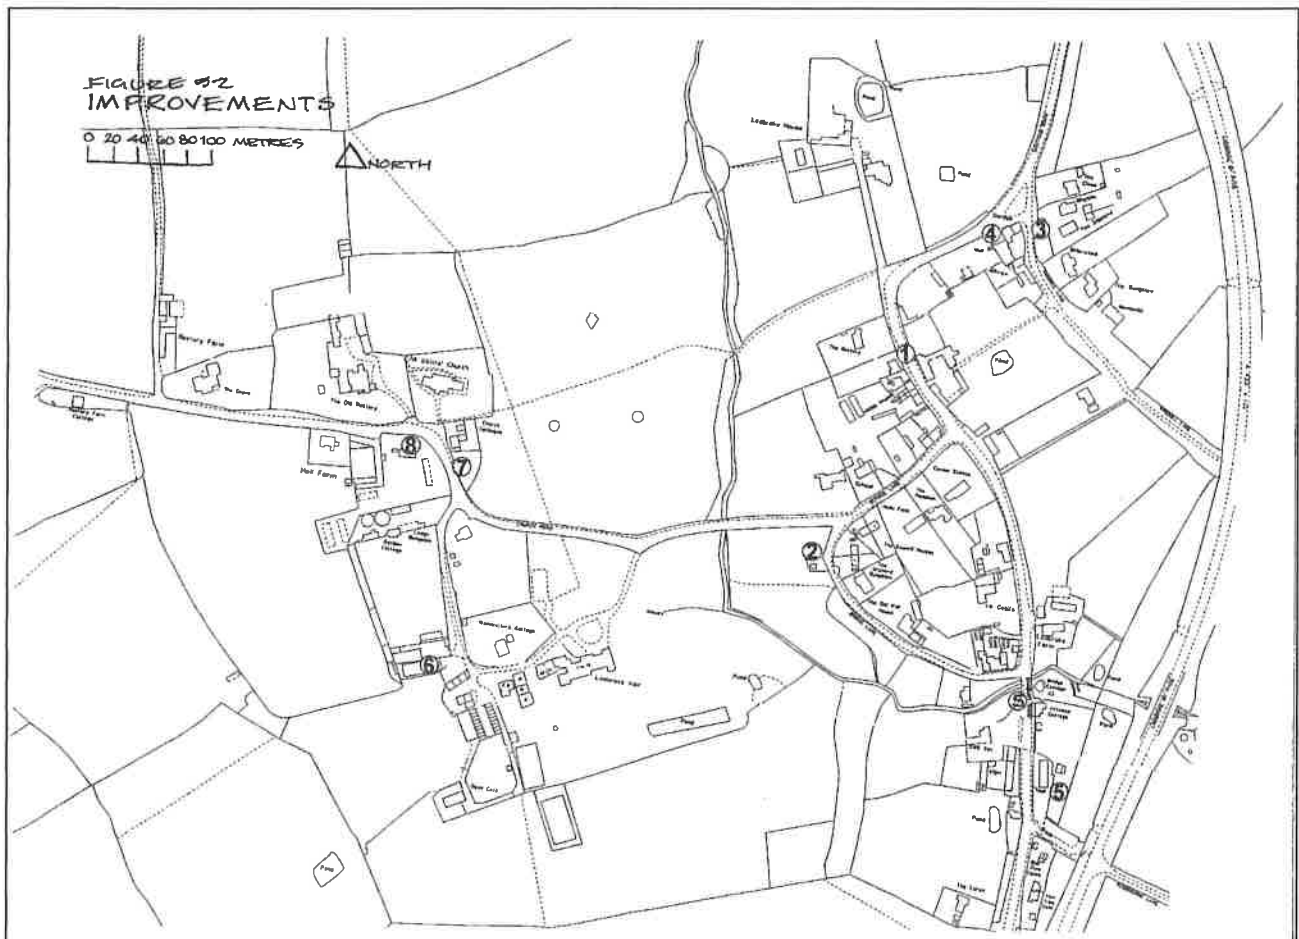
The quality of the historic environment in Ladbroke is very variable. The church area and Ladbroke Hall are of a high standard, but the village centre is relatively poor. Undoubtedly this is a legacy from before the by-pass, when Banbury and Southam Roads were heavily trafficked. The new by-pass offers the opportunity to redress those earlier problems with comprehensive improvement and enhancement to the main street. Figure 5.2 shows where these opportunities exist, and points out other potential improvements in the village.

2. Bridge Lane sewage pumping station - unattractive building and chain-link compound. Planting scheme required to screen.
3. Unsightly timber garage in prominent location at entrance to village - encourage owner to reposition/rebuild.

1. General street improvements - street edges and grass verges require repair, footways currently tarmacked could be paved or flagged, kerbstones in clay or granite. Parking bays properly laid out and edged, possibly road width narrowed in conjunction with on-street parking scheme.
