STRATFORD ON AVON DISTRICT COUNCIL

CONSERVATION AREA REVIEWS

ILMINGTON

August 1995

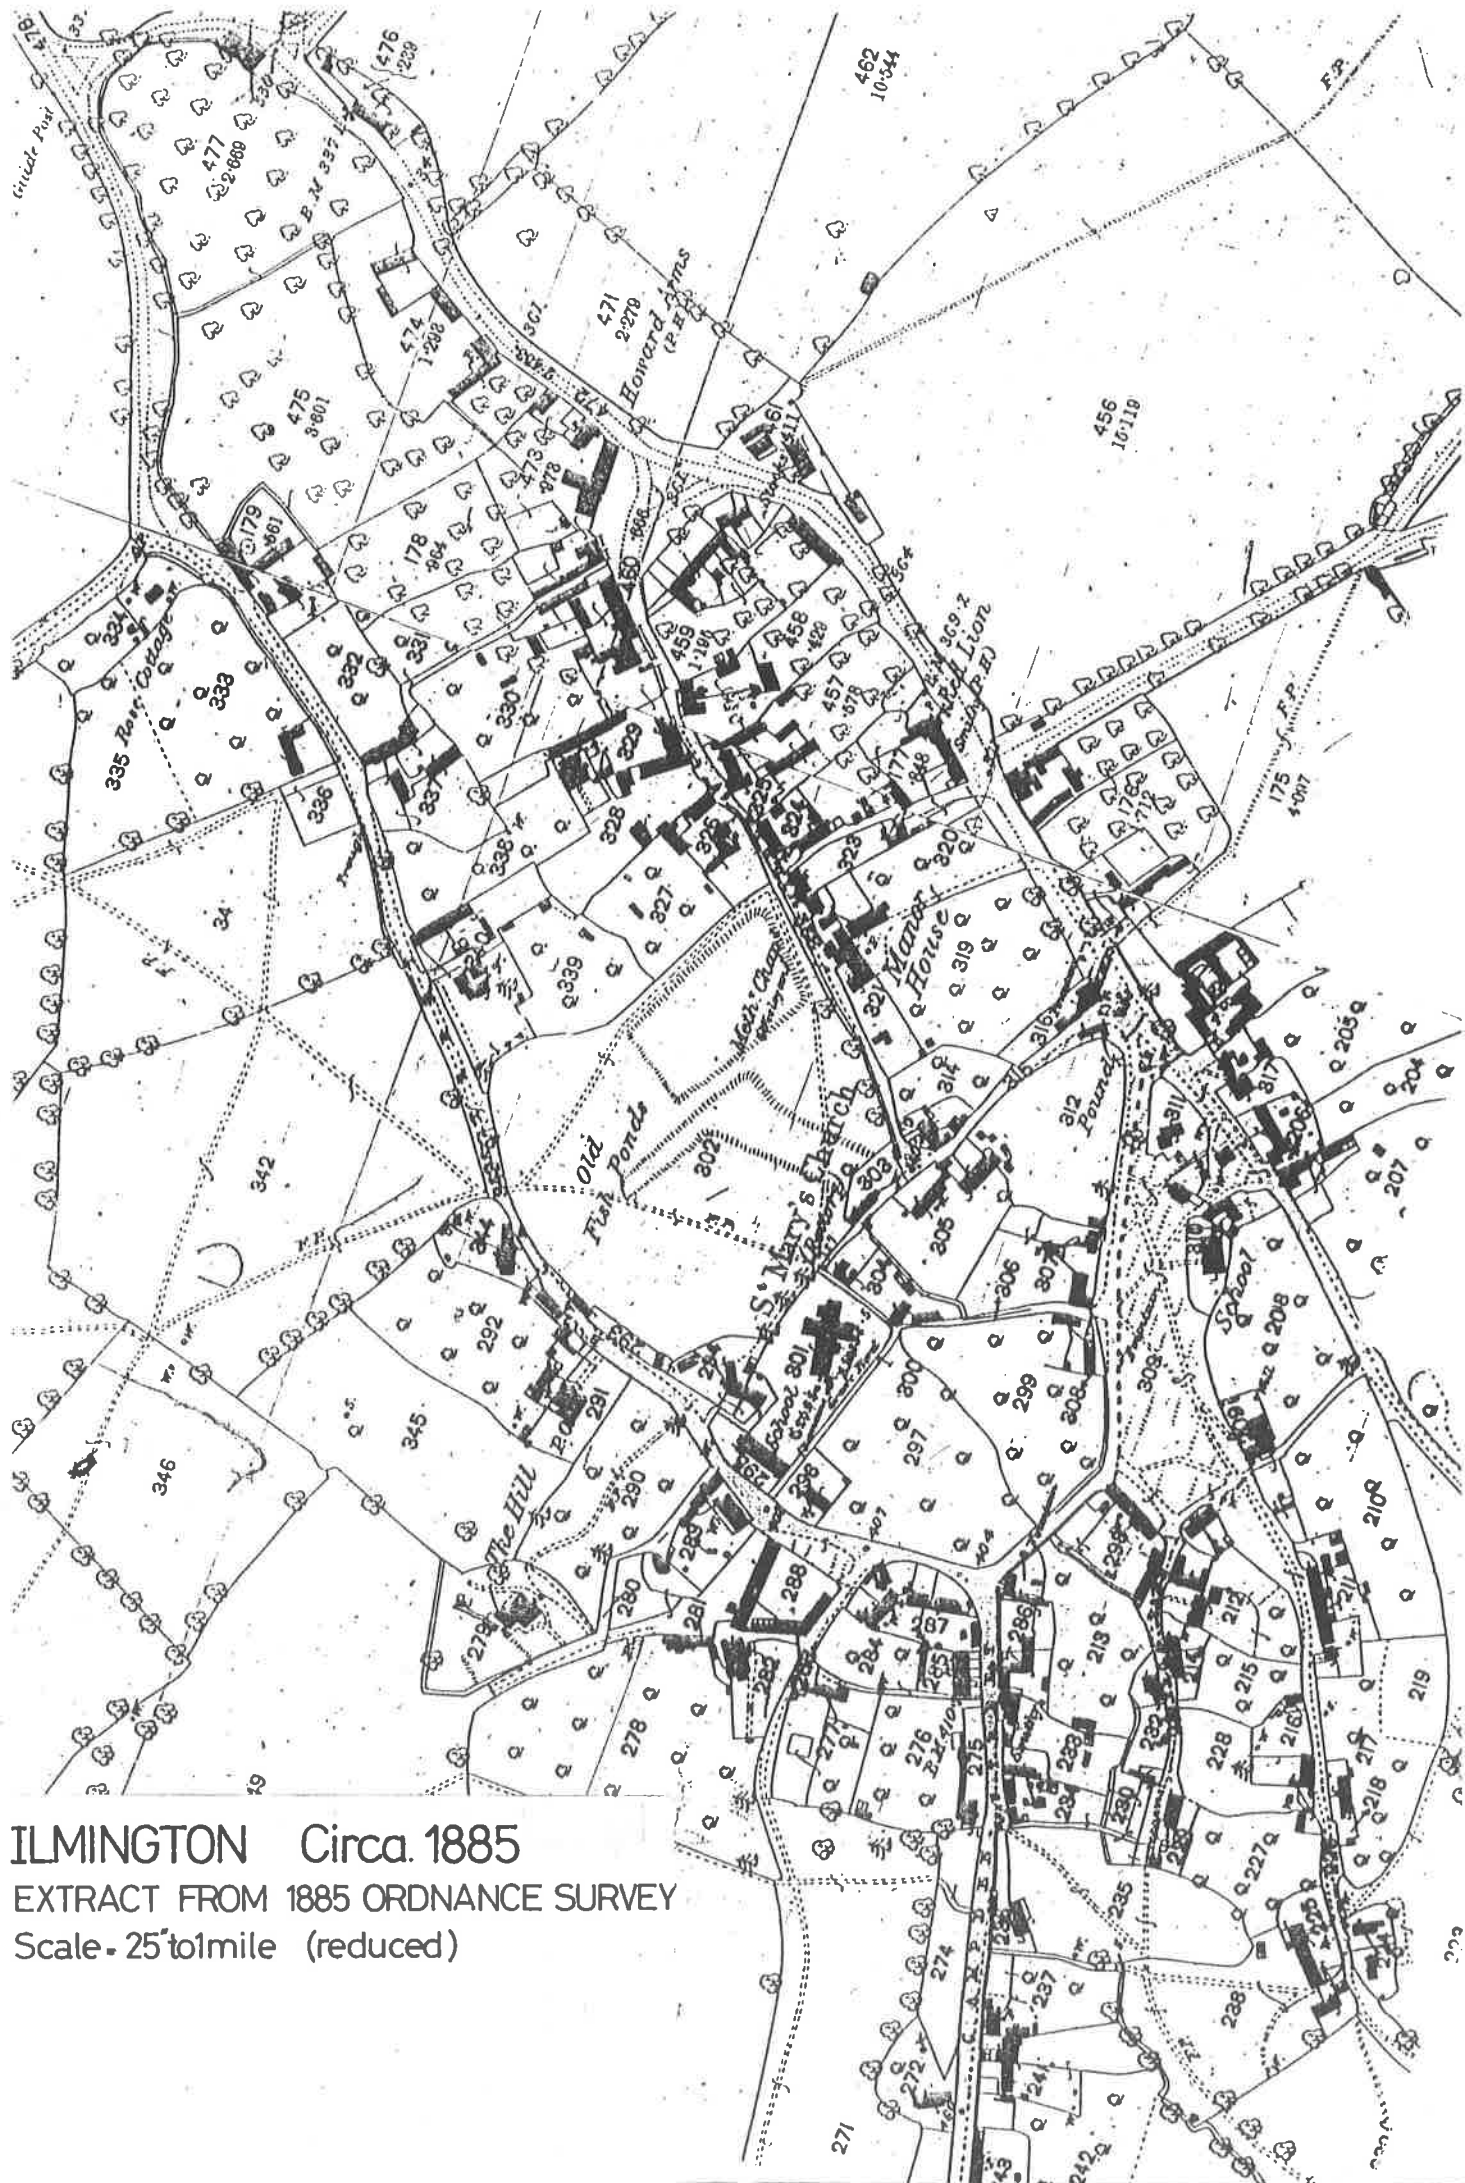
ILMINGTON Circa. 1885  
EXTRACT FROM 1885 ORDNANCE SURVEY  
Scale - 25 to 1 mile (reduced)

In recent times there has been little change to the basic layout and size of the village - as can be see by comparing the 1885 OS map with the present map. There has been a significant amount of 'infill' residential development along the ancient streets. Only the south-east corner has been developed beyond the old village settlement area.

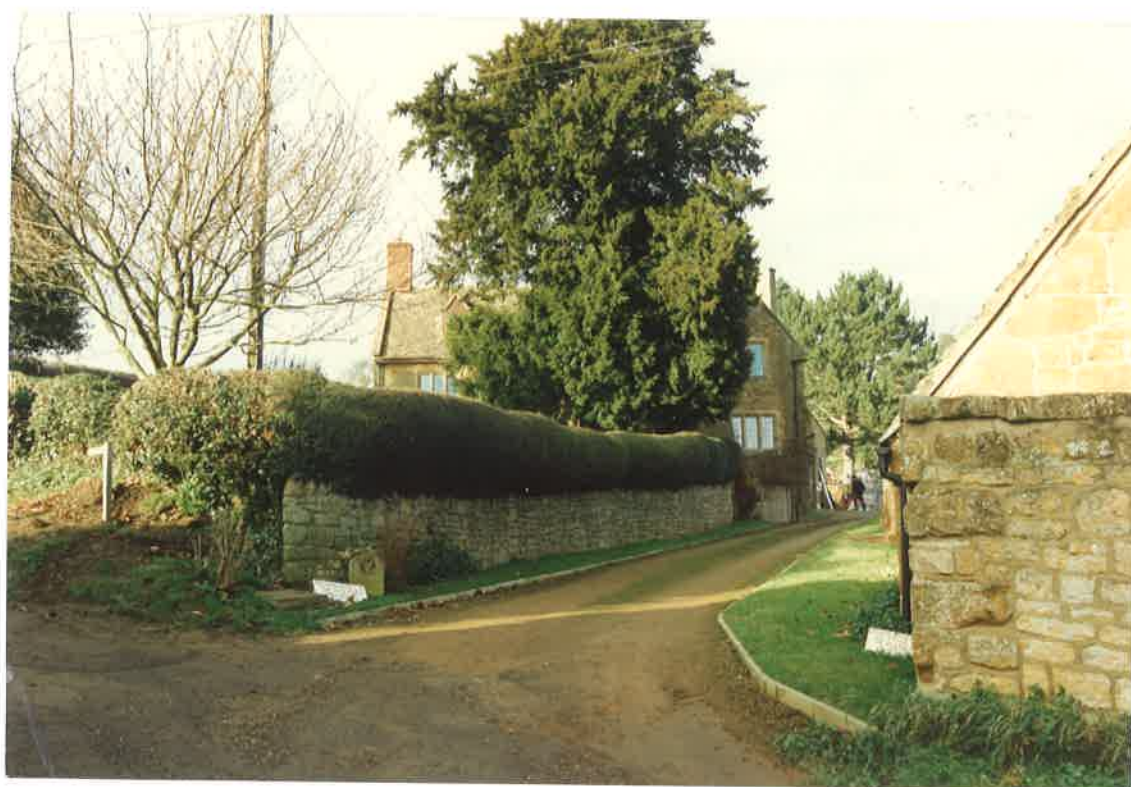
9/37	Hill Farmhouse, Back Street (Listed Building Ref 9/37 - Grade II)
------	--

*(Key farmstead in village)*

Farmhouse. Late C16 or early C17 with late C17 additions. Squared, coursed limestone with quoins and coped gables. Stone slate roof with brick end stacks. 2 storeys plus attic; 4-window range. L-shaped plan, the gabled wing to right. Immediately to left of wing a part-glazed door with C20 lean-to hood. To left a large C20 three-light casement. To first floor left an ovolo-moulded 3-light mullioned window. 2-light 12-pane casement to right. 2 gabled dormers. Gable end has a later tall round-headed staircase light rising to first floor. C20 casement to right. Blocked C17 window in gable, the hood mould and label stops remaining. Similar blocked opening with hood mould and label stops below to left. Blocked, part-destroyed 4-centred arched doorway below tall light. Further gabled range to right tied in with first gable has a brick stack, and ashlar external stack with 2 flues. C19 stucco canted bays to gable rising to second floor. To rear two 4-light ovolo-moulded mullioned windows, with single stone light above.

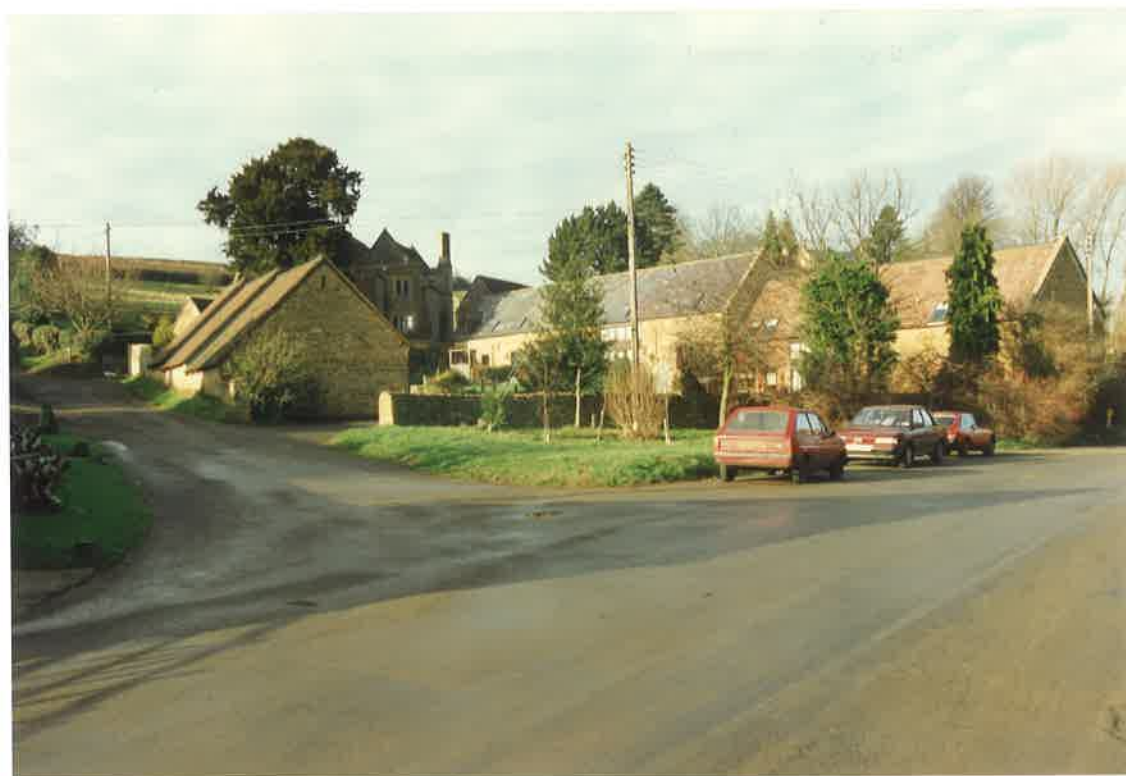
9/36 Barn approx. 5m. E of Hill Farmhouse, and attached barn, Back Street.  
(Listed Building Ref 9/36 - Grade II)

*(Prominent range of barns in village street - now converted to dwellings)*

List description : Barn. Early C18. Squared, coursed limestone with coped gables. Slate roof. 6 bays. To centre left a large opening with corresponding opening to rear. To centre and left a round window with a stable door opening with wood lintel between, flanked by 2 small square openings. Further doorway to far left. To either side of large doorway small square ventilation holes. Attached to right a late C18 barn of squared, coursed limestone with coped gable to right and stone slate roof. 5 bays. Barn rebuilt in brick to left of a large opening, with corresponding opening to rear. Small doorway with wood lintel in brick part. Dentilled brick eaves cornice to rear. Interior: main barn has pegged queen strut roof with collars. Original purlins, rafters replaced. Attached barn has pegged queen strut roof with collars and original purlins. Stone flagged threshing floor.

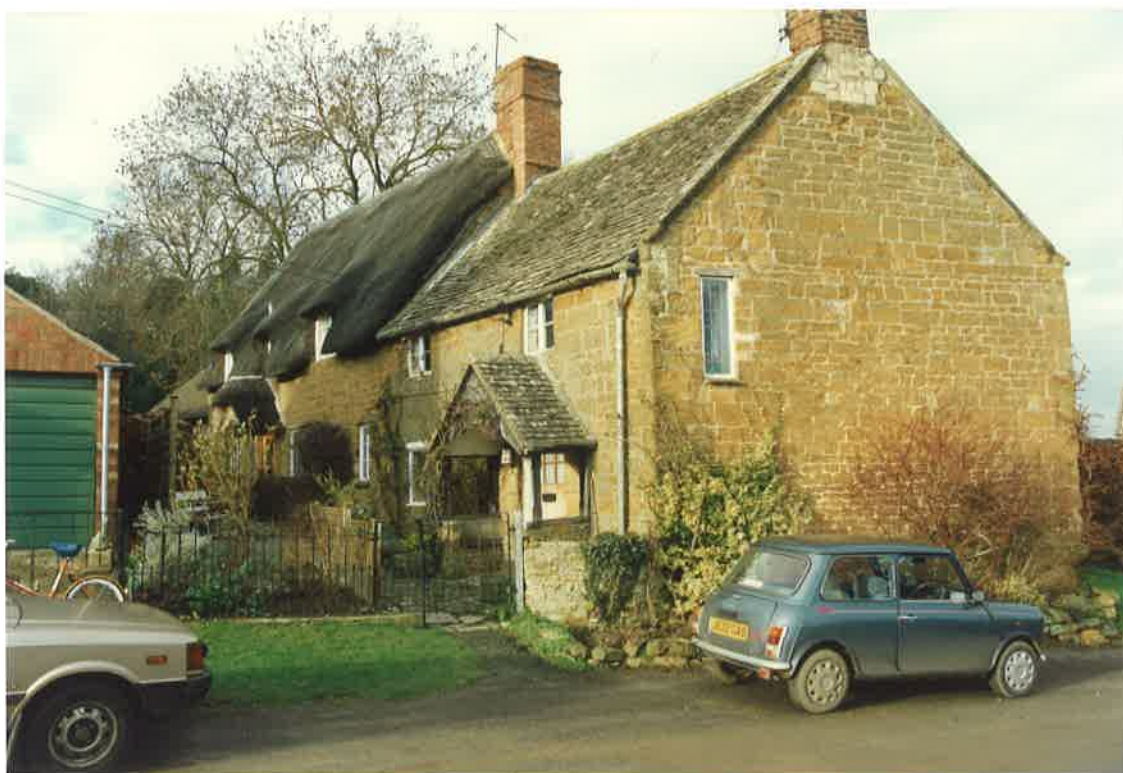
9/35 The Glen and attached cottage, Back Street  
(Listed Building Ref 9/35 - Grade II)

*(Picturesque pair of cottages - gable end onto street)*

List description : Cottage. Early C18. Squared, coursed limestone with thatch roof and brick end stack. 2 storeys; 2-window range. 2-unit plan. To centre a C20 part-glazed door with C20 thatched porch. C20 two- and three-light casements to ground floor, that to right with flat stone arch. Three C20 two-light swept dormers.

Interior: noted as having chamfered spine beam, and open fireplace with timber chamfered bressumer.

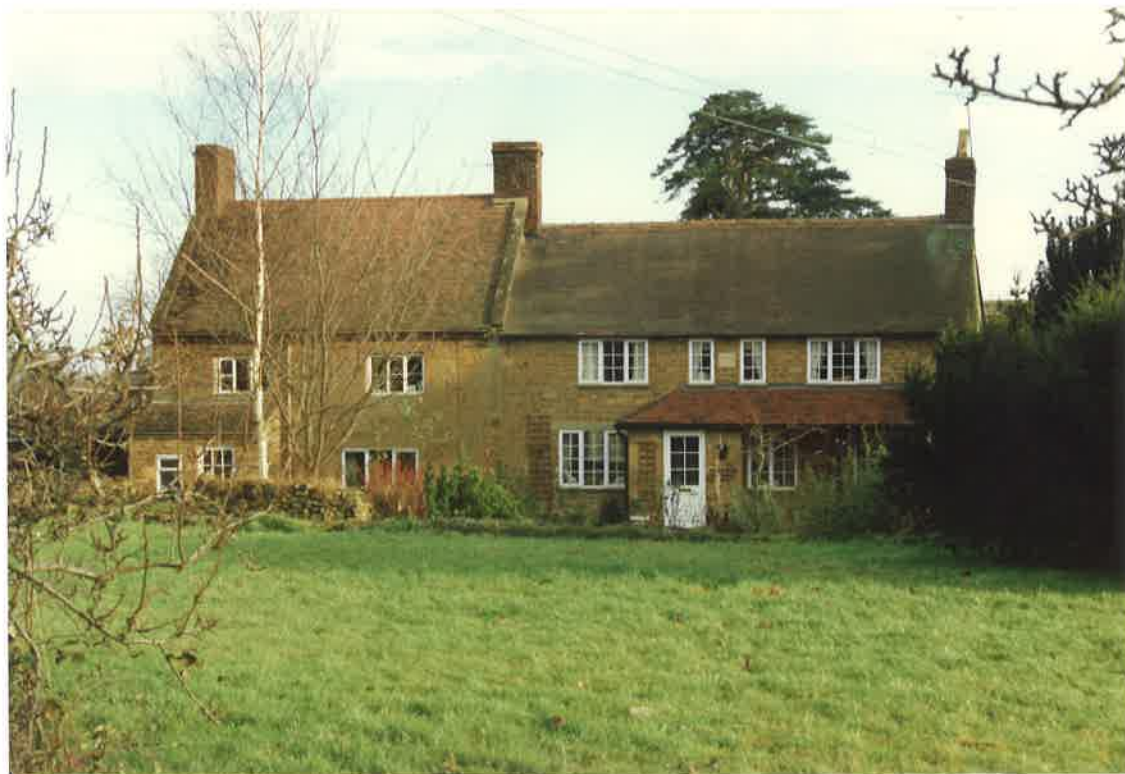
9/32 Bassett Cottage, Back Street  
(Listed Building Ref 9/32 - Grade II)

*(Very prominent position next to churchyard from Back Lane approach)*

List description : House. Mid/late C18. Squared, coursed limestone with quoins and coped gables. Dentilled brick eaves cornice. Tile roof with brick end stacks. 2 storeys; 2-window range. 2-unit plan. To left a C20 glazed door within C20 lean-to stone porch. To left a C20 three-light window. To first floor left and right a C19 three-light casement with wood lintel. Interior: said to have beams and an old fireplace.

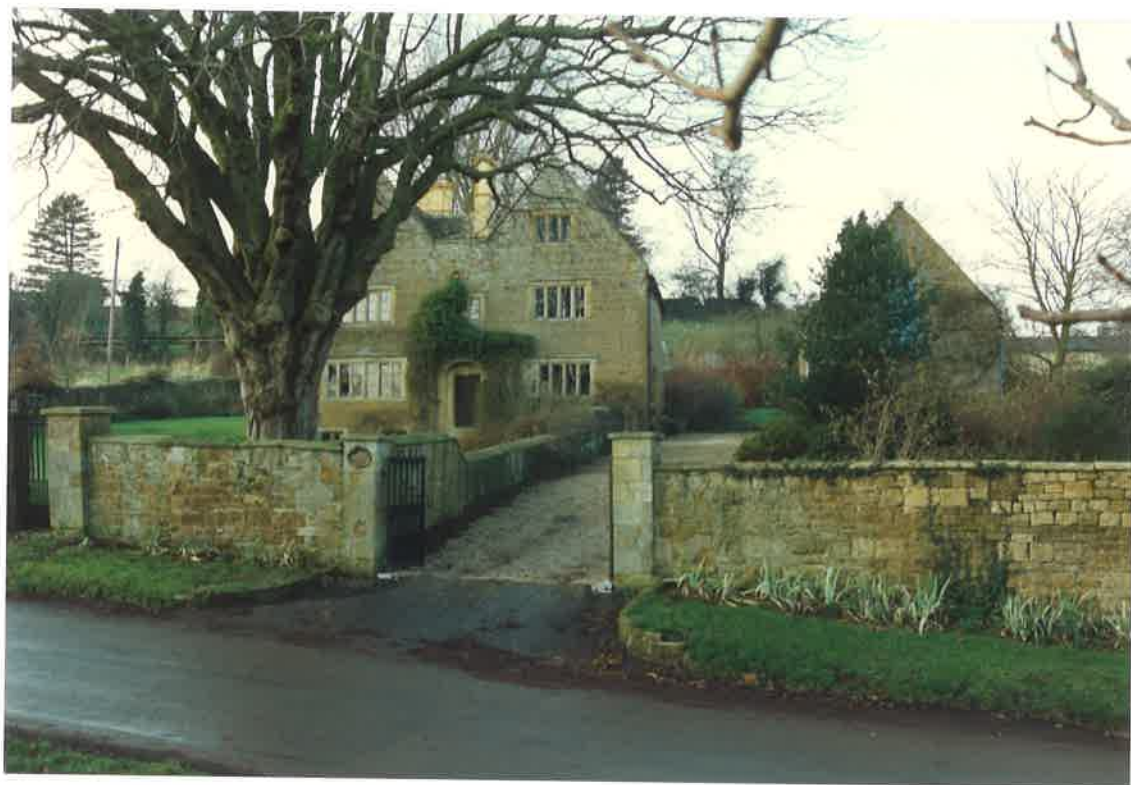
9/34 The Dower House, Back Street  
(Listed Building Ref 9/34 - Grade II)

*(Finest 'cotswold' style large house in village -prominent position on north side of back street)*

List description : House. C16 and C17. Limestone ashlar with quoins and coped gables. Stone slate roof with ashlar ridge stacks. 2 storeys plus attic; 3-window range. Double depth plan, the 2 gabled wings to front. To centre a C20 plank door within moulded stone surround with hood, and lintel with keystone. To left of door a 6-light ovolo-moulded mullioned window with king mullion. To right a 5-light mullioned window. To left and right of first floor a 4-light mullioned window with a 2-light mullioned window between. In each gable a 3-light mullioned window. All mullioned windows have hood moulds and label stops. Small coped gable to centre.

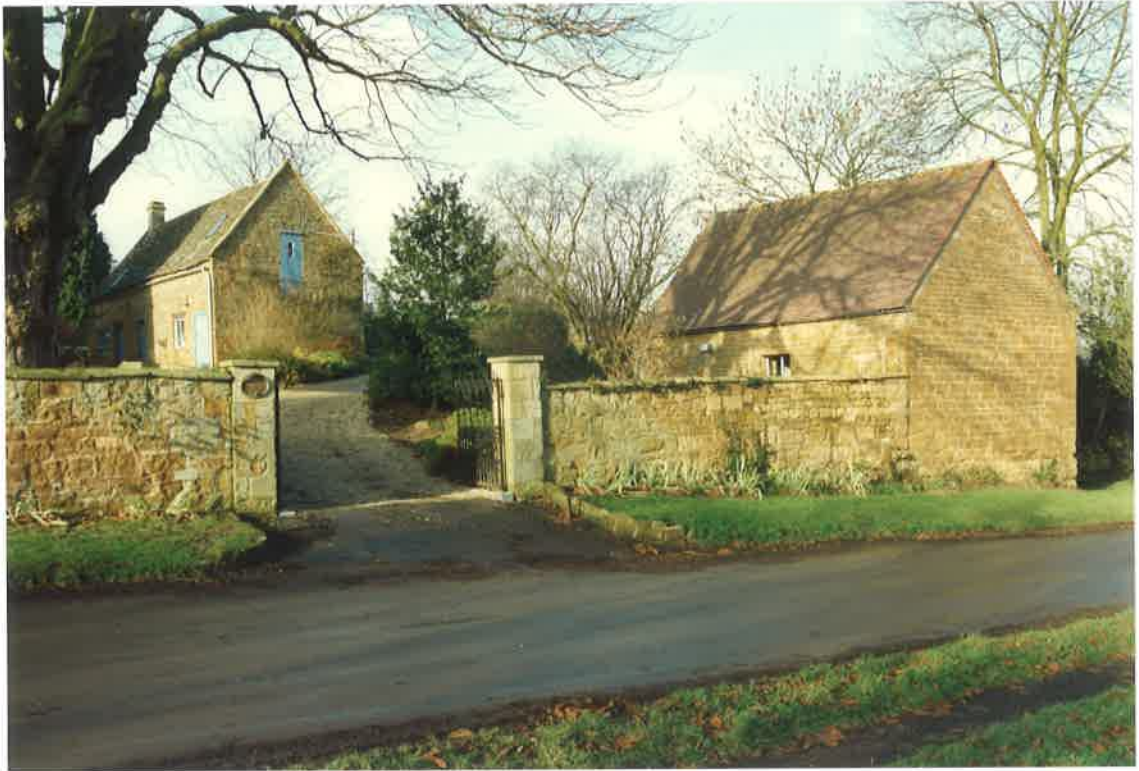
9/33 Stableblock approx. 10m. NW of The Dower House Back  
Street (Listed Building Ref 9/33 - Grade II)

List description : Stableblock and dovecote. C17. Squared, coursed limestone with coped gables. Stone slate roof with stone end stacks. 3 bays. Range of 3 doorways, that to left with wood lintel. To centre right a C19 two-light casement with wood lintel. To left a C18 three-light casement with wood lintel.

Interior: chamfered ceiling beam. Some original purlins. The central section is a dovecote.

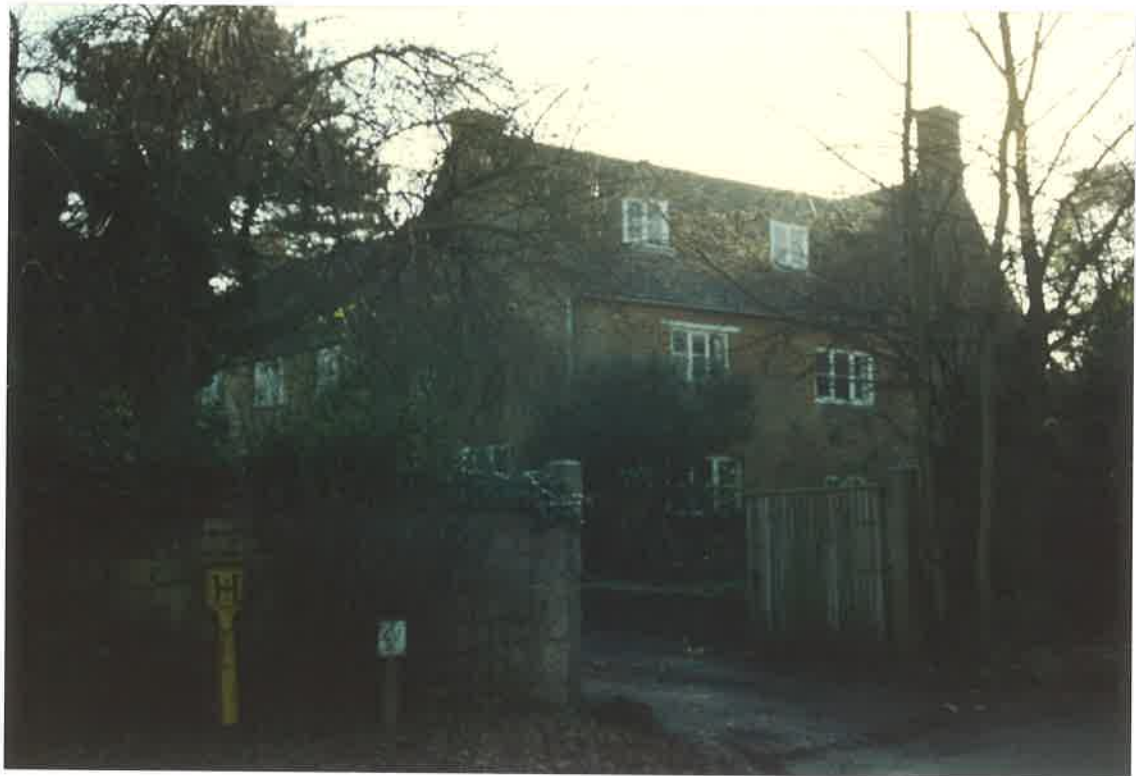
10/31 Sansome House, Back Street  
(Listed Building Ref 10/31 - Grade II)

List description : House. Mid C18. Squared, coursed limestone with coped gable. Stone slate roof with ashlar end stacks with moulded bases and cornices. 2 storeys plus attic; 3-window range. L-shaped plan. To centre a C20 glazed door. A C20 four- and three-light casement to ground floor, that to right with stone flat arch. To first floor a range of three C20 cross casements with original wood lintels. 2 gabled dormers, hung with stone slates. Wing to rear, and left gable end have further 2- and 3-light casements, with flat stone arches. Lead County 'Britannia' firemark. C20 range to rear in imitative style.

Interior: chamfered spine beams, and joists to ground and first floor. Open fireplace rebuilt, the original timber bressumer re-used.

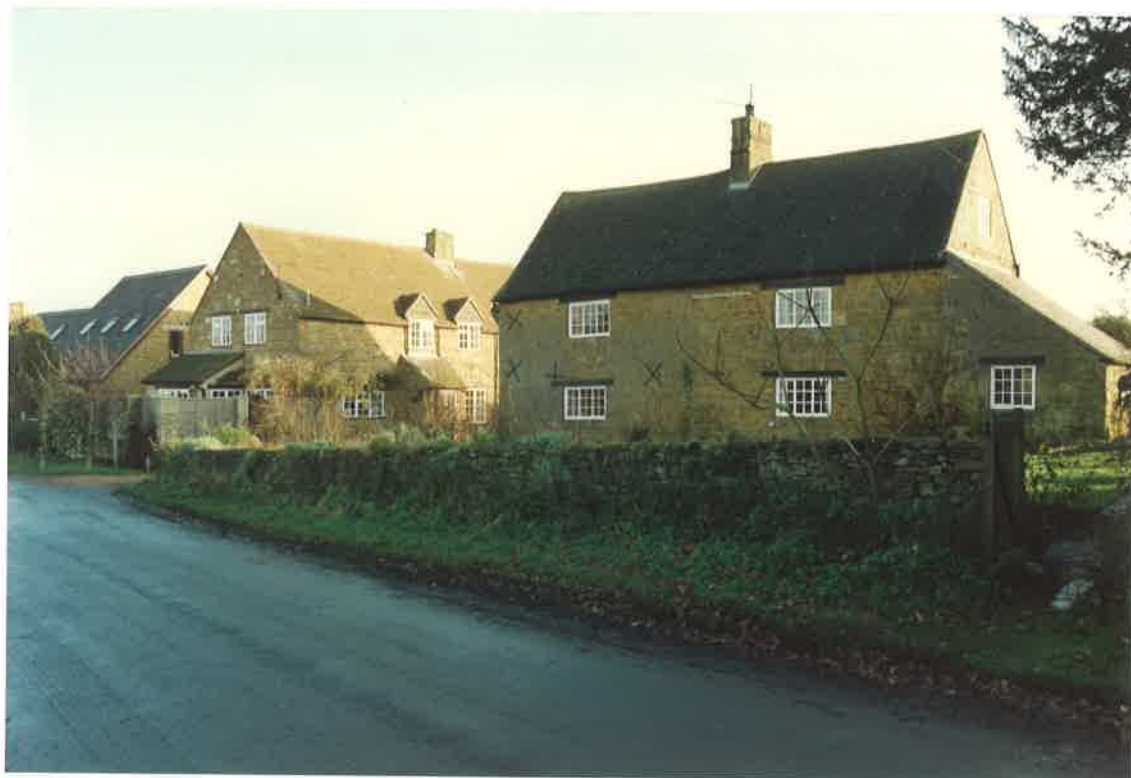
10/30.Mabels Farmhouse, Back Street  
(Listed Building Ref 10/30 - Grade II)

*(Simple stone farmhouse prominent in streetscape)*

List description : Farmhouse. Early C18. Squared, coursed limestone with concrete tile roof. Rendered ridge stacks. 2 storeys; 2-window range. To centre left a C19 plank door with iron hood. To left and far right a C20 three-light casement with wood lintel. To first floor a range of three 2- and 3-light C20 casements, 2 with wood lintels. Further C20 three-light casements to rear. All C20 windows in their original openings. House said to have had a datestone of 1710.

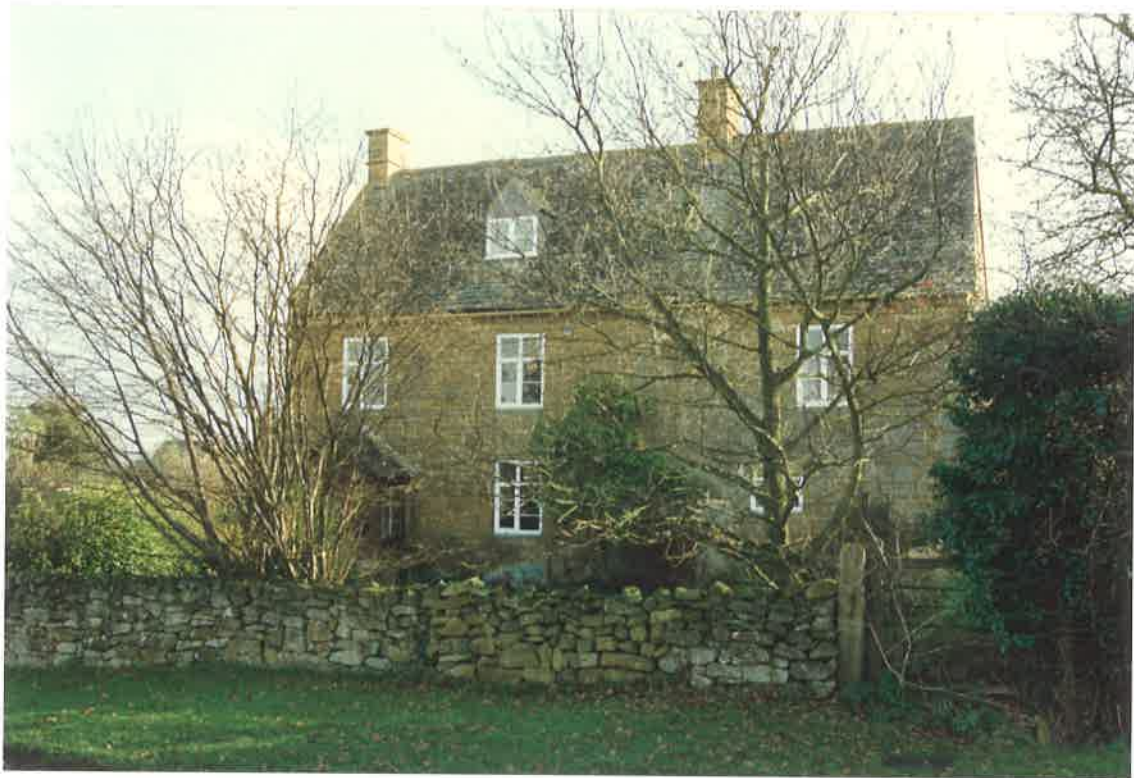
10/29.Folly Farmhouse, Back Street  
(Listed Building Ref 10/29 - Grade II)

List description : Farmhouse. Early and mid C18. Squared, coursed limestone with quoins and coped gable to left. Plinth to left gable end. Stone slate roof with ashlar ridge and end stacks with moulded bases and cornices. 2 storeys plus attic; 3-window range. 3-unit plan. To left a C20 door with C20 timber gabled porch. To right of door C19 cross casement with stone flat arch. To first floor a range of 3 cross casements with stone lintels and keystones. To rear ground and first floors C18 three-light leaded casements, some with original glass. 2 casements part renewed.

Interior: stone flagged floors and chamfered spine beams. 2 open fireplaces with timber bressumers. Bread oven of one fireplace bows out from main front.

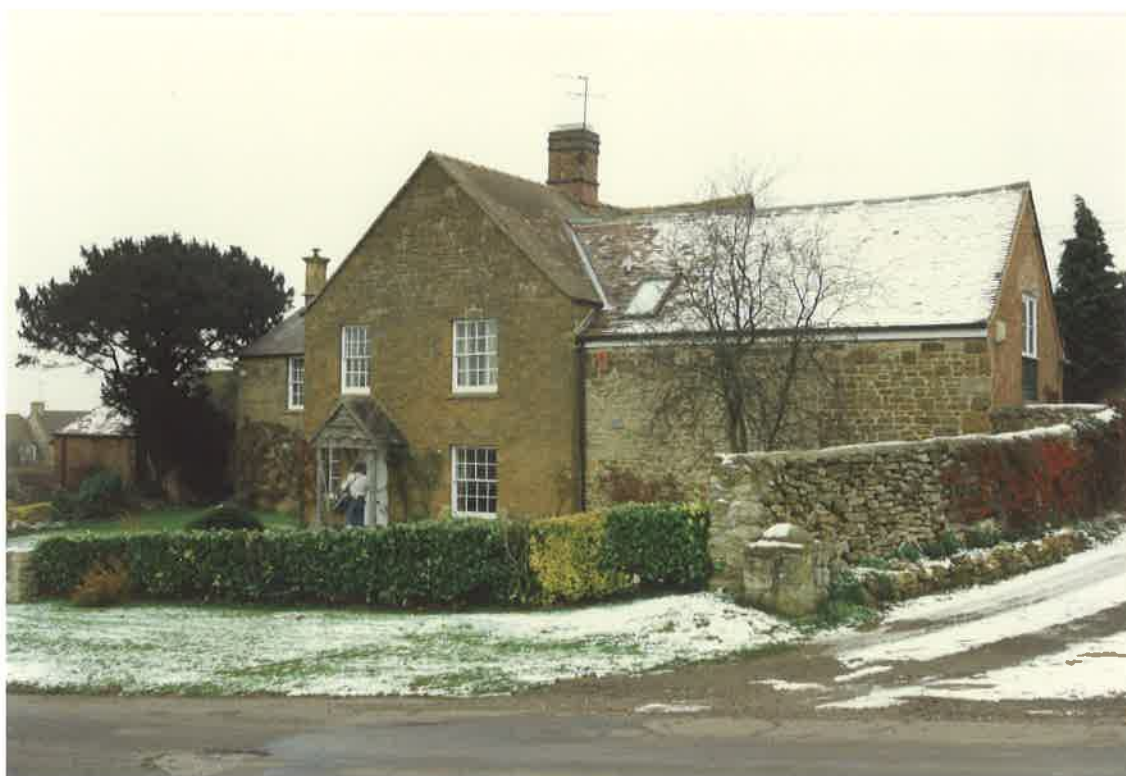
10/45. Rowney's Farmhouse, Foxcote Hill  
(Listed Building Ref 10/45 - Grade II)

*(Prominent and important farmstead group on s/e side of village)*

List description : House. Dated 1664 with early C19 extensions. Fine squared, coursed rubble with ashlar end stack. Stone slate and tile roofs. 2 storeys plus attic; 3-window range. 2-unit plan. To centre a C20 door. To left a 4-light mullioned window with king mullion. To right a C20 three-light casement. To first floor a range of three 3-light mullioned windows. Above, to left and right a small C17 stone gable, each with a 2-light mullioned window. All mullioned windows have hood moulds with label stops. Above door a moulded datestone inscribed 'JOHN/ROWNEY/1664'. Further 2-light mullioned window with hood mould, and lead 'Britannia' firemark to left gable end. Attached to right a 2-storey, early C19 stone range. Further early C19 stone range to rear (now front). Interior not inspected but likely to be of interest.

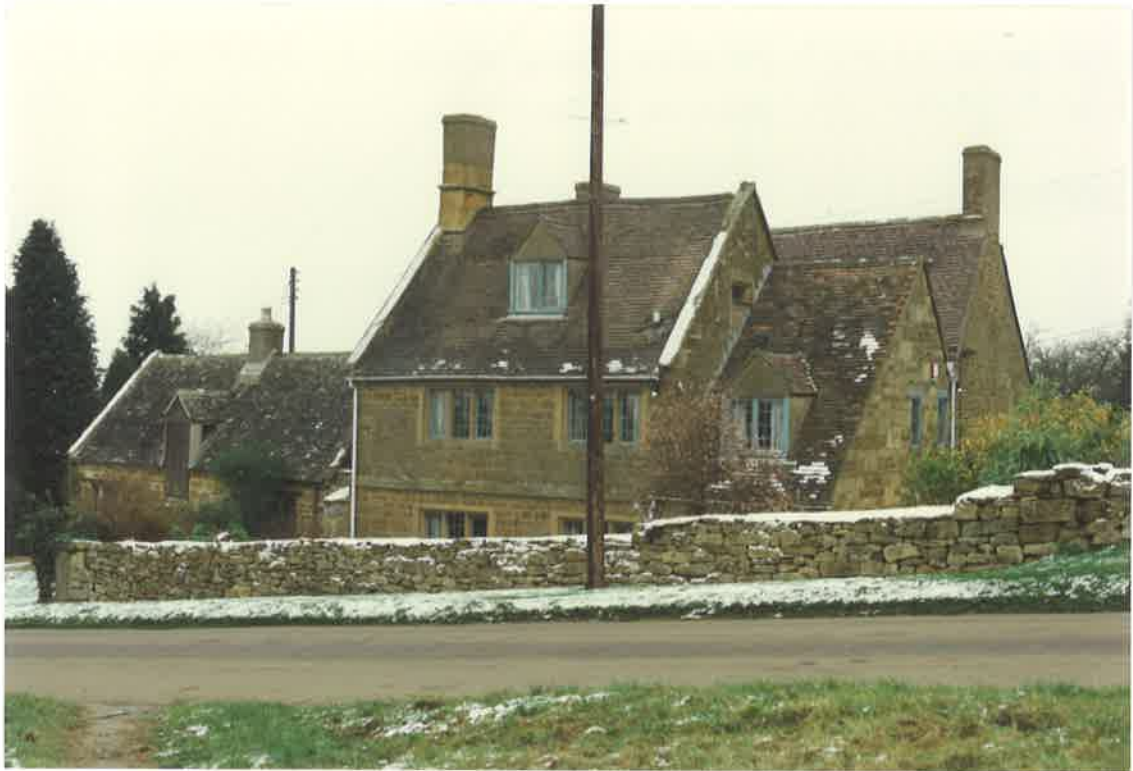
10/47.Ye Olde Foxe House, Foxcote Hill  
(Listed Building Ref 10/47 - Grade II)

*(fine cotswold stone house prominent on Foxcote Hill)*

List description : House. Late C17. Squared, coursed limestone with storey band and coped gables. Tile roof with ashlar and concrete rendered end stacks. 2 storeys plus attic; 2-window range. L-shaped plan. To left and right of ground and first floor a 3-light mullioned window. C20 gabled dormer. To left gable end a small window of 2 pointed lights. C17 range to rear. Interior not inspected but likely to be of interest.

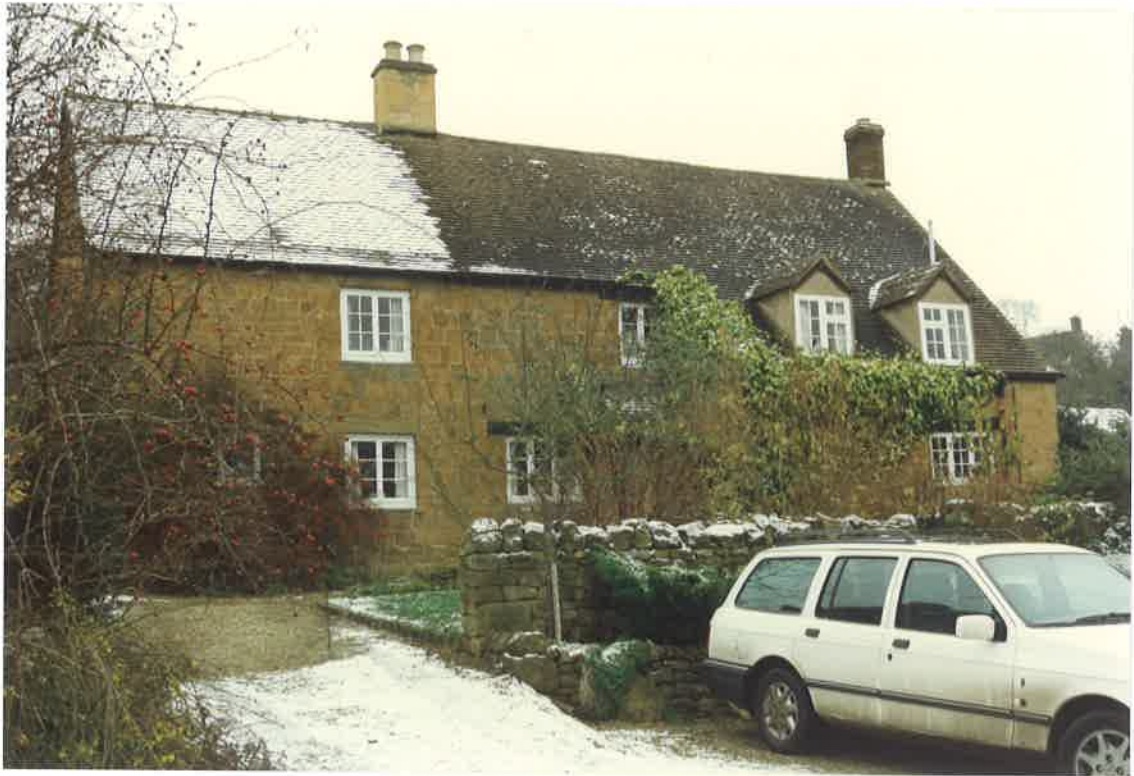
9/48 Park Farmhouse, Frog Lane  
(Listed Building Ref 9/48 - Grade II)

List description : House. Mid/late C18. Fine squared limestone with quoins. C20 tile roof with stone ridge and brick end stacks. 2 storeys; 4-window range. 3-unit plan. To centre a plank door with C20 hood. To left of door and above a 3-light casement with wood lintel. To ground and first floor left a 2-light casement with stone lintel. Further single casement to far left. Range to right of door projects slightly with catslide roof. To right a 3-light casement with wood lintel. Two C20 dormers.

Interior: noted as having chamfered spine beam and large open fireplace with chamfered stone jambs and chamfered timber bressumer.

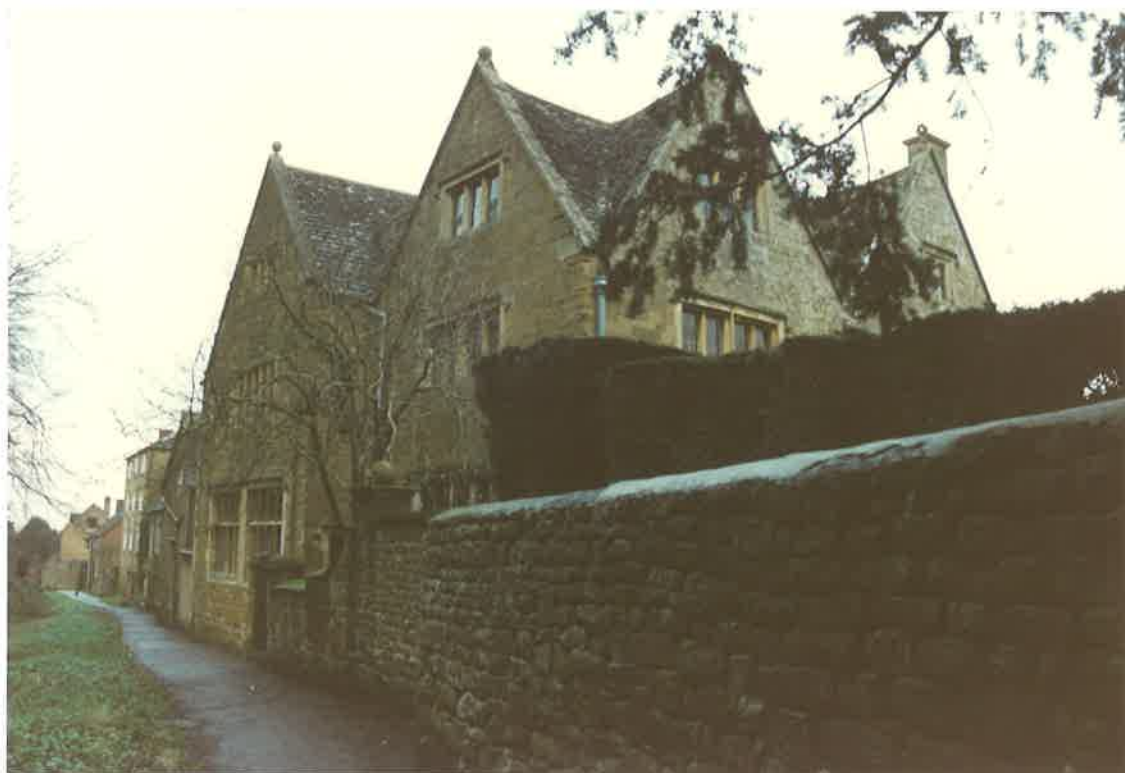
10/52. Ilmington Manor and attached barn, Front Street  
[Formerly listed as Ilmington Manor House]  
(Listed Building Ref 10/52 - Grade II\*)

*(Key building in village and in centre of conservation area - important garden area and enclosing stone boundary walls.)*

List description : Manor house. Early/mid C16, with early C20 additions. Limestone ashlar with quoins and coped gables. Stone slate roof with ashlar end stack and large external stack; the flues diagonally set, with moulded plinth and cornice. 2 storeys plus attic; 4-window range, with 3 gables rising to ridge level. L-shaped plan, with early C20 wing to rear. To centre right a C20 plank door within 4-centred, moulded surround with carved face on lintel. To ground floor a range of three 2, 3 and 4-light ovolo-moulded mullioned windows, that with 4 lights to right with king mullion. Further double-chamfered 4-light mullioned window to left. To first floor a range of one 2-light and two 3-light double-chamfered mullioned windows with further 4-light ovolo-moulded mullioned window to right with king mullion. Gables to left and centre have double-chamfered 2-light mullioned windows; that in gable to right a 3-light ovolo-moulded mullioned window. All mullioned windows have hood moulds with label stops and most have some or all old glass in their leaded lights. Left facade of 2 gables has a 4-light mullioned and transomed ovolo-moulded window to ground floor left with a

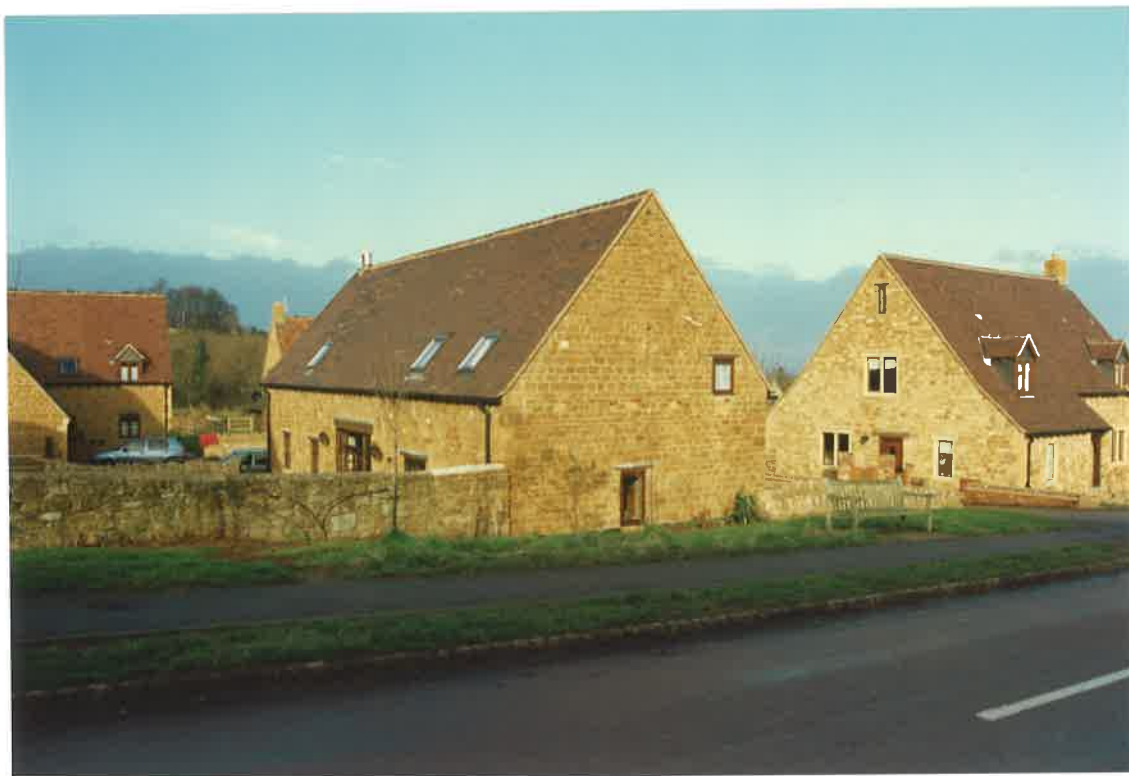
10/50. Barn approx. 12m. NE of Bay Tree Barn (not included) Front Street.  
(Listed Building Ref 10/50 - Grade II)

*(barn now converted to dwelling and part of new group of dwellings in similar style - key group on east approach into village)*

List description : Barn. Early C18. Squared, coursed limestone with slate roof. 3 bays. To centre a large opening with wood lintel. 2 long ventilation slits to either side. Larger, corresponding opening to rear, with 2 ventilation slits.

Interior: pegged queen strut roof with collars. Original purlins, the rafters replaced.

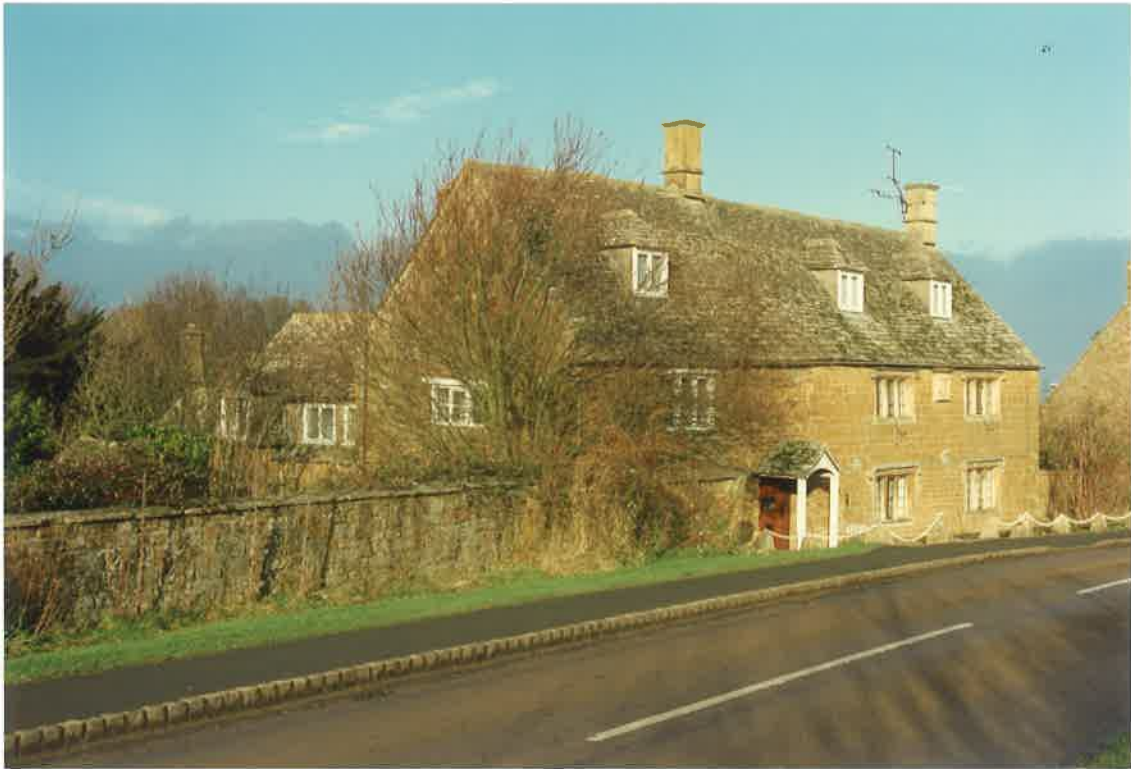
10/51.Hobdays, Front Street.  
(Listed Building Ref 10/51 - Grade II)

*(Fine Cotswold stone house - prominent position on Front street).*

List description : House. Dated 1709. Limestone ashlar with quoins. Stone slate roof with ashlar ridge and end stacks with moulded plinths and cornices. 2 storeys plus attic; 3-window range. L-shaped plan. To centre left a C20 plank door in chamfered wood surround. Original wood lintel. To ground and first floor left a wood 3-light casement with C20 leaded lights. Hood moulds and label stops of former mullioned windows. To ground and first floor centre and right a three-light mullioned window with double chamfered surround, hood mould and label stops. Small chamfered leaded light to centre of building. To first floor centre right a moulded datestone with 'S/IM/1709' inscribed in bas relief. Moulded hood above. Three C20 hipped dormers. To rear two 2-light mullioned windows with double chamfered surrounds and hood moulds with label stops. Buttress. Also to rear a C18 range with 2- and 3-light casements. C20 lean-to in angle. Interior: stone flagged floors in lobby and room to left. Chamfered spine beams with ogee stops. 2 open fireplaces with stone surrounds, one with broach-stop chamfers. Chamfered timber bressumers. C18 plank doors and winder staircase. (V.C.H.: Warwickshire, Vol.5, p.98).

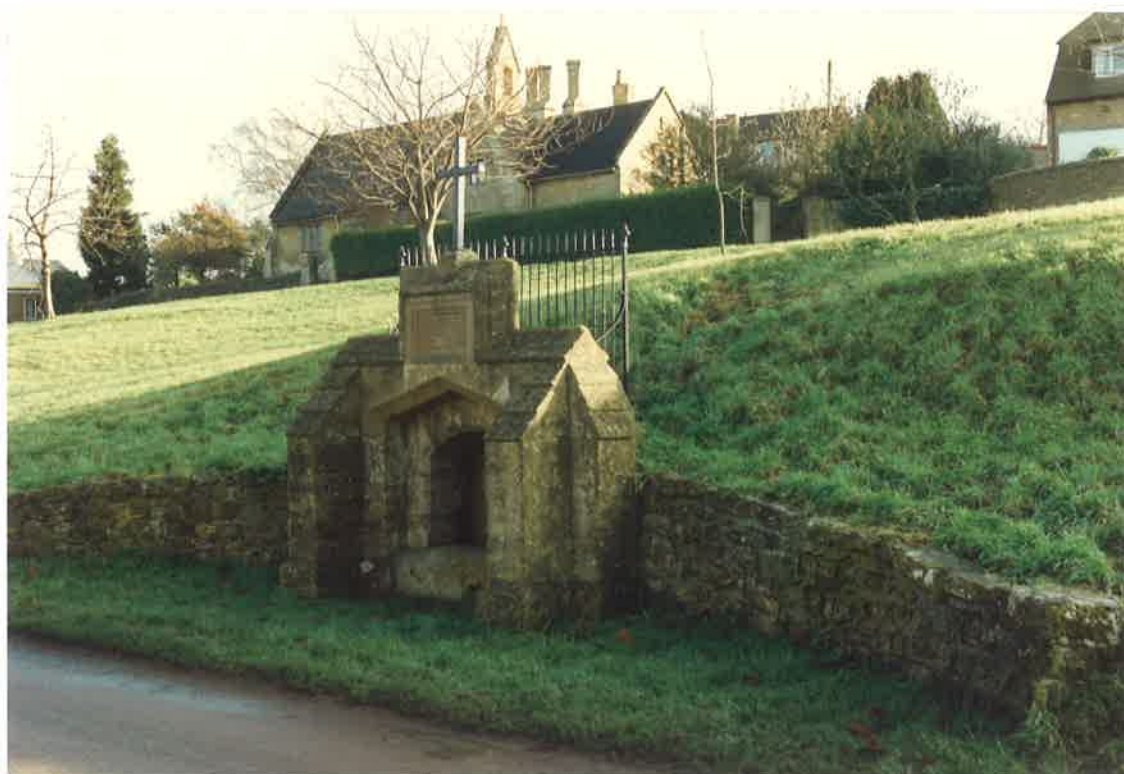
10/49. Well-head at SP 21014334, Front Street  
(Listed Building Ref 10/49 - Grade II)

*(Key feature on upper green)*

List description : Well-head. Dated 1864, restored 1920. Limestone ashlar structure has a Tudor arch with tablet above inscribed 'O all ye fountains bless ye the Lord/ This tablet commemorates the exertions of those who provided/ the blessing of pure water for/ the inhabitants of Ilmington/ Their names are enrolled in the vestry/ of the Church. The originators were/ Philip Henry Howard, Esq. Julian Charles Young M.A. RECTOR. Timothy Smith. James Bennet. George Crossley. A.D. 1864'. The structure has angle buttresses.

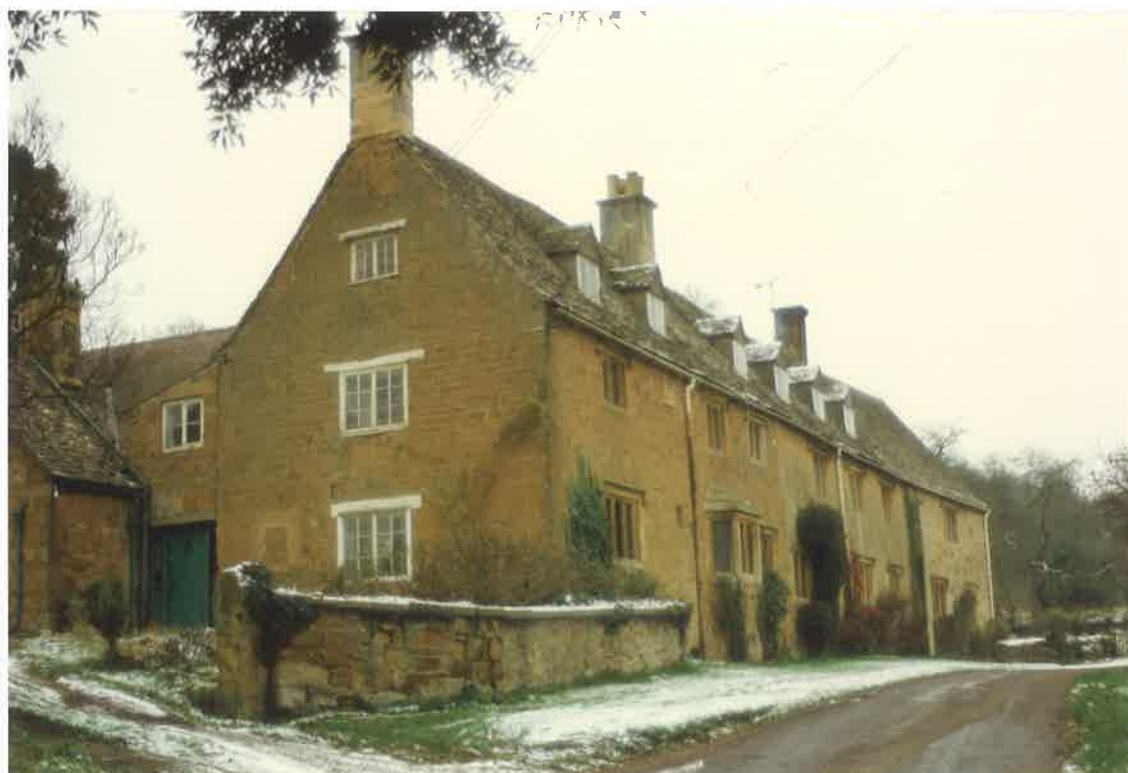
9/55 Crab Mill, Grump Street.  
(Listed Building Ref 9/55 - Grade II)

*(long stone terraced house in high prominent position overlooking s/w end of village)*

List description : House, formerly an inn and 3 cottages. Dated 1711. Limestone ashlar with quoins. Stone slate roof with ashlar ridge and end stacks. 2 storeys plus attic. 6-window range. To ground floor a range of six 2- and 3-light mullioned windows, and one later stone canted bay with mullioned window. To first floor a range of six 2- and 3-light mullioned windows. All windows have hood moulds and label stops, some windows restored. 6 gabled dormers. To first floor left a moulded datestone inscribed: 'V.G.H./1711'. Early C20 range in imitative style to right. Lead firemark, possibly Phoenix, inscribed 'PROTECTION'. Blocked light to left gable end. Further C20 stone ranges to rear.
