STRATFORD ON AVON DISTRICT COUNCIL

CONSERVATION AREA REVIEWS

ILMINGTON

August 1995

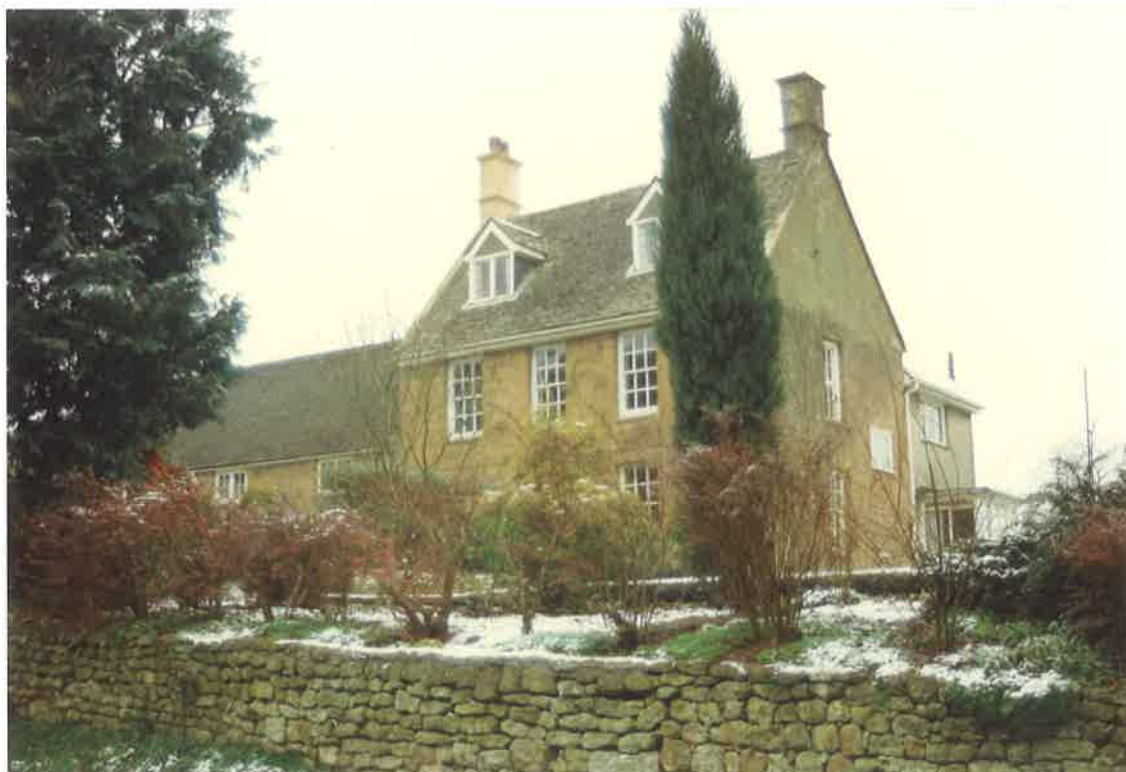
9/53 The Grey House, Grump Street  
(Listed Building Ref 9/53 - Grade II)

List description : House. Mid C18. Limestone ashlar and squared, coursed rubble, with storey band and coped gables. Stone slate roof with ashlar end stacks on moulded plinths. 2 storeys plus attic; 3-window range. To centre, the original 6-panelled door, the top 2 panels now glazed. Lintel with keystone. To left and right a 12-pane sash. To first floor a range of 3 twelve-pane sashes. All windows have lintels with keystones and stone sills. 2 gabled dormers. Further sashes to right gable end. Large C20 range to rear is not of special architectural interest. Interior not inspected but likely to be of interest.

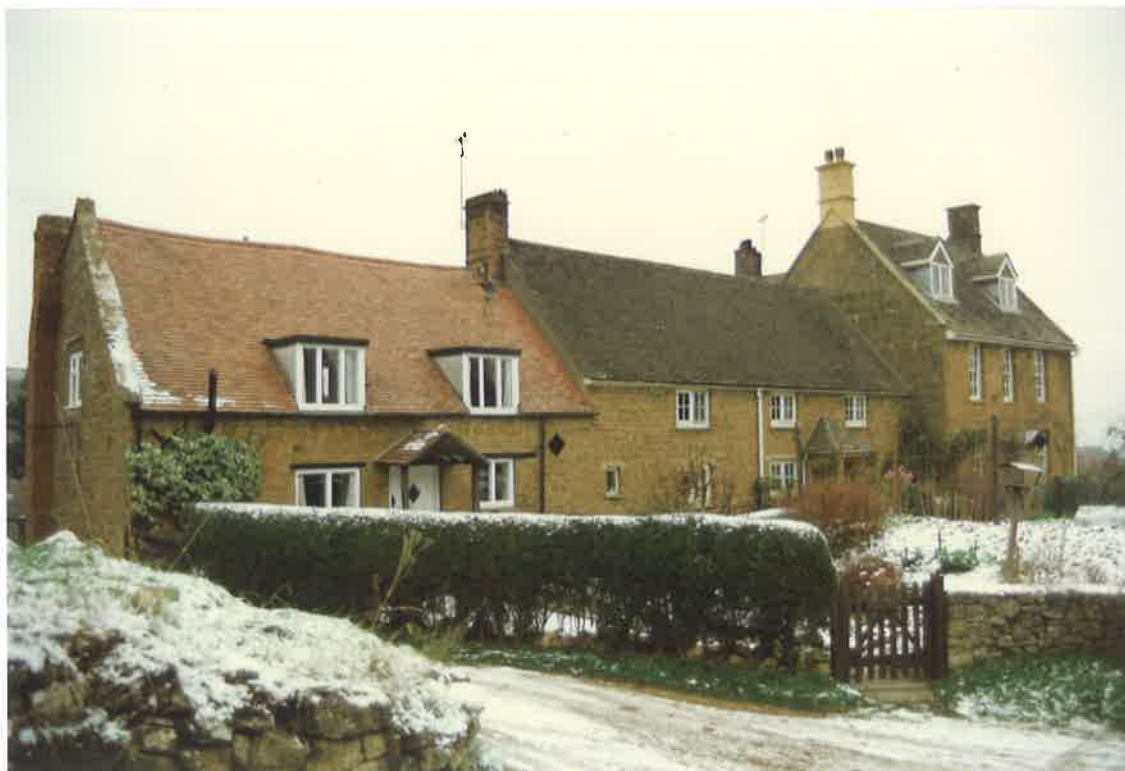
9/54 1 and 2 Springfield Cottages, Grump Street  
(Listed Building Ref 9/54 - Grade II)

*(part of important group of building at top of Grump Street)*

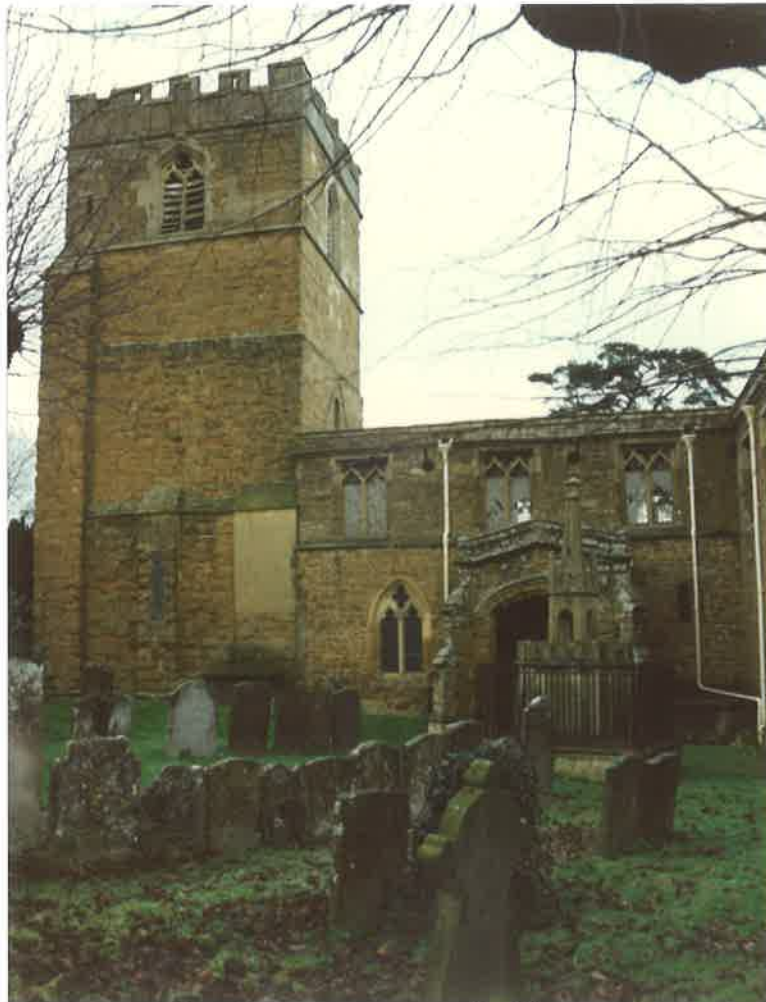
9/65 Church of St. Mary, Middle Street  
(Listed Building Ref 9/65 - Grade I)

*(prominent location in centre of village - most important building in conservation area)*

To east and west square-headed, 2-light window with iron transoms and mullion ending in spear head. 4-centred arched doorway with chamfered and hollow-chamfered surround. Above, the remains of the C12 arch with zig-zag mould. C15 cusped niche with poppy head, broken through C12 arch. C20 plank door with carved mouse on surround. To right of porch a doorway of 2 orders with shaft and capital, now blocked, with leaded window. To left of porch a C14 two-light window with reticulated tracery and double-chamfered surround. Clerestory to north and south has three 2-light cusped square-headed windows with double chamfered surrounds. North transept is C13, enlarged C15 and has diagonal offset buttresses, coped parapet and plinth. To north a C19 three-light window in Decorated style. To east and west two C15 two-light square-headed windows with hood mould and carved label stops. C19 three-light window to east in Decorated style. C15 south transept, almost entirely rebuilt C19, has Perpendicular style windows to east and west, with a 3-light window to south in Decorated style. West tower of 3 stages, the first 2 stages are C12 with broad, flat buttresses and C12 round-headed lancets to south and west. C15 top stage has castellated parapet with a gargoyle below to each side. C15 two-light cusped bell-chamber windows with stone slate louvres. C12 stair turret has single lights to west with a further C15 light to top stage. Painted sundial to south face of tower, with clock to west dated 1868.

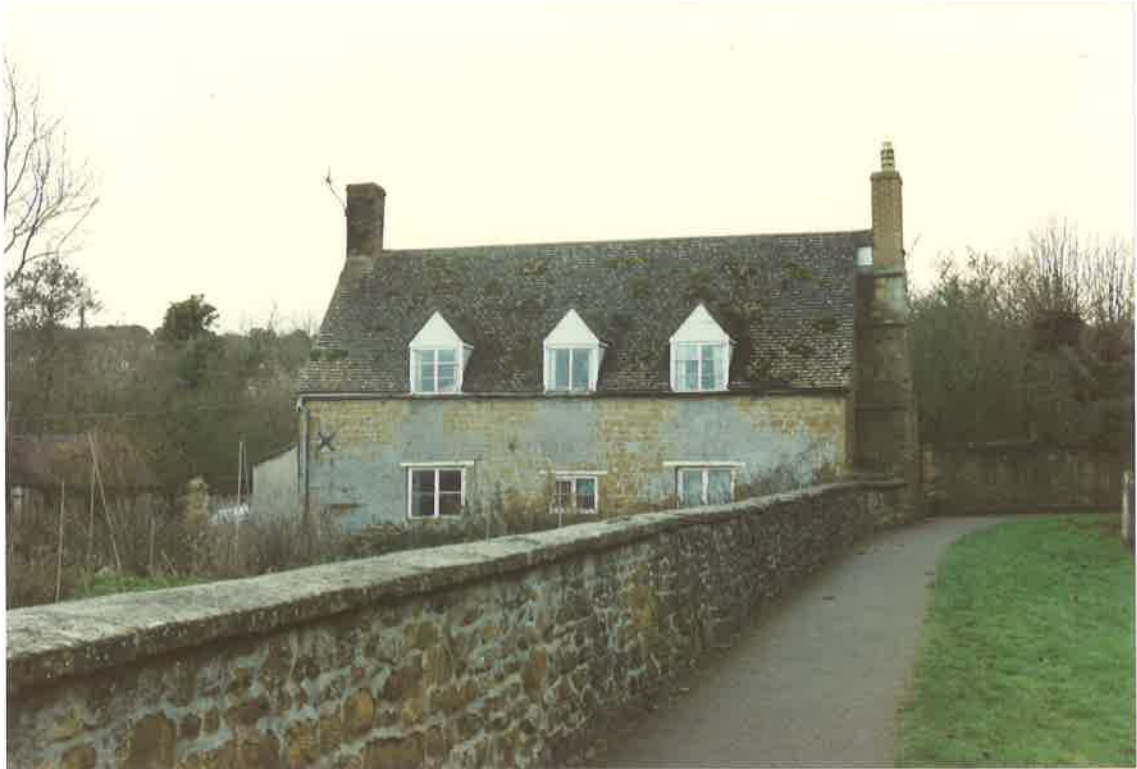
9/59 Glebe Cottage, Middle Street  
(Listed Building Ref 9/59 - Grade II)

*(key building - little altered - in corner of churchyard area)*

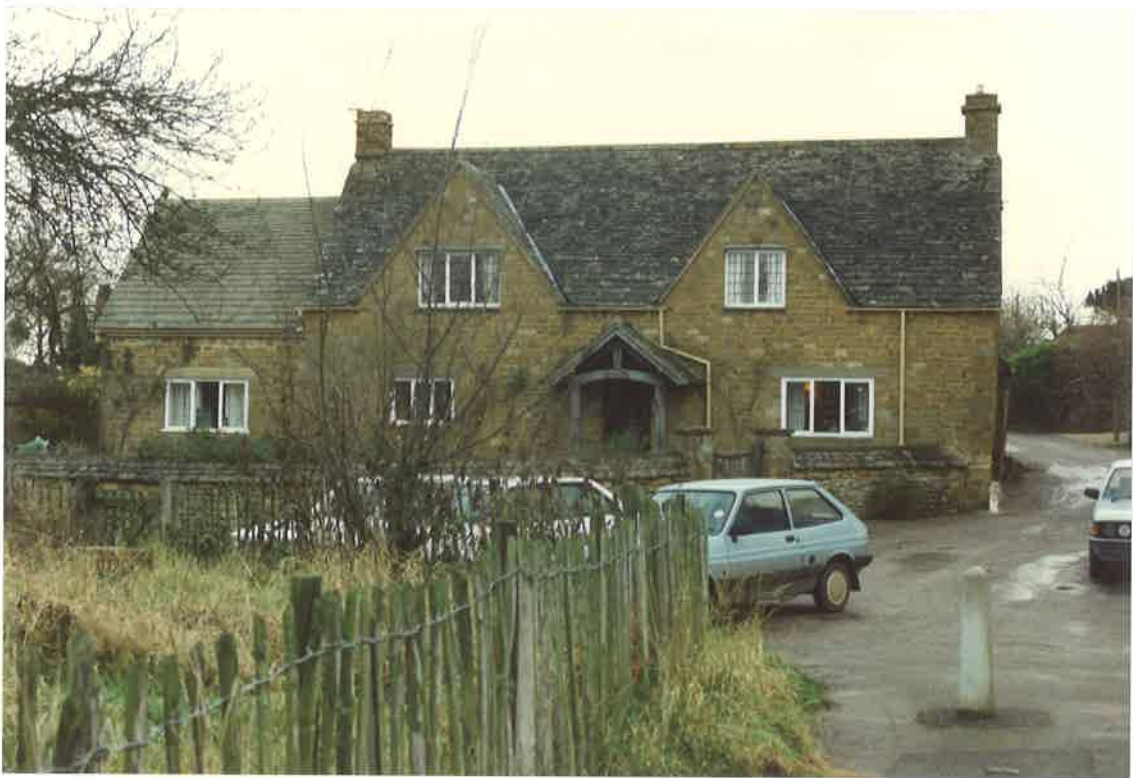
10/58. The Grey Cottage, Middle Street  
(Listed Building Ref 10/58 - Grade II)

List description : Cottage. C17, restored C20. Squared, coursed limestone with stone slate roof. Stone end stacks. One storey plus attic; 2-window range. 2-unit plan. To centre a C20 door and C20 gabled timber porch. To left and right a C20 three-light casement, that to right with concrete lintel. To left and right a gable, that to left with 3-light casement, that to right with 2-light casement, both C20. To left a C20 one-storey stone range. Interior: some stone flagged floors, chamfered spine beams and timber and plaster partition. 2 large open fireplaces with timber bressumers, each chamfered, with ogee stops. Included for group value only.

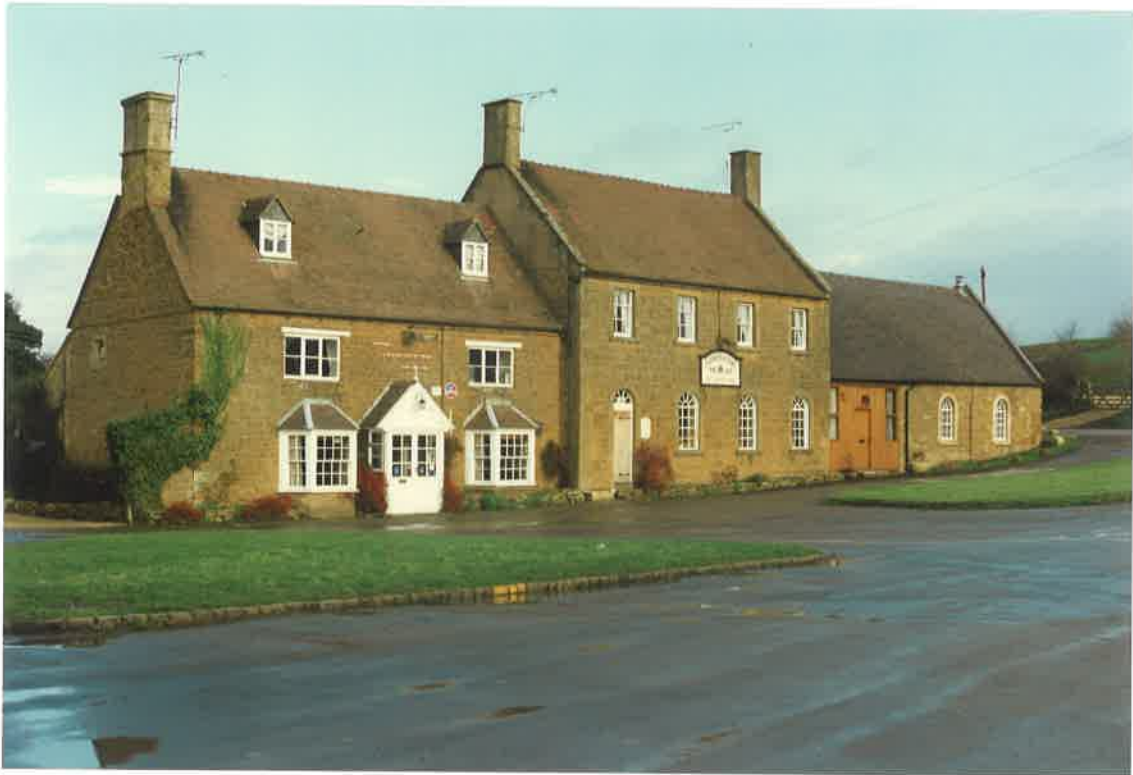
10/60. The Howard Arms Inn and attached outbuilding,  
Middle Street  
(Listed Building Ref 10/60 - Grade II)

*(Large imposing building group on Lower Green - key building on east side of village)*

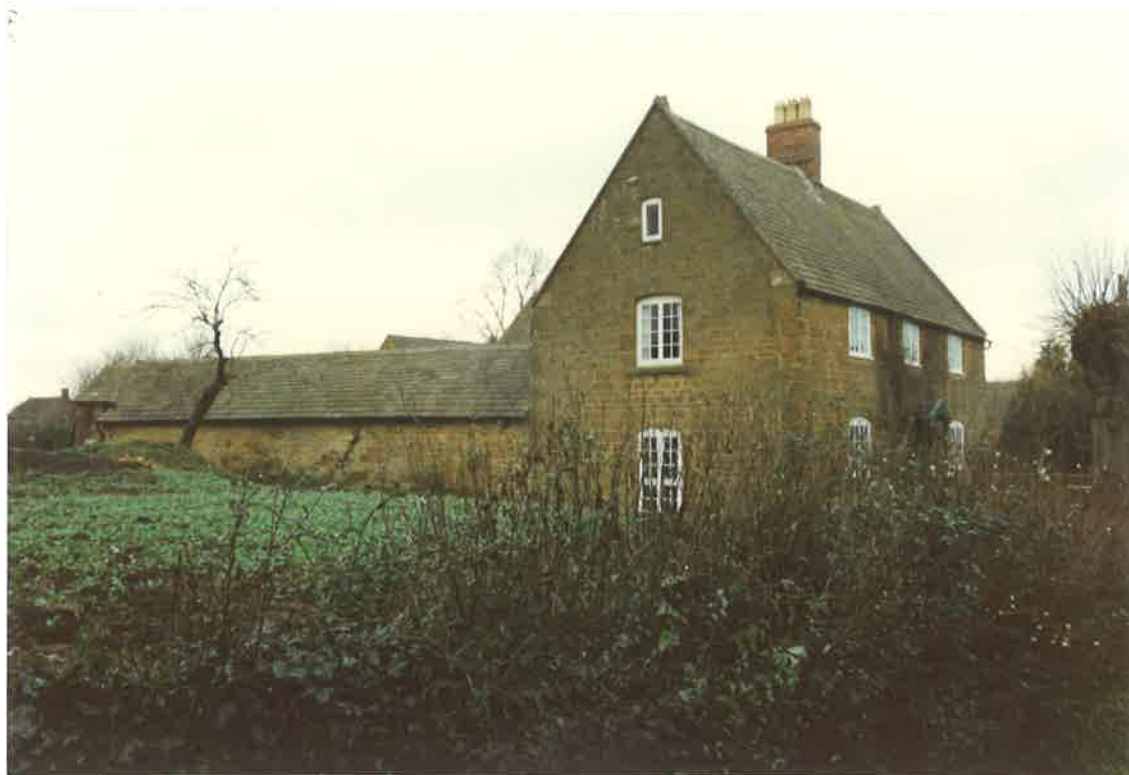
10/64. Wharf Farm House, Middle Street  
(Listed Building Ref 10/64 - Grade II)

List description : Farmhouse. Mid/late C18. Squared, coursed limestone with quoins and coped gables. Artificial stone slate roof with brick ridge stack. 2 storeys; 2-window range. 2-unit plan. To centre a C19 four-panelled door with overhead light and brick arch. Lattice porch. To left and right a 2-light, 12-pane casement with segmental arch. To first floor a range of three 2-light, 12-pane casements. C19 stone and brick kitchen range to rear. Interior not inspected.

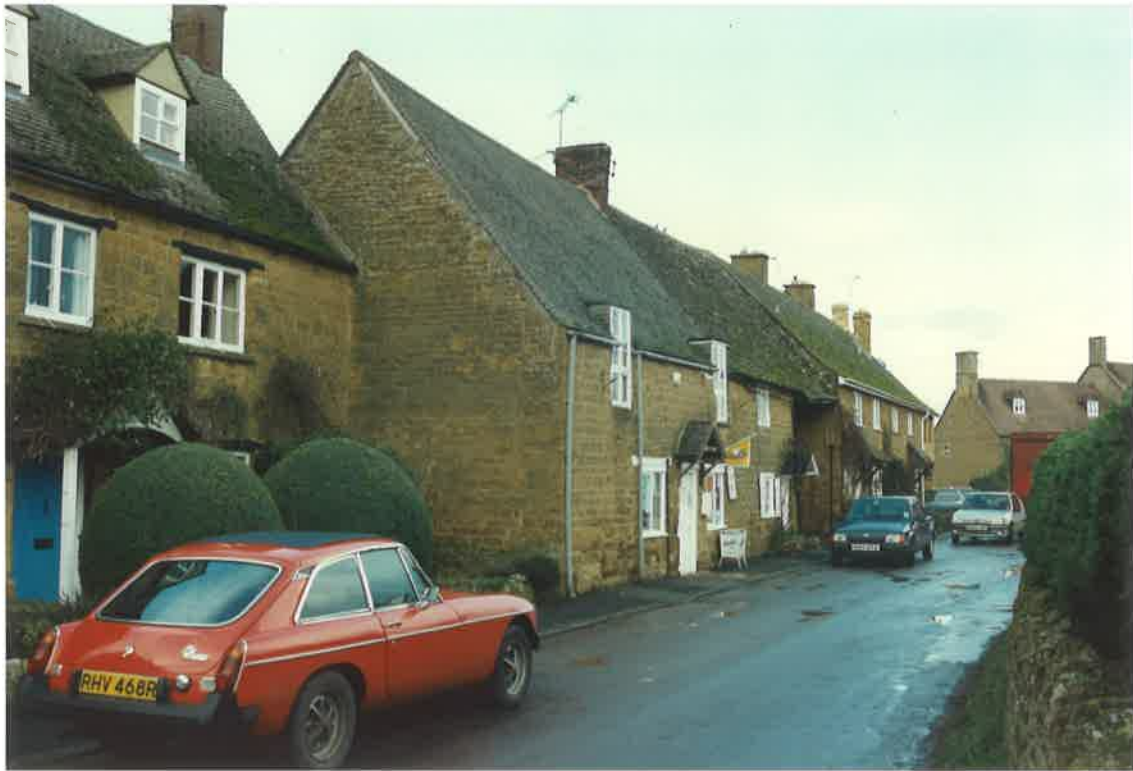
10/62. The Cottage and attached shop, Middle Street  
(Listed Building Ref 10/62 - Grade II)

*(Roof over carriageway through terrace is a key feature in the street)*

Interior: shop retains chamfered spine beam with run-out stops, though rear opened up. The Cottage is noted as having ceiling beams. Included for group value.

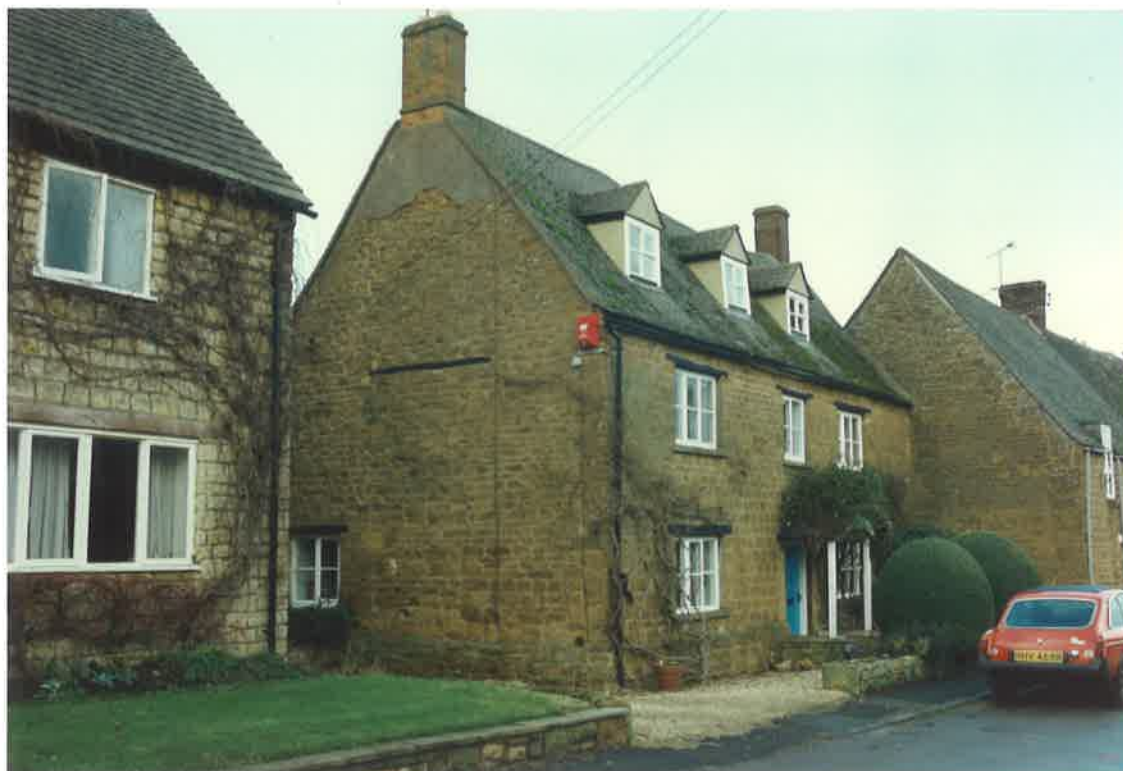
10/63.Rivendell, Middle Street  
(Listed Building Ref 10/63 - Grade II)

List description : House. Mid/late C18. Squared, coursed limestone with quoins. C20 tile roof with brick end stacks. 2 storeys plus attic; 3-window range. 2-unit plan. To centre a plank door with gabled hood. To left, and to first floor left and right a 3-light casement with wood lintel to ground floor right. 2-light casement to first floor centre, with wood lintel. Three C20 gabled dormers. C20 stone lean-to to rear. Interior not inspected but likely to be of interest.

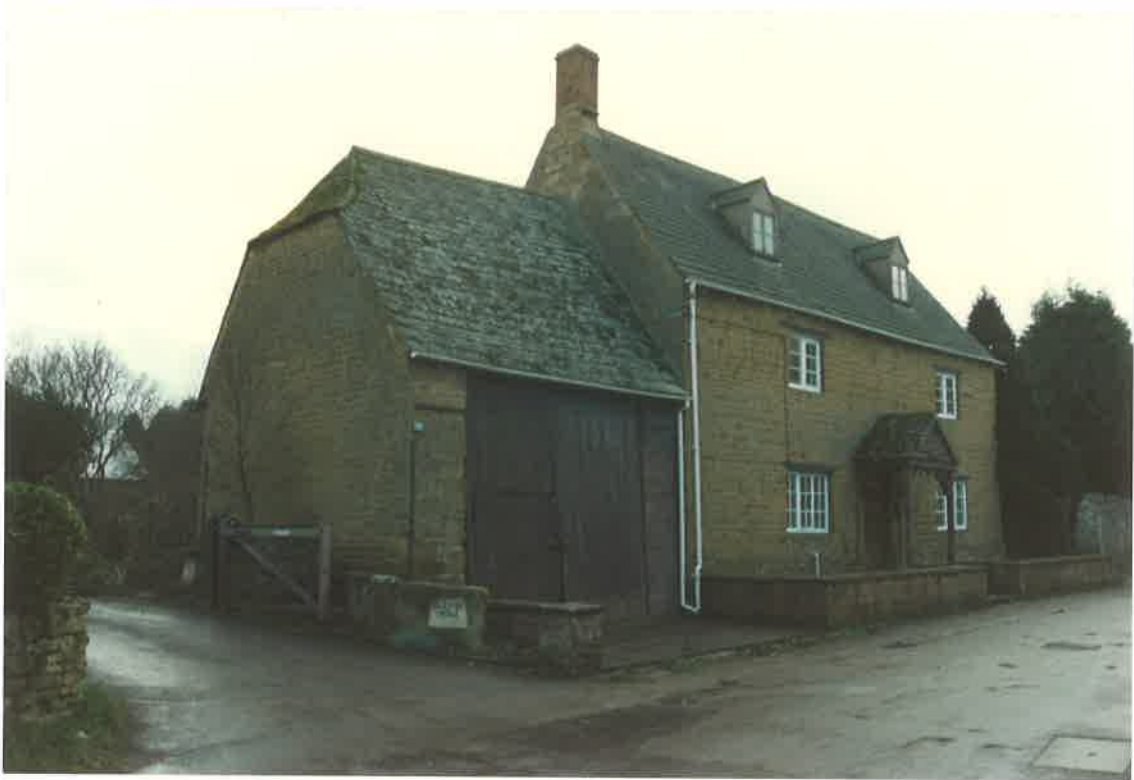
10/57. Middle Meadow and attached outbuilding,  
Middle Street  
(Listed Building Ref 10/57 - Grade II)

*(important building - encloses street on south side)*

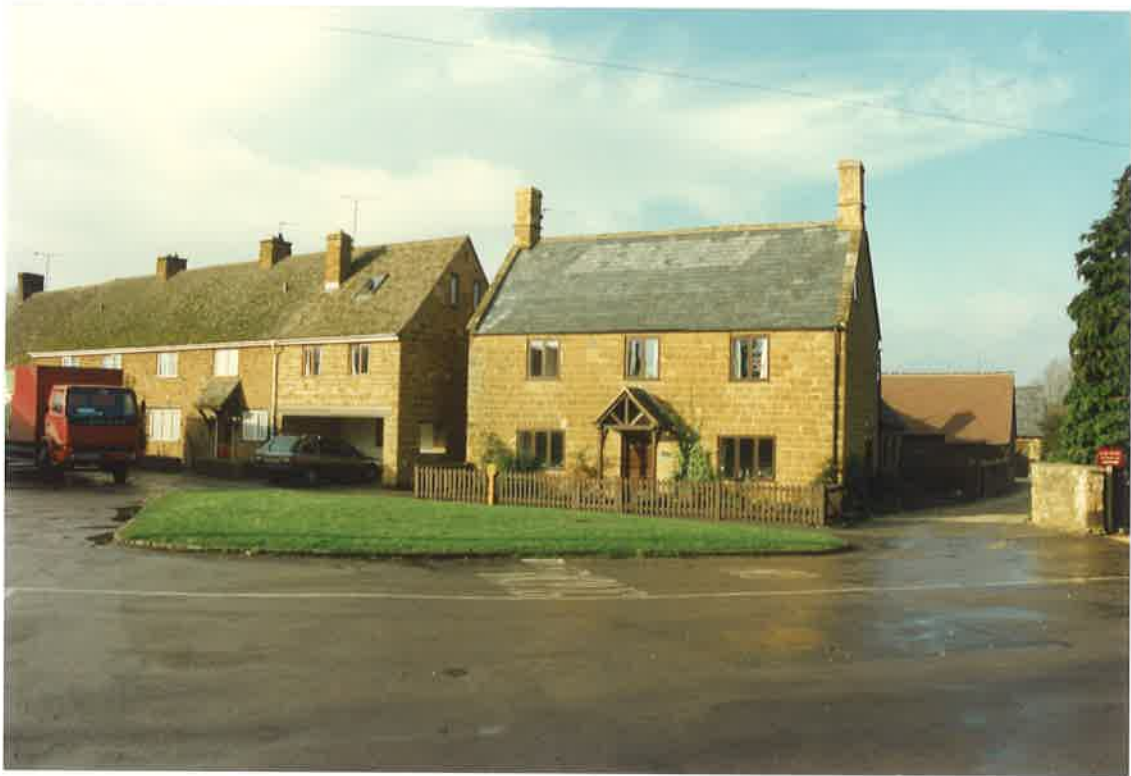
10/61.Vine Cottage and attached outbuilding range,  
Middle Street  
(Listed Building Ref 10/61 - Grade II)

*(unfortunately modernised with inappropriate windows)*

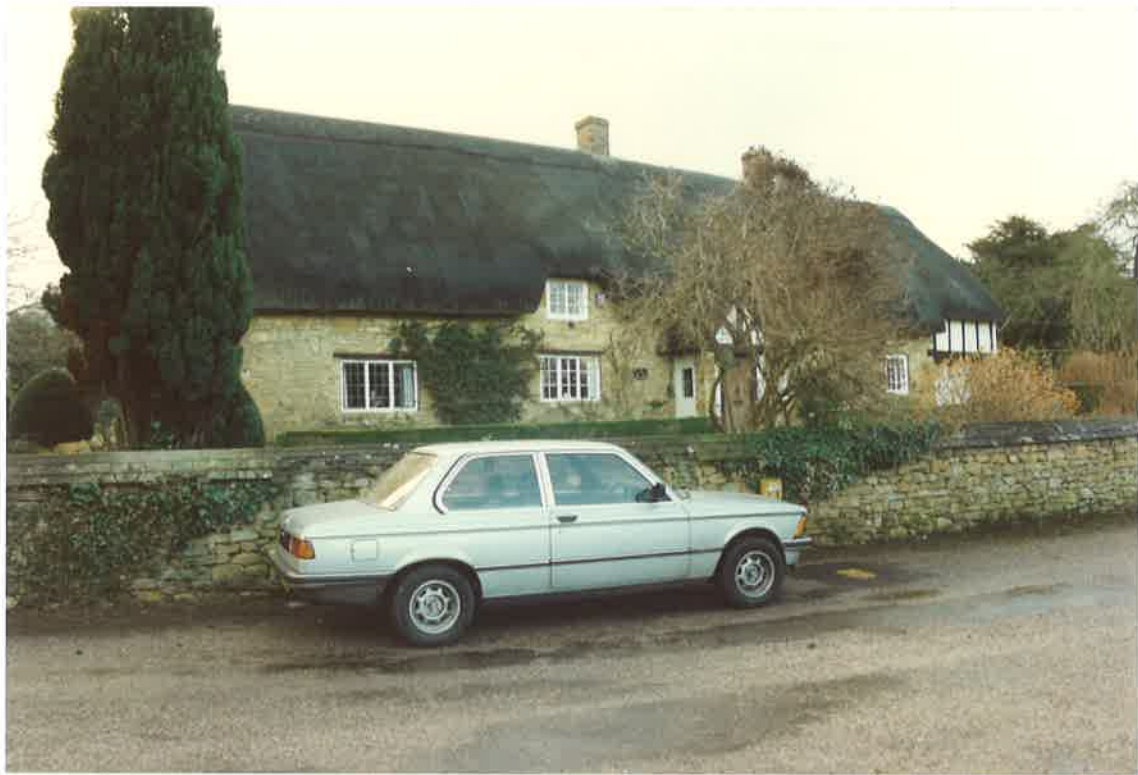
10/74. Bevingtons, Valenders Lane  
(Listed Building Ref 10/74 - Grade II)

List description : Shown as The Bevington on Ordnance Survey map. House, possibly once 2 cottages. Mid C18. Squared, coursed limestone with thatch roof. Stone end stack, with brick ridge stacks. One storey plus attic; 4-window range. 4-unit plan. To centre a C20 gabled stone and thatch porch with C20 plank door. To left a 3-light, 18-pane casement with wood lintels. C20 three-light casement with leaded lights to far left, and to right of door. Further 2-light, 16-pane casement to right with round-headed arch. 2 swept dormers of 2-light, 12-pane casements. C20 stone and timber range to right.

Interior: noted as having spine beams and 2 large open fireplaces.

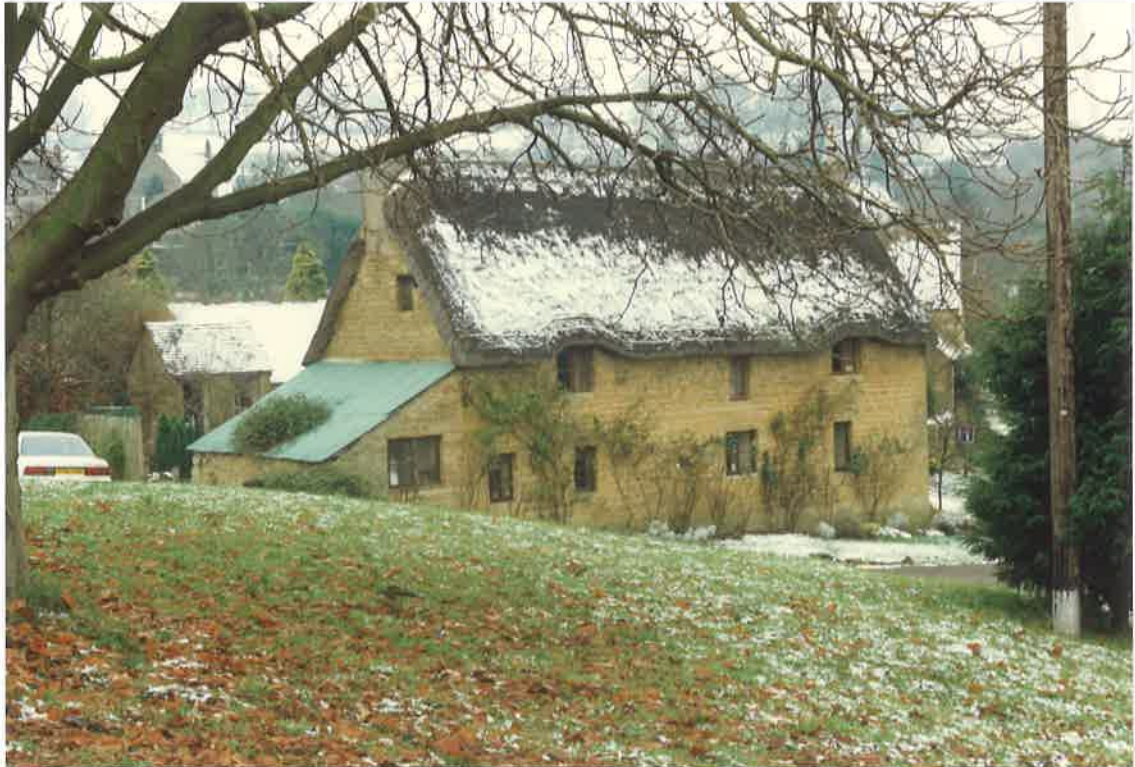
9/73 Thatch Cottage, Upper Green  
(Listed Building Ref 9/73 - Grade II)

*(Key building on Upper Green)*

List description : House. Early C18. Squared, coursed limestone with quoins. Thatch roof and brick end stacks. 2 storeys; 3-window range. To ground floor a range of 4 one- and 2-light C20 casements. Range of 3 one- and 2-light C20 casements to first floor. All windows in their original openings. Small casement in left gable end, with stone lean-to below. Small casement in right gable end. C20 doors and casements with original chamfered wood lintels to rear. Also to rear a C20 rendered and thatched brick range. Interior: noted as having 2 open fireplaces with chamfered timber bressumers, and chamfered spine beams with run-out stops.

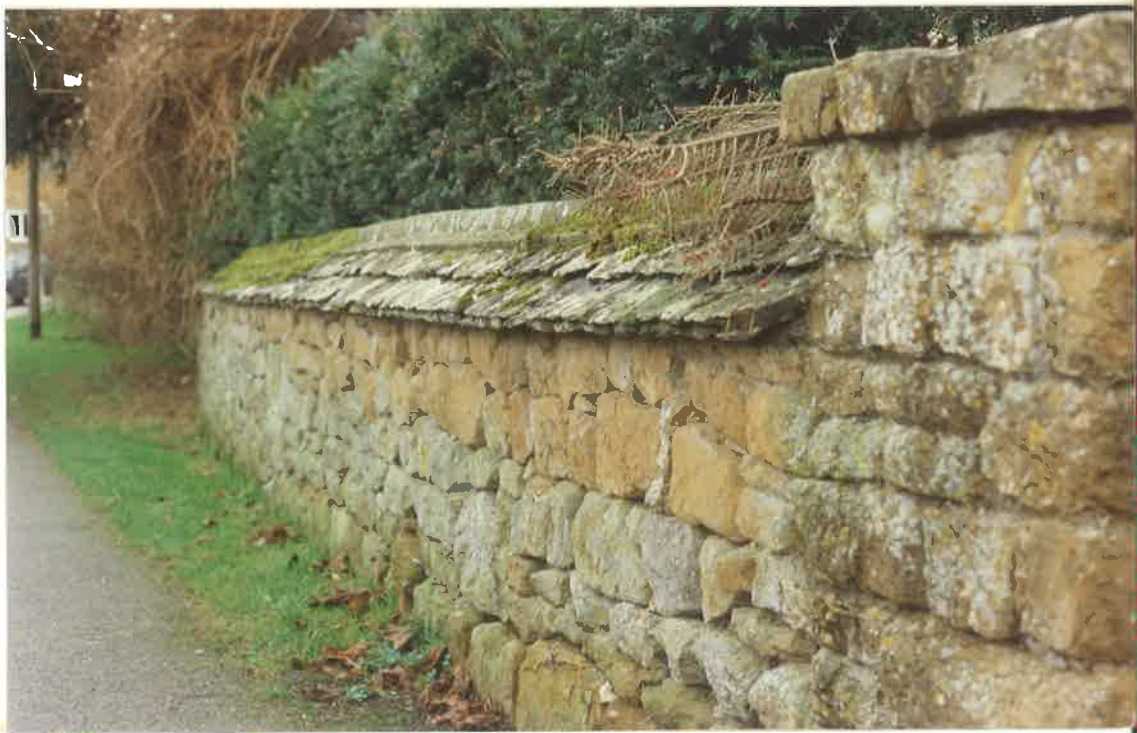
21

21. The wall to Church Cottage, one of the many types of stone detailing found in the village and a very good example of a two-tier pitched stone coping on a squared coursed rubble stone wall.
