STRATFORD ON AVON DISTRICT COUNCIL

CONSERVATION AREA REVIEWS

ILMINGTON

August 1995

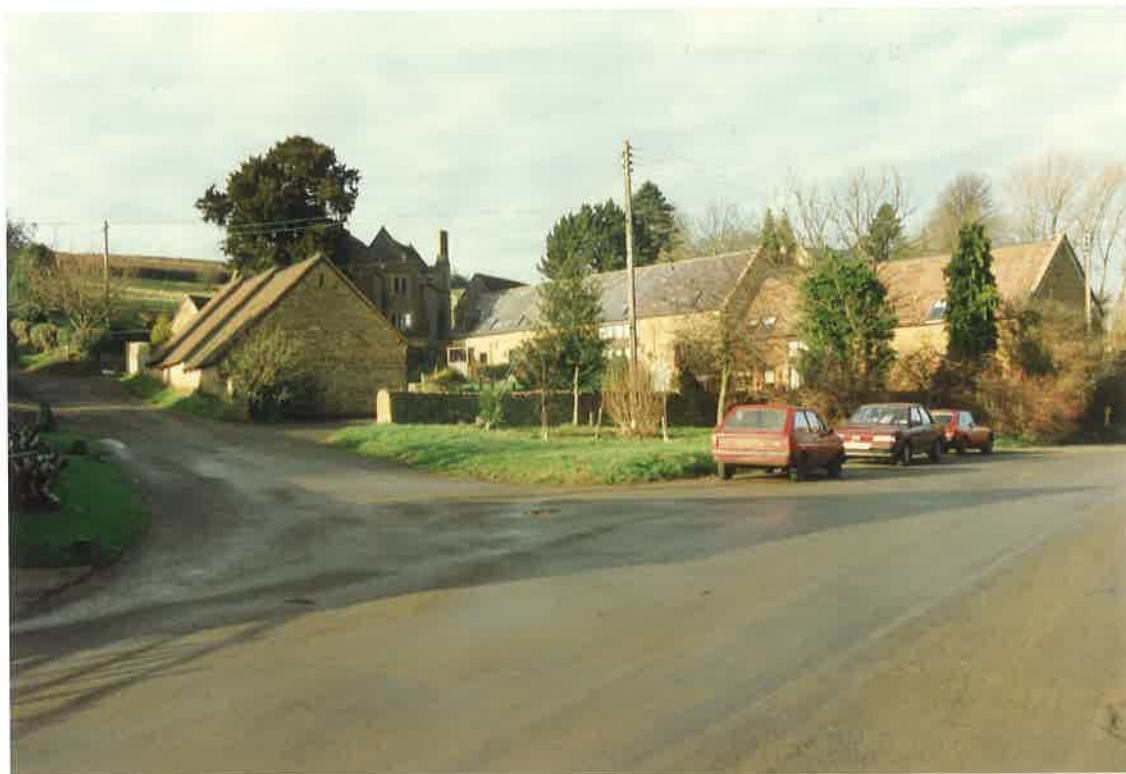
9/36 Barn approx. 5m. E of Hill Farmhouse, and attached barn, Back Street.
(Listed Building Ref 9/36 - Grade II)

(Prominent range of barns in village street - now converted to dwellings)

List description : Barn. Early C18. Squared, coursed limestone with coped gables. Slate roof. 6 bays. To centre left a large opening with corresponding opening to rear. To centre and left a round window with a stable door opening with wood lintel between, flanked by 2 small square openings. Further doorway to far left. To either side of large doorway small square ventilation holes. Attached to right a late C18 barn of squared, coursed limestone with coped gable to right and stone slate roof. 5 bays. Barn rebuilt in brick to left of a large opening, with corresponding opening to rear. Small doorway with wood lintel in brick part. Dentilled brick eaves cornice to rear. Interior: main barn has pegged queen strut roof with collars. Original purlins, rafters replaced. Attached barn has pegged queen strut roof with collars and original purlins. Stone flagged threshing floor.

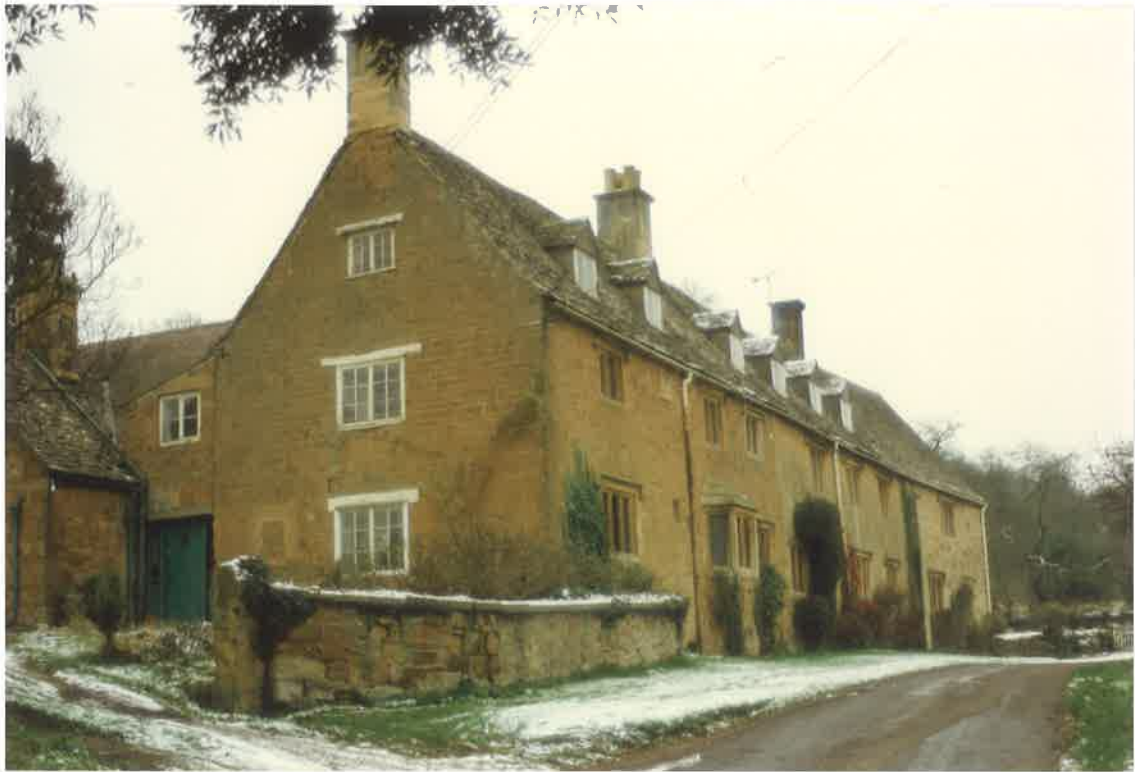
9/55 Crab Mill, Grump Street.
(Listed Building Ref 9/55 - Grade II)

(long stone terraced house in high prominent position overlooking s/w end of village)

List description : House, formerly an inn and 3 cottages. Dated 1711. Limestone ashlar with quoins. Stone slate roof with ashlar ridge and end stacks. 2 storeys plus attic. 6-window range. To ground floor a range of six 2- and 3-light mullioned windows, and one later stone canted bay with mullioned window. To first floor a range of six 2- and 3-light mullioned windows. All windows have hood moulds and label stops, some windows restored. 6 gabled dormers. To first floor left a moulded datestone inscribed: 'V.G.H./1711'. Early C20 range in imitative style to right. Lead firemark, possibly Phoenix, inscribed 'PROTECTION'. Blocked light to left gable end. Further C20 stone ranges to rear.

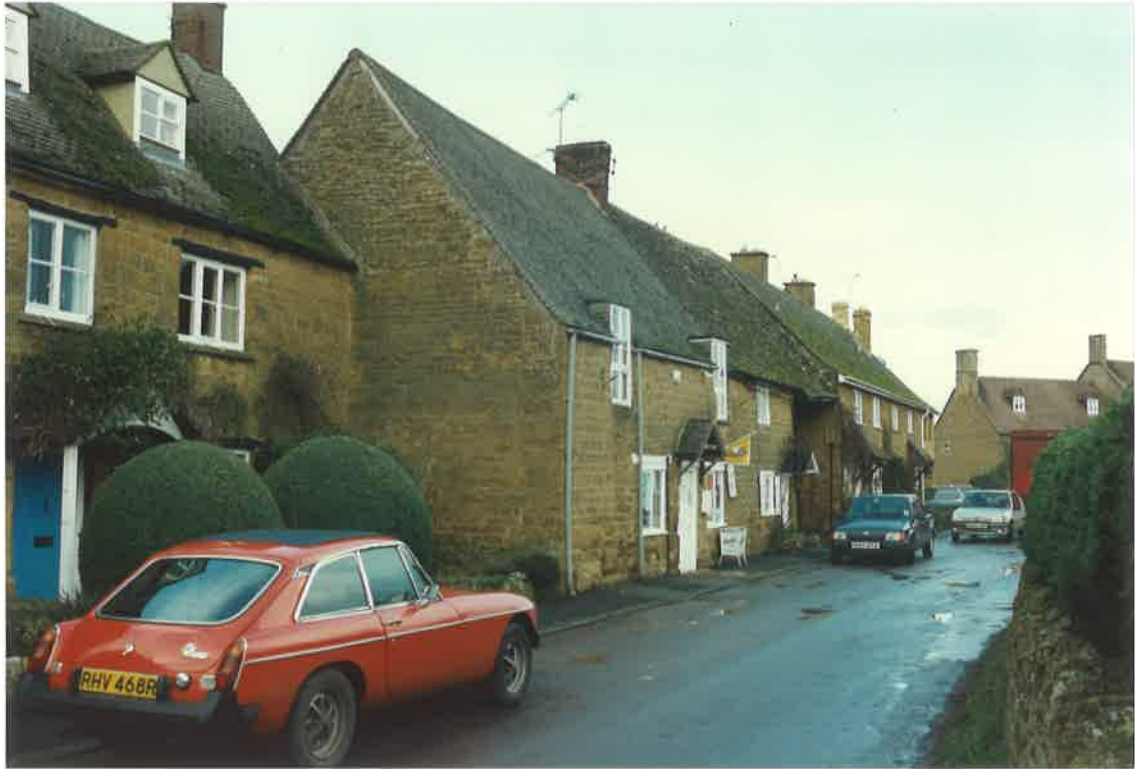
10/62. The Cottage and attached shop, Middle Street
(Listed Building Ref 10/62 - Grade II)

(Roof over carriageway through terrace is a key feature in the street)

Interior: shop retains chamfered spine beam with run-out stops, though rear opened up. The Cottage is noted as having ceiling beams. Included for group value.

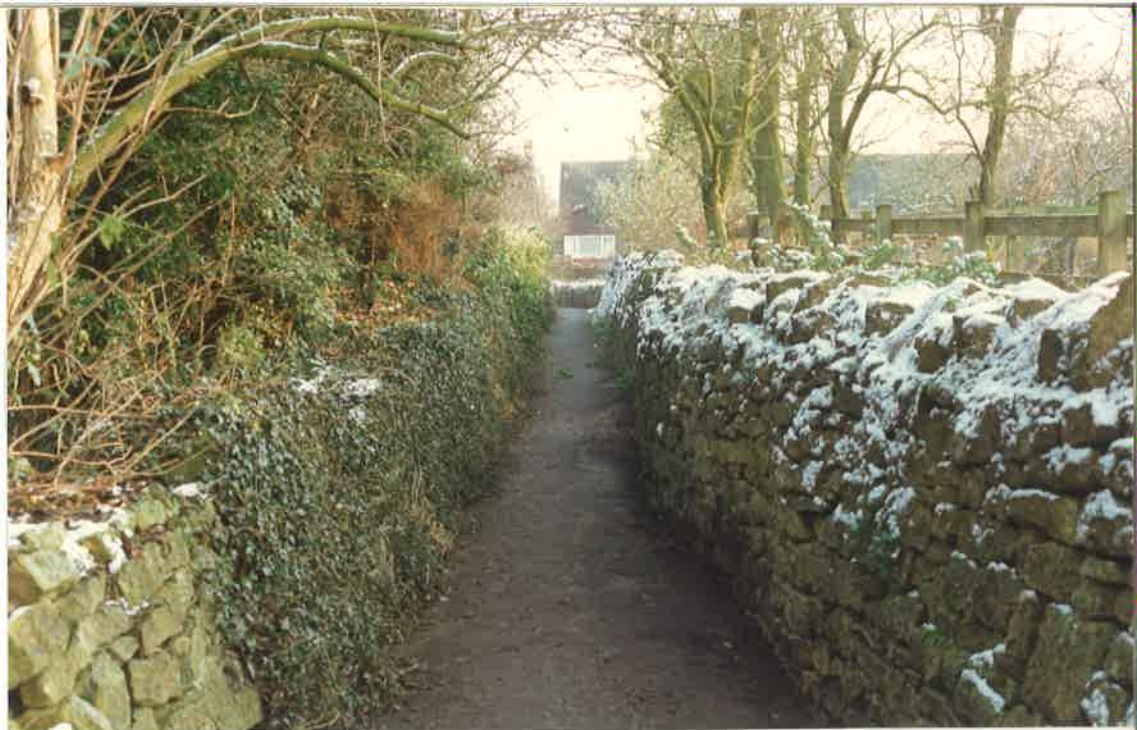
4

The whole village is served by an effective and comprehensive network of footpaths, often defined by stone walls (photo 4) or banks and hedges.

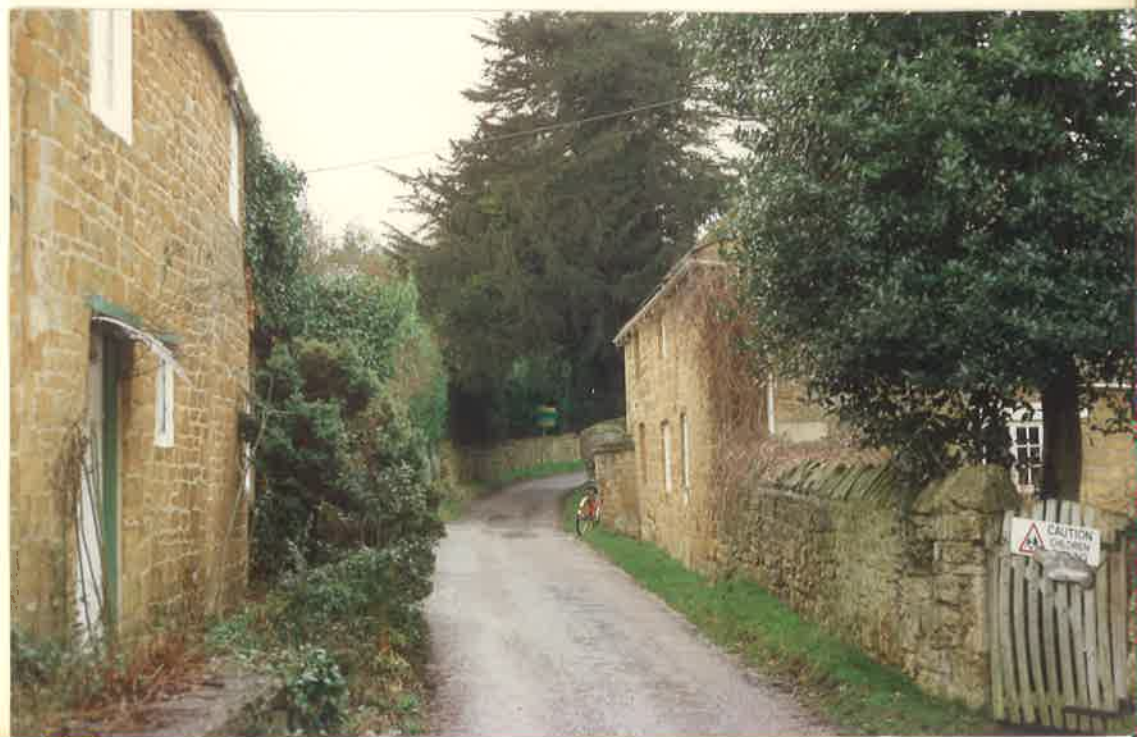
24

Within Ilmington as a whole, the variety of detail and interest created by the local stone walls, trees, enclosed spaces and tree, hedge and shrub groups is of great importance to the character of the Conservation Area and the village. The charm of the village is enhanced by the presence of the hurdle maker at Ashbourne Cottages (photo 23) whose work has permeated throughout the village with great benefit to the character of boundaries and enclosures within the village (gateway- photo 24).
