PREFACE

This report is the result of an independent survey and analysis of the buildings and landscape form of the village of Wellesbourne, Warwickshire. It identifies the architectural, historical and environmental qualities of the settlement and gives recommendations for the protection and enhancement of the Conservation Area.

Stratford-on-Avon District Council by

Alan Smith and Partners

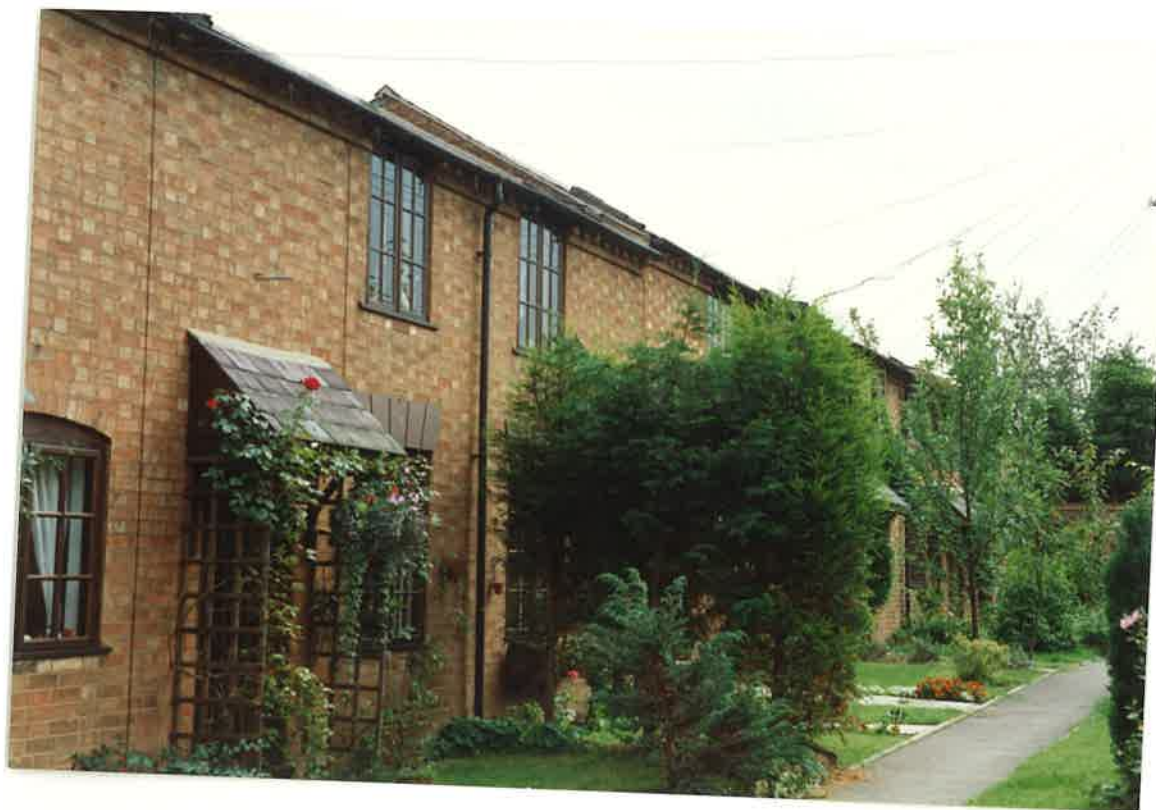
**<< fig 4. Garden Terrace, Bldg 132,
Tree 102**

Garden Terrace and Garden Row, **figs 13 & 14**, reached by a narrow street and a footpath, is a recently successfully refurbished group of nineteenth century terraced dwellings set in delightful cottage gardens, extremely tranquil and almost monastic.

Map Ref - 132 (see fig 4 & 13)

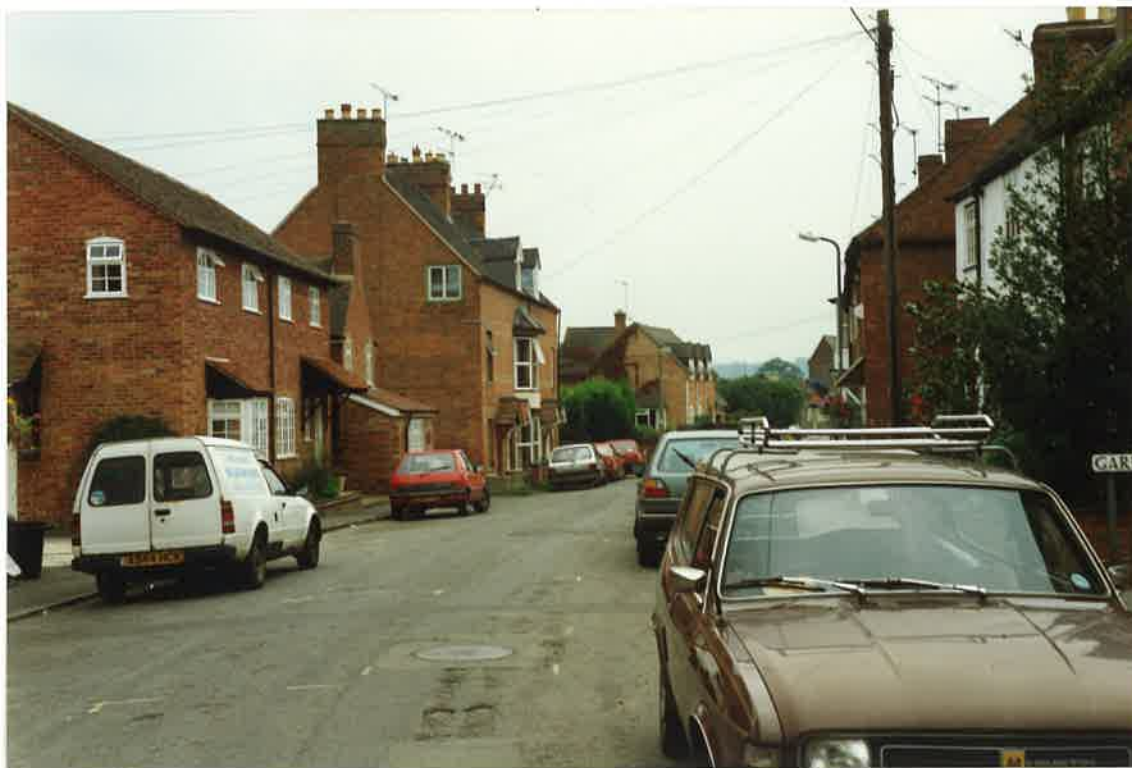
<< fig 6, No 6 Chestnut Square,
Bldg 22, Trees 86 & 89

Chestnut Square forms the heart of Wellesbourne Mountford, and is surrounded by the finest buildings in the village. Church Walk, probably due to the construction of the present bridge, remains a largely unaltered backwater, retaining its seventeenth century street pattern.

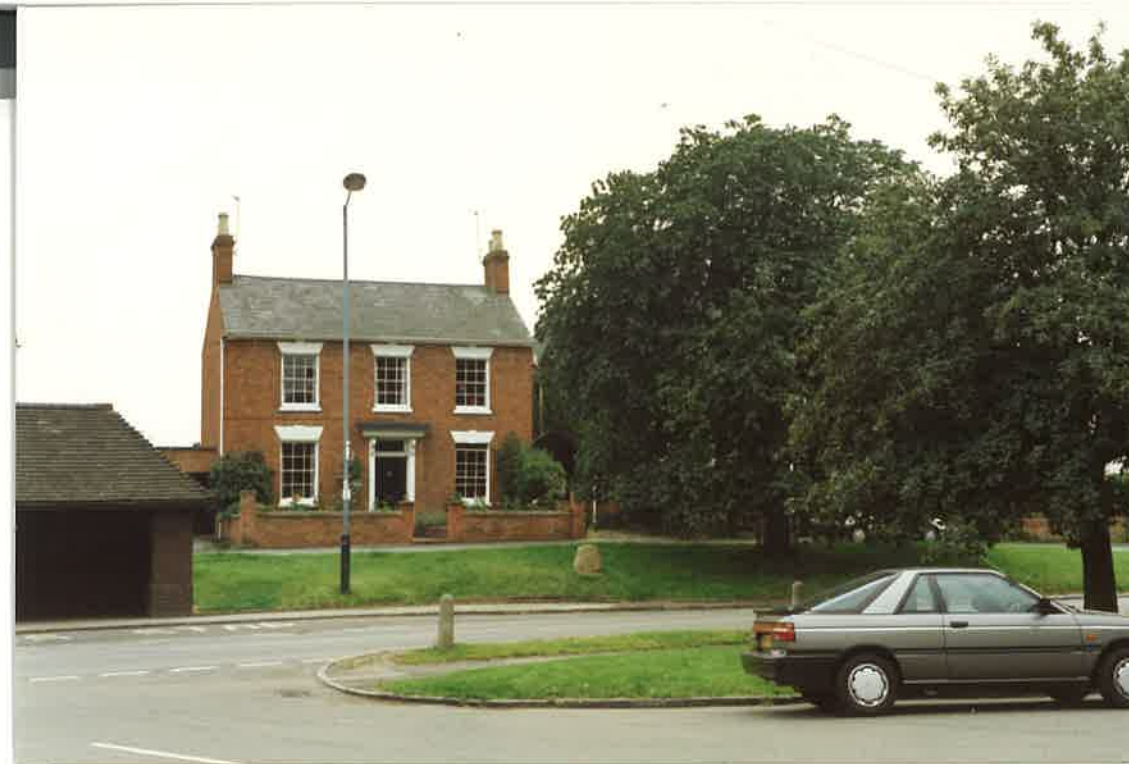
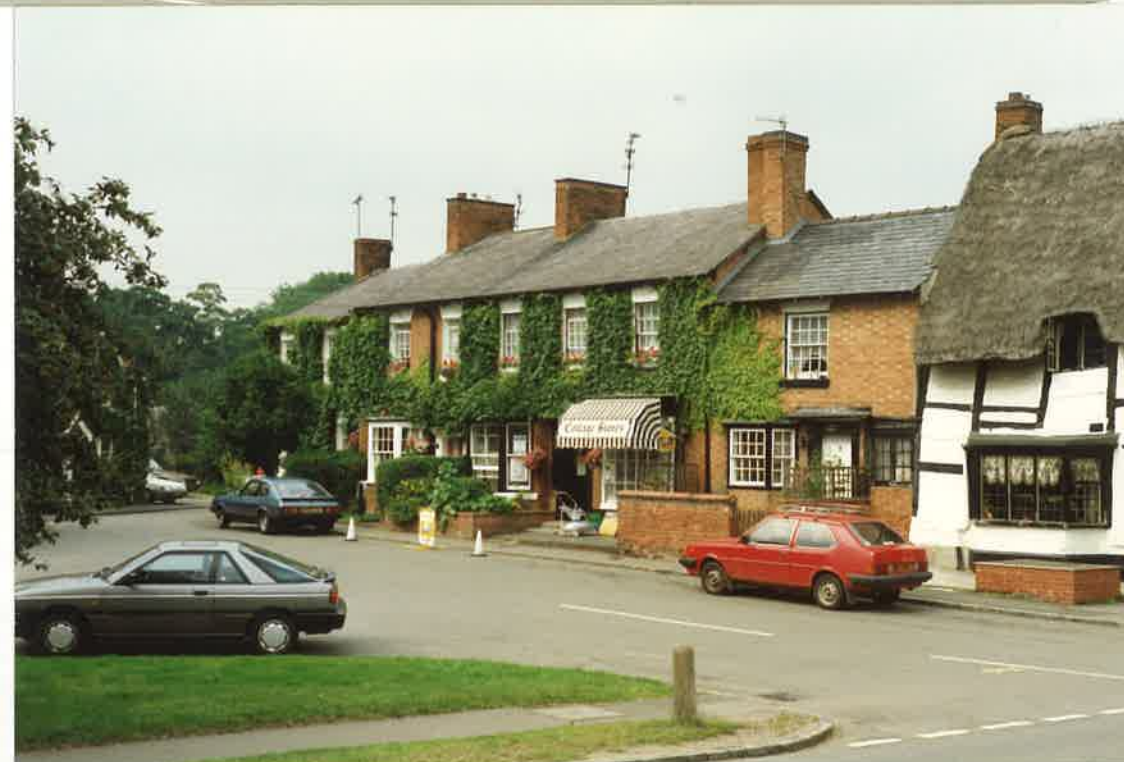
<< **fig 10, Chestnut Square.**
Bldgs, 19, 110 - 113

Chestnut Square, **fig 10**, forms the centre of this area, and is very much the focal point of the whole village. The road layout suggests that Bridge Street is later than the square itself, and has cut through what would have been the north side of the square. This has given The Stags Head extreme importance in its siting, **figs 5 & 10**. Very picturesque, and of historic interest, it is probably the key building in the village, closing the vista of Ettington Road.

Adjoining the Stags Head, to the west, is a row of cottages, equally picturesque, ivy clad and inflected towards Church Walk, the sense of enclosure is continued on the west side of the square. The grade II* listed, The Little House, and the two adjoining listed houses form a fine group, slightly raised and dominating the square.

Nos. 6, 8 & 10, all listed, contain Chestnut Square on the east side, again set high they make an impressive group. The Manor House, to the north of Chestnut Square is set back behind yew, holly and horse chestnut and a brick boundary wall, which contribute more to the townscape than the building itself.

There is unfortunately an excess of tarmac in Chestnut Square, this and associated traffic detracts a little from the quality of this fine space. The four roads leading from here each have a different character.

Map Ref - 110 (see fig 10)

Map Ref - 111 (see fig 10)

Map Ref - 112 (see fig 10)

Map Ref - 113 (see fig 10)

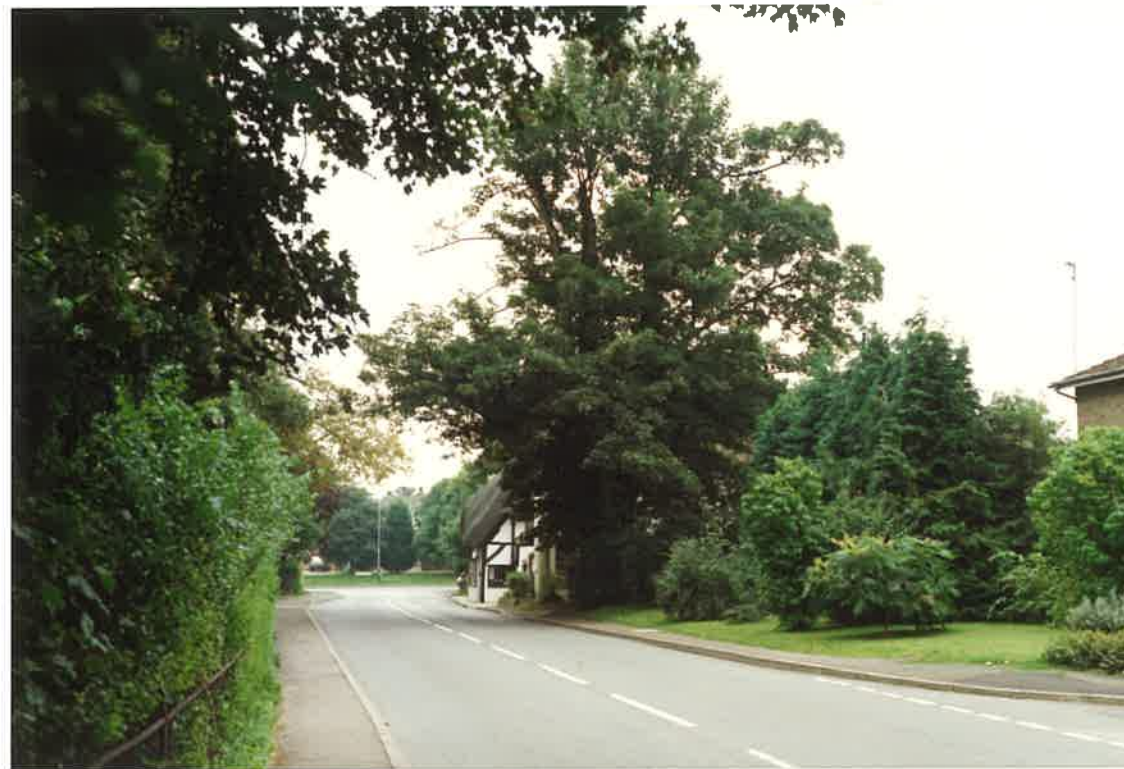
<< fig 11, No 3 Stratford Road,
Bldg 4, Tree 94

The Stratford Road, is pleasant and well wooded on its north side. On the south, the Old Dispensary, and the listed thatched, No. 3 form an intriguing group, fig 11.

Map Ref - 40 (see figs 11 & 61)

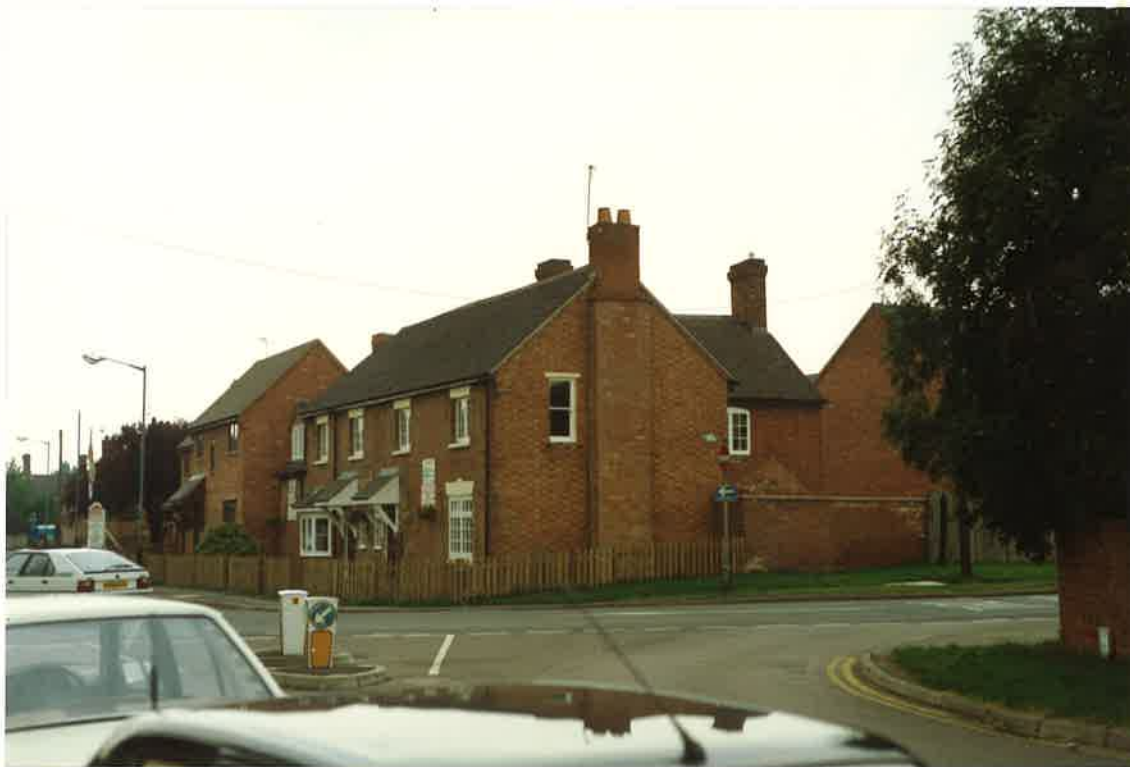
<< fig 17, Hammond Cottages,
Bldgs 117 & 118, Tree 78

Towards the north end, the street widens to form a delightful small space enclosed by trees and two short terraces, Hammond Cottages and Nos. 16-22, **fig 17**. An attractive footpath continues northwards towards the footbridge, although it is a pity that this is bounded by unpleasant fencing.

Map Ref - 117 (see fig 17)
Nos. 16, 18, 20 & 22, Church Walk
 C19, terraced dwellings, brick, arched window heads, plain tile roof, original multipane casements

Map Ref - 118 (see figs 17 & 40)
Hammond Cottages,
Nos. 24, 26, 28 & 30, Church Walk
 C19, terraced dwellings, two storey, brick, slate roof, original multipane casements

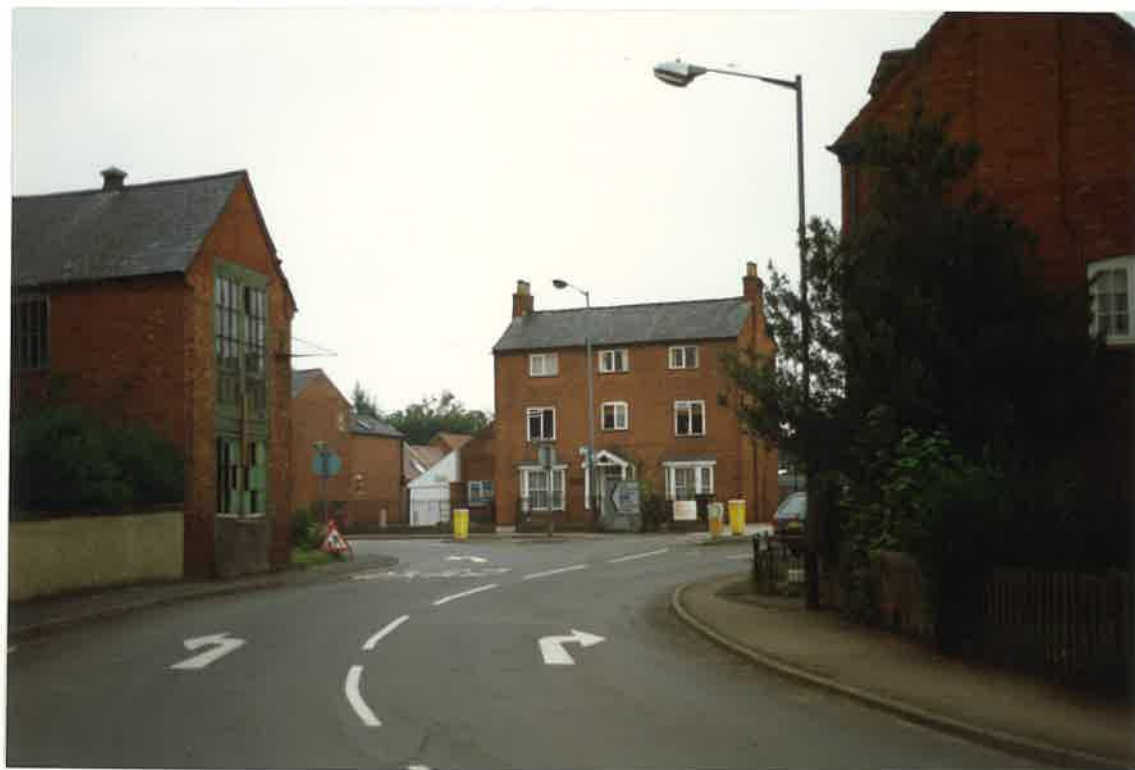
-- **fig 20, The Kings Head, Bldg 4**
 << **fig 21, The Chestnuts,**
Bldg 95, Tree 45

Hopper's Lane leads to Charlecote Road and Warwick Street. This side of The Kings Head feels a little over restored, **fig 20**. The modern Warwick House, although a little bland, terminates the vista of Warwick Street acceptably, **fig 11.71**. It also incorporates a Victorian post box. The remainder of Warwick Street is an attractive group of substantial late nineteenth century houses, some of which have had their ground floors converted to shops and offices.

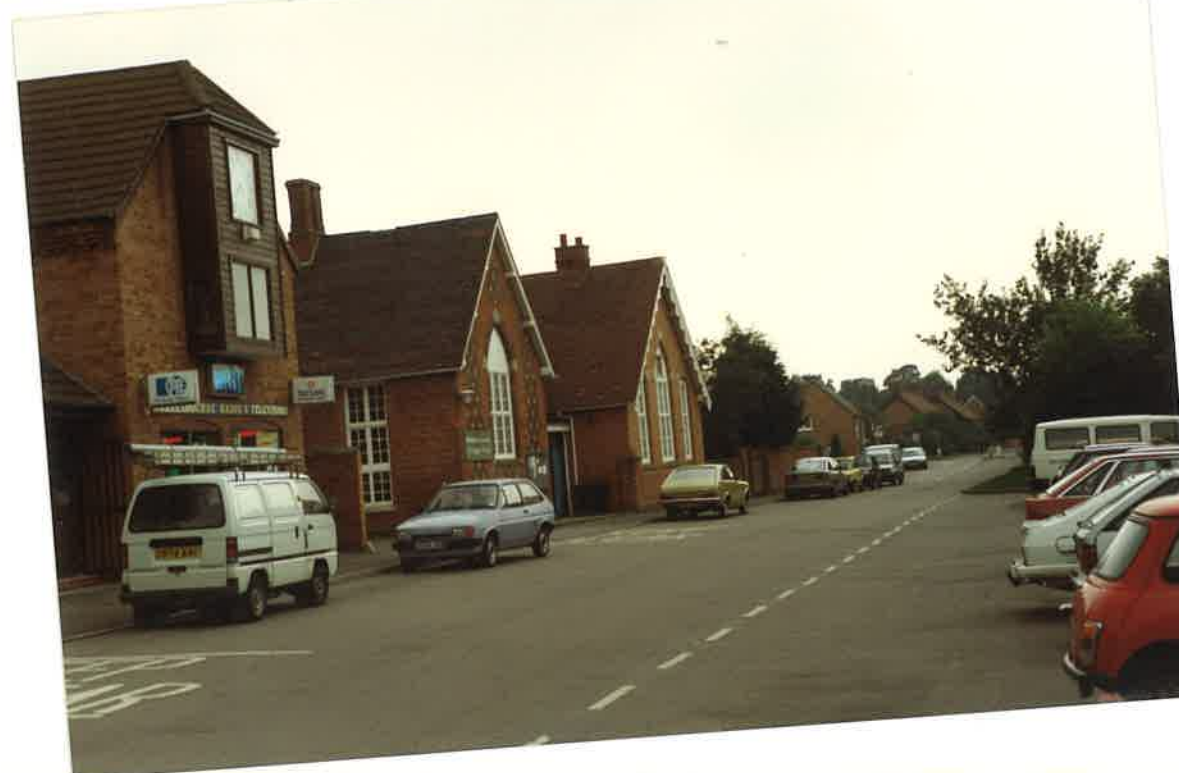
-- fig 22, The Wellesbourne from Newbold Road, Bldg 104

The Wellesbourne, originally known as The Talbot Hotel, was altered considerably in the nineteenth century, and together with the King's Head, has strong connections with the Warwickshire Hunt, **fig 22**

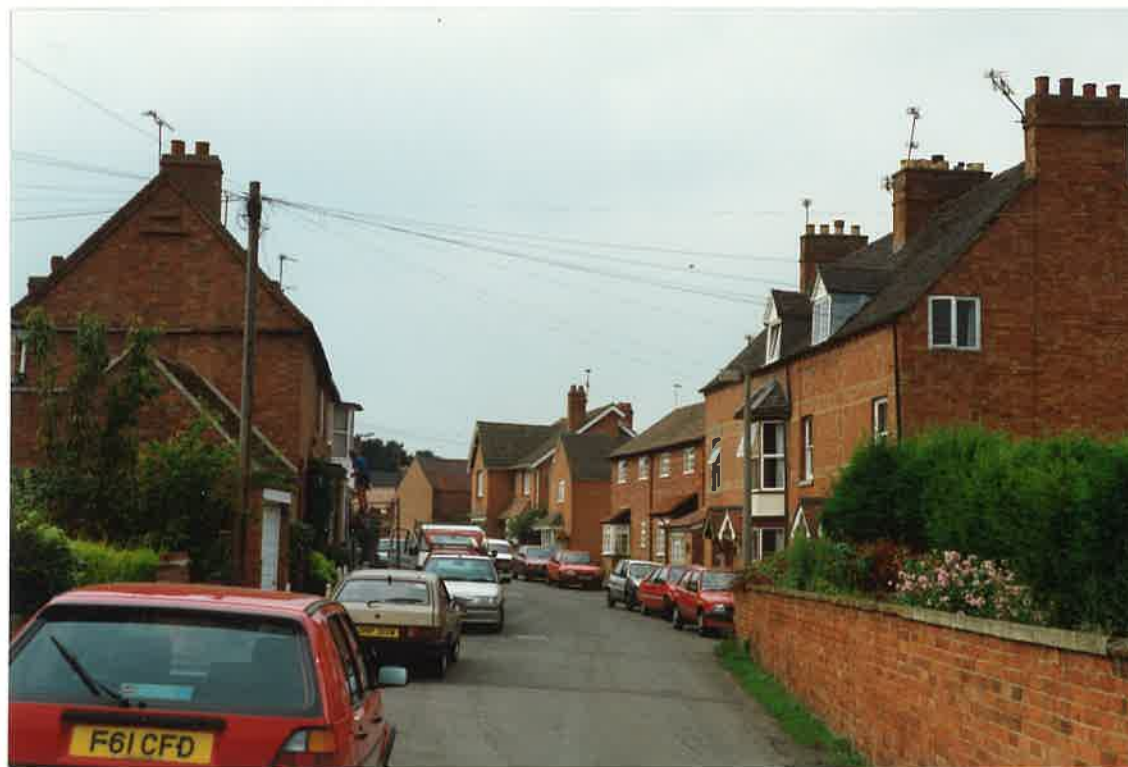
<< fig 23, School Road

School Road has unfortunately suffered from modern developments associated with Wellesbourne's growth as a settlement. The shopping precinct, surgery and residential properties have left the buildings of quality somewhat isolated and gaining nothing from their setting, fig 23.

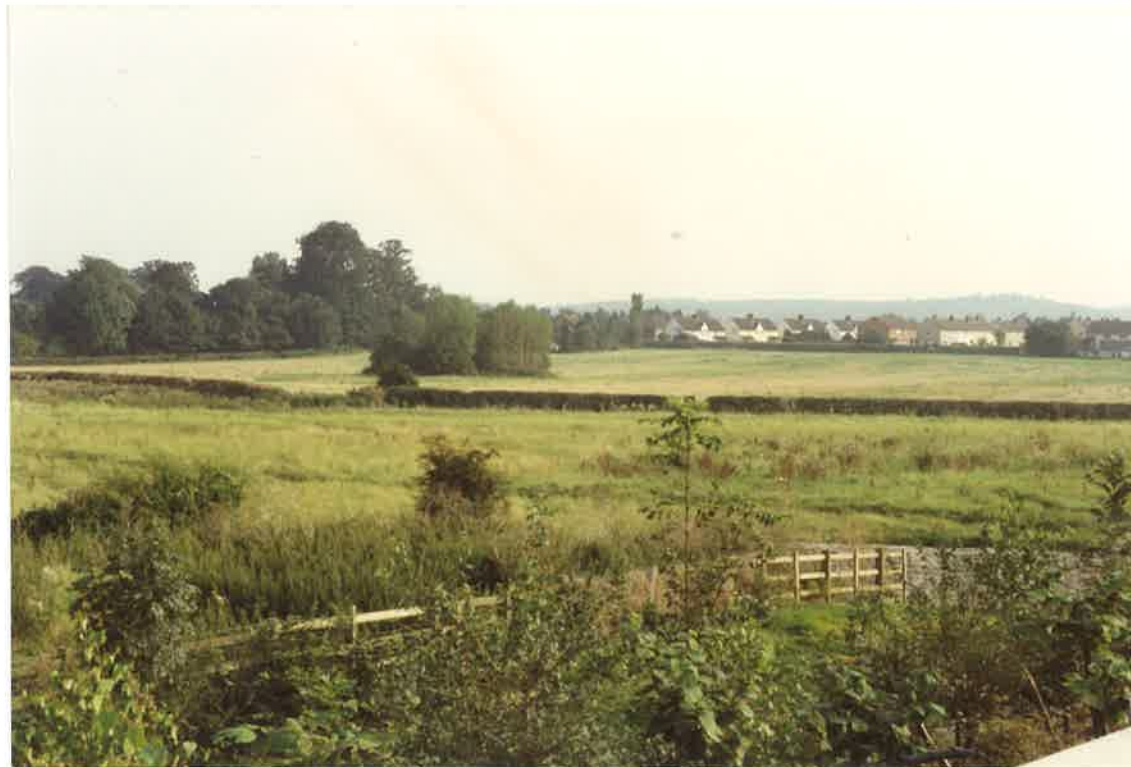
<< **fig 34. The Meadows**

These flank the ^ucourse of the river through the heart of the conservation area. They are an important green open space within the village, without which the village would lose its rural character. The footpaths which traverse these areas are a recreational amenity of great value, **fig 34**.

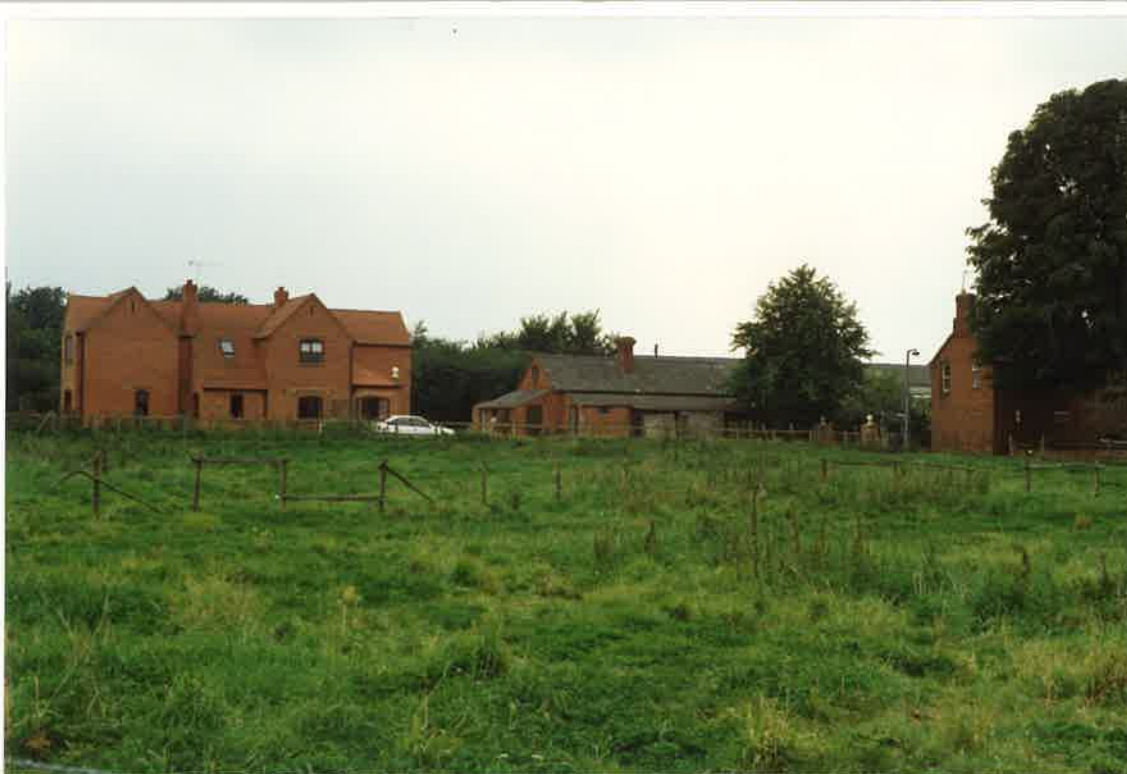
« fig 35.
Tree group 95, from the by-pass

The willows along the course of the river are of great amenity value. Some of these are in a state of collapse and need to be re-pollarded to prevent them splitting.

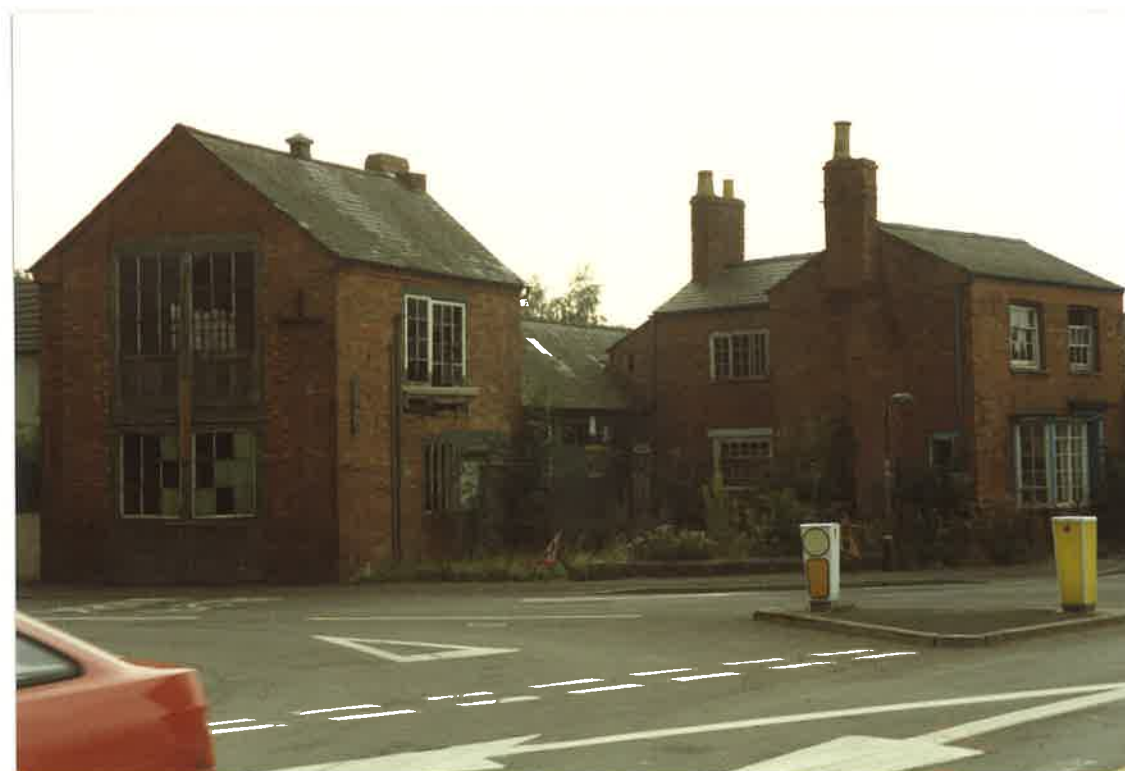
<< fig 48, Warwick St. Bldg 94

↑ demolished SEPT/OCT 1993

being redeveloped winter 1994/5

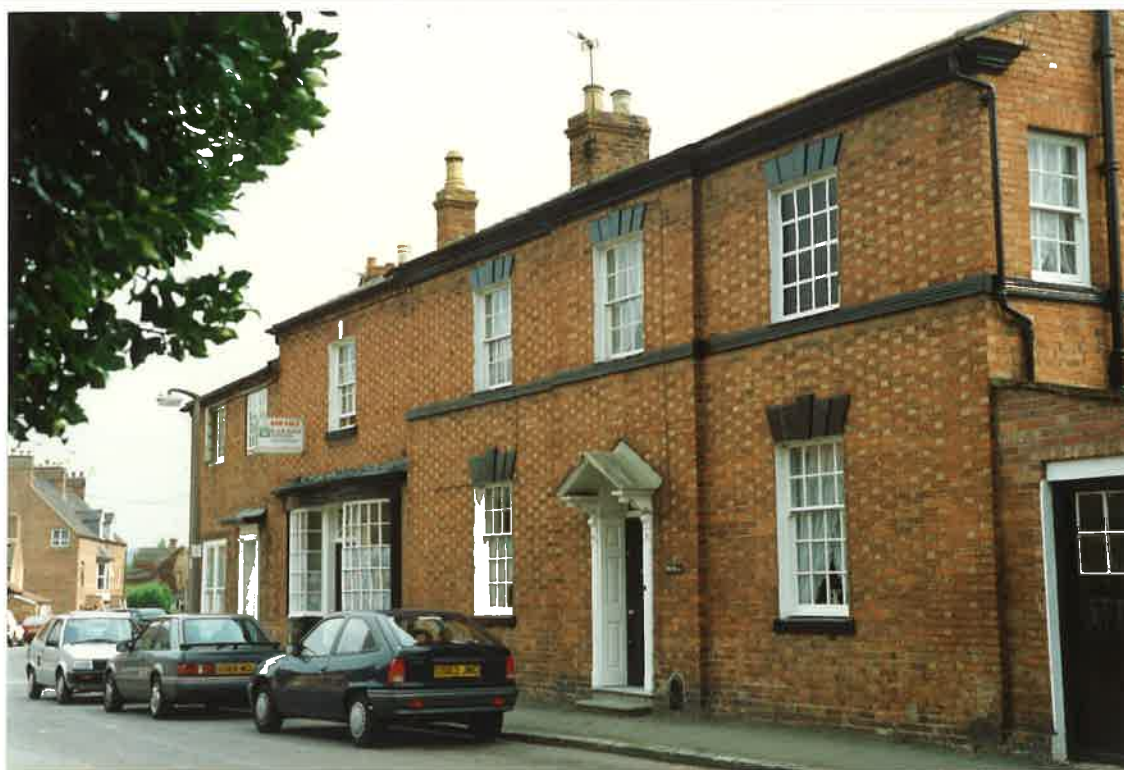
↖ fig 56

Map Ref - 20 (see fig 56)

C18 altered C19, two storeys, three sash windows, facade rendered in stucco, rusticated stone quoins and moulded cornice with frieze, hipped tiled roof, Doric portico, six panel door and traceried fanlight, architrave surround with keystone

Map Ref - 21 (see fig 56)

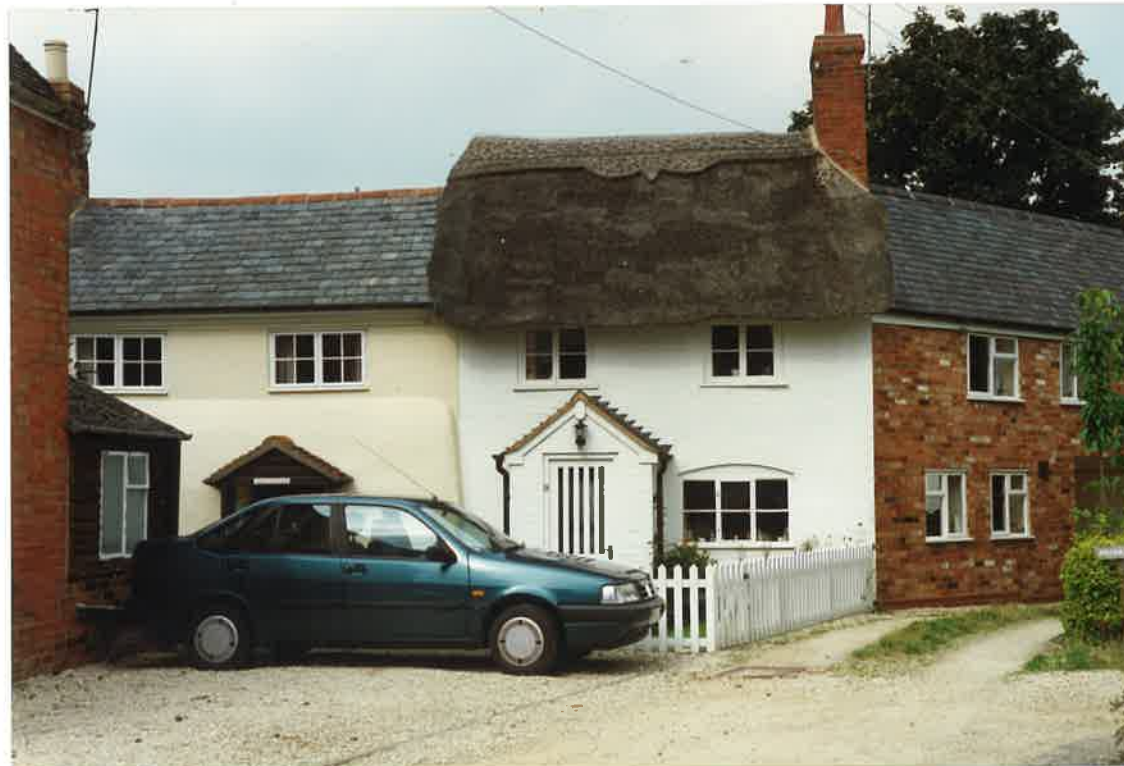
-- fig 57

Map Ref - 24 (fig 57)

Old House, No. 2, Chapel Street

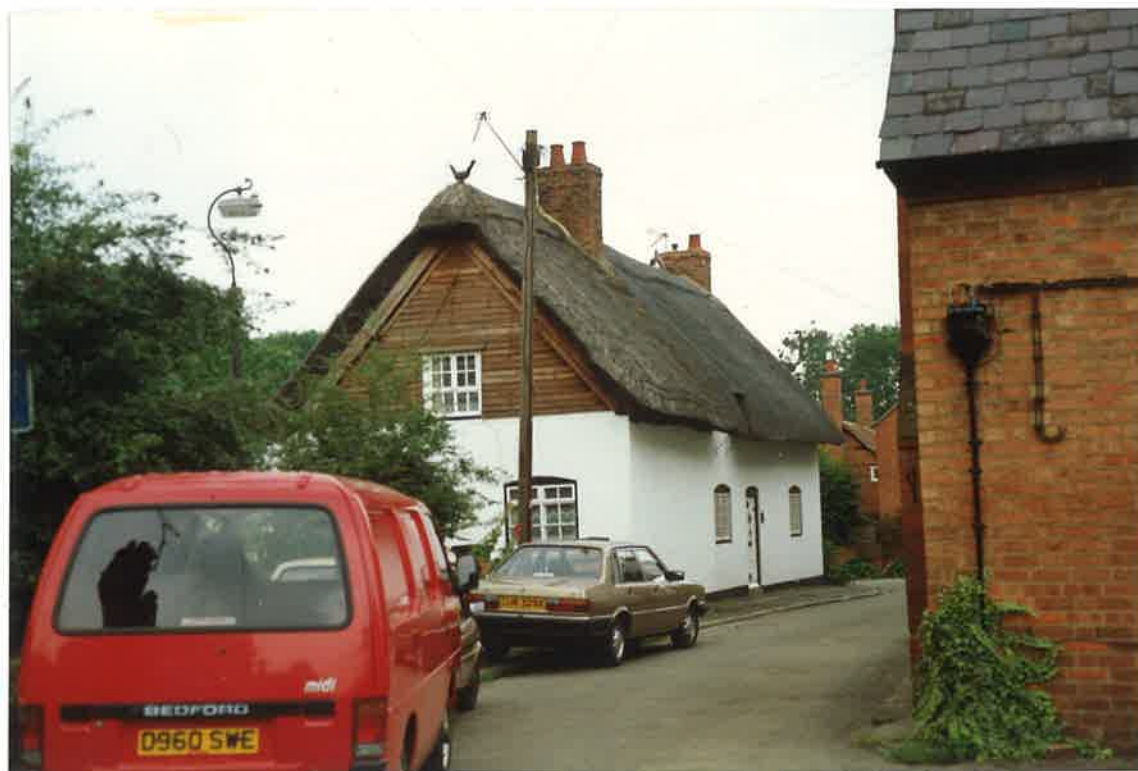
<< fig 58

Map Ref - 26 (see fig 58)

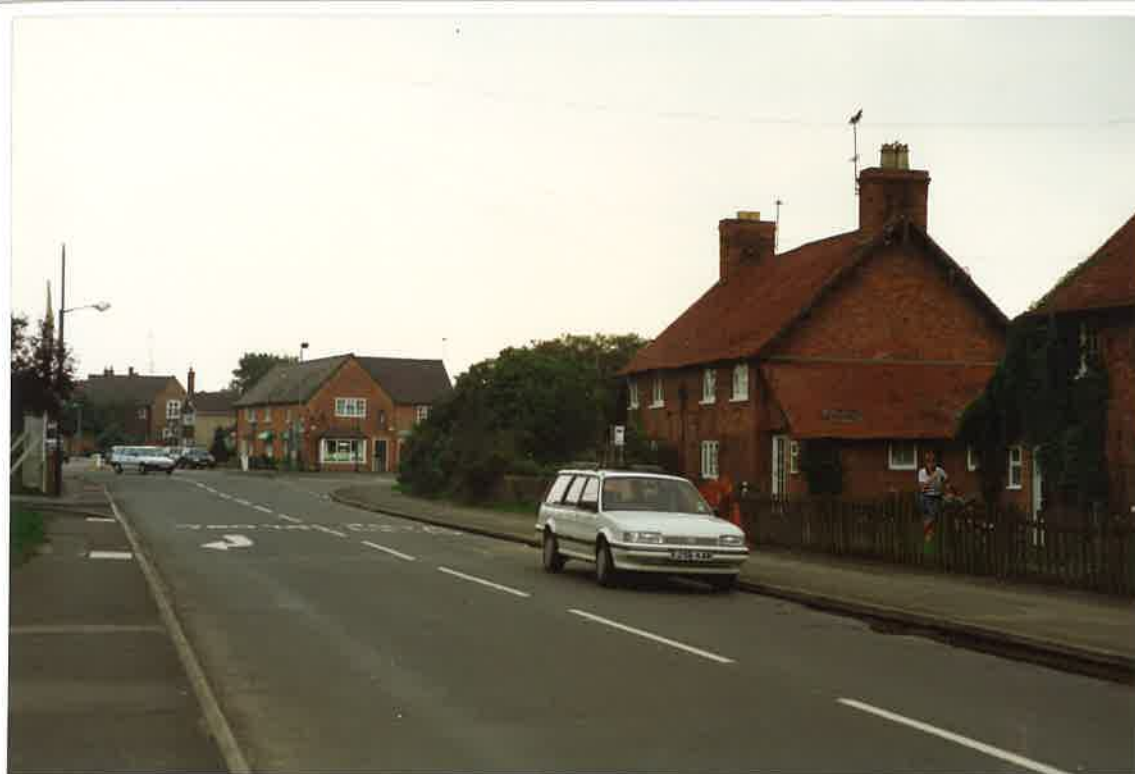
<< fig 59

Map Ref - 30 (see fig 59)

C17, timber frame, brick nogging, old tile roof, one storey and attic, east side rebuilt in red brick

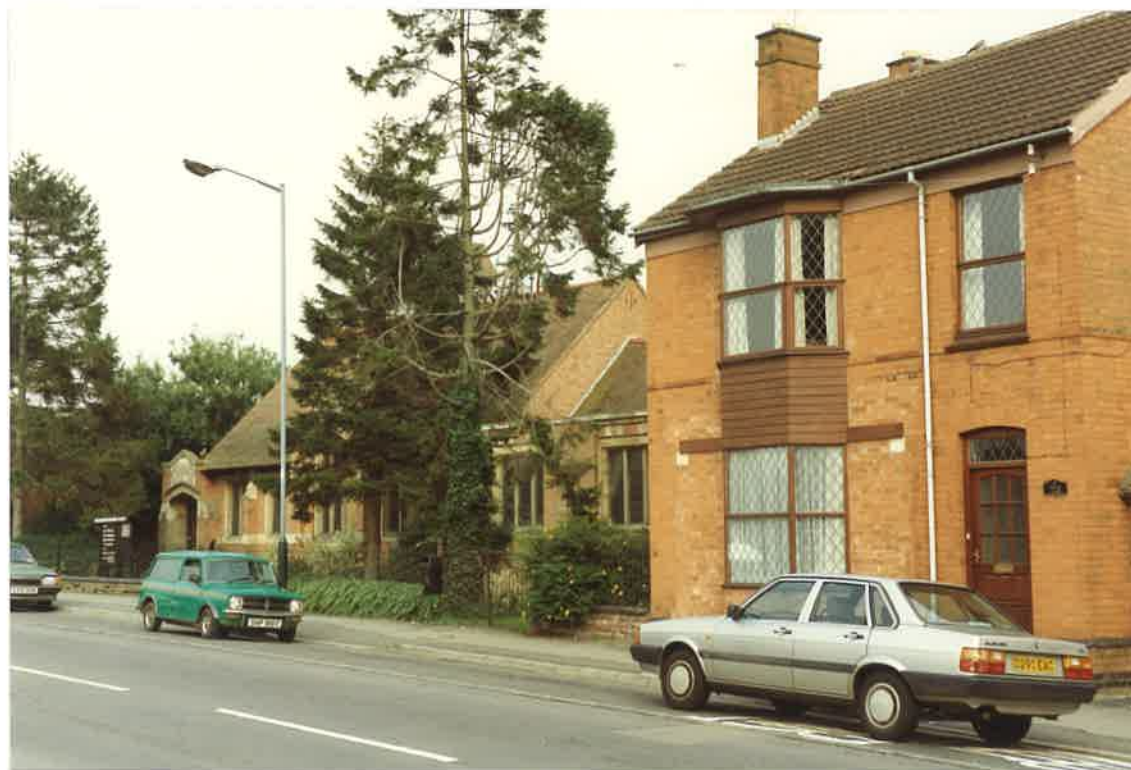
^^ fig 66, (Tree 31)
 << fig 67, (Tree 38)

Map Ref - 72 (see fig 66)

Map Ref - 73 (see fig 66)

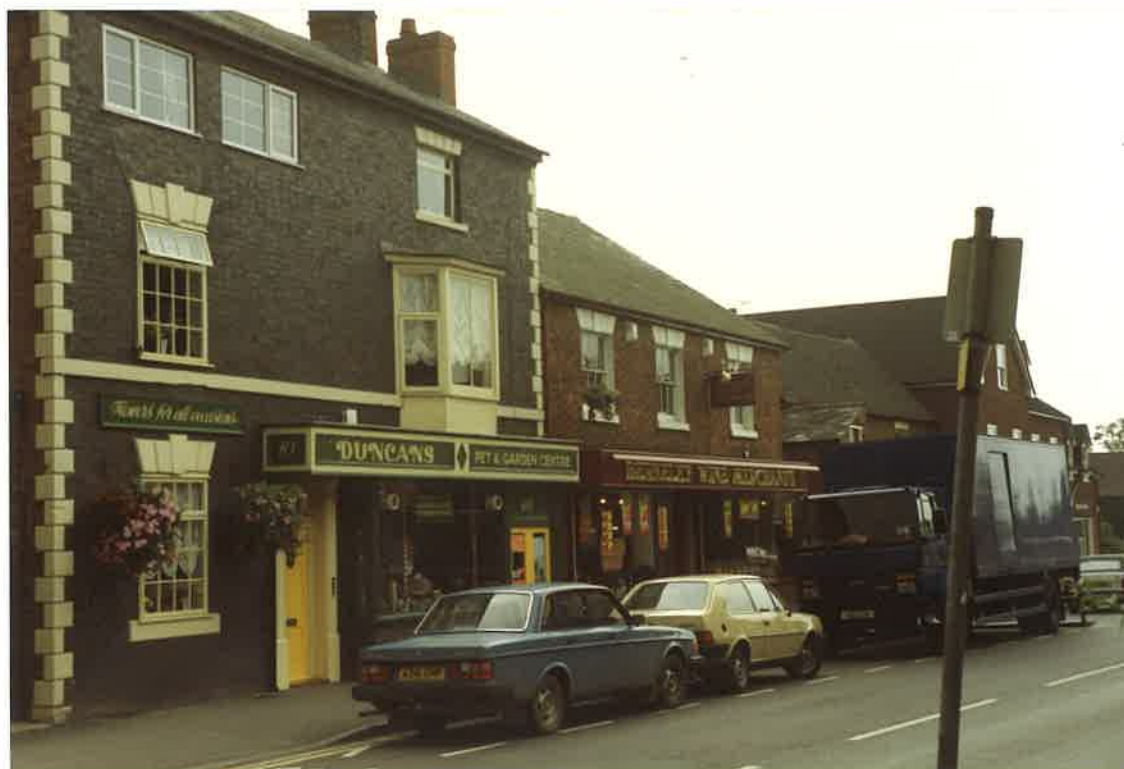
-- fig 72

Map Ref - 90 (see fig 72)

**West's Bakery & adjacent office,
Warwick Street**

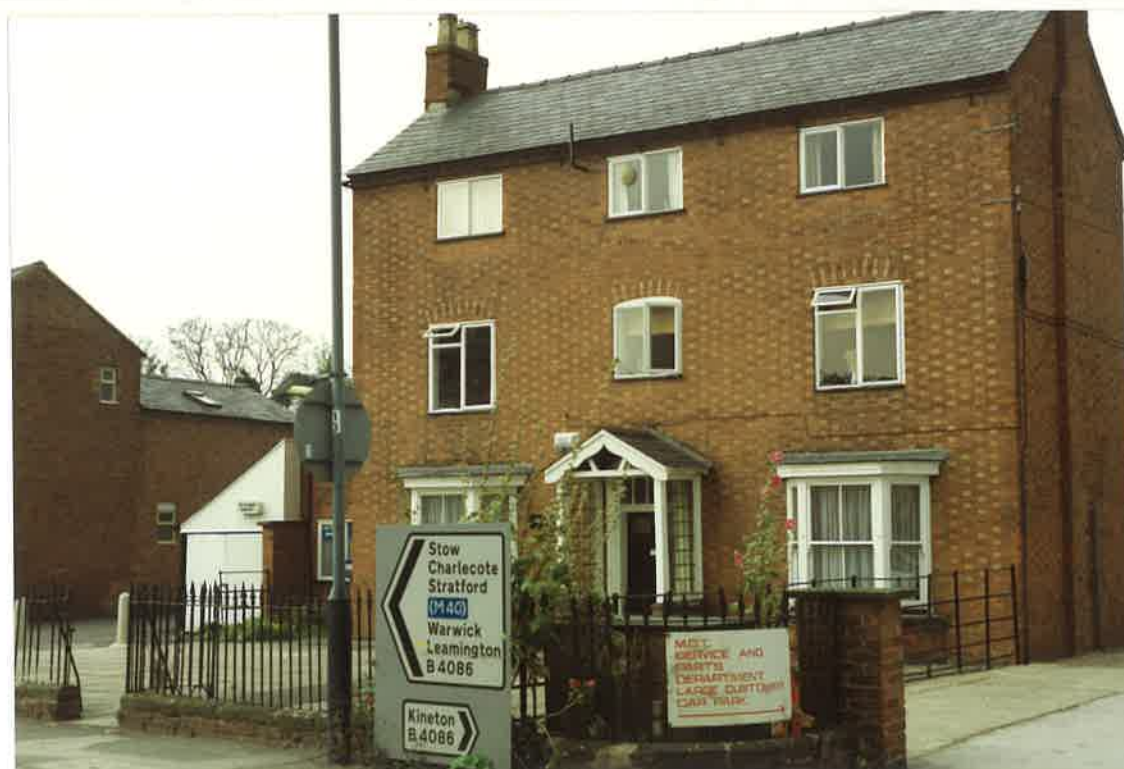
<< fig 73

Map Ref - 91 (see fig 73)

Map Ref - 92 (see fig 73)

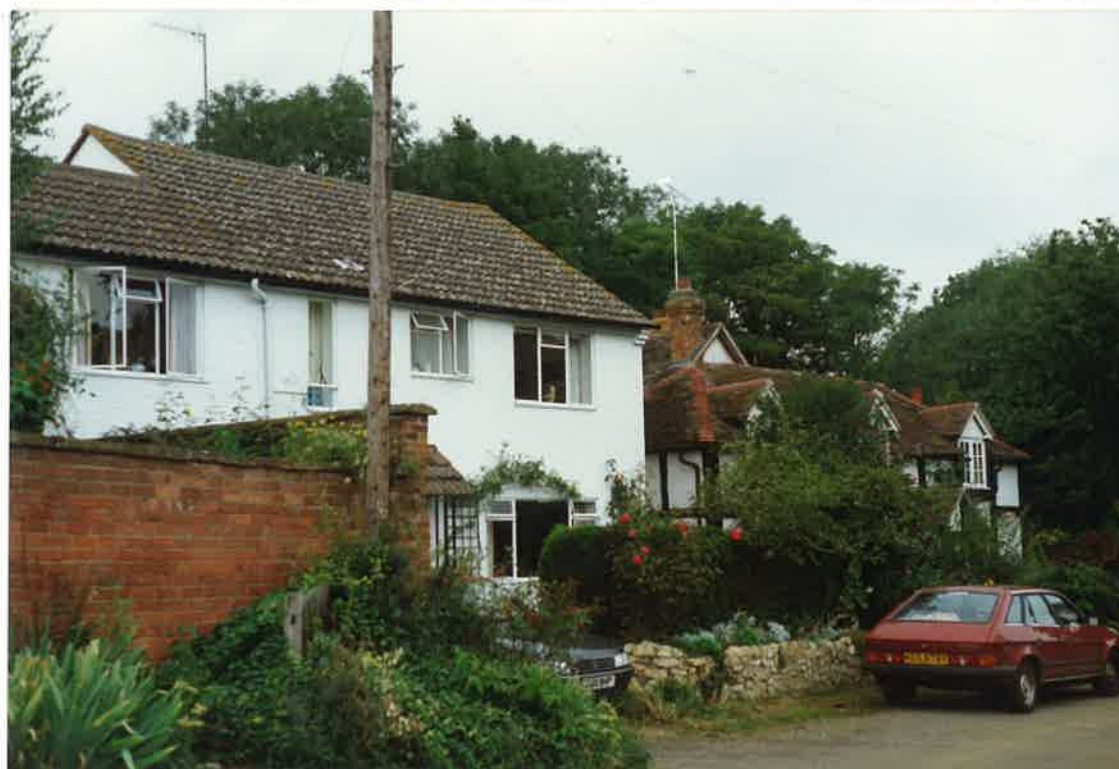
Map Ref - 115 (see fig 80)
West Cottage, No. 12, Church Walk
 C19, detached dwelling, two storey, painted brick, plain tile roof, original sashes

Map Ref - 116 (see fig 80)
Buckle House, Church Walk
 C19, dwelling, two storey and attic, brick, plain tile roof, original casements, ivy clad

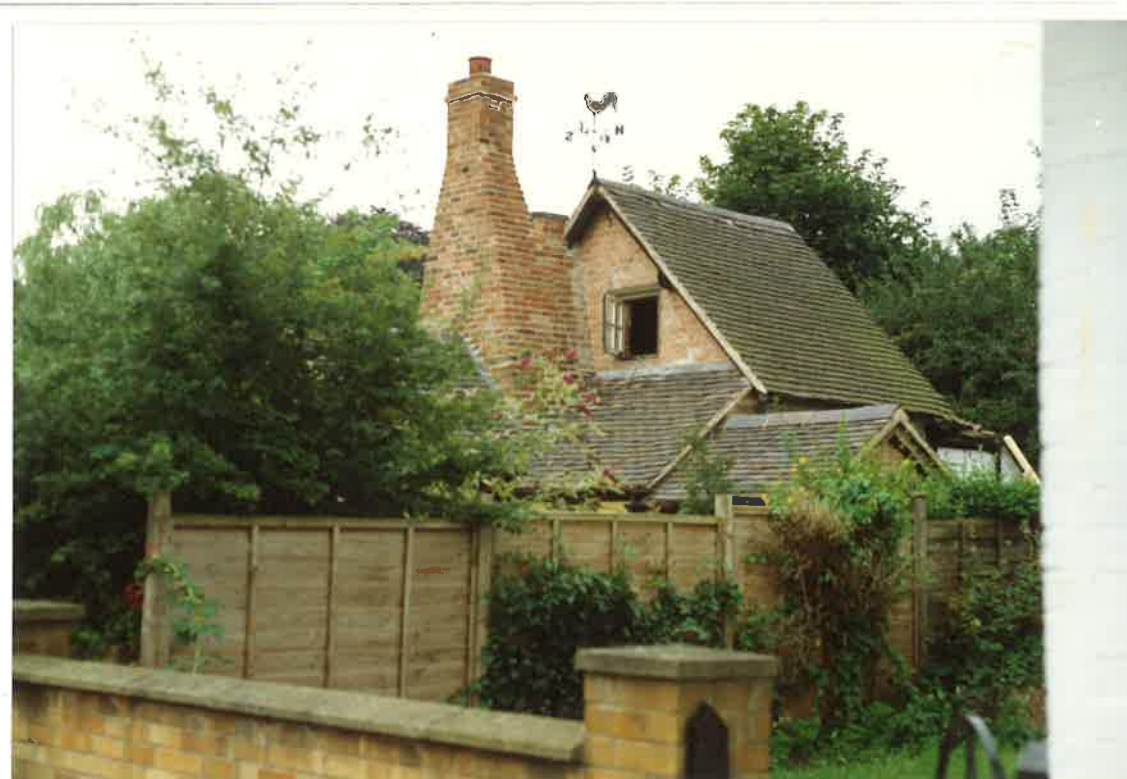
Map Ref - 122 (see fig 81)
Un-named dwelling, Church Walk
C20, detached dwelling, one storey and attic,
plain tile roof

Map Ref - 123 (see fig 81)
Rose Cottage, Church Walk
C20, detached dwelling, two storey, painted
brick, interlocking concrete tile roof

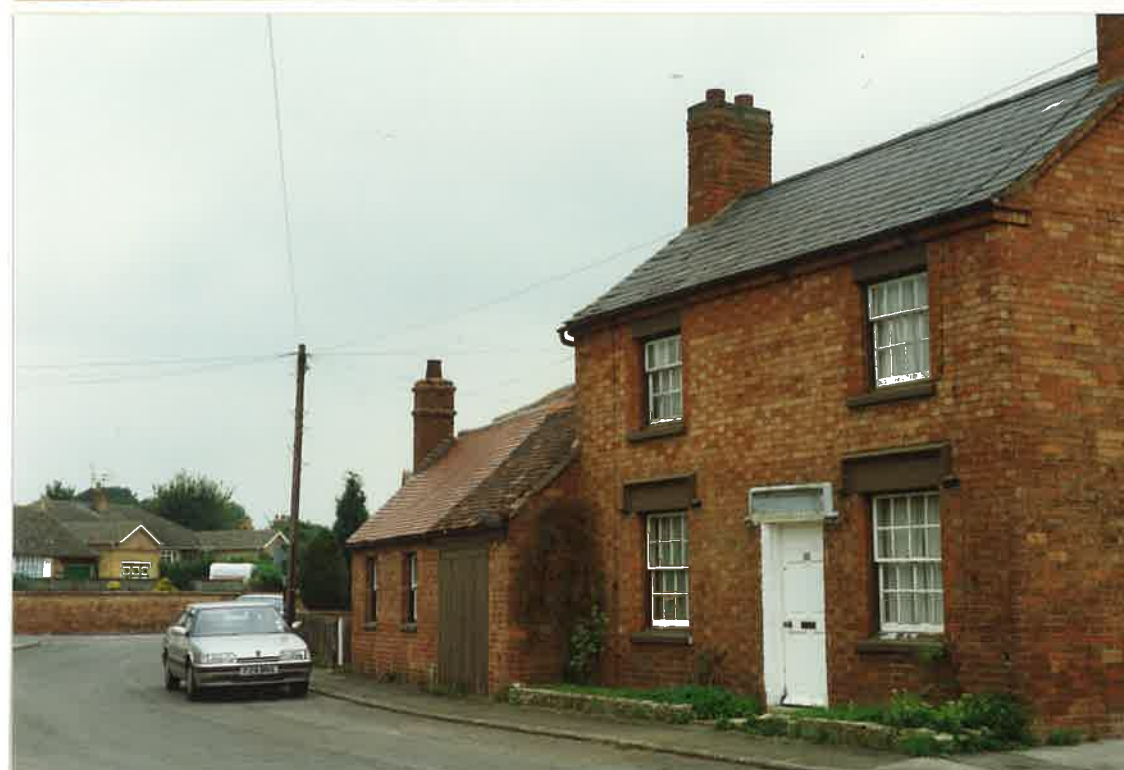
Map Ref - 145 (see fig 88)
Nos 49 & 51, Chapel Street
 Semi-detached dwellings, two storey, brick, slate roof, No. 49 has commemorative plaque, No 51 painted brickwork and decorative applied stone window surrounds

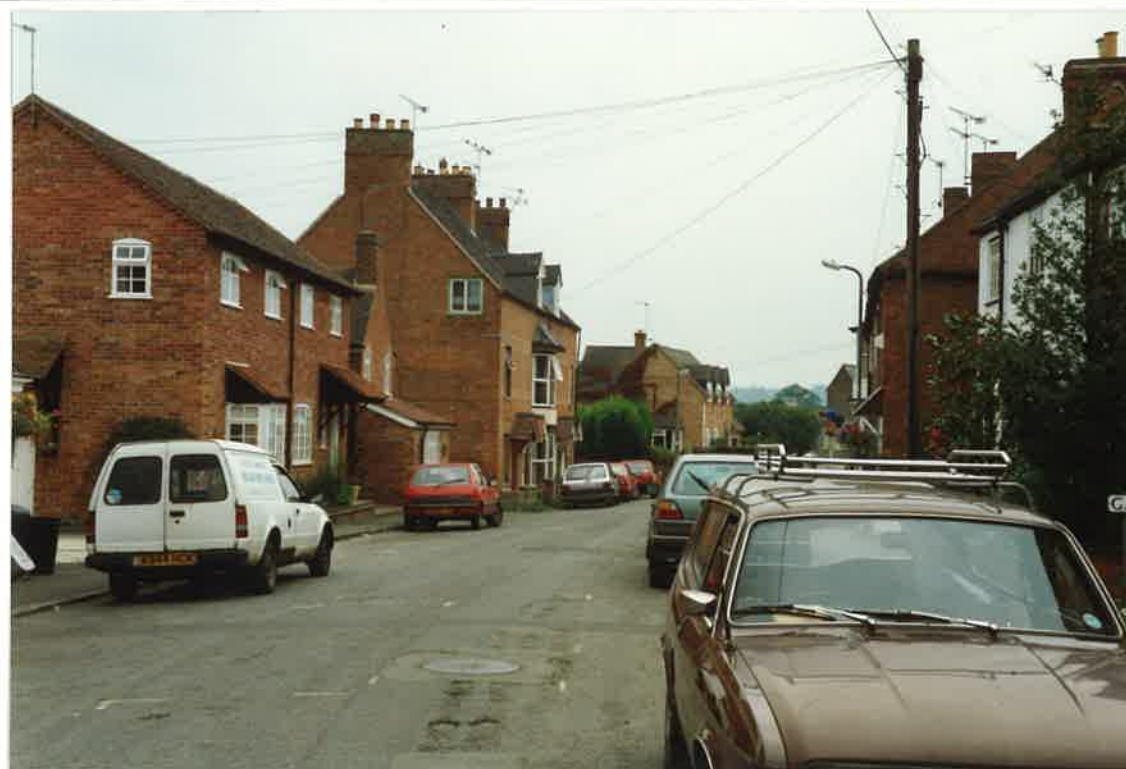
Map Ref - 143 (see fig 89)
No. 55, Peacock Court, Chapel Street
 C20/19, detached dwelling, two storey, brick, slate roof

Map Ref - 144 (see fig 89)
No. 53, Chapel Street
 C20/19, semi-detached dwelling, one storey, brick, plain tile roof, conversion

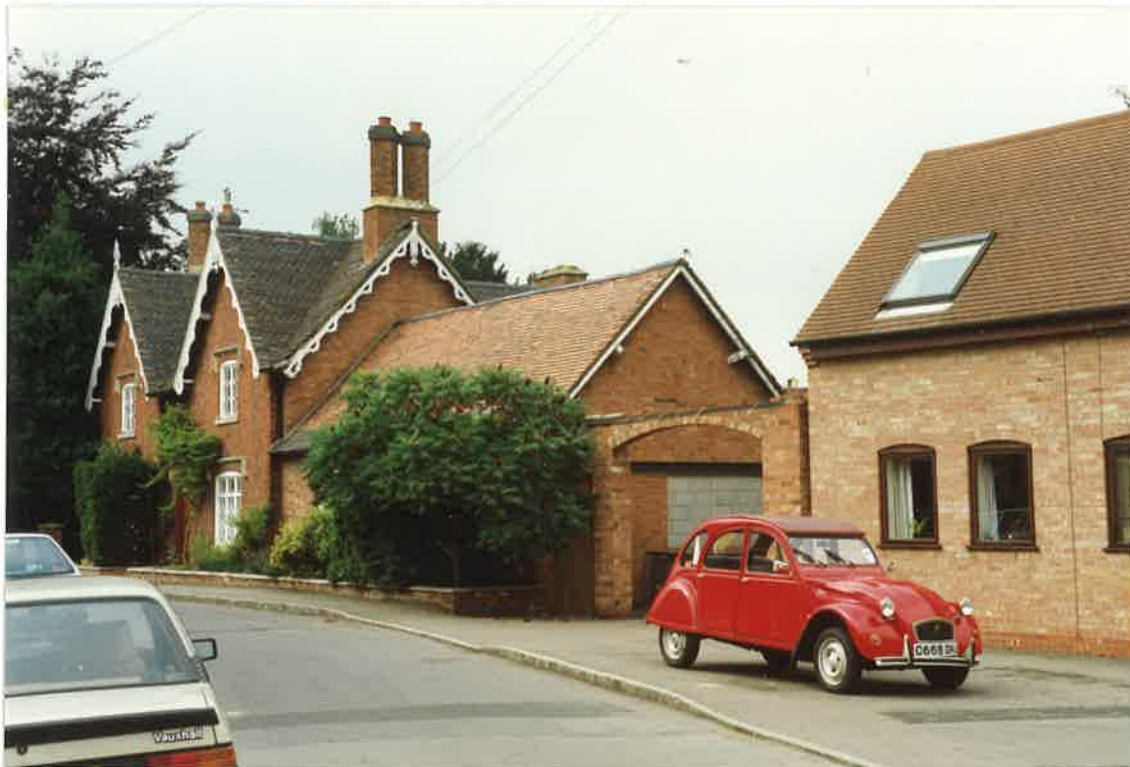
-- fig 92

Map Ref - 155 (see fig 92)

No. 5, Chapel Street

Map Ref - 156 (see fig 92)

Map Ref - 157 (see fig 92)
