PREFACE

This report is the result of an independent survey and analysis of the buildings and landscape form of the village of Wellesbourne, Warwickshire. It identifies the architectural, historical and environmental qualities of the settlement and gives recommendations for the protection and enhancement of the Conservation Area.

Stratford-on-Avon District Council by

Alan Smith and Partners

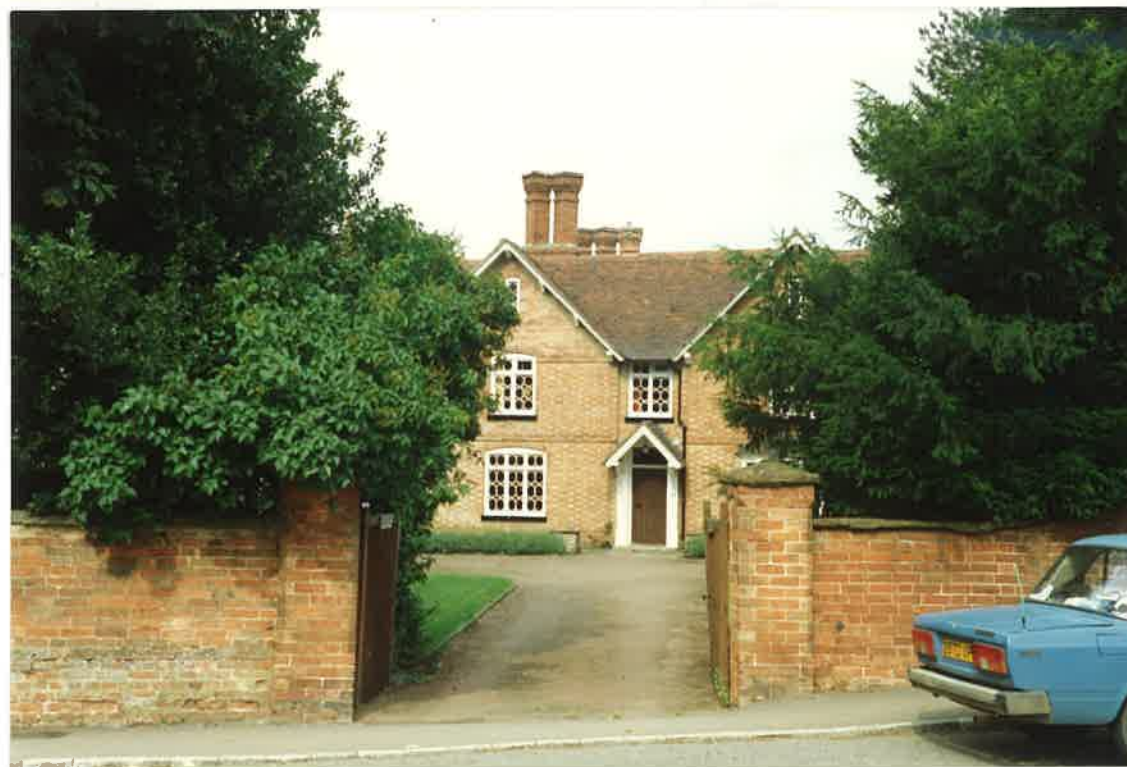
<< fig 93

Map Ref - 160 (see fig 93)

Map Ref - 161 (see fig 93)

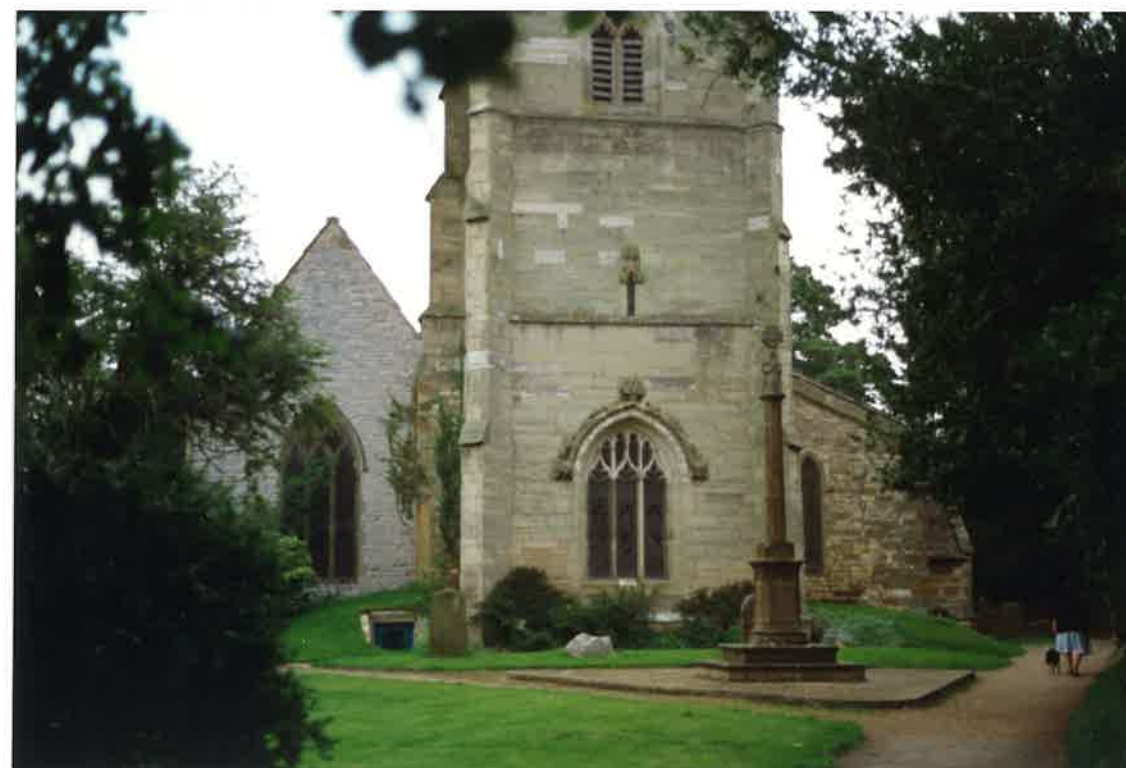
<< fig 109

Map ref. 2 (see fig 109)
Stone war memorial in the churchyard

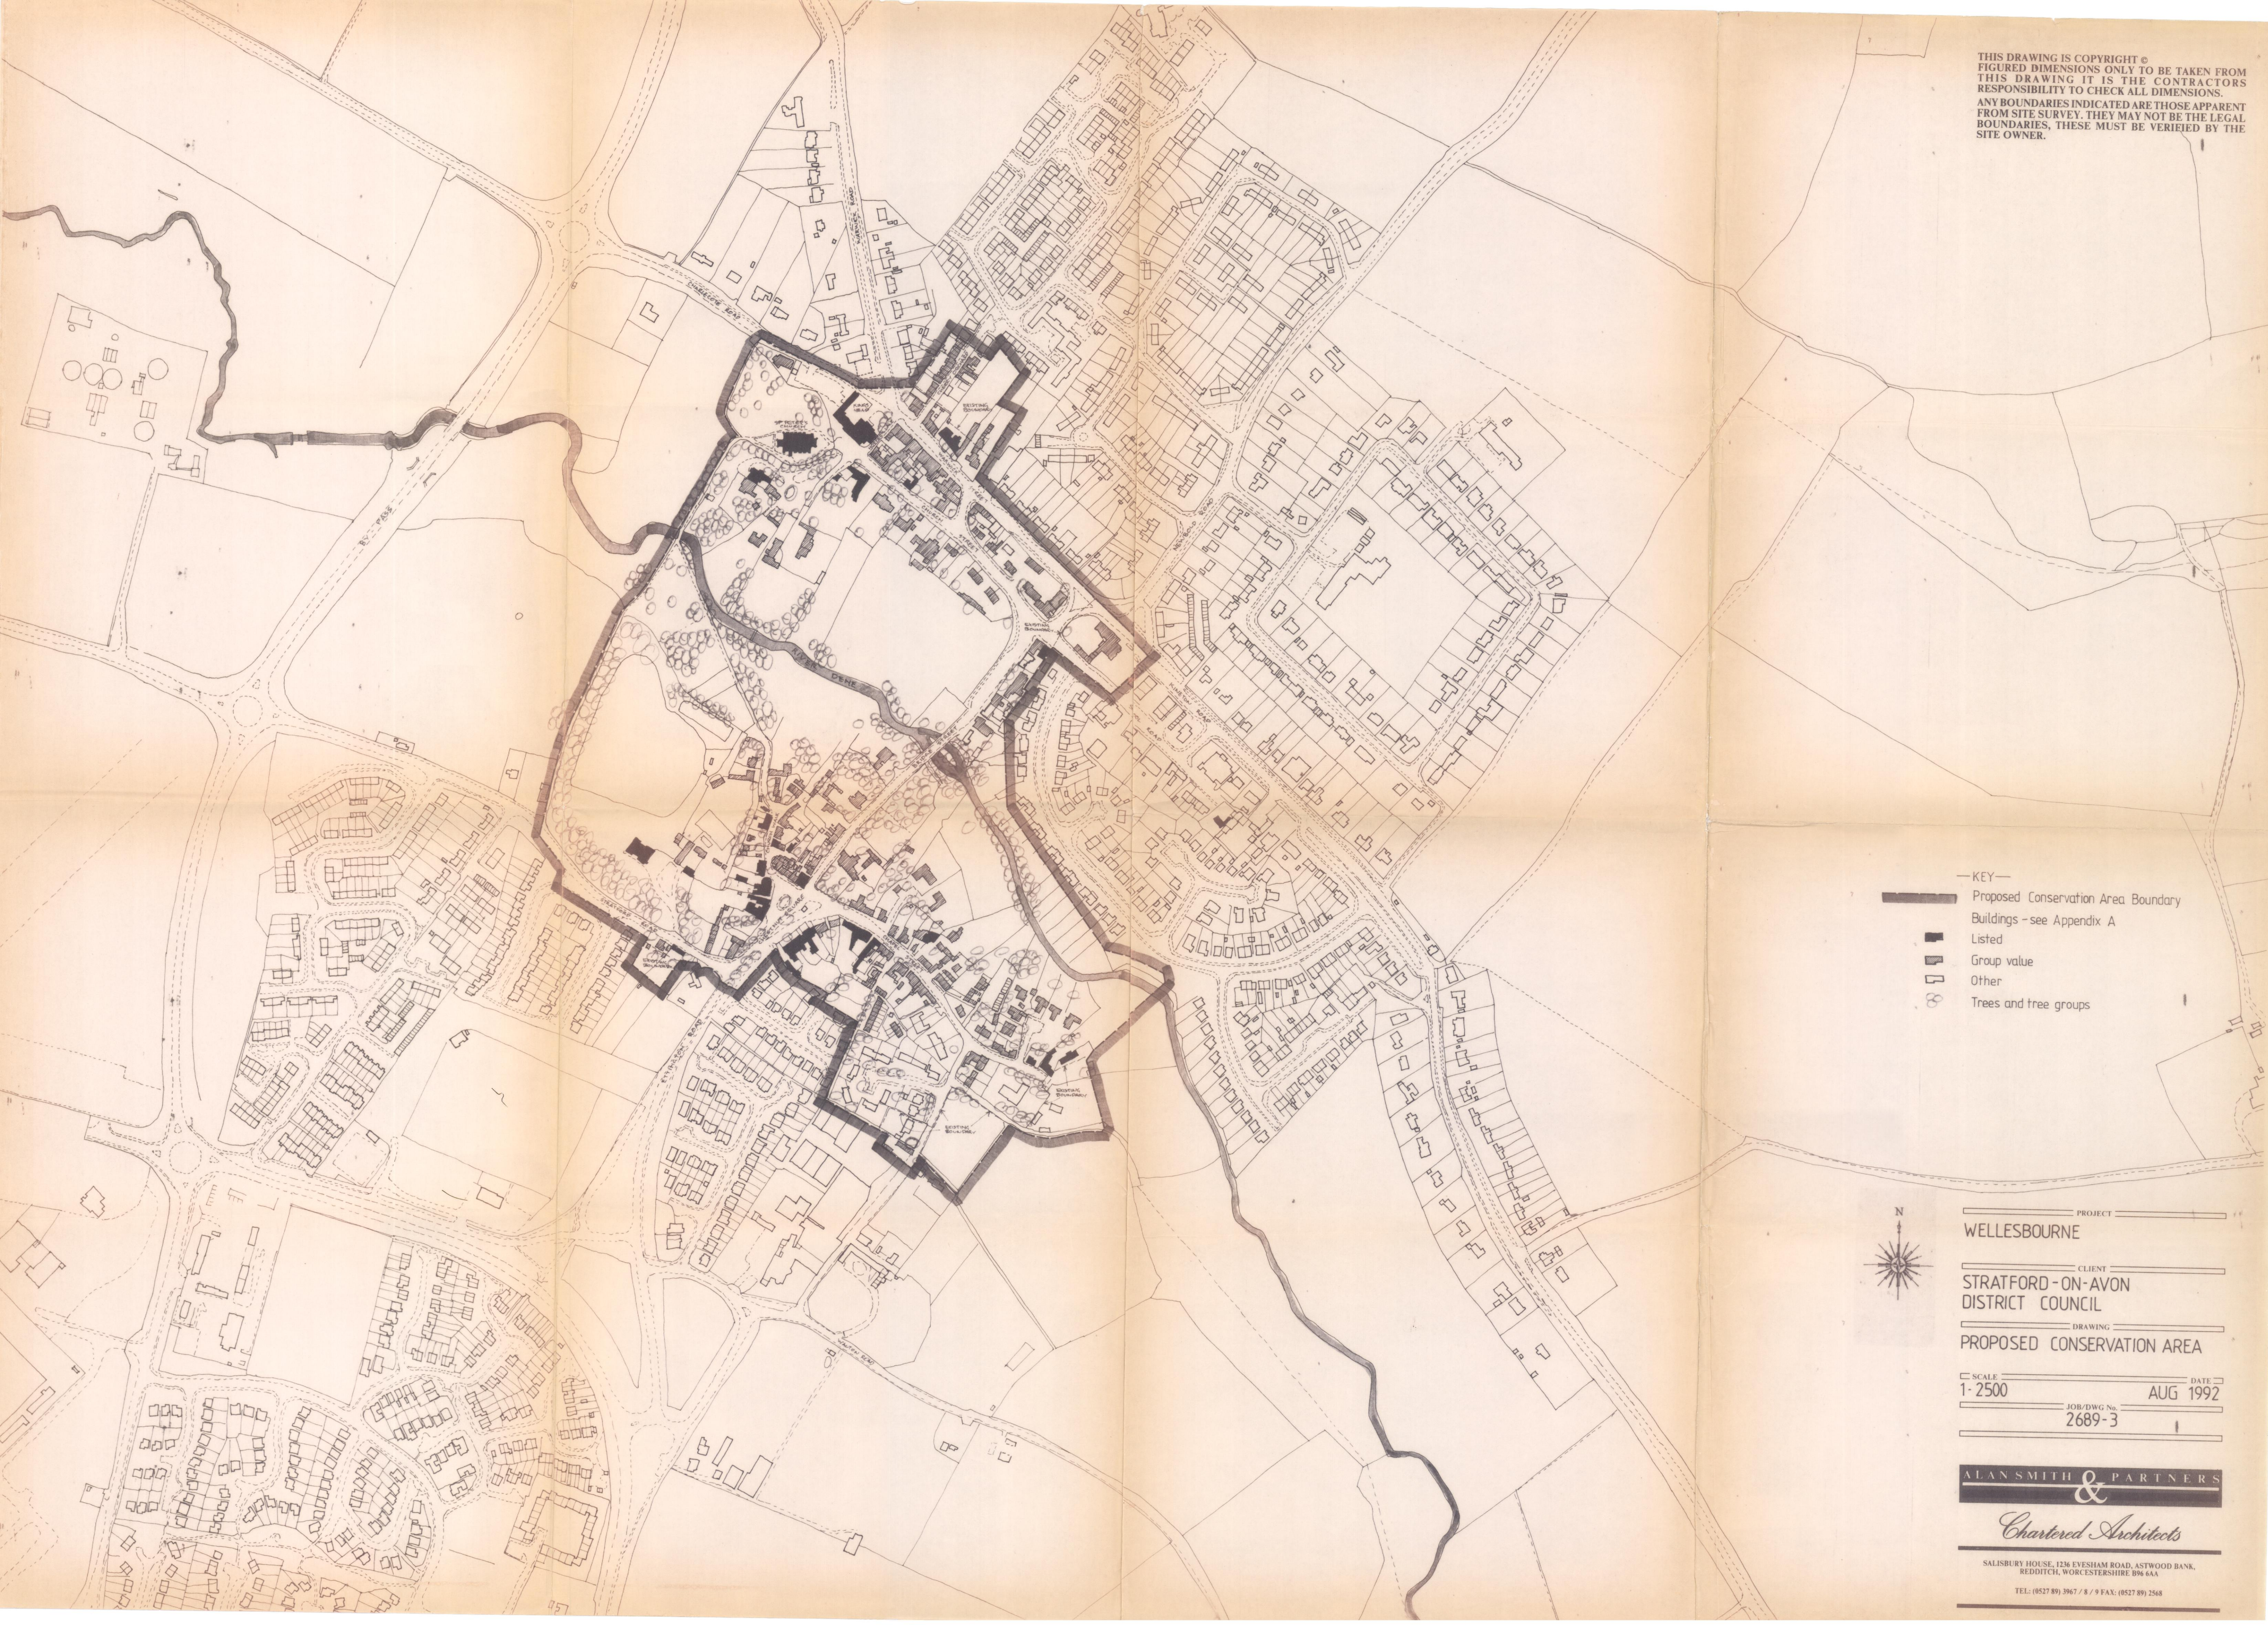
- KEY—
- Proposed Conservation Area Boundary
 - Buildings - see Appendix A
 - Listed
 - Group value
 - Other
 - Trees and tree groups
