STRATFORD ON AVON DISTRICT COUNCIL

CONSERVATION AREA REVIEWS

RATLEY

February 1994

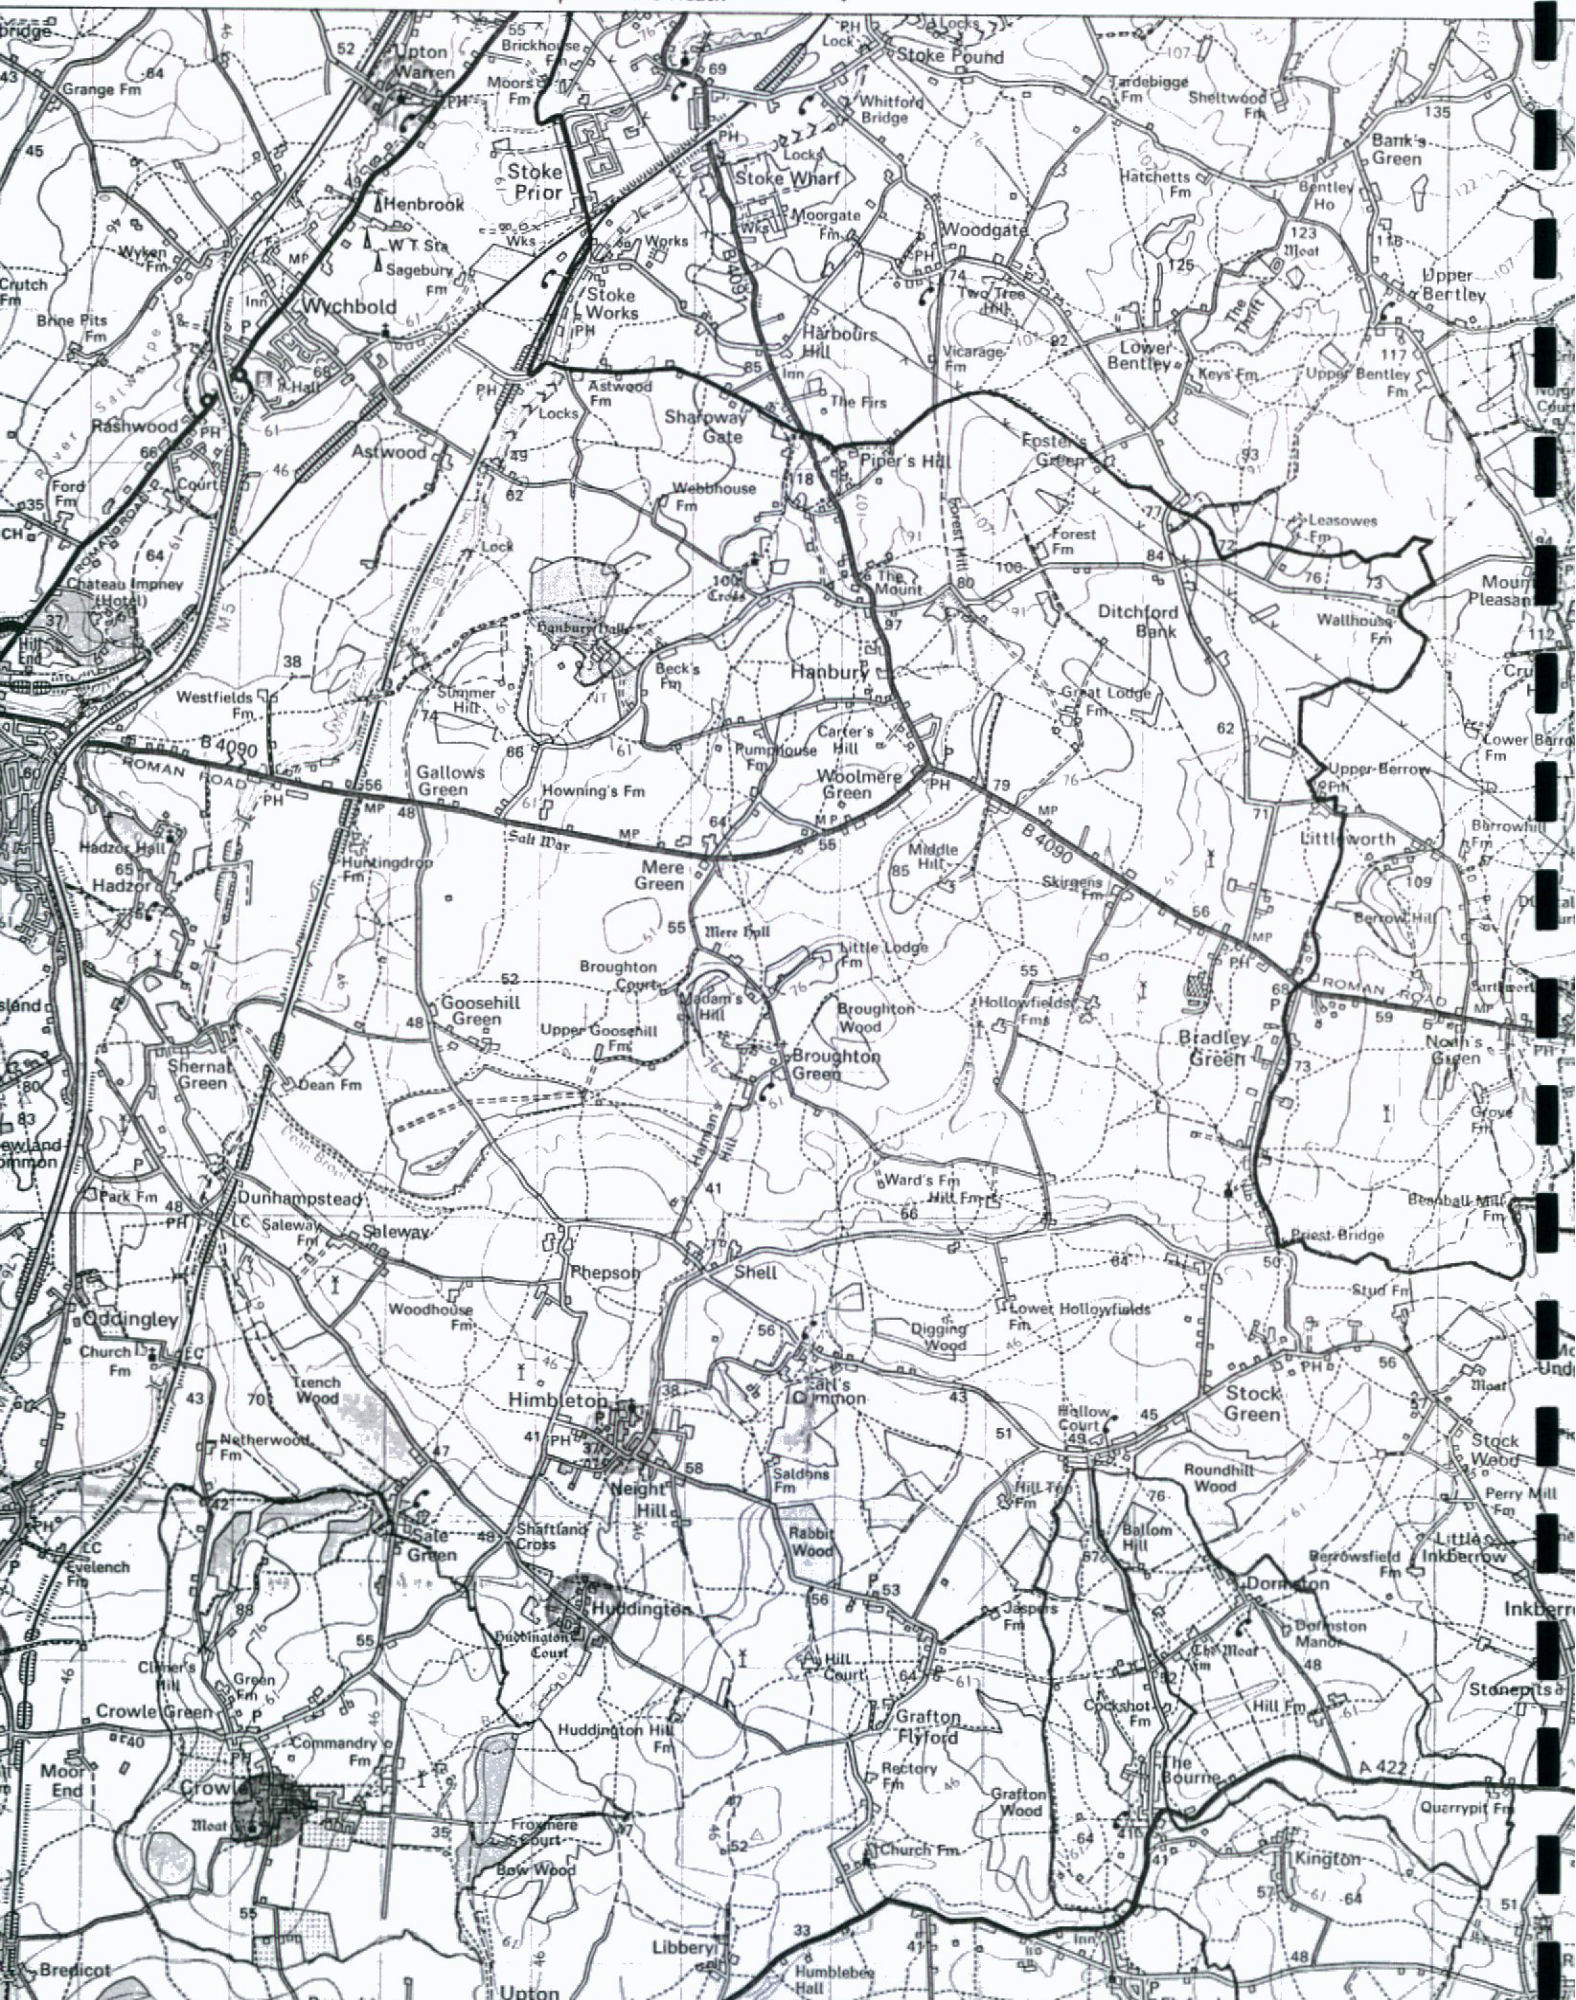
EXTRACT FROM 1900 ORDNANCE SURVEY Scale 25" to 1 mile

RATLEY Circa.1900

There has been a degree of change in the numbers of buildings and form of roads and footpaths since the turn of the century, including a significant amount of 'infill' and a few buildings have been lost since that time.

The one significant loss is that of the Manor Farmhouse and its main barn ranges (two smaller stable ranges remain from the original group).

There was also a row of cottages between the church and pub which have gone, except for one; a row in the north-east corner of the village has been reduced to two cottages and there are now gaps in the once continuous terrace of cottages and barns down the west side of the High Street. There is no doubt that, from a conservation point of view, the losses have been greater than the gains.

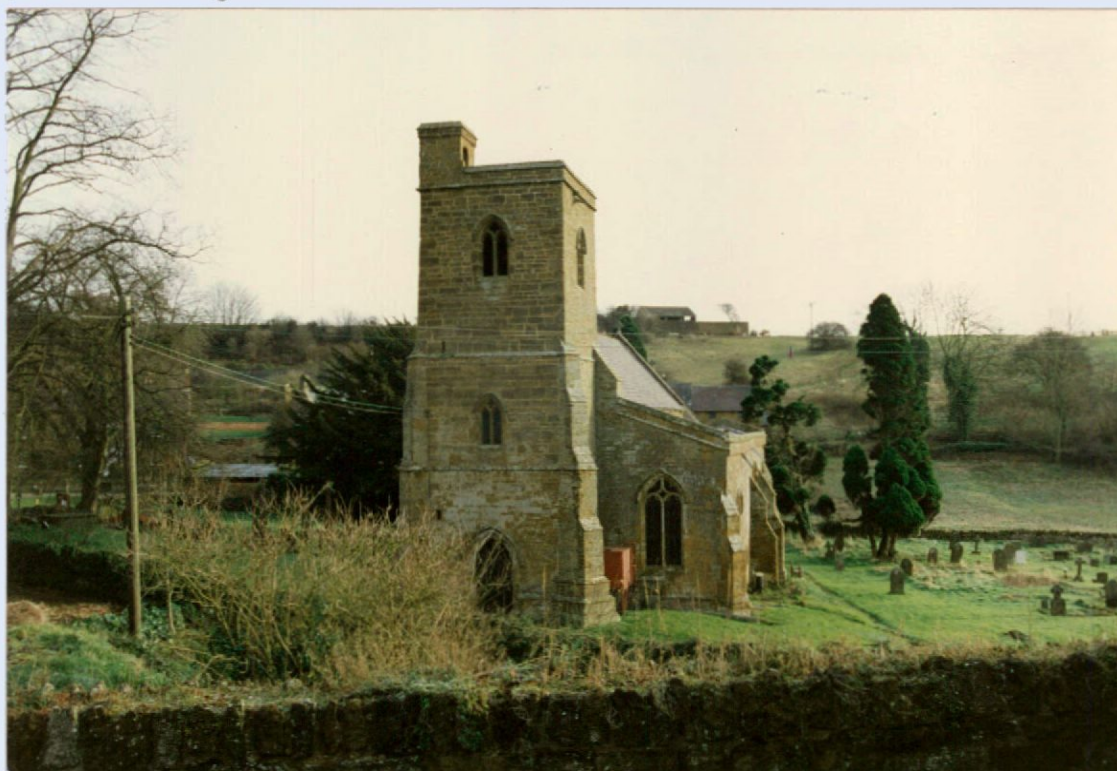
- 3/117 Church of St. Peter Ad Vincula
(Listed Building Ref 3/117 - Grade II*)

(Key building in the landscape - churchyard and fields form a large 'space' around it)

List description : Church. C12 chancel, C13 nave and tower, C14 south aisle and chapel and alterations; C17 porch. Restored 1872. Nave, tower and porch of regular coursed ironstone; chancel, aisle and chapel of squared coursed ironstone rubble. Chancel roof of tiles, nave of slates, aisle of lead; nave and chancel have coped gable parapets. Chancel, nave, south aisle, south chapel, north porch and west tower. Decorated style. 3-bay nave, 2-bay chancel. Chancel has diagonal buttresses with 2 offsets. Renewed 4-light window with curvilinear tracery. North side has small chamfered priest's doorway with C19 plank door. 2-light eastern window has curvilinear tracery. Small low western 2-light window has reticulated tracery. South side has 3-light window of cusped intersecting tracery. Hood moulds with return stops. Porch has chamfered and moulded Tudor-arched doorway with hood mould. Stone benches inside. Decorated north doorway has 2 major and 2 minor orders of roll moulding and deep hollow chamfers. Hood mould with block stops. C19 double-leaf doors. 3 partly-restored two-light north windows with ogee arches and hood moulds with return stops and finials.

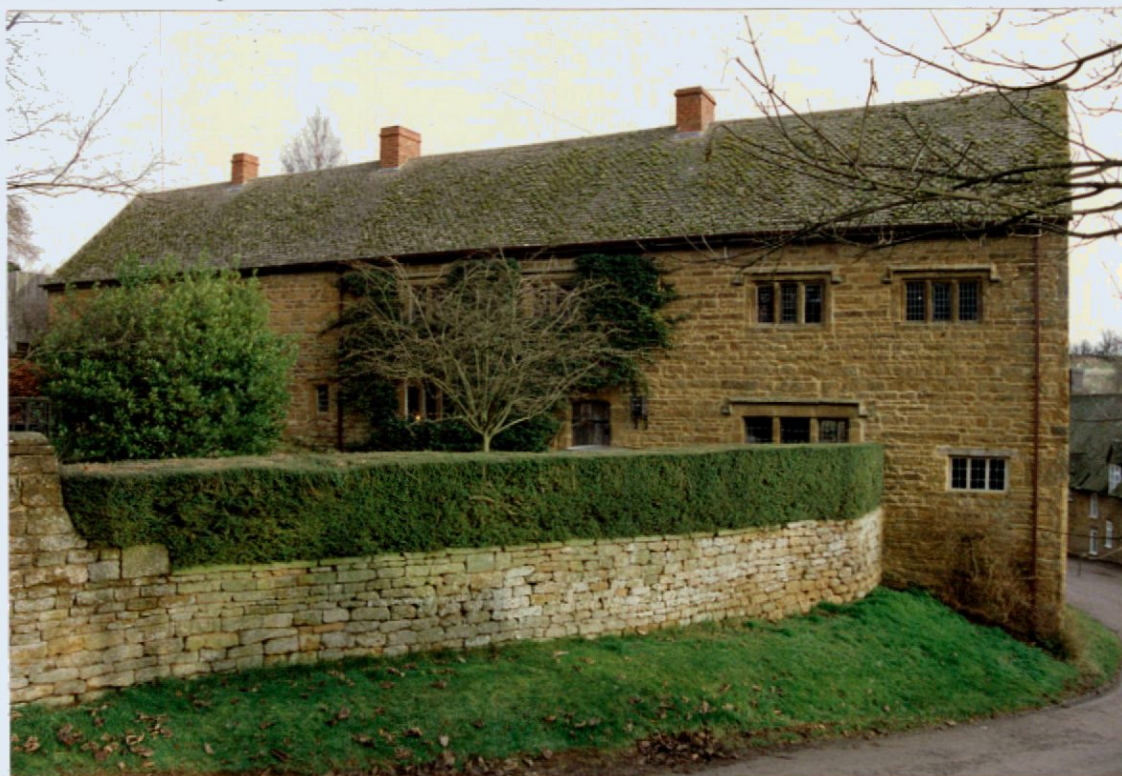
**3/113. The Leigh, Chapel Lane (Formerly known as Mount Farmhouse)
(Listed Building Ref 3/113 - Grade II)**

(Prominent position on bend - high gable and dominates street)

List description : House. C16, with mid/late C20 alterations. Regular coursed ironstone; concrete tile roof; three late C20 brick ridge stacks. Plan indeterminate, but possibly 4-unit. 2 storeys and attic; 5-window range. Entrance to right of centre has plank door with strap hinges in chamfered Tudor arch doorway with remains of hood mould. Stone mullioned windows, some old, with chamfered mullions in recessed surround; some mid/late C20 with plain mullions; all have hood moulds. Left end has small single-light in block surround. Irregular fenestration. Ground floor has to left of entrance two 3-light windows, the left C20, and moulded fire window, and to right an original 3-light window and small old casement with wood lintel. First floor has three 2-light windows wholly or largely renewed, and 2 original 3-light windows. 2 windows have some coloured glass. Right return side has first floor casement and 2-light mullioned attic window. Rear irregular. 2 entrances, one with old plank door and wood lintel, the other late C20 with a half-glazed door and chamfered stone lintel. Interior not inspected.

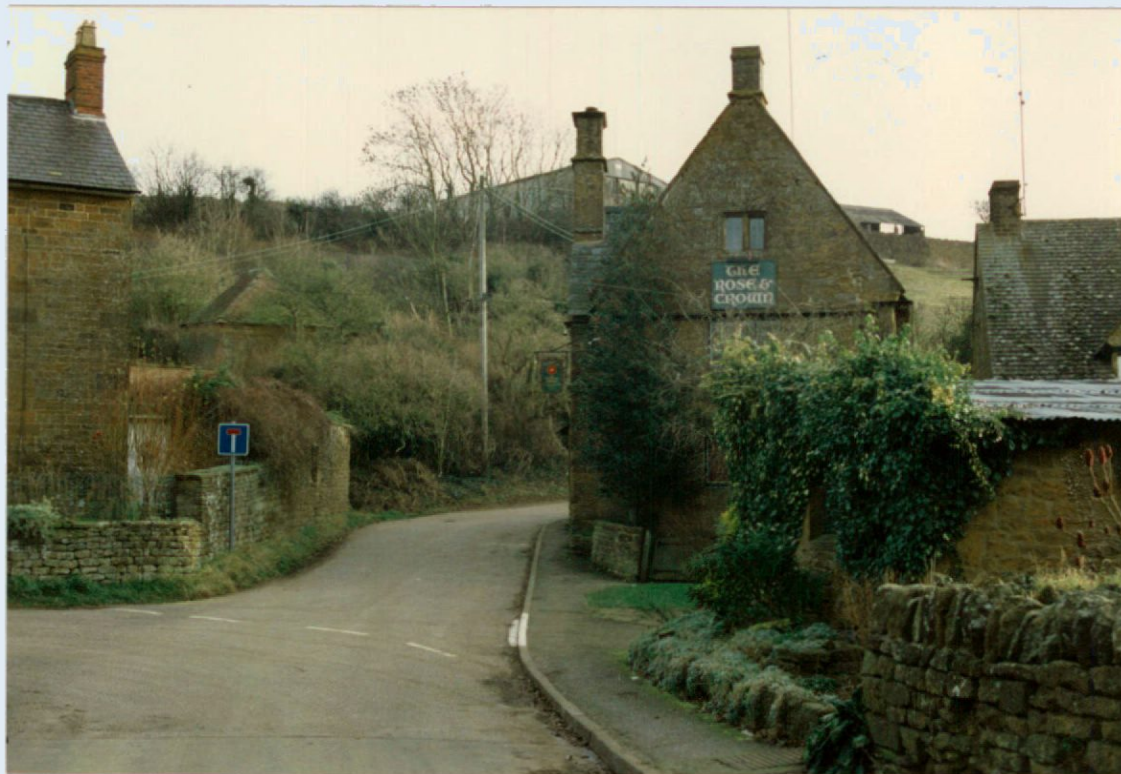
**3/116. The Rose and Crown Public House, Church Street
(Listed Building Ref 3/116 - Grade II)**

*(Group value with Church Farm House on Featherbow Lane corner.
Steep pitched gable dominant in street scene.)*

List description : Public house. C17 with C19 additions and alterations. Coursed ironstone. Slate roof has moulded coped gable parapets; stone lateral and end stacks with string courses and C19 brick shafts. 2-unit plan. 2 storeys and attic; one-window range to road, 3-window range to garden. Front to road has plank door in C19 painted wood frame with chamfered lintel. Small C19 casement in old chamfered stone surround to right. First floor has C19 chamfered 2-light casement under old wood lintel. Attic has single light in block surround. Wide external stack, projects on right; 2 square shafts. C19 single storey addition on left, partly across front. 2-window range. Right return side has splayed plinth, and string course. Single moulded cellar window. C20 casements, on first floor in original stone surrounds. Attic has chamfered 2-light mullioned window. Front to garden has splayed plinth stepped up on right, and string course. Central plank door in chamfered stone surround with large lintel. 2-light part-ledged casement above. Left section has 3-light chamfered mullioned windows in recessed surround; blocked on first floor. Right side has C20 casements. Interior: opened up into one room. Stone flagged floor. Chamfered ceiling beams. Open fireplace in external stack has cambered chamfered bressumer. Inglenook fireplace has chamfered bressumer and wooden benches. Small cupboard inside has butterfly hinges. Winder stairs.

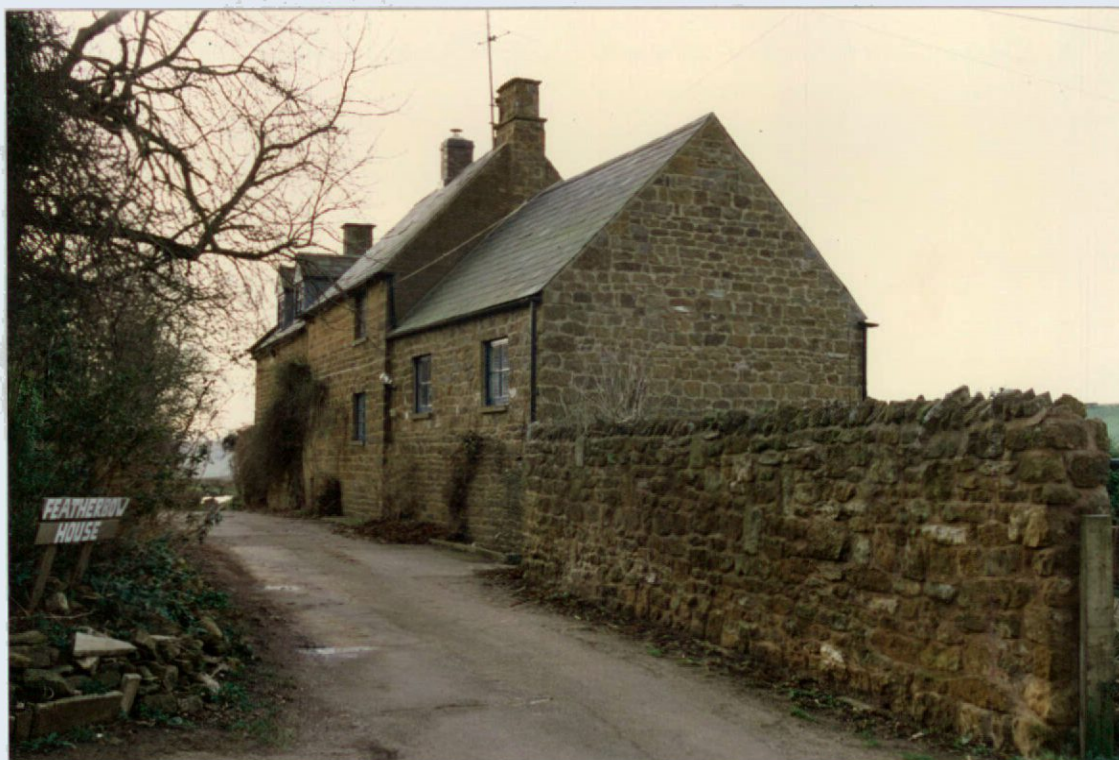
**3/126. Featherbow House, Featherbow Lane
(Listed Building Ref 3/126 - Grade II)**

List description : House, formerly 3. Late C18/early C19; not of one build; left range C19/C20. Regular coursed ironstone with irregular quoins. Left range has rougher stonework. Slate roofs, with coped gable parapet on right; stone end stacks to centre and right ranges, and central C20 brick ridge stack. Main front to garden. Each range 2-unit plan. Left range 2 storeys, central and right ranges 3 storeys: each 2-window range. Each range has central doorway and C19 casements. Left range has late C20 glazed door. Stone lintels. Central and right ranges have part-glazed doors and stone lintels with keystones. Central range has small stone projection on right. Ground floor has 3 windows, with 3-light casement on left. Late C20 conservatory. Right range has semi-circular lead canopy porch with timber posts. 3-light part-leaded casement to right. End stack has string course. Rear irregular. Interior not inspected.

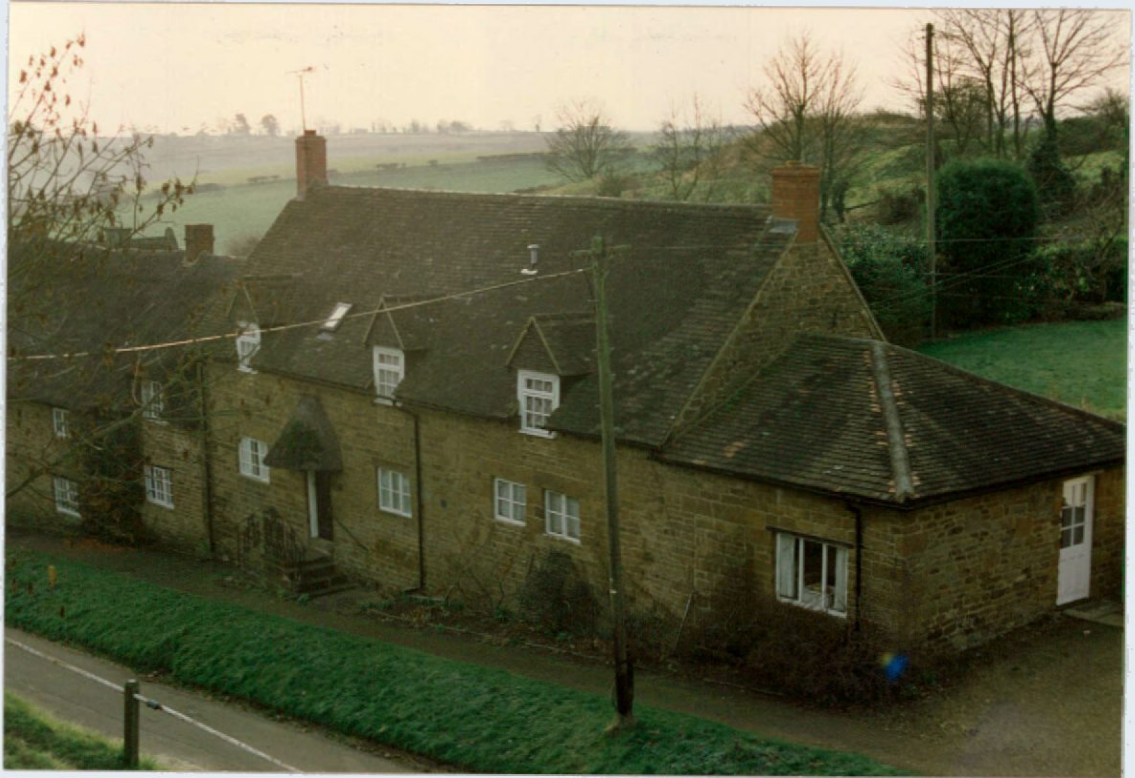
3/127. The Steps, High Street
(Listed Building Ref 3/127 - Grade II)

(Important building in terrace group down the main street - good stone steps and thatch canopy to front door)

List description : Cottage, formerly several; semi-detached. Mid/late C18, altered late C20. Regular coursed ironstone. C20 tile roof; brick end stacks. 3-unit plan. One storey and attic; 3-window range. Entrance has 6-panelled door with thatched hood, and steps. Blocked doorway with window inserted on right. Ground floor has old 3-light casements with horizontal glazing bar, and stone lintels with flush keystones. First floor windows formerly below eaves, but now with late C20 half dormers and casements.

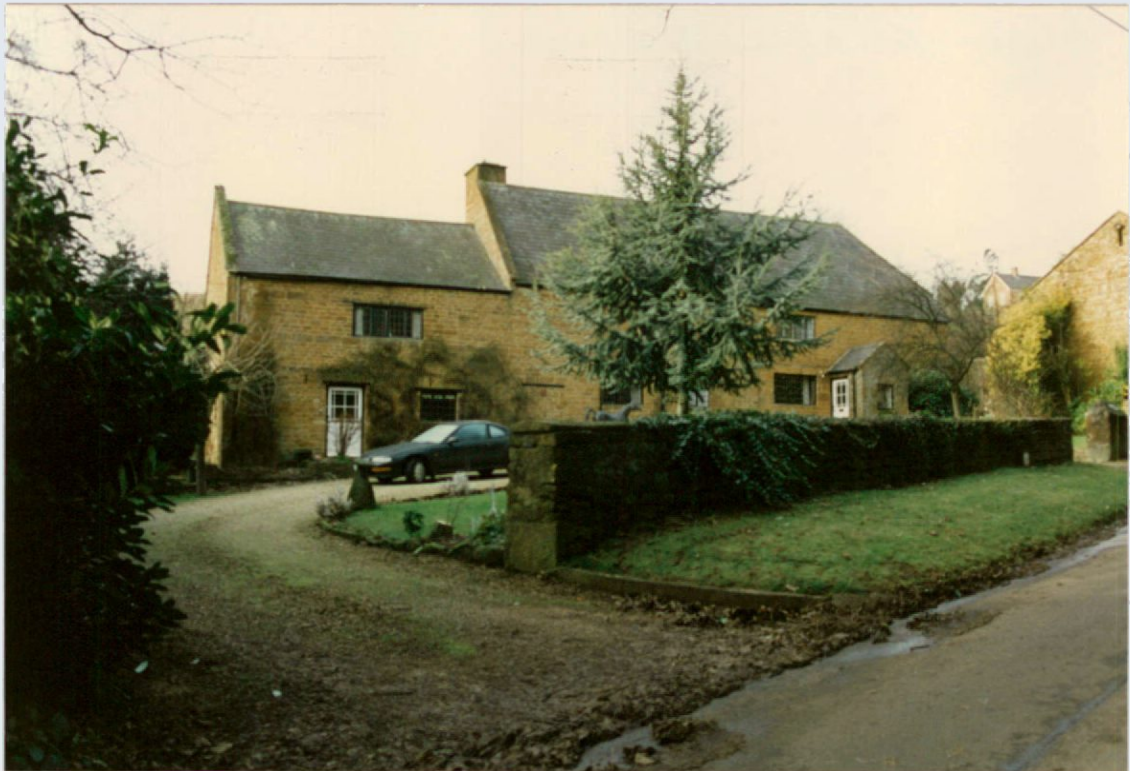
**3/129. Mount Farmhouse, High Street
(Listed Building Ref 3/129 - Grade II)**

(Enclosed by frontage stone boundary wall, barn and converted barn range building - all important to setting of LB)

List description : Farmhouse. C15/C16 rear wing, C18 front ranges, with later alterations. Regular coursed ironstone. Slate roofs with coped gable parapets; stone ridge end and lateral stacks. L-plan, with wing to rear on left. 2 storeys and attic: 3-window range. Long irregular front to road of 2 ranges has entrance at right end. C20 stone porch with coped gable and leaded light, and half-glazed door in left return side. Blocked doorway in left end of right range. Left range, at lower level, has half-glazed door. Irregular fenestration of leaded 2,3 and 4-light casements. On right 3-light ground floor and 4-light first casements have stone lintels with keystones. Other openings have painted wood lintels, some old. Both ranges have gabled parapets on left; roof hipped on right. Left return side has 2-light stone-mullioned windows with hood moulds. Right return side has old casements, C20 three-light mullioned window, and one and 2-light old mullioned windows. Large external stack has two C19 square stone shafts. To rear: irregular main range has leaded light casements and mullioned windows, some C20. Higher wing on left: stone mullioned windows with hood moulds throughout. One-window front has 3-light and 2-light attic windows. Coped gable parapet. Right return side has 3-light windows to left, lengthened on ground floor and 2-light to right, with mullion removed on first floor. Interior not inspected.

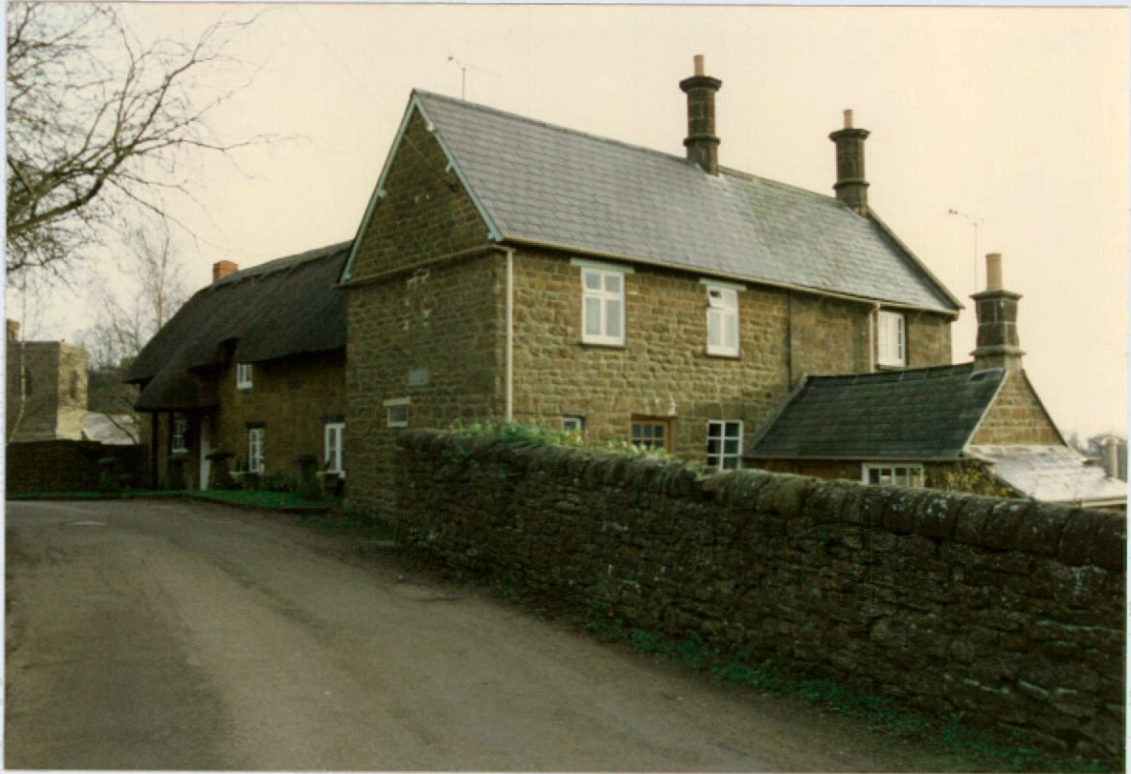
- 3/130. Goggles Spring Cottage (now known as 'The Thatch Cottage')
High Street
(Listed Building Ref 3/130 - Grade II)

(Key building along roadside - one of two remaining thatch roofs in the village)

List description : Cottage. C17/C18, raised late C18/early C19; late C19/early C20 rear addition. Coursed ironstone. Thatched roof; addition has slate roof; C19 and C20 brick end and ridge stacks. 3-unit plan, extended to L-plan with wing on left to rear. One storey and attic; one-window range. Entrance between first and second bays has ribbed plank door. Stone lintel. Thatched open porch continued down from roof. 3 ground floor casements with painted wood lintels. Eyebrow dormer. Rear irregular.
Interior: noted as having open fireplace.

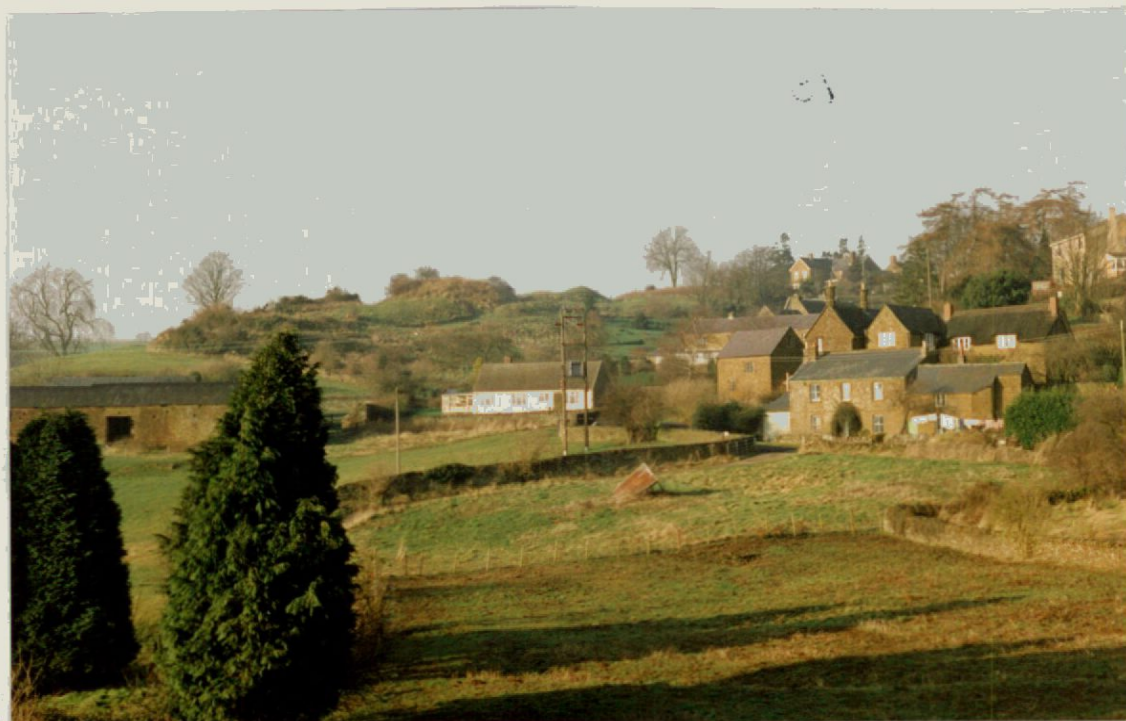
1

As a consequence, the views to the south-west from many parts of the village, over the open countryside, are spectacular (Photo 1).

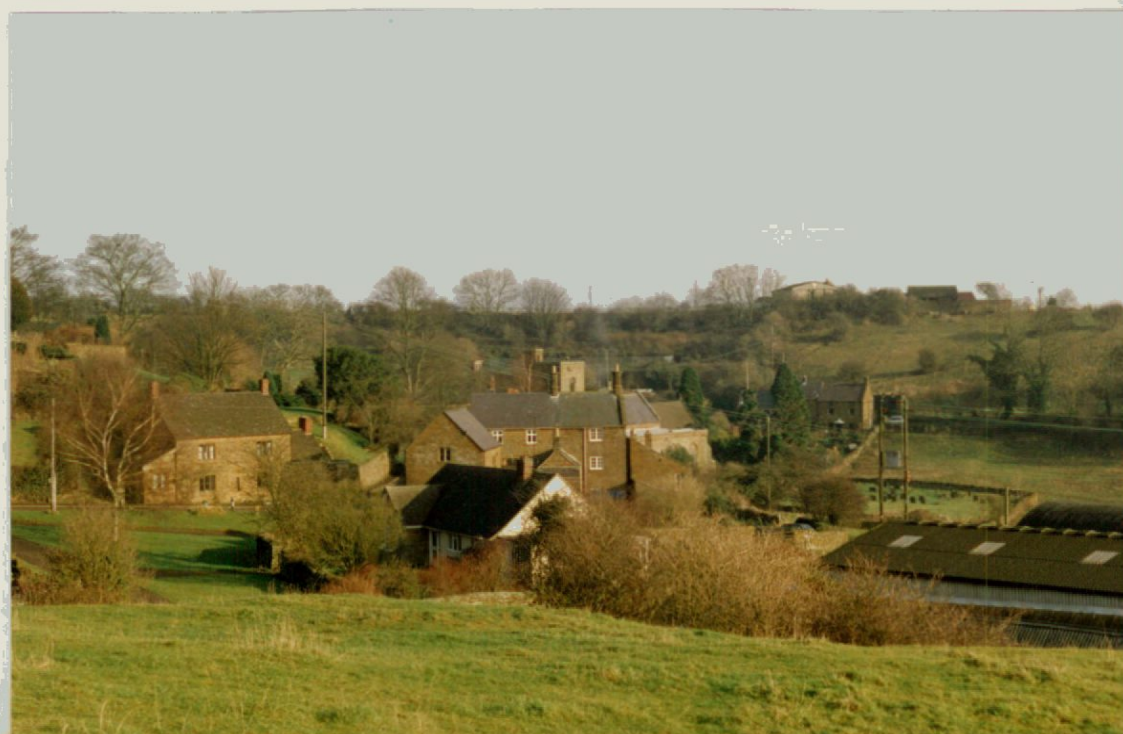
2

The sides of this valley in which the village is located are defined on the west by the earthworks of the Motte and Bailey (Photo 2) and on the east by a scrub clad slope behind Church Farm (Photo 3). The focus is towards the centre, being around a small green between the Church of St Peter ad Vincula, Ratley House, Church Farm and The Rose and Crown Inn (Photo 4).

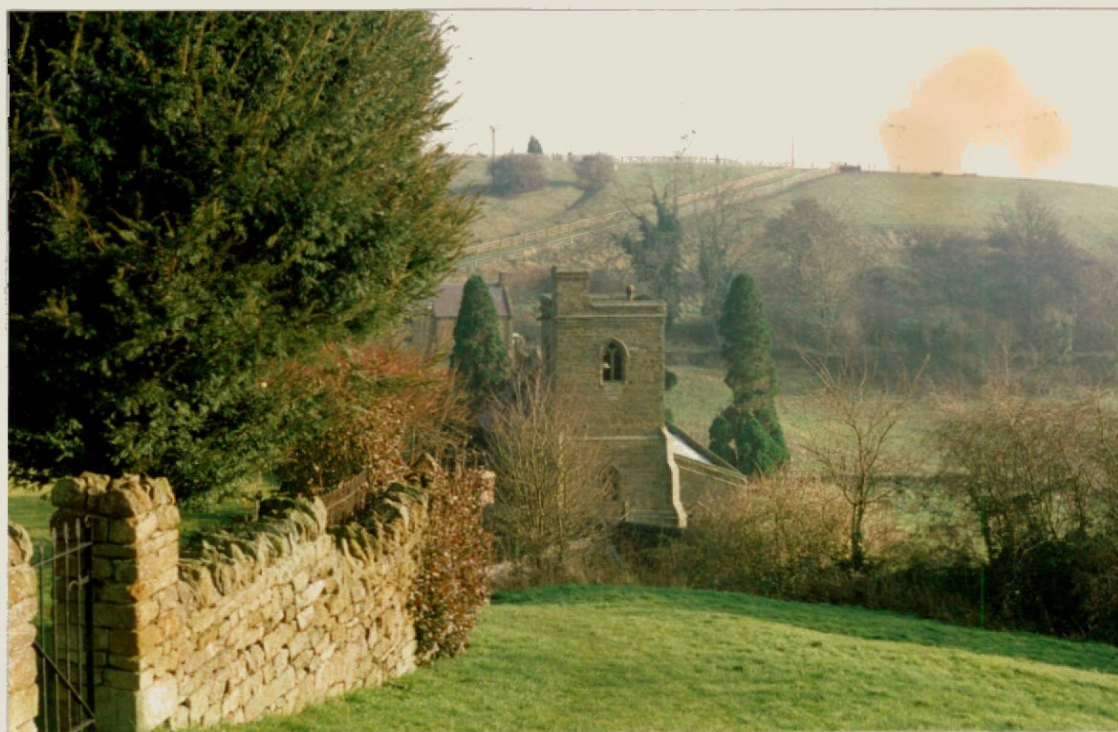
5

The Conservation Area is tightly drawn in around the village and includes the Motte and Bailey site and the slopes behind Church Farm. It is regrettable that the farm access tracks up this slope are so obtrusively fenced however (Photo 5).

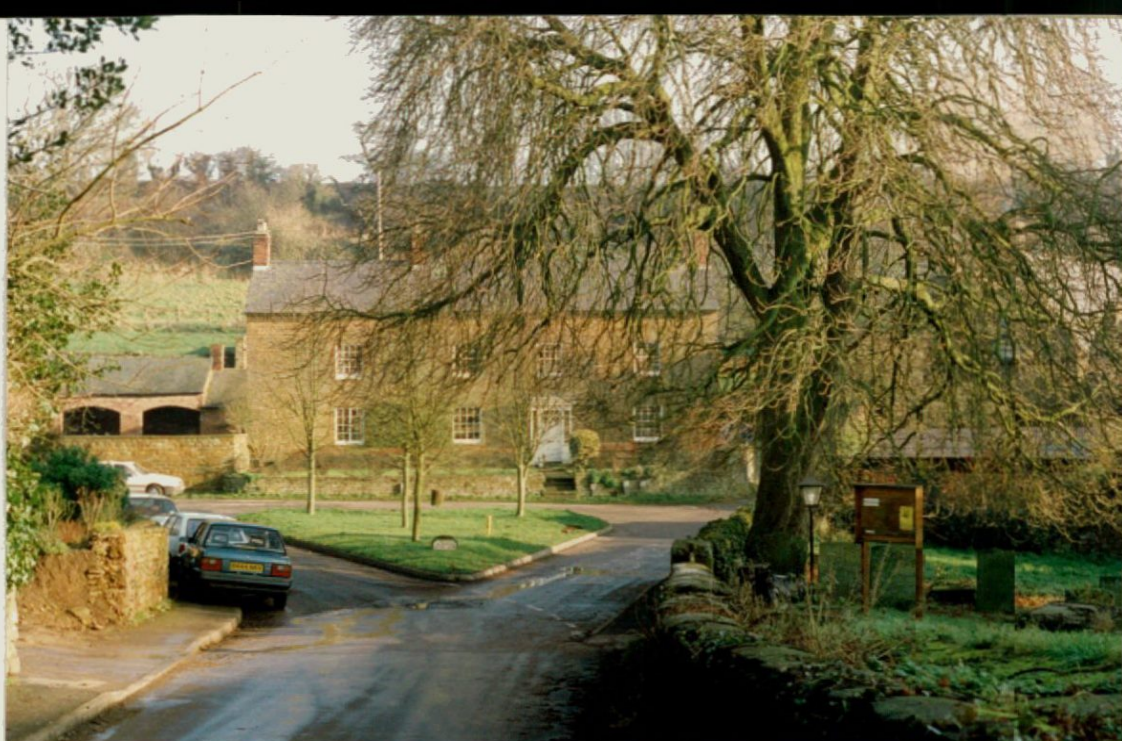
7

At the east end the view is nicely stopped by Church Farm (Photo 7) outside of which is a triangular green, planted with young limes, and the public house tucks neatly in the corner.

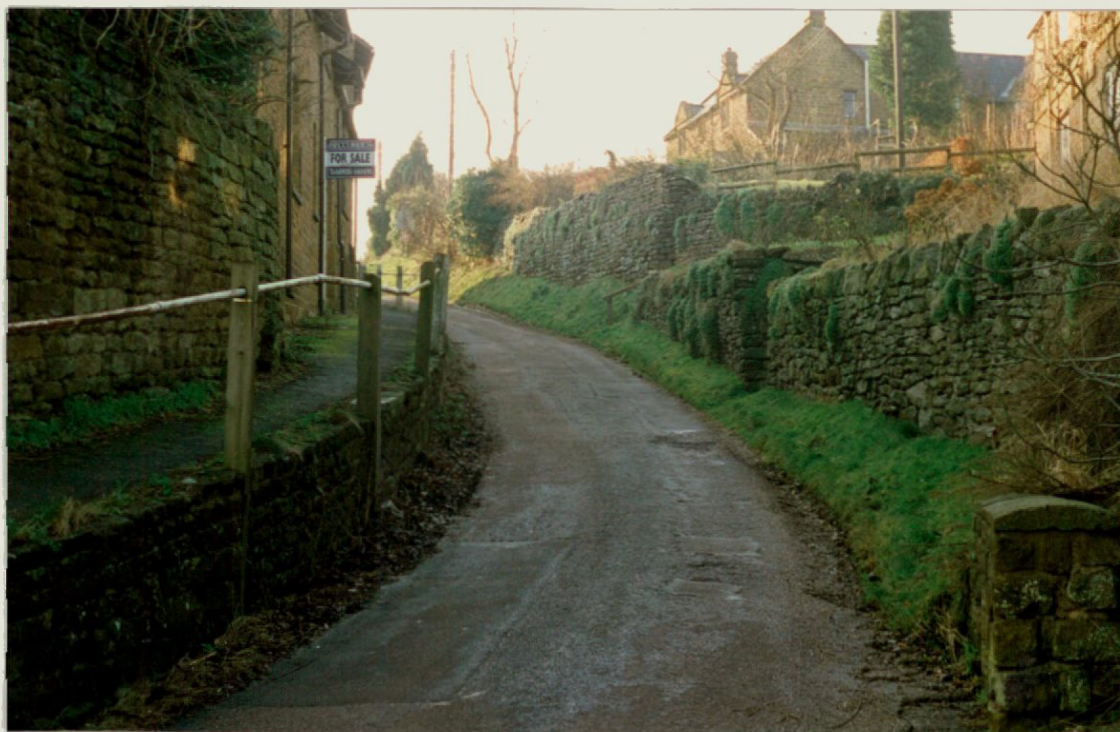
11

Chapel Lane is a narrow road, free of kerbed edges, enclosed by stone walls with narrow banked grass verges and with a footpath sited above the road level (Photo 11). It is an attractive corridor, only marred by some wire and poles and the poor state of the footpath railing, and some new development at its east end. There is an entrance gate to The Leigh which is of good design with stone pillars topped by ball caps and simple iron gates painted black (Photo 12). The Leigh itself forms an effective visual stop at the bend in the Lane.

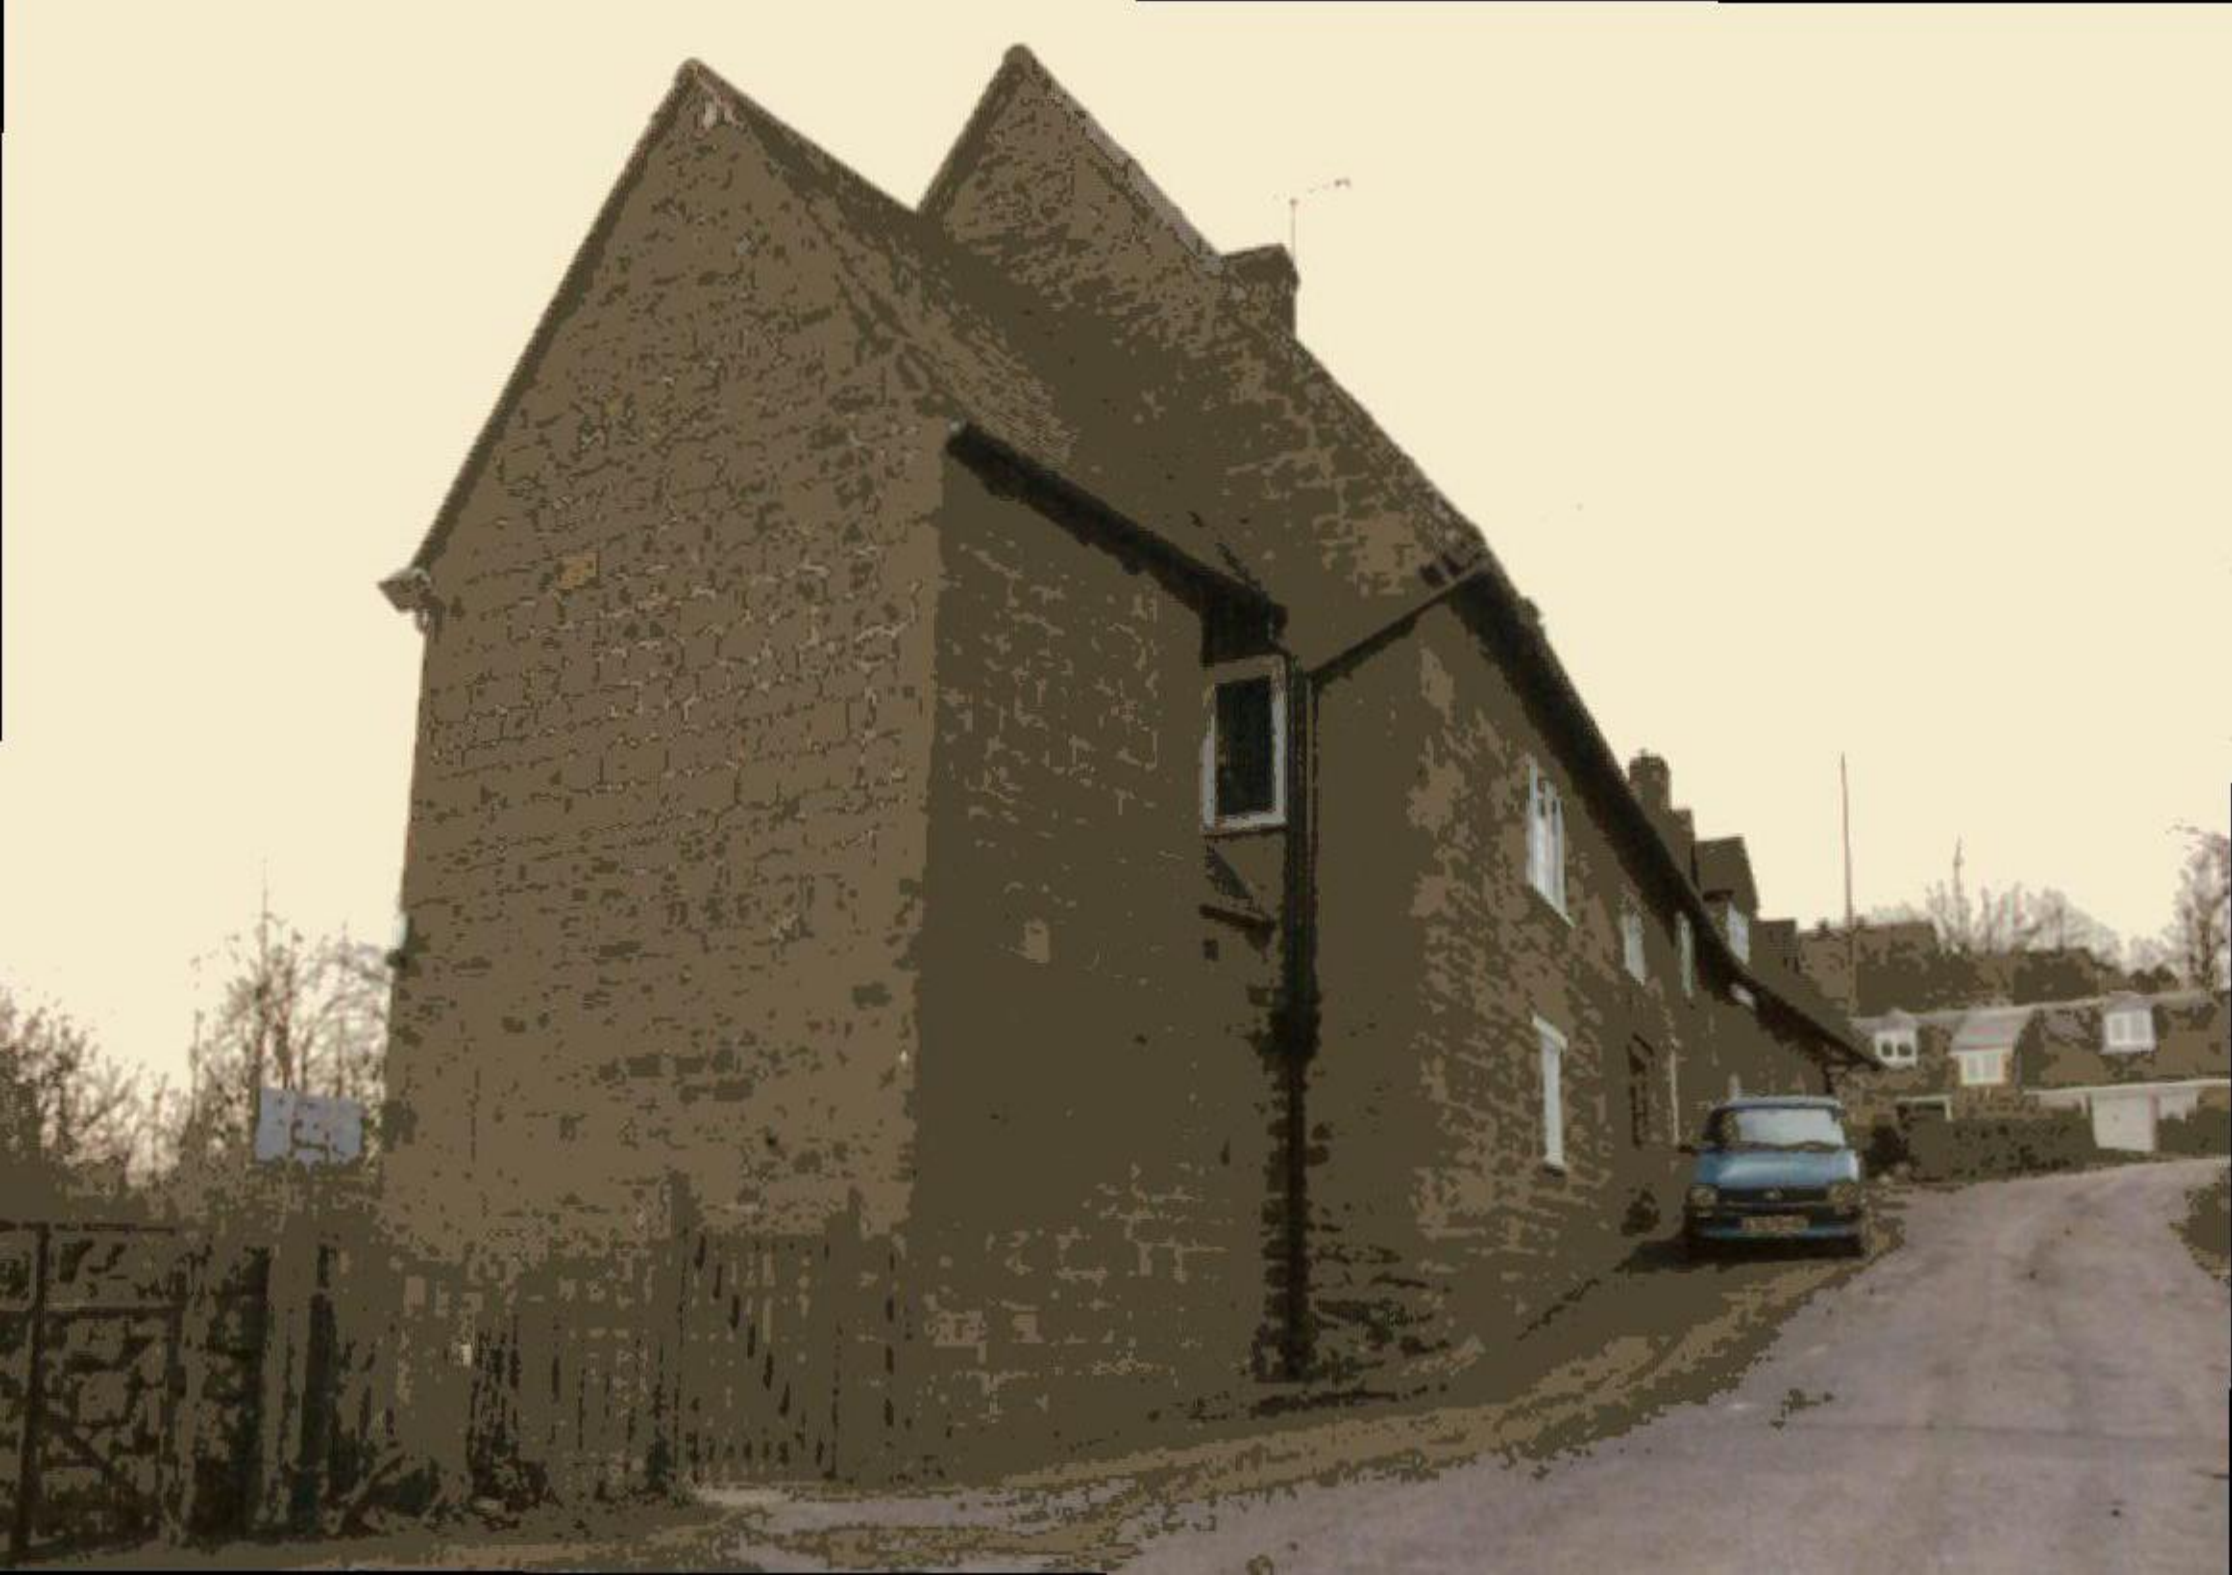
B7- West Wharfedale - Chapel La.

B7	West Winds, Chapel Lane. Early C18th long terrace cottage range, low, 2-storey attics, stone, large steep roof, clay plain tile (probably originally thatched). Important building in Chapel Lane.
B8	Farm Cottage and Homewood, Chapel Lane. Early C20th, rebuilding of earlier terrace, stone, clay plain tile. Group value.
B9	Ratley House (former Vicarage). Late C19th, victorian gothic style, 2-storey, big scale, low range to rear, rusticated coursed, squared rubble, dressed stone detailing, steep welsh slate roof, long drystone wall to frontage. Prominent on corner.
