STRATFORD ON AVON DISTRICT COUNCIL

CONSERVATION AREA REVIEWS

RATLEY

February 1994

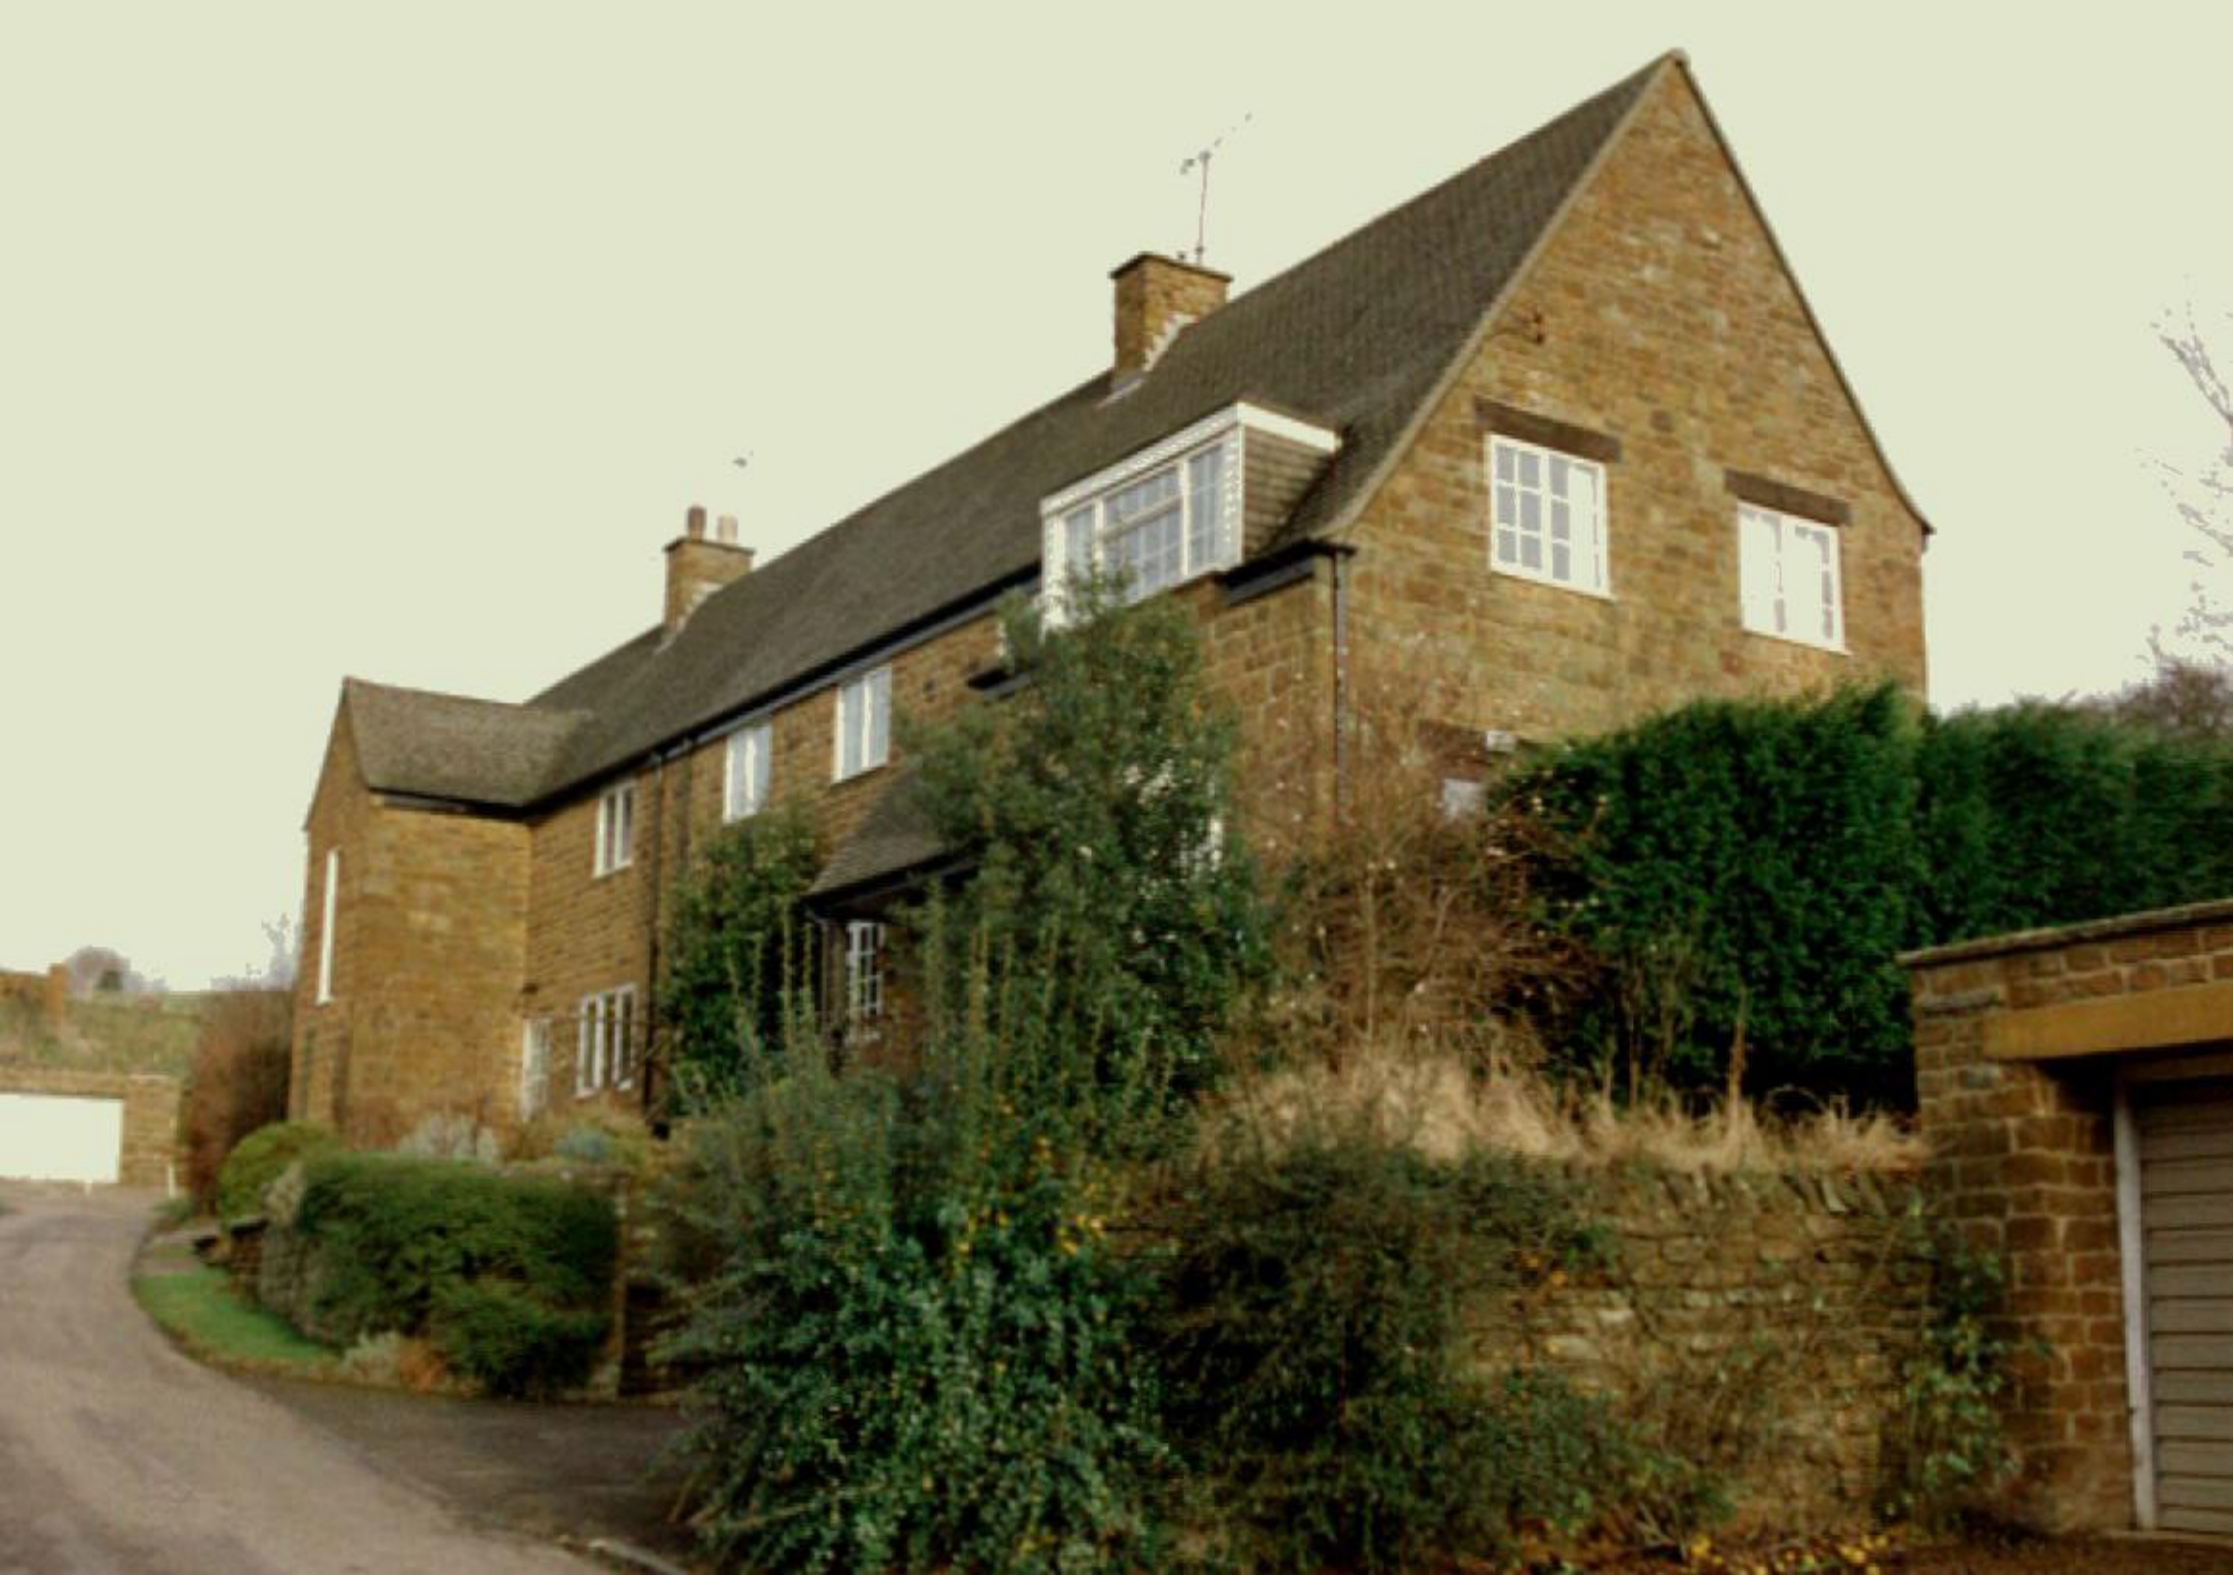
B8 - Farm Cottage - Hamewood.

B7	West Winds, Chapel Lane. Early C18th long terrace cottage range, low, 2-storey attics, stone, large steep roof, clay plain tile (probably originally thatched). Important building in Chapel Lane.
B8	Farm Cottage and Homewood, Chapel Lane. Early C20th, rebuilding of earlier terrace, stone, clay plain tile. Group value.
B9	Ratley House (former Vicarage). Late C19th, victorian gothic style, 2-storey, big scale, low range to rear, rusticated coursed, squared rubble, dressed stone detailing, steep welsh slate roof, long drystone wall to frontage. Prominent on corner.
