## Stratford-on-Avon District Council – Site Allocations Plan

### Heritage Impact Assessment

SHLAA Reference	BID.02
Site Address	West of Grafton Lane, Bidford-on-Avon
Site Capacity	Approx. 150 dwellings

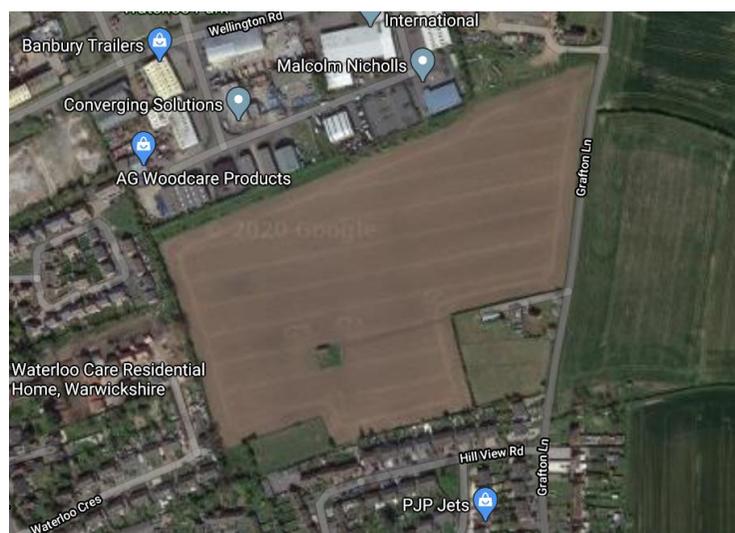
The site is located on the North Eastern corner of the settlement of Bidford-on-Avon between residential development to the south, and an industrial estate to the north. The site itself is mainly farmland that is being used in sections to grow varying crops. Having been farmed the site has undergone extensive ploughing. The site is relatively flat. The south eastern corner of the site contains a small dwelling with what appears to be some of its own land, and near the middle of the site is an isolated shed on a small patch of grass that remains untouched. Access to the site is possible off Grafton Lane. The site, lying on the outskirts of the settlement is far from any Listed Buildings and the Conservation Area.

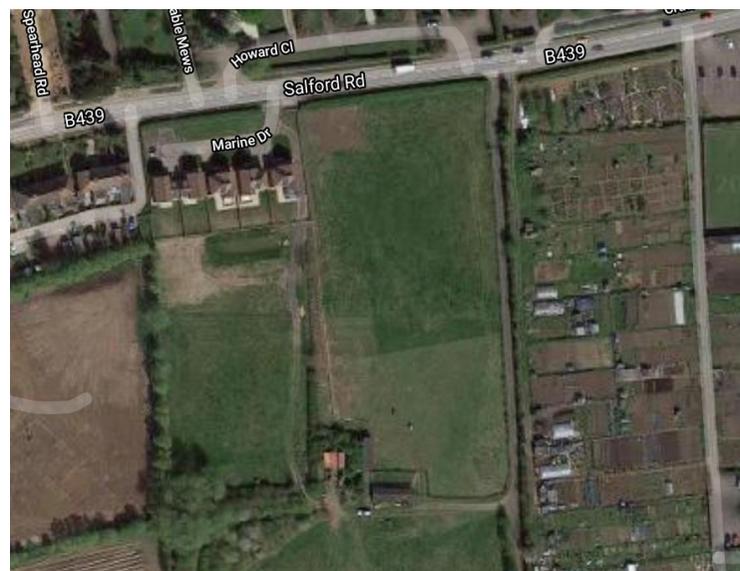
The site is located south of the Salford Road towards the western edge of the town. The site is currently pasture land and was being grazed by a horse on the day of the visit. To the east of the site lie the community allotment gardens which are well used and there is an established hedge that runs between the two areas. To the western side of this hedge, and along the edge of the site runs a gravel track that leads up to a small stable block. Directly west of the site are 5 new builds and beyond that there is a larger estate that has recently been developed.

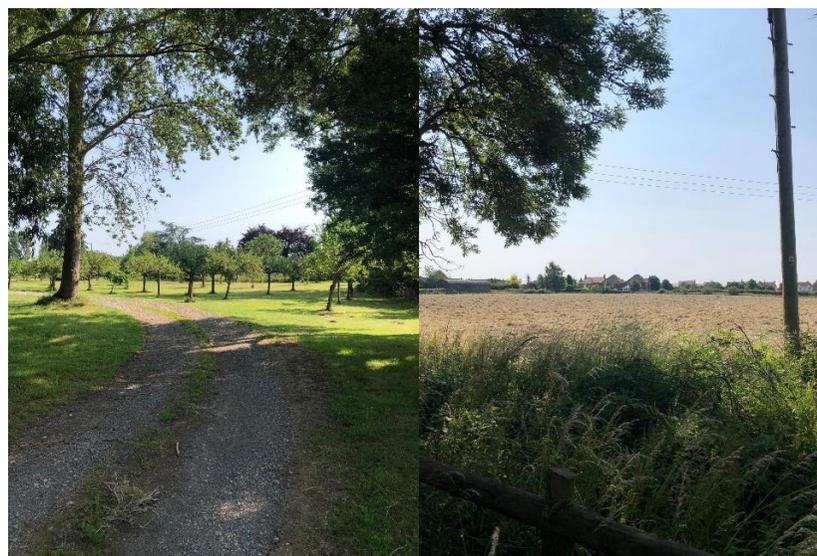
The site is situated north of the Salford Road on the western edge of the settlement. The site has been split and has multiple uses. The southern section of the site is a small pasture field that has a shed and small stable in the western corner. The mid-section of the site is used as farmland where grass had recently been cut to make hay. The Northern section of the site contains Marriage Hill farm which is accessible via a gravel road that meanders through what appears to be a small orchard. The entirety of the site is flat and is at a distance from any heritage assets.

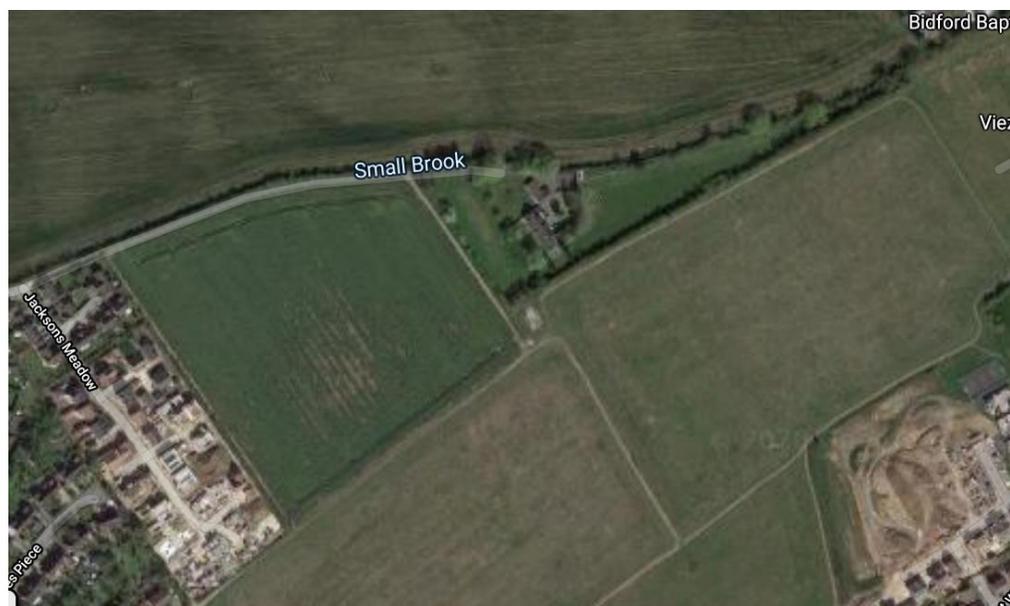
The site is situated in the northern part of Bidford-on-Avon and all bar the western edge of the site is surrounded by farmland. There is a track that runs up the northern edge of the site that leads to Lovelies Grange. The site itself has been farmed and crops were growing on the day of the visit. The site is flat, and is located a distance from any heritage assets. Recent development has taken place to the west of the site.

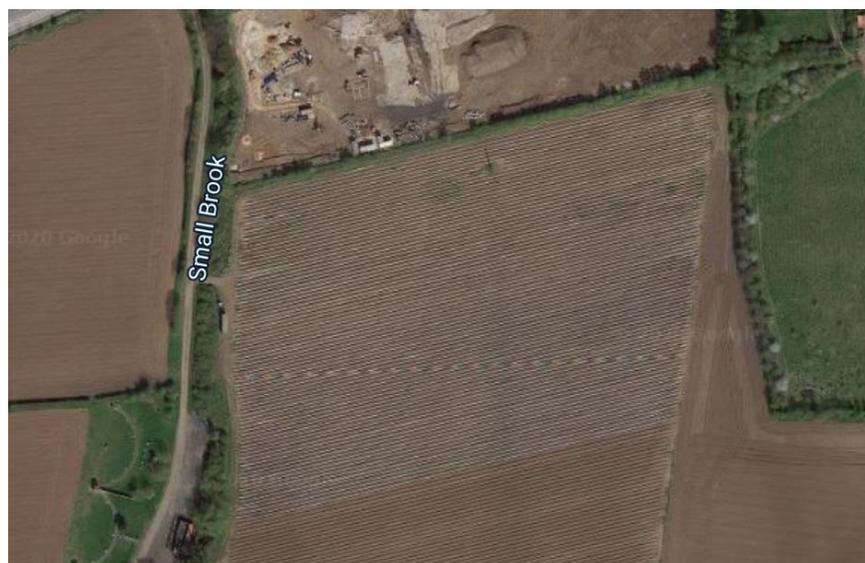
The site is situated on the south eastern edge of the settlement next to the new development of Avon Way. The site is currently being used to grow crops and is slightly raised in comparison to the surrounding land. The site appears to have no obvious ditches or gully's and instead has a smooth curving aspect. West of the site is a small road that runs to riverside shooting ground. Surrounding the site, on all bar the northern side, lies farmland with views south towards the river. Despite the uninterrupted vista, the curvature of the land and the slight elevation prevents a direct view to the river.
