Stratford-on-Avon District Council – Site Allocations Plan

Heritage Impact Assessment

SHLAA Reference	FEN.01
Site Address	North of Northend Road (west), Fenny Compton.
Site Capacity	Approx. 15 dwellings

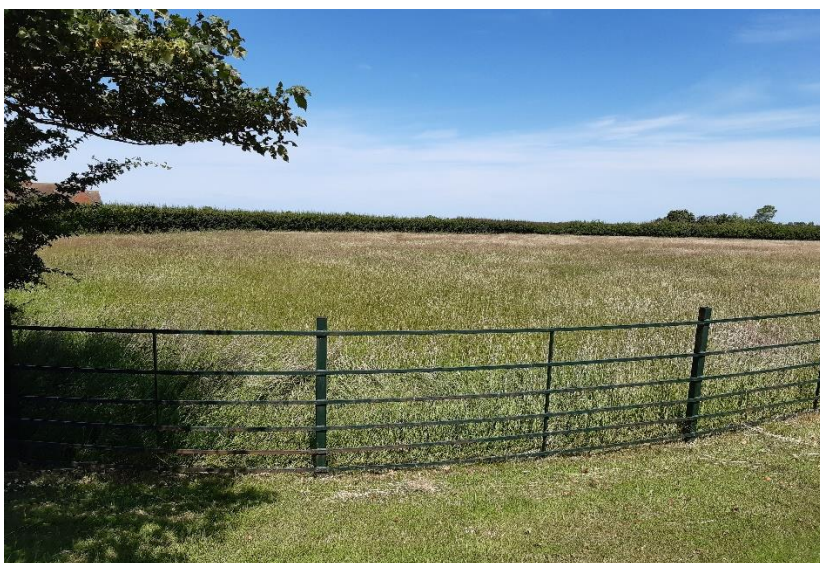
Site is located to the west of a row of cottages fronting Northend Road and opposite dwellings forming 'ribbon development' on the western edge of the village. Immediately to the west of the site is the vehicular access driveway serving businesses operating from buildings at Manor Farm, located to the northeast corner of the site in question. The site itself is a small grassed field bounded by mature hedgerow. The site is flat, with no sign of earthworks of any sort. The Grade II listed Manor Farmhouse is located approximately 120 metres to the east of the site. Public footpaths in vicinity of the site would afford views of the site from the north.

Based on the assessment of the designated and non-designated heritage assets affecting this particular site, it is concluded that development would cause less than substantial harm to nearby heritage assets and mitigation measures (such as the introduction of a landscaping buffer on the southern site boundary) would be possible in order to attempt to reduce the potential harmful impact development in this location would cause. It is concluded that development in this location would result in less than substantial harm to designated and non-designated heritage assets.

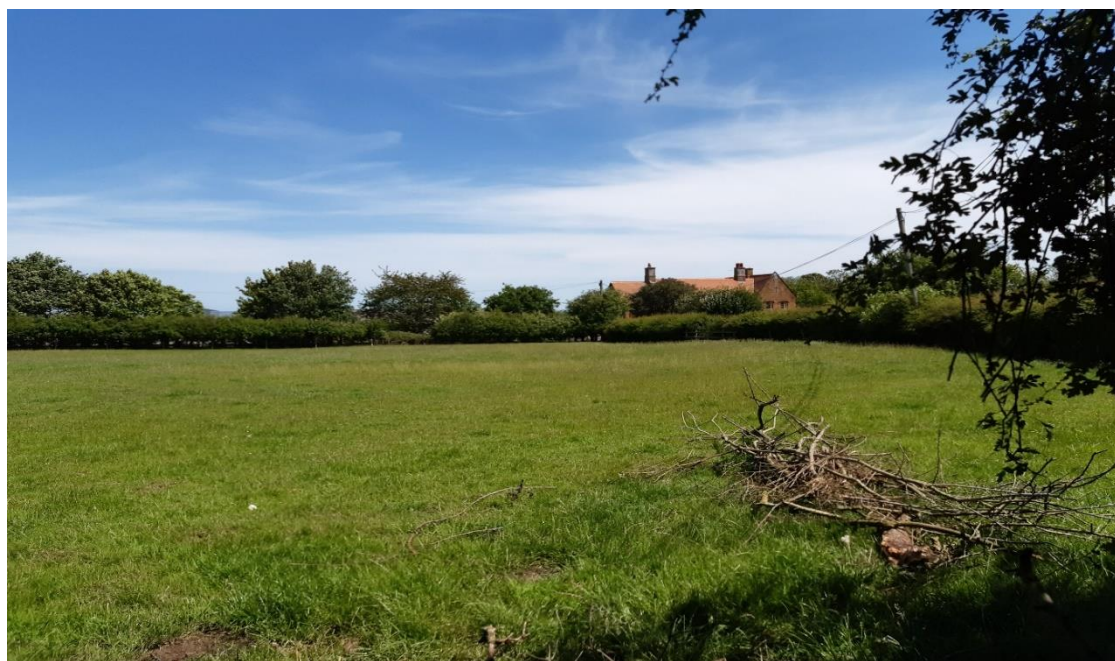
Site is located between row of cottages fronting Northend Road and buildings associated with Manor Farm. The site itself is a small grassed field bounded by mature hedgerow, being grazed by a small flock of sheep on the day of the visit. The site is reasonably flat, but with evidence of mounds and hollows throughout the site. The Grade II listed Manor Farmhouse is located approximately 20 metres from the NE corner of the site. A public footpath runs along the access driveway to the Farmhouse, adjacent to the eastern boundary of the site – affording close-up views of the listed building and the site.

Based on the assessment of the designated and non-designated heritage assets affecting this particular site, it is concluded that mitigation measures (such as reduced dwelling capacity) would not be possible in order to attempt to reduce the impact of the substantial harm development in this location would cause in particular to the setting of the listed building and the Conservation

Area, cumulatively. This is due to the fact that the permanent loss of any land associated with the historic curtilage connected with the listed farmhouse would be irreversible.

It is concluded that development in this location would result in substantial harm (overall) to both designated and non-designated heritage assets when considering the cumulative impacts on each asset.

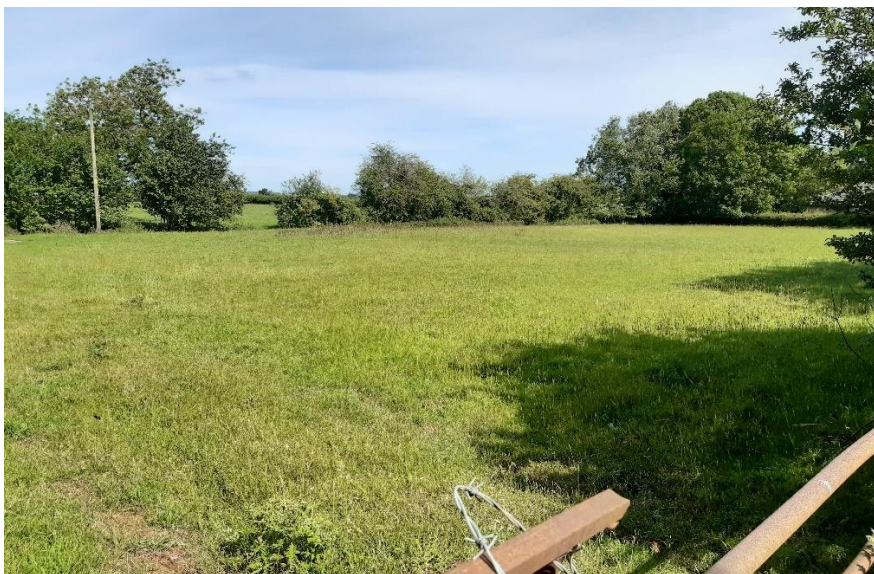
Site is located between row of dwellings to the south and doctor's surgery to the north, fronting High Street. Dwellings are located to the east, on the opposite side of High Street. The site itself is a small grassed field/paddock bounded by mature hedgerow. The site is reasonably flat, but with evidence of mounds and hollows throughout the site. The Grade II listed Manor Farmhouse is located approximately 45 metres from the SW corner of the site. A public footpath runs through the centre of the site, leading past Manor Farm, affording close-up views of the listed building and the site.

Based on the assessment of the designated and non-designated heritage assets affecting this particular site, it is concluded that mitigation measures (such as reduced dwelling capacity) would not be possible in order to attempt to reduce the impact of the substantial harm development in this location would cause in particular to the setting of the listed building and the Conservation Area, cumulatively. This is due to the fact that the permanent loss of any land associated with the historic curtilage connected with the listed farmhouse would be irreversible.

It is concluded that development in this location would result in substantial harm (overall) to both designated and non-designated heritage assets when considering the cumulative impacts on each asset.

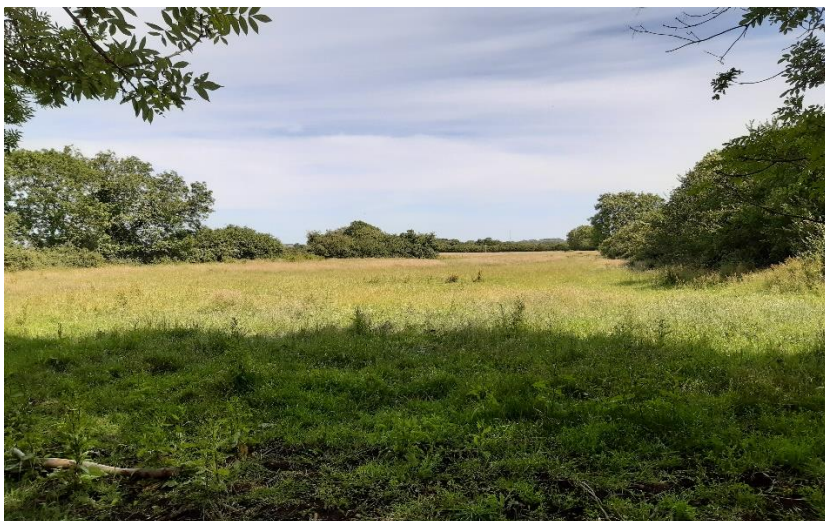
Site is situated on the northern edge of the village, adjacent to a relatively modern housing estate, which is located to the east. Vehicular access to the site would be to the north of the doctor's surgery on High Street. Open countryside to the north and west. The site itself is long and narrow, bounded by mature hedgerow on all sides except for the north, since it is part of a larger field. The site is reasonably flat throughout, but with evidence of mounds and hollows throughout the site. The Grade II listed Manor Farmhouse is located approximately 150 metres to the SW of the site. A public footpath runs along the eastern boundary of the site, leading into the wider agricultural landscape to the north.

Based on the assessment of the designated and non-designated heritage assets affecting this particular site, it is concluded that development would cause less than substantial harm to nearby heritage assets and mitigation measures (such as the introduction of a landscaping buffer on the southern site boundary) would be possible in order to attempt to reduce the potential harmful impact development in this location would cause. It is concluded that development in this location would result in less than substantial harm to designated and non-designated heritage assets.

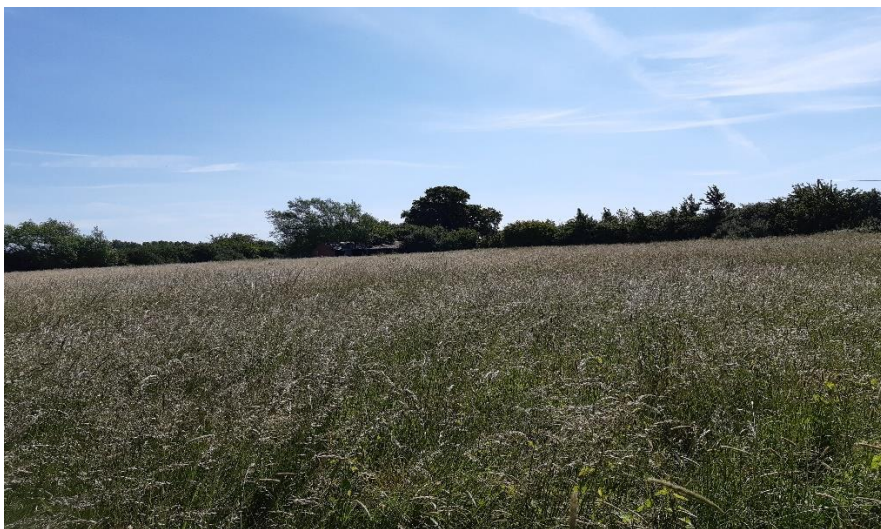
The site consists of a roughly rectangular shaped piece of grassed land, situated to the north east of the village of Fenny Compton just beyond the current edge of the built form of the village. The village playing fields are located immediately to the northwest of the site. The site is located 380 metres north east of the village Conservation Area and there are no nearby listed buildings. The closest footpath runs along the northern boundary of the recreation ground, affording public views from the north east. The land slopes from a high point at the south east roadside boundary, down to the level of the recreation ground. The site is well contained in that it is surrounded by mature hedgerows. To the north and southeast are further grassed fields.

Based on the assessment of the designated and non-designated heritage assets affecting this particular site, it is concluded that development would cause less than substantial harm to the non-designated heritage asset when taking into account the site specific issues, although it is acknowledged that mitigation measures would not be possible in order to attempt to reduce the potential harmful impact development in this location would cause, seeing as the ridge and furrow earthworks would be lost to any development process. It is concluded that development in this location would result in less than substantial harm to the non-designated heritage asset based on the site specific circumstances.

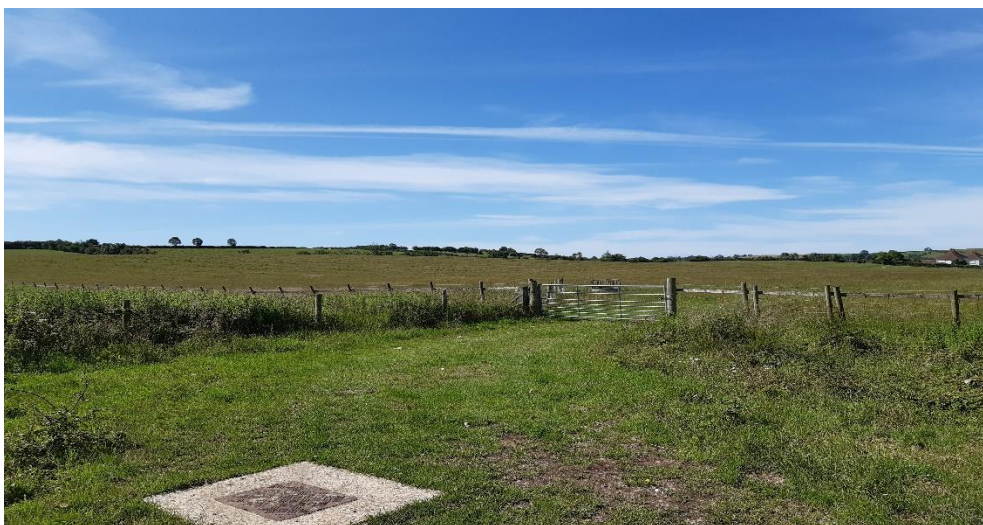
The site consists of the lower slopes of a large field located to the north east of the village of Fenny Compton, between a row of dwellings and the ex-Compton Works commercial site, which has been levelled and has planning consent to be re-developed with housing. The site is located 260 metres north east of the village Conservation Area and there are no nearby listed buildings. The closest footpath runs along the ridgeline to the south of the site, affording public views from an elevated position. The land slopes from a high point to the south, down to the level of the road running parallel to the North West boundary. The site is well screened from Station Road by a tall mature hedgerow. This is part of one field forming a patchwork of agricultural land to the south east.

Based on the assessment of the designated and non-designated heritage assets affecting this particular site, it is concluded that development would cause less than substantial harm to the non-designated heritage asset when taking into account the site specific issues, although it is acknowledged that mitigation measures would not be possible in order to attempt to reduce the potential harmful impact development in this location would cause, seeing as an element of the existing the ridge and furrow earthworks would be lost to any development process. However, it is concluded that development in this location would result in less than substantial harm to the non-designated heritage asset based on the site specific circumstances.

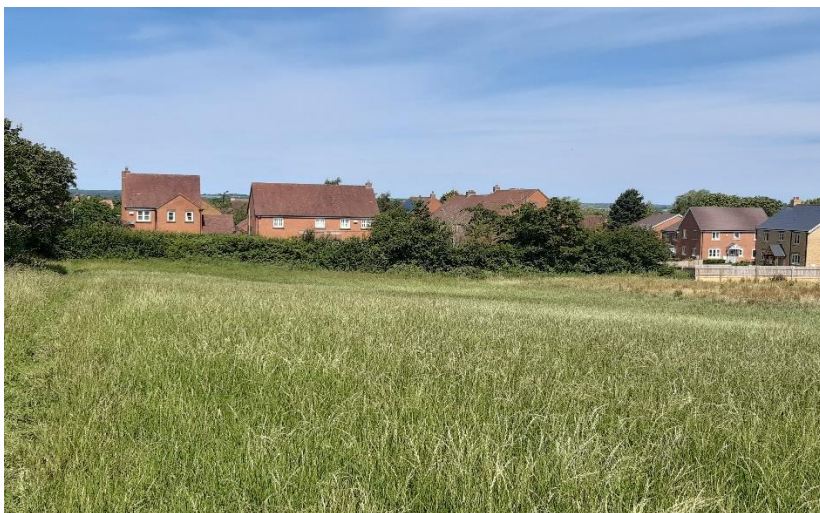
The site consists of a roughly rectangular shaped area of a much larger field, situated on the eastern edge of Fenny Compton just beyond the current edge of the built form of the village. New allotments associated with a recently completed housing development are located immediately to the northeast of the site. The northwest site boundary is coterminous with the village Conservation Area. There are no listed buildings in the vicinity of the site. A public footpath runs along the north western boundary of the site affording public views. The land is on rising ground, sloping from a high point to the south east roadside boundary, down to the edge of the village. The entire field was covered in long grass, which began to be cut during the time of the site visit.

Based on the assessment of the designated and non-designated heritage assets affecting this particular site, it is concluded that development would cause less than substantial harm to the setting of Conservation Area and possible ridge and furrow. Mitigation measures (such as the introduction of a landscaping buffer on the southern site boundary) would be possible in order to attempt to reduce the potential harmful impact development in this location would cause. It is concluded that development in this location would result in less than substantial harm to designated and non-designated heritage assets.
