Stratford-on-Avon District Council – Site Allocations Plan

Heritage Impact Assessment

SHLAA Reference	NAP.03
Site Address	East of Butt Hill (south), Napton-on-the-Hill
Site Capacity	Approx. 6 dwellings

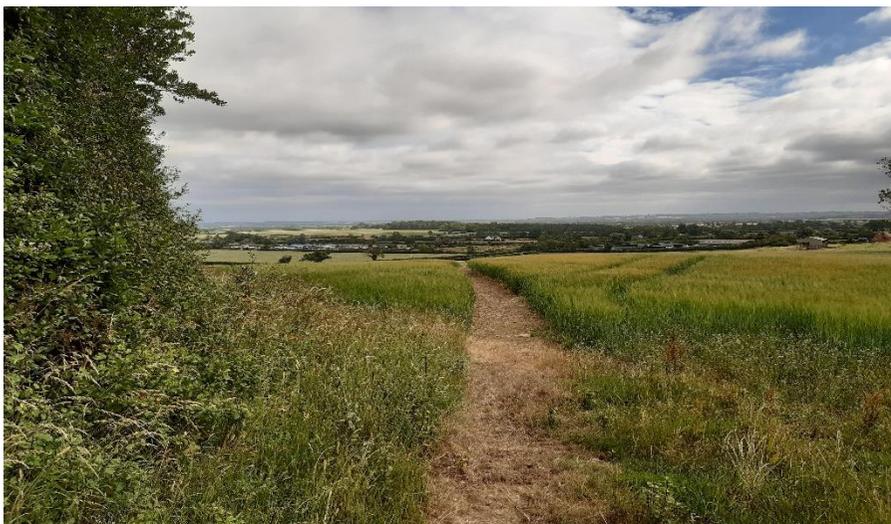
The site consists of the south western corner of a much larger agricultural field in an elevated position on the north-east edge of the village, accessed off Butt Hill. The field was planted with a crop at time of site visit. The site is relatively level, but at the northeast edge of the site, the land falls away significantly towards Shuckburgh Road. Mature hedgerow boundary along Butt Hill. A public footpath runs through the site. Modern agricultural barns associated with Manor Farm to the south of the site, with Grade II farmhouse, beyond. The village does not have a Conservation Area. Two Grade II listed dwellings located 215 metres to the NW – no inter-visibility, no functional relationship with the site and as such, not assessed as part of this work.

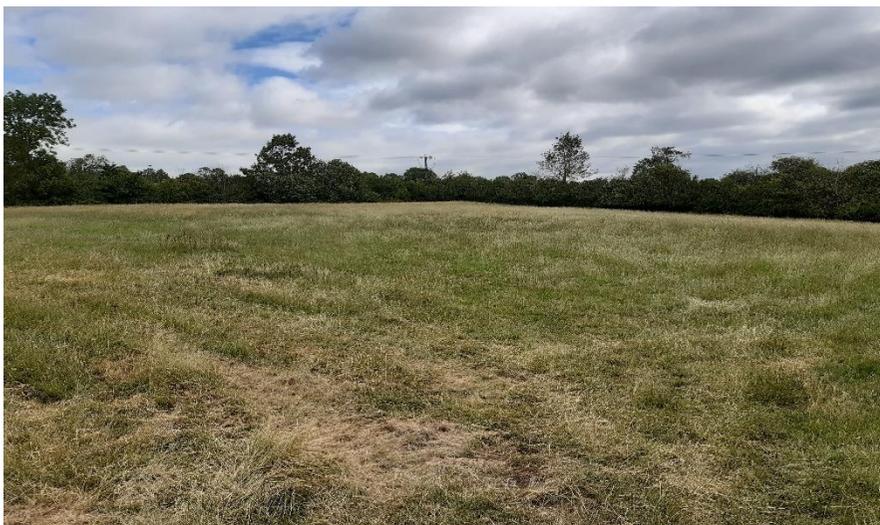
The site is located on the lower slopes of the hill on the eastern edge of the village. The land comprises a paddock area with an old stable block/storage barn and yard to the western boundary. The site benefits from mature hedgerow boundaries except for vehicular access to southern corner. There are mounds and hollows across the central portion of the site, but no evidence of ridge and furrow. The village does not have a Conservation Area. The nearest listed building is over 150 metres to the west of the site, with no inter-visibility. A development of a dozen new dwellings between the listed building and the site in question was completed last year. Therefore, there would be no harm to designated heritage assets – the listed building has not been formally assessed.

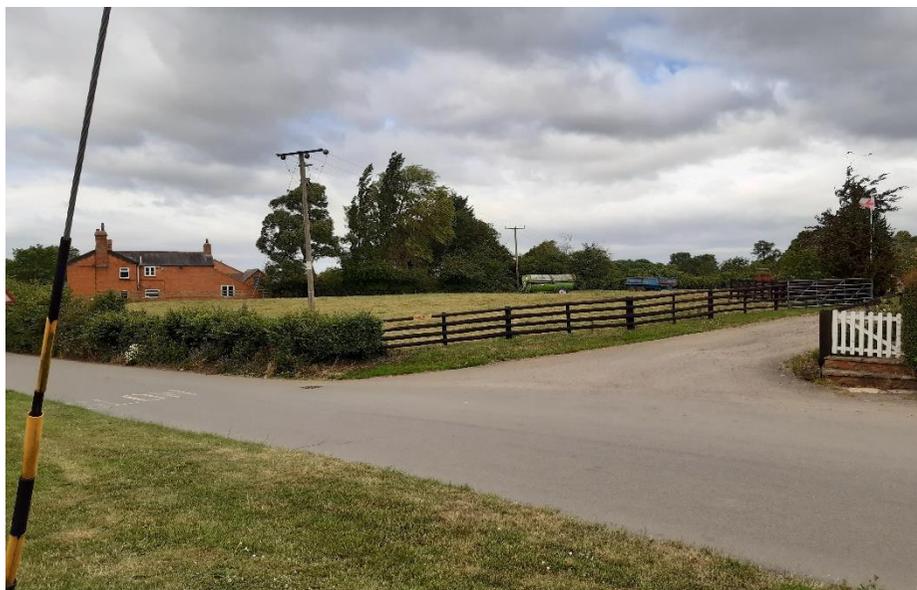
The site is part of the agricultural land associated with the property 'The Weir', which wraps around three sides of the property. The land is approximately 1.5 metres higher than the level of the adjacent road and has numerous mounds and hollows throughout. The land forms part of the immediate rural setting for 2 no. listed farmhouses. There are a number of public footpaths on rising ground to the north, affording clear views of the site. There is no village Conservation Area and no nearby Scheduled Monuments.
