Stratford-on-Avon District Council – Site Allocations Plan

Heritage Impact Assessment

SHLAA Reference	SHIP.01
Site Address	South of Darlingscote Road, Shipston on Stour
Site Capacity	Approx. 45 dwellings

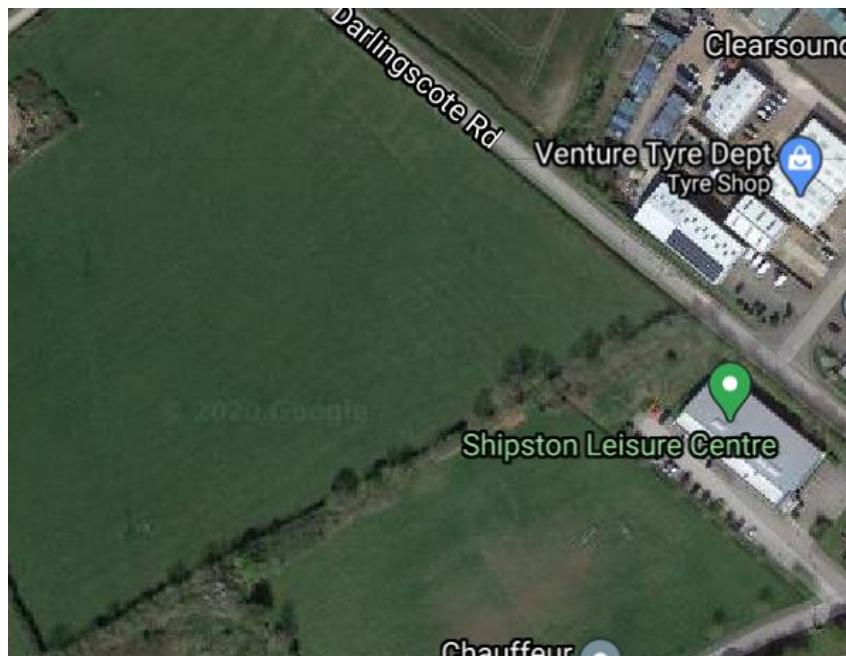
The site is part of a field located to the south of Darlingscote Road, on the western edge of the settlement. It is surrounded by mature hedgerows and trees. Shipston Leisure Centre is adjacent to the site to the south and Tilemans Lane Industrial Estate is located opposite to the east. The nearest listed building is located over 200m away and the Conservation Area over 500m away.

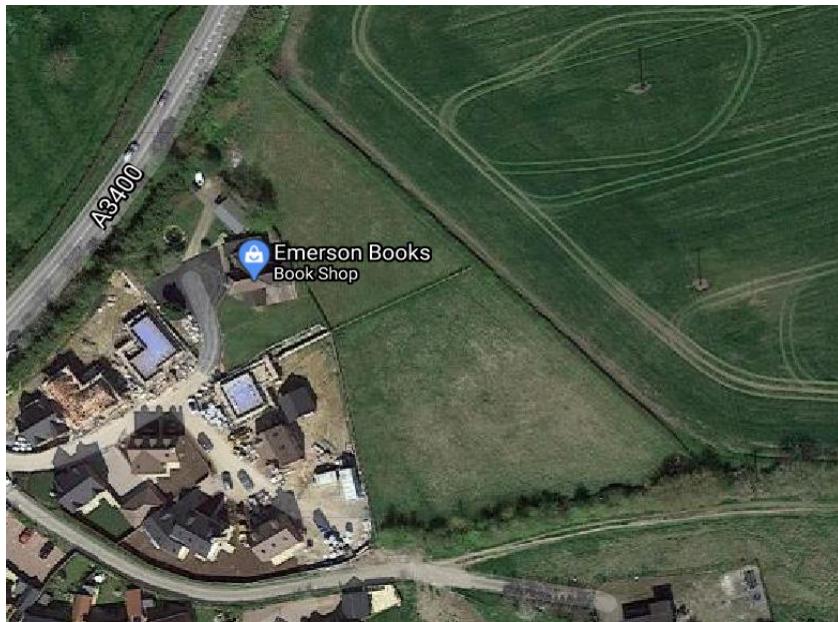
The site is roughly triangular in shape and located on the north eastern tip of the settlement. The site is grassed and has the look of a paddock. To the west is a recently completed residential development, to the east is agricultural land, to the north is the A3400 and to the south is a small sewage treatment works with the River Stour and open countryside, beyond. The northern and southern site boundaries are mature hedgerows. Land levels rise through the site, with the low ground to the south and high ground to the north.

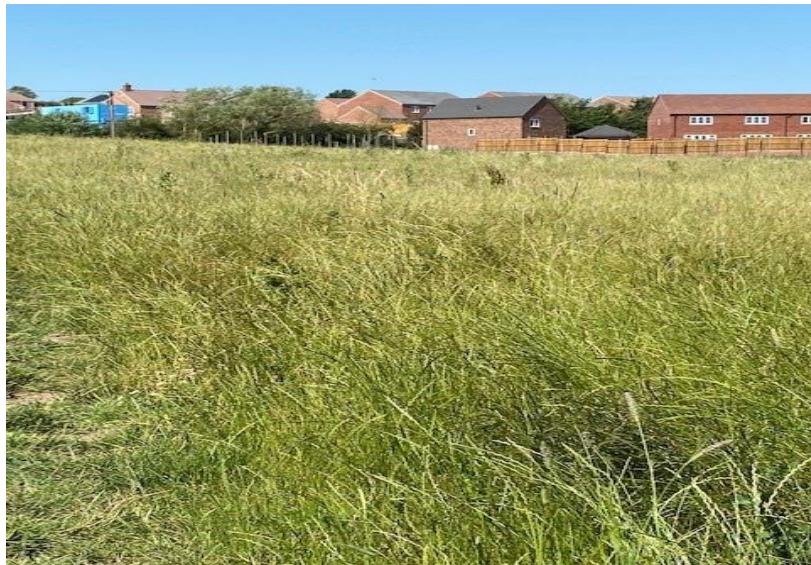
The site can be viewed from a public footpath to the south of the site. It is a large field of overgrown grass, currently. The site is relatively level, but land does climb to the west beyond the site. The site is on the edge of the residential area with dwellings to the north and east. Open countryside lies to the south and west. The site lies over 500m away from the Conservation Area and the nearest listed building is also over 500m away.

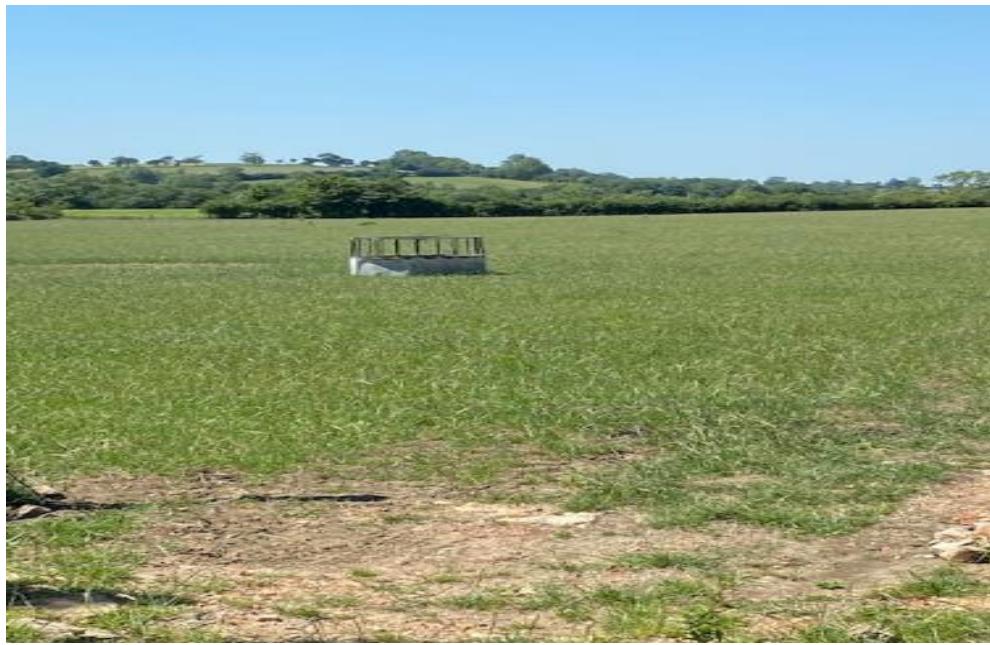
The site is predominantly grassland bounded by trees and hedging and is approx. 6.5ha in size. There is a cemetery and allotments to the north east of the site, existing residential development to the north and east and open countryside to the south and west. The site lies over 500m away from the Conservation Area and the nearest listed building is over 100m away.
