Heritage Impact Assessment

SHLAA Reference	SOU.02
Site Address	Land East of By-pass, Southam
Site Capacity	Approx. 240 dwellings

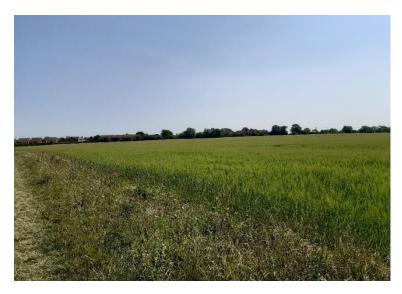
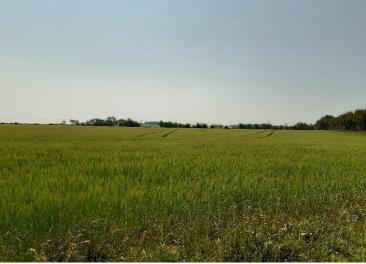
Large agricultural field located to the east of the Southam By-pass. Public footpath runs NW-SE through the southern part of the field. Mature trees/hedgerow/vegetation to western site boundary running parallel to the by-pass. The site has a housing estate to the north, Galanos House Nursing Home to the south, open countryside to the east and the outskirts of Southam to the west, beyond the by-pass. The Conservation Area is located over 200 metres away and there are no listed buildings within 230 metres.

Conclusion of harm on the heritage asset	There are no designated or non-designated heritage assets that would be adversely affected by development of this site.
	Conclusion on harm to heritage asset: No harm.

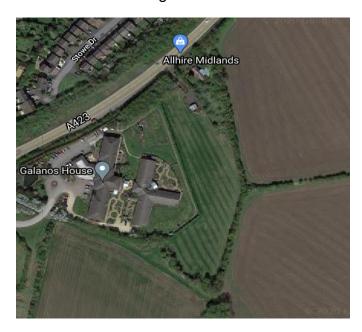
This site is private property and officers were unable to gain access to the site for assessment purposes. There were no clear views of the site from public footpaths and no views into the site from the adjacent by-pass. The site benefits from mature vegetation to all boundaries. The site is accessed from the by-pass. The settlement Conservation Area is 240 metres northwest of the site and the closest listed building is 260 metres northwest of the site. There are no Scheduled Monuments close to the settlement.

Name of Heritage Asset	Area of surviving Ridge and Furrow
affected by allocated site	Thea of sarving raage and ranew
Type of heritage asset/Listed	Non-Designated Heritage Asset.
Grade	No listed status.
Contributing elements to significance of the heritage asset	The land parcel is not identified as an area of extant ridge and furrow earthworks on WCC's Historic Environment Records. Unfortunately, officers were not able to gain entry to the site due to the land being locked and in private ownership. The site visit was inconclusive due to lack of clear views into the site from public vantage points due to mature vegetation to site boundaries. However, aerial images appear to indicate potential ridge and furrow across the site, which may be a remnant of a wider historic agricultural landscape. The aerial images appear to show 'ghost images' of similar
	'lines' on the same alignment, in adjacent fields that do not have any above-ground earthworks surviving due to modern agricultural farming methods. If ridge and furrow is surviving on this site, the quality is unsubstantiated. However, given the small, irregular size of the site and the lack of ridge and furrow on the eastern edge of the settlement due to recent agricultural farming methods and modern housing developments, any remaining ridge and furrow on this site would be a remnant of the 'wider' heritage asset. The significance of this particular non-designated asset has been diminished due to it being a small remnant.

Assessment of impact of	Development of this land could lead to the loss of ridge and furrow earthworks of unidentified
development on significance of the asset	quality and result in the potential loss of archaeological remains. It is currently unknown what quality the ridge and furrow is, or if it survives at all. Clearly any development of the site could lead to the loss of a non-designated heritage asset, should above earthworks still exist.
Potential mitigation measures for identified harm	Desk based assessment and potential further archaeological evaluation should be undertaken prior to any development, in line with Chapter 16 of NPPF (February 2019).
	These additional assessments would need to be undertaken as part of any planning application for the development of the site. Clearly, due to the type of non-designated asset (i.e. above ground earthworks) there are no mitigation measures that could be introduced to reduce or remove the harm to the asset.

Development of this site could lead to the loss of a 'pocket' of ridge and furrow of unknown quality, which is a remnant of a wider medieval field structure in this general location. Further archaeological evaluation work would need to be carried out associated with a planning application for development of the site in order to determine the existence, extent and quality of the remaining non-designated asset. Due to the unknown nature of the asset and the size of the site, it is concluded the loss of ridge and furrow on this site would result in less than substantial harm.

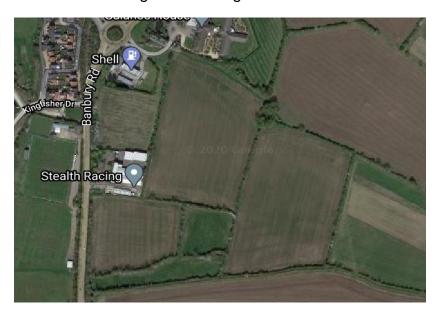
The site consists of four different sized agricultural fields on the southern edge of the settlement, immediately adjacent to a site recently developed for housing. Public views limited to the Banbury Road to the western boundary and a public footpath to the north. The individual fields all benefit from mature boundaries of hedgerows and trees. The land south of Southam to the east of Banbury Road is reasonably level. The three larger fields had crops growing. The smallest field was overgrown with long grass. There are no designated heritage assets within half a kilometre of the site.

Name of Heritage Asset	Possible area of surviving Ridge and Furrow
affected by allocated site	
Type of heritage asset/Listed	Non-Designated Heritage Asset.
Grade	No listed status.
Contributing elements to significance of the heritage asset	The land parcel is not identified as an area of extant ridge and furrow earthworks on WCC's Historic Environment Records, but a small square field is part of a GiS layer 'Ridge and Furrow Region'. Unfortunately, officers were not able to gain entry to this field to confirm whether or not ridge and furrow still existed within this land parcel. Aerial images appear to indicate potential ridge and furrow across the site, which may be a remnant of a wider historic agricultural landscape. However, if ridge and furrow does survive in this one field, the quality is unsubstantiated and the aerial images are inconclusive. However, given the small scale of this land parcel and the lack of ridge and furrow within surrounding fields due to modern agricultural farming methods, any remaining ridge and furrow on this site would be a remnant of the 'wider' heritage asset. The significance of this particular non-designated asset has been diminished due to it being a small remnant.

Assessment of impact of	Development of this land could potentially lead to the loss of ridge and furrow earthworks of
development on significance	unidentified quality and result in the potential loss of archaeological remains. It is currently unknown
of the asset	what quality the ridge and furrow is, or if it survives at all. Clearly any development of the site could lead to the loss of a non-designated heritage asset, should above earthworks still exist.
Potential mitigation measures for identified harm	Desk based assessment and potential further archaeological evaluation should be undertaken prior to any development, in line with Chapter 16 of NPPF (February 2019).
	These additional assessments would need to be undertaken as part of any planning application for the development of the site. Clearly, due to the type of non-designated asset (i.e. above ground earthworks) there are no mitigation measures that could be introduced to reduce or remove the harm to the asset.

Conclusion of harm on the	Development of this site could lead to the loss of a 'pocket' of ridge and furrow of unknown quality,
heritage asset	which is a remnant of a wider medieval field structure in this general location. Further
	archaeological evaluation work would need to be carried out associated with a planning application

for development of the site in order to determine the existence, extent and quality of the remaining non-designated asset. Due to the unknown nature of the asset and the size of the site, it is concluded the loss of ridge and furrow on this site would result in less than substantial harm.

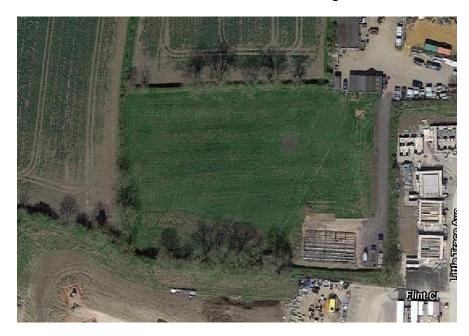
This site is private property and officers were unable to gain access to the site for assessment purposes. There were no clear views of the site from public footpaths and no views into the site from the highway. The site benefits from mature vegetation to all boundaries. The site is accessed via a long private driveway and sits behind a recently completed housing development. The Conservation Area and nearest listed building are half a kilometre south of the site. Land in this location is relatively level.

Name of Heritage Asset	Area of surviving Ridge and Furrow
affected by allocated site	
Type of heritage asset/Listed	Non-Designated Heritage Asset.
Grade	No listed status.
Contributing elements to significance of the heritage asset	The land parcel is not identified as an area of extant ridge and furrow earthworks on WCC's Historic Environment Records, but located within a potential 'region' of ridge and furrow to the northwest corner of the settlement. Unfortunately, officers were not able to gain entry to the site due to the land being locked and in private ownership. The site visit was inconclusive due to lack of clear views into the site from public vantage points due to mature vegetation to site boundaries. However, aerial images appear to indicate potential ridge and furrow across the site, which may be
	a remnant of a wider historic agricultural landscape. The aerial images appear to show feint lines running east-west which could indicate surviving above-ground earthworks. If ridge and furrow is surviving on this site, the quality is unsubstantiated. However, given the small scale of the site and the lack of ridge and furrow in surrounding fields due to modern agricultural farming methods and modern housing developments, any remaining ridge and furrow on this site would be a remnant of the 'wider' heritage asset. The significance of this particular non-designated asset has been diminished due to it being a small remnant.

Assessment of impact of	Development of this land could lead to the loss of ridge and furrow earthworks of unidentified
development on significance of the asset	quality and result in the potential loss of archaeological remains. It is currently unknown what quality the ridge and furrow is, or if it survives at all. Clearly any development of the site could lead to the loss of a non-designated heritage asset, should above earthworks still exist.
Potential mitigation measures for identified harm	Desk based assessment and potential further archaeological evaluation should be undertaken prior to any development, in line with Chapter 16 of NPPF (February 2019).
	These additional assessments would need to be undertaken as part of any planning application for the development of the site. Clearly, due to the type of non-designated asset (i.e. above ground earthworks) there are no mitigation measures that could be introduced to reduce or remove the harm to the asset.

Name of Heritage Asset affected by allocated site	Possible site of Civil War skirmish in 1642 (WCC HER Ref: 774)
Type of heritage asset/Listed Grade/Significance Value	 Non-designated Heritage Asset Site not registered as an official Battlefield
Contributing elements to significance of the heritage asset	Site SOU.12A is part of a wider area to the north of Southam suggested as the possible site of a skirmish in the Civil War which took place during 1642. The site cannot be defined with confidence due to a relative lack of historical sources and limited archaeological evidence. The suggested location is to "the northwest of Southam". The Battlefields Trust proposes that the skirmish took place to the northwest of the town, based on landscape analysis considered against the documentary sources. Given the topography around Southam, the routes available to the Royalists, accounts of the battle taking place next to a river, in "Southam field" and some limited finds data, the possible site of the skirmish is placed somewhere on the northern side of the town between the modern A423 and the River Itchen. As such, there is potential for below ground archaeological remains relating to this historic event.

Conclusion of harm on the heritage asset	Development of this site could lead to the loss of a 'pocket' of ridge and furrow of unknown quality, which is a remnant of a wider medieval field structure in this general location. Further archaeological evaluation work would need to be carried out associated with a planning application for development of the site in order to determine the existence, extent and quality of the remaining non-designated asset. Due to the unknown nature of the asset and the size of the site, it is concluded the loss of ridge and furrow on this site would result in less than substantial harm.
	Conclusion on harm to heritage asset: Less than substantial harm.

Assessment of impact of development on significance of the asset	Development could lead to loss of archaeological remains of indeterminate significance.
Potential mitigation measures for identified harm	Desk based assessment and potential further archaeological evaluation should be undertaken prior to any development, in line with Chapter 16 of NPPF (February 2019).

These additional assessments would need to be undertaken as part of any planning application for the development of the site.
Conclusion of harm on the heritage asset	Development of this site could potentially lead to the loss of archaeological remains of indeterminate significance. However, further archaeological evaluation work associated with a planning application for development of the site could lead to a better understanding of the historic environment.
	Conclusion on harm to heritage asset: Less than substantial harm.

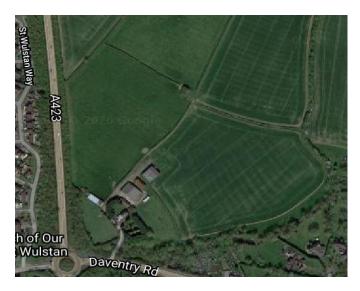
The site includes the farmhouse and agricultural buildings plus two fields, associated with Glebe Farm to the east of Southam, off the Daventry Road. The land in question is on the lower slopes of rising ground as you leave Southam in a northerly direction. Due to land levels changes and mature planting, there are no public views from the west (by-pass). There are long-range views into the site from the east on Daventry Road, when approaching the settlement. Field boundary hedges divide the land parcels. The Conservation Area is 180 metres west of the site and the nearest listed building is 215 metres west, both on the opposite side of the by-pass with no inter-visibility with the site in question.

Name of Heritage Asset	Potential area of surviving Ridge and Furrow
affected by allocated site	Total and or sarviving radge and ranew
Type of heritage asset/Listed	Non-Designated Heritage Asset.
Grade	No listed status.
Contributing elements to significance of the heritage asset	The land parcel is not identified as an area of extant ridge and furrow earthworks on WCC's Historic Environment Records, but one field is part of a GiS layer 'Ridge and Furrow Region'. Unfortunately, officers were not able to gain entry to this site to confirm whether or not ridge and furrow still existed within this land parcel. Aerial images appear to indicate that ridge and furrow remains within this particular field, together with the adjacent field to the northeast, which lies just outside the hatched area denoting the extent of site SOU.14. These fields would be remnants of a wider historic agricultural landscape, which is shown up as 'ghost images' in adjacent fields now ploughed by modern farming methods. If ridge and furrow does survive in these fields, the quality is unsubstantiated. The significance of this particular non-designated asset has been diminished due

to it being a remnant of the wider historic landscape.
Assessment of impact of development on significance of the asset	Development of this land could potentially lead to the loss of ridge and furrow earthworks of unidentified quality and result in the potential loss of archaeological remains. It is currently unknown what quality the ridge and furrow is, or if it survives at all. Clearly any development of the site could lead to the loss of a non-designated heritage asset, should above earthworks still exist.
Potential mitigation measures for identified harm	Desk based assessment and potential further archaeological evaluation should be undertaken prior to any development, in line with Chapter 16 of NPPF (February 2019).
	These additional assessments would need to be undertaken as part of any planning application for the development of the site. Clearly, due to the type of non-designated asset (i.e. above ground earthworks) there are no mitigation measures that could be introduced to reduce or remove the harm to the asset.

The existence of a second field of potential ridge and furrow adjacent to site SOU.14 could provide opportunity to protect this particular non-designated heritage asset as part of any future

development of the adjacent site.
Conclusion of harm on the heritage asset	Development of this site could lead to the loss of a field of ridge and furrow of unknown quality, which is a remnant of a wider medieval field structure in this general location. Further archaeological evaluation work would need to be carried out associated with a planning application for development of the site in order to determine the existence, extent and quality of the remaining non-designated asset. Due to the unknown nature of the asset and the size of the site, it is concluded the loss of ridge and furrow on this site would result in less than substantial harm.
	Conclusion on harm to heritage asset: Less than substantial harm.

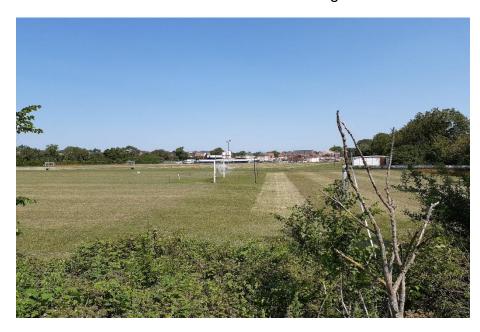
Site is laid out as football/playing pitches. Land level throughout. Mature vegetation to eastern site boundary adjacent to Banbury Road. Public footpath running along western boundary, affording public views of the site. Attenuation pond associated with recent housing development to the west, housing site to the north, open countryside to the south (including alignment for HS2). The Conservation Area and nearest listed buildings are 0.7 kilometres north of this site. There is no Scheduled Monument in the vicinity.

Name of Heritage Asset	Possible Iron Age/Romano-British Roundhouse and Ditch (WCC HER Ref: MWA19300)
affected by allocated site	
Type of heritage asset/Listed	Non-designated Heritage Asset
Grade	No listing grade applicable
Contributing elements to	The HER lists a possible round house and length of ditch of probable Iron Age or Romano-British
significance of the heritage	date was recorded during magnetic survey carried out to the south of Southam. GiS has this plotted
asset	at the northeast corner of this site. As such, there is potential for below ground archaeological
	remains to enhance the understanding of historic origins of the settlement.
Assessment of impact of	Development could lead to loss of archaeological remains of indeterminate significance.
development on significance	
of the asset	
Potential mitigation measures for identified harm	Desk based assessment and potential further archaeological evaluation should be undertaken prior to any development, in line with Chapter 16 of NPPF (February 2019).

These additional assessments would need to be undertaken as part of any planning application for the development of the site.
Conclusion of harm on the	Development of this site could lead to the loss of archaeological remains of indeterminate
heritage asset	significance. However, further archaeological evaluation work associated with a planning
	application for development of the site could lead to a better understanding of the historic environment.
	Conclusion on harm to heritage asset: Less than substantial harm.
