## Stratford-on-Avon District Council – Site Allocations Plan

### Heritage Impact Assessment

SHLAA Reference	WELF.04
Site Address	North of Millers Close (west), Welford-on-Avon
Site Capacity	Approx. 8 dwellings

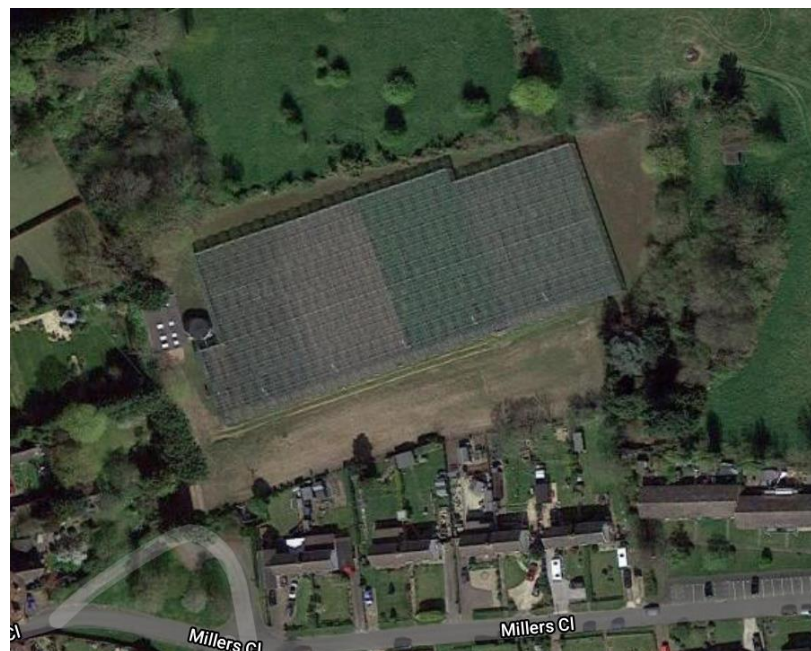
WELF.04 is situated north of Millers close and east of the High Street; in both instances the site lies behind other dwellings. As an old nursery, there are currently a number of disused greenhouses on the site. On the North, East and West sides of the site large trees encase the greenhouses and restrict the view into the site.

Potential mitigation measures for identified harm	<p>Trees and existing development adequately protect the conservation area from visibility into the proposed site from most angles. However, given the coterminous border on the western site of the site, some mitigation measures should be employed. It may be possible to further enhance the green infrastructure west of the site to create a buffer between the Conservation Area and any new dwellings. This could be achieved through further planting of trees or by creating some green open space. Development should also be considerate in its style and design. Given the proximity of the Conservation Area and the number of listed buildings within that area, all development should be in keeping with the local vernacular.</p>
Conclusion of harm on the heritage asset	<p>Existing mature vegetation helps protect the Conservation Area from any harm that would be caused by development within the proposed site. However, given the proximity to the Conservation Area on the western side of the site, it would be appropriate to employ mitigation measures to try and reduce the level of harm further, thus protecting the setting and appearance of the Conservation Area.</p> <p><b>Conclusion on harm to heritage asset: Less than Substantial</b></p>

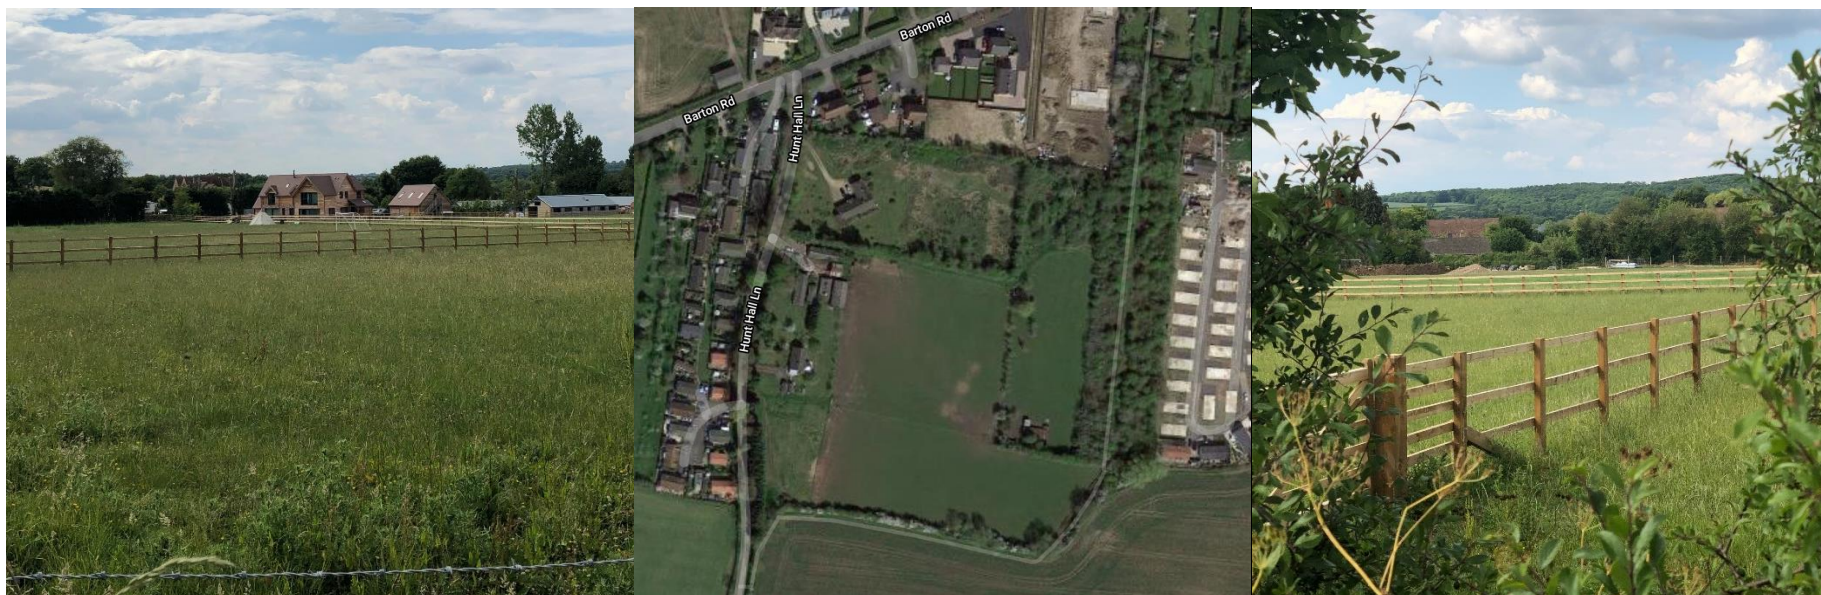
Site WELF.10 lies at the south western corner of the settlement and backs onto farmland. On the day of the visit there were developments taking pace, likely as part of 18/01872/COUQ for the change of use of five barns to dwelling houses. The site is relatively level and predominantly pasture apart from a strip of wooded area on the eastern side of the proposed site. There is a footpath that runs along the east, south and west side of the site.

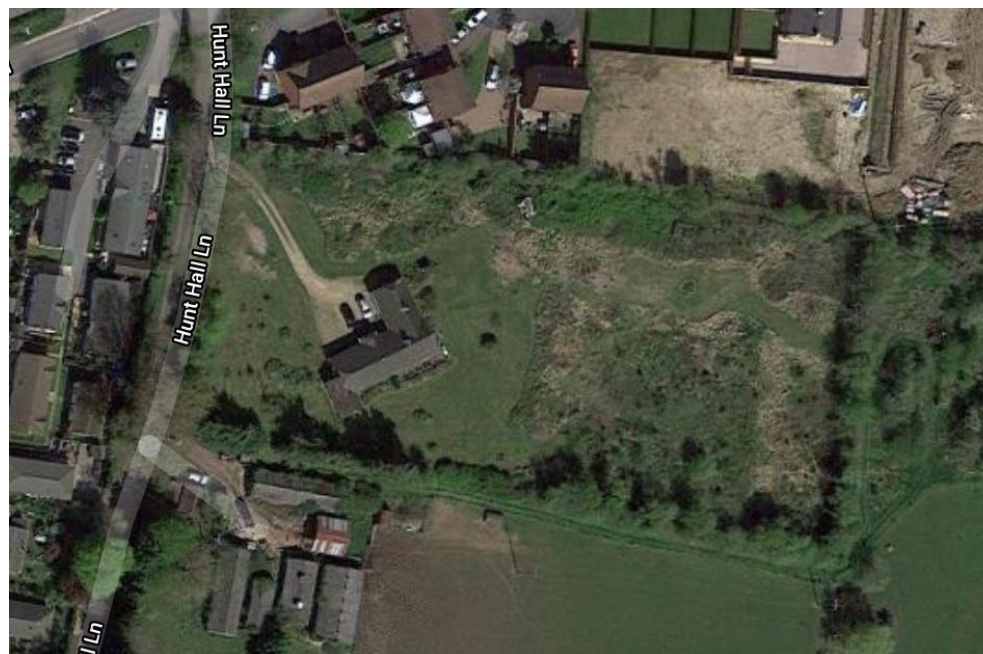
Site WELF.17 lies at the south western corner of the settlement and currently contains a bungalow and accompanying land. The site is accesible off Hunt Hall Lane. There is some development north of the site and west of the site lies Loncast Park Home Estate. At present there is greenspace east and south of the site.
