*Farnborough Conservation Area*

*Shankland Cox*

*April 1994*

## **Farnborough Conservation Area**

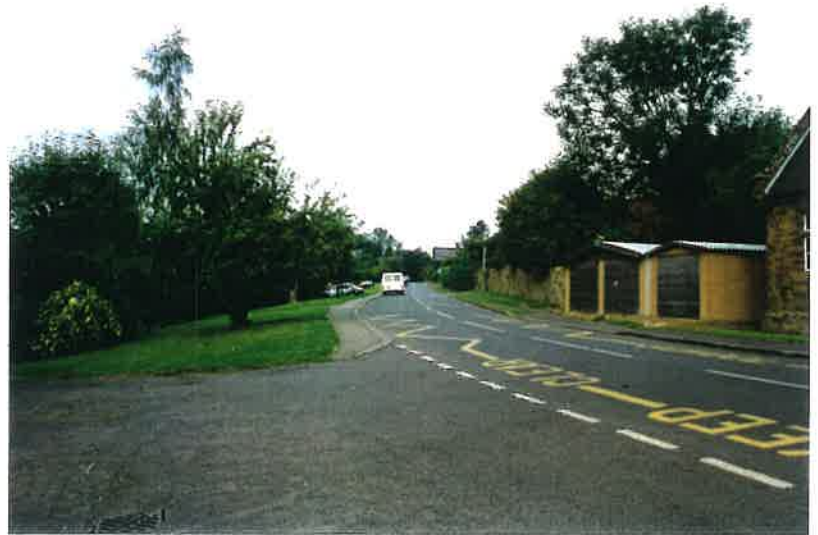
Main Street, garages adjacent to Butcher's Arms.

Up from the school hall is the Butcher's Arms public house (listed). Again its setting is spoiled by poor ground surfaces (ie a tarmac car park) although it is set very well back and high behind a stone retaining wall. The cottages opposite (two listed) are very well set back and widely separated, so that there are views through to the steep hillside immediately behind them. These fields are included in the Conservation Area because of their importance to the setting.

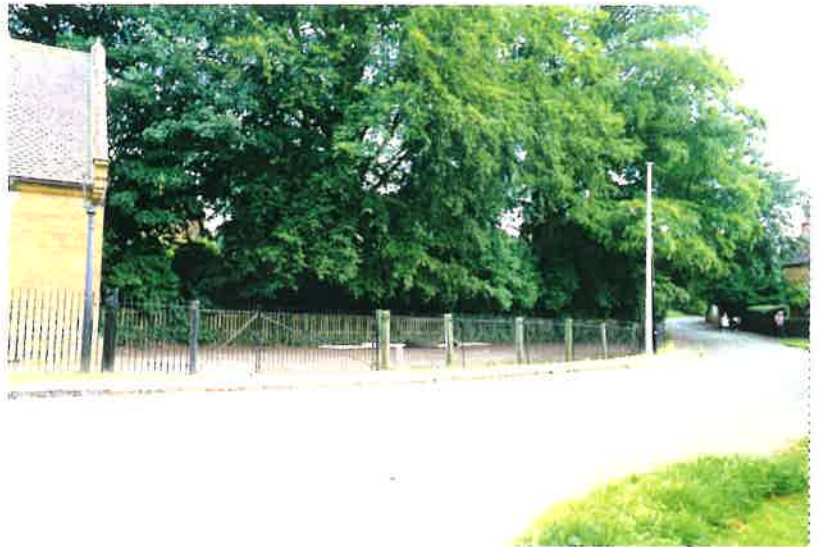
Main Street, poor ground surfaces.

- Walnut Tree Bank: improvement of signage around cast-iron lamp standard.
- Pump: renovation of pump, paving and railing.
- Little House: removal of 'wild' planting on roadside bank.
- Butchers' Arms: improvements to car park surface.
- Main Street: planting scheme to north side opposite Butchers' Arms.
- Main Street: replacement of concrete stepped kerb with traditional materials outside the Village Stores.
- General: replacement of tarmac footways with clay paviers.
- General: traffic calming and removal of unnecessary road markings.

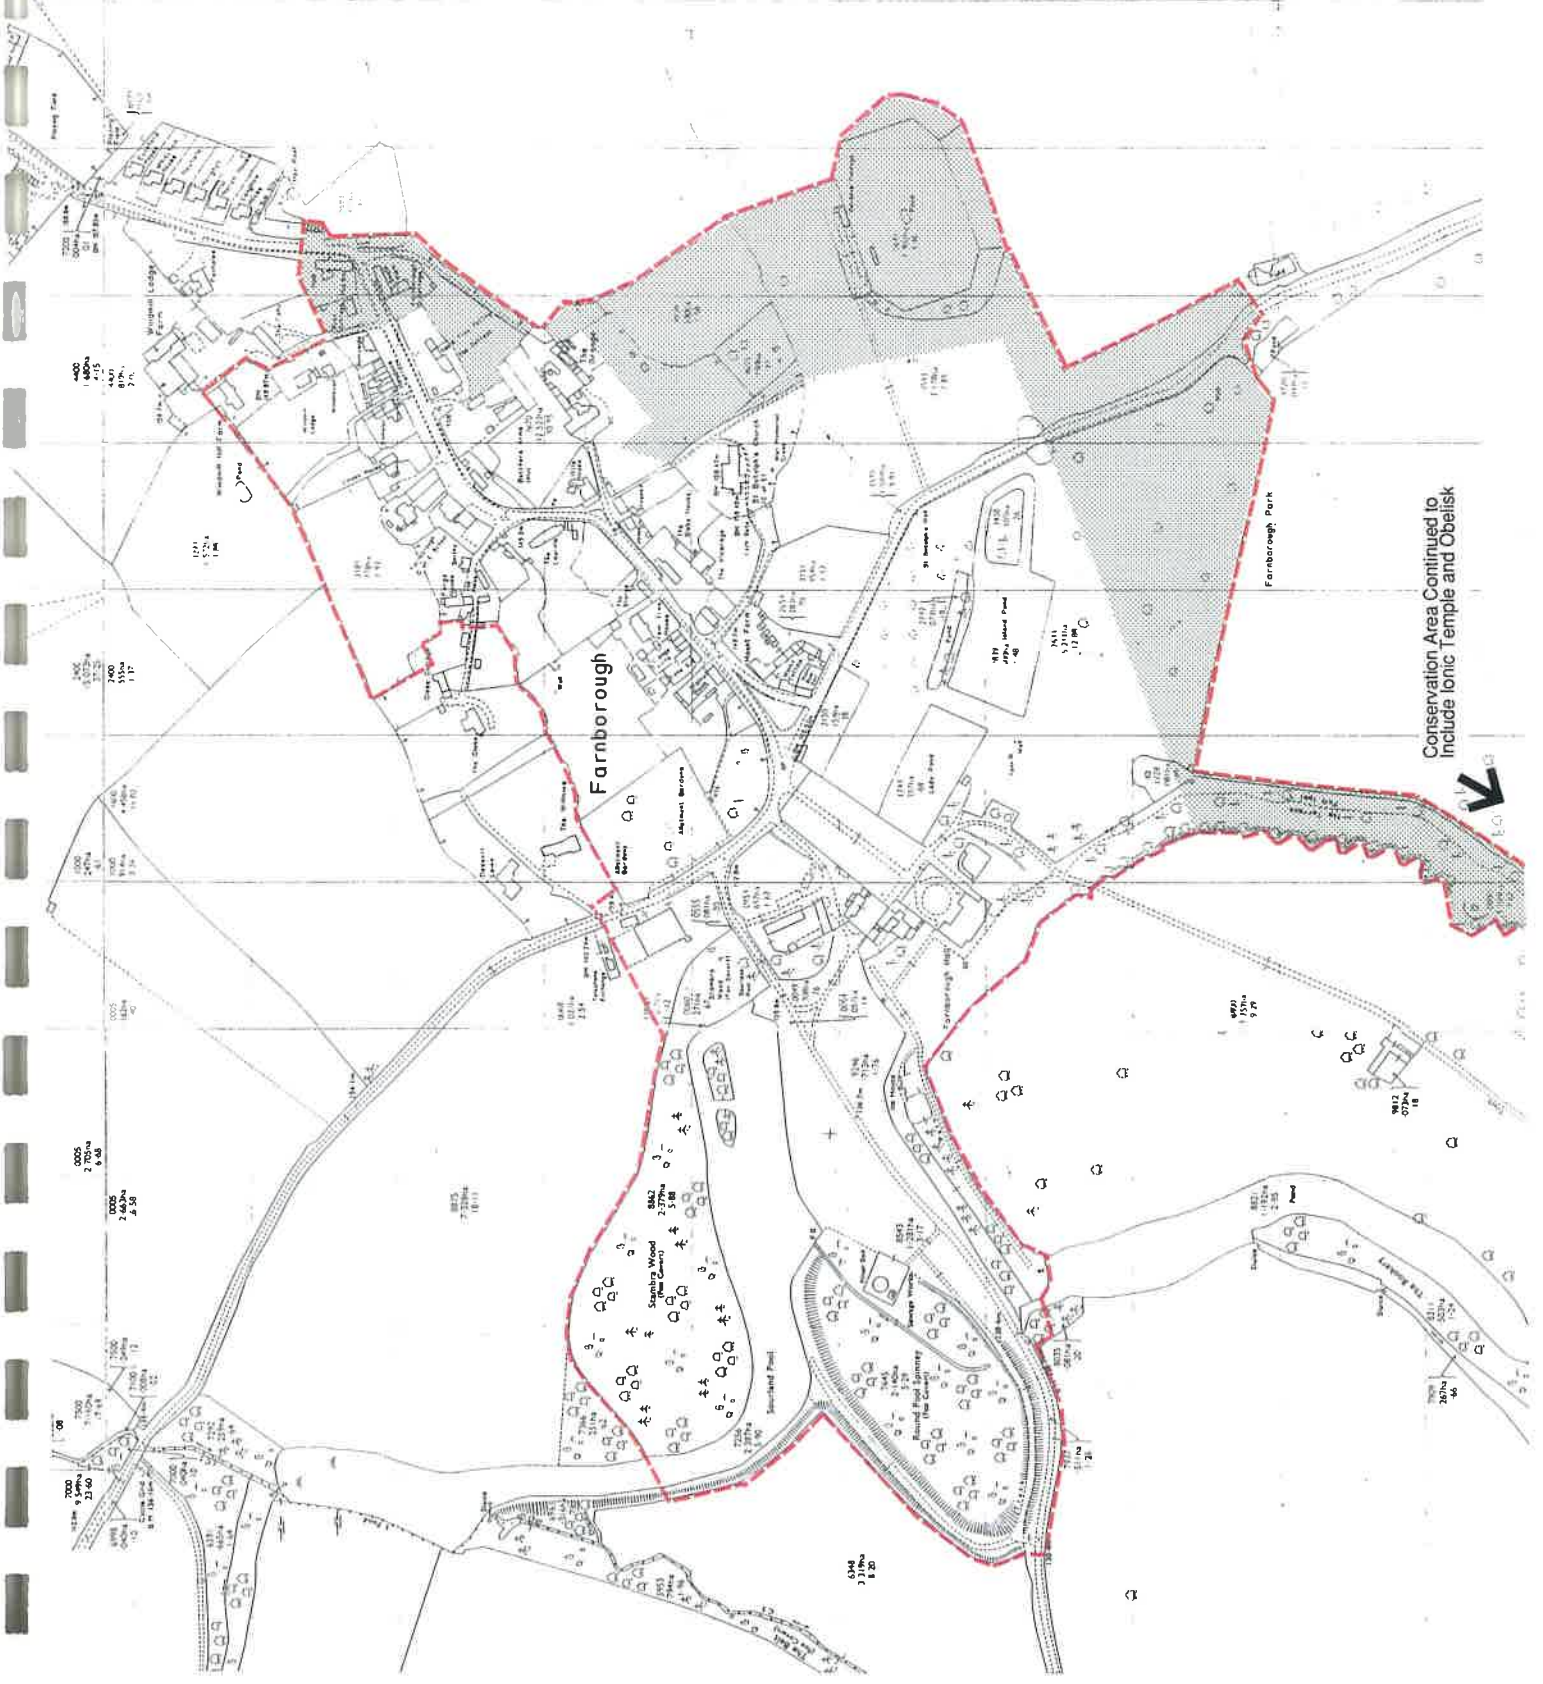
**Figure 6  
Revised Conservation Area  
Shankland Cox 1994**

Conservation Area Continued to  
Include Ionic Temple and Obelisk

Similar considerations apply, then, to the following recommended extension to the Conservation Area.
