STRATFORD ON AVON DISTRICT COUNCIL

CONSERVATION AREA REVIEWS 1996 / 97

FENNY COMPTON

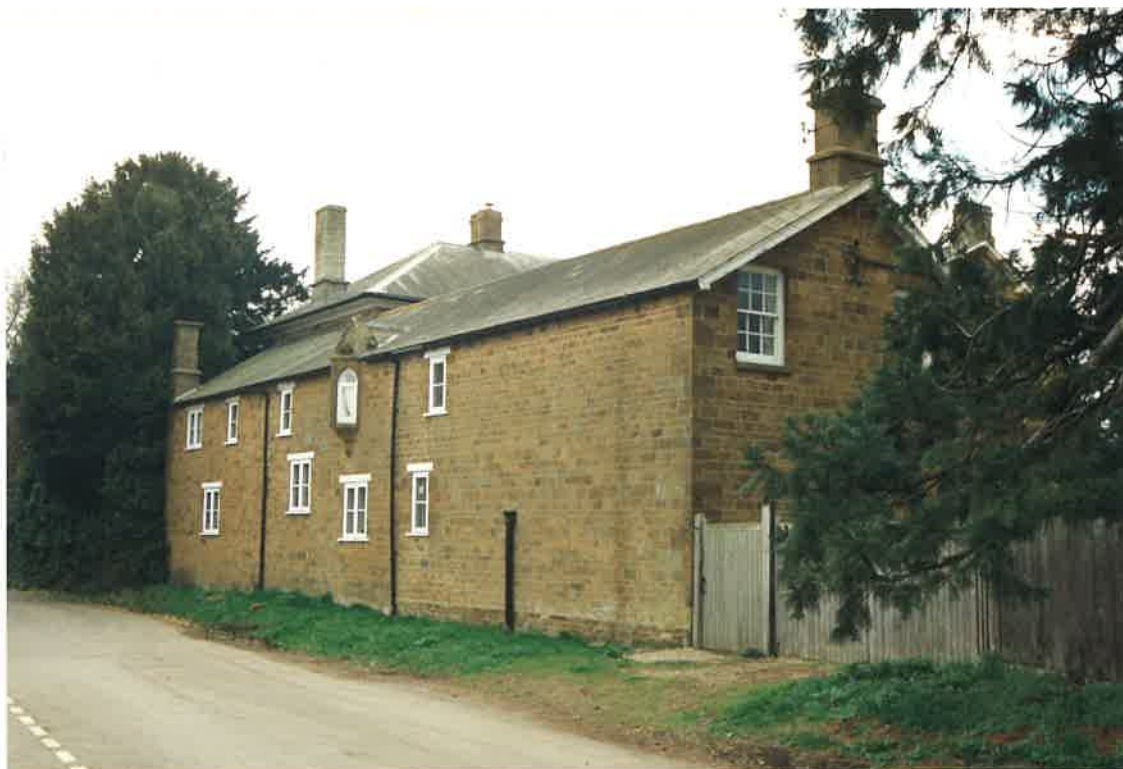
Ref. No.	Description
2/27	Fenny Compton Lodge, Avon Dassett Road. (Listed Building Ref. 2/27 - Grade II)

(Prominent building on village green)

House. Early C19, with mid C19 rear wing. Ironstone ashlar. Slate hipped roof with moulded plaster eaves cornice; rendered ridge and end stacks. L-plan, with wing on left to rear. Late Georgian style. 2 storeys; 4-window range. Panelled door of 2 vertical panels and overlight with decorative glazing. Doorcase of thin Tuscan columns and entablature. Sashes have stone lintels with flush keystones. Irregular left return side has canted bay. On right return side irregular rear wing fronts directly on to The Slade. Small Gothic stone triangular oriel with arched lights and leaf corbel. Interior: two good early C19 marble fireplaces. Straight flight staircase has moulded string.

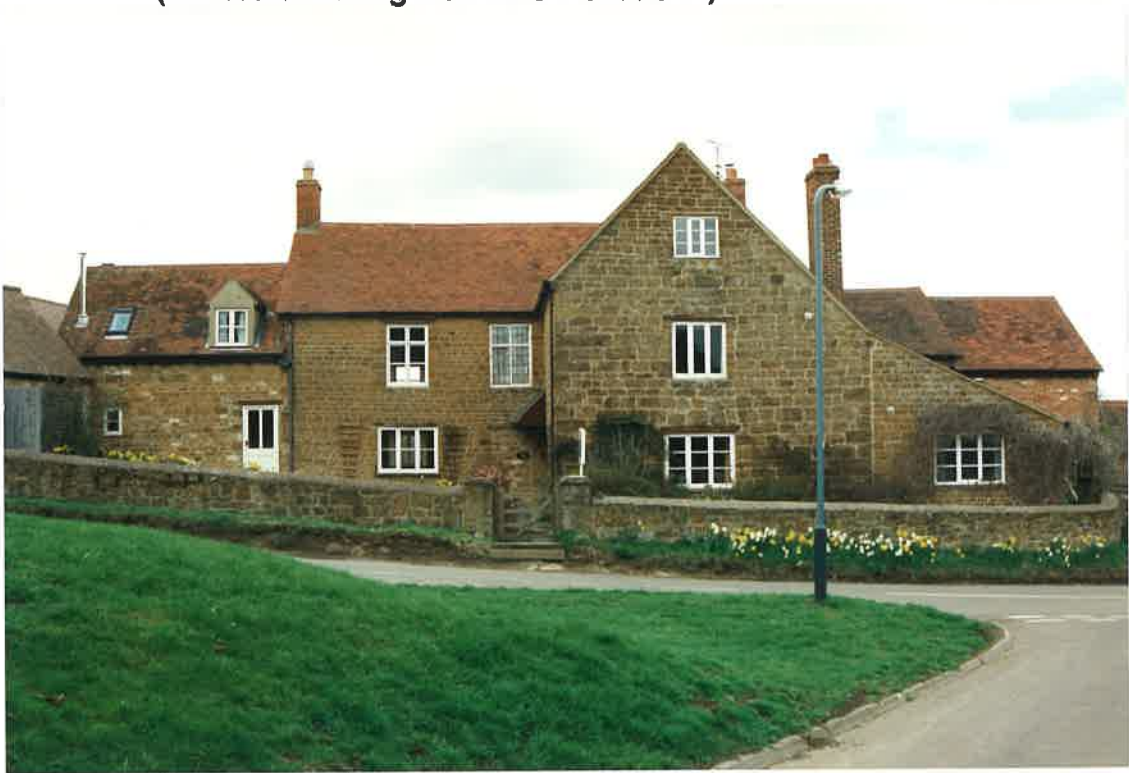
**Rectory Farmhouse, Avon Dassett Road.
(Listed Building Ref. 2/28 - Grade II)**

Farmhouse. Early C18, with C18/early C19 and early/mid C19 additions. Coursed ironstone with irregular quoins. Old tile roof; brick end and lateral stacks. Central staircase plan, extended to complex L-plan with wing projecting on right. 2 storeys and attic. 3-window range. Central entrance has half-glazed door. C19 and C20 casements. First floor has 2 original leaded cross windows, on left partially reglazed. Wing has attic window. Left return side of wing has part-glazed plank door in angle, and casement. Addition on left has corrugated iron roof; two C20 windows. Wing has lean-to addition on right, with 3-light leaded casement. All openings have painted wood lintels. Return side of brick. C19 brick wing. Interior not inspected.

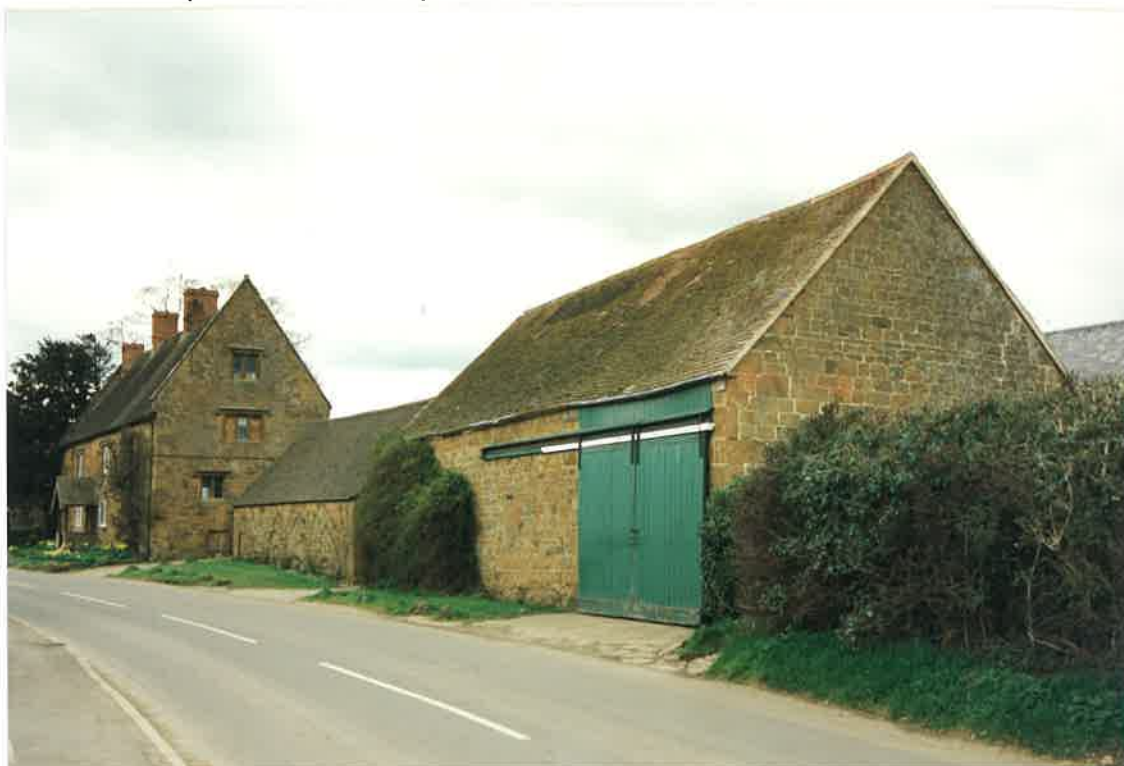
**Barn approx. 30m north of Contone House, Bridge Street.
(Listed Building Ref. 6/33 - Grade II)**

Barn. C18/C19. Regular coursed ironstone. Old tile roof. 3 bays. Front to yard has double doors to first bay. Vents. Front to road has C19 sliding doors on right. Interior not inspected. Included for group value.

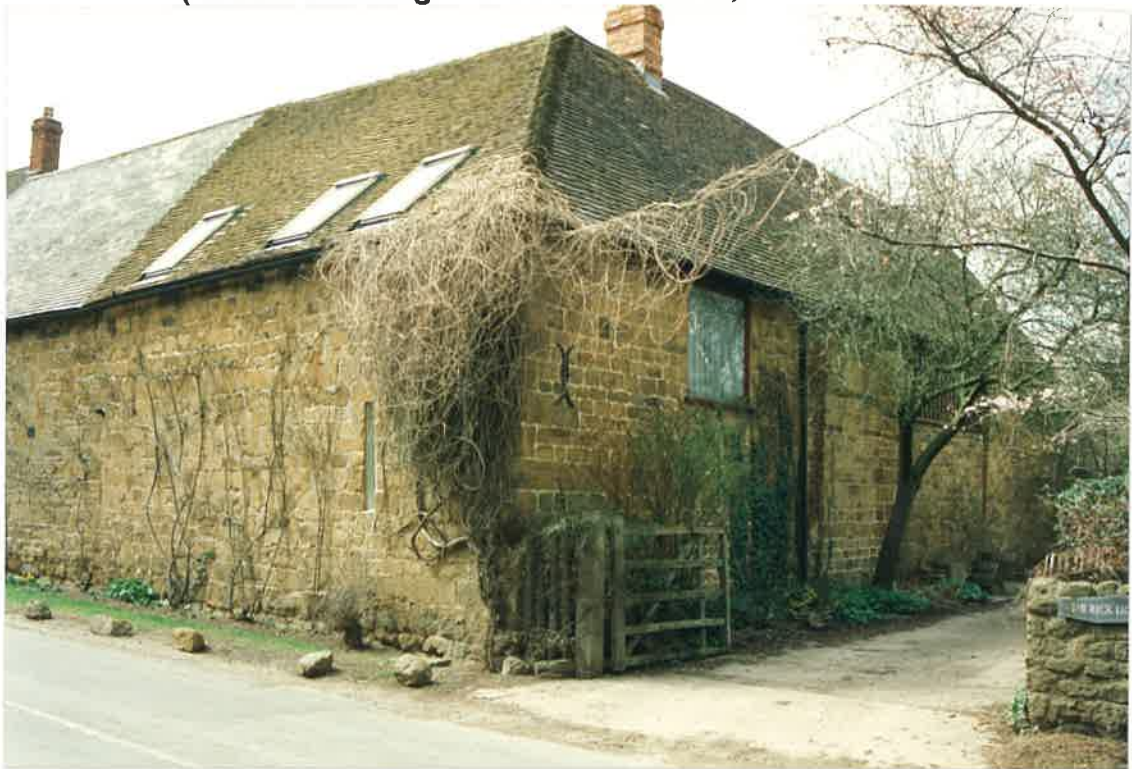
**Baynards, Bridge Street.
(Listed Building Ref. 6/33 - Grade II)**

Barn range, converted to house. C18 and C19; converted late C20. Coursed limestone with irregular quoins. Old tile roof, hipped to right; left section of late C20 tiles; late C20 brick ridge stack. The front to Bridge Street has slit window on right, and 3 sky lights. Right return side has 3 slit windows, and window inserted. Barn doorway partially blocked, with window inserted in upper part. Left return side has C19 fixed 2-light window. To yard: late C20 windows, garage doors and alterations. Interior not inspected.

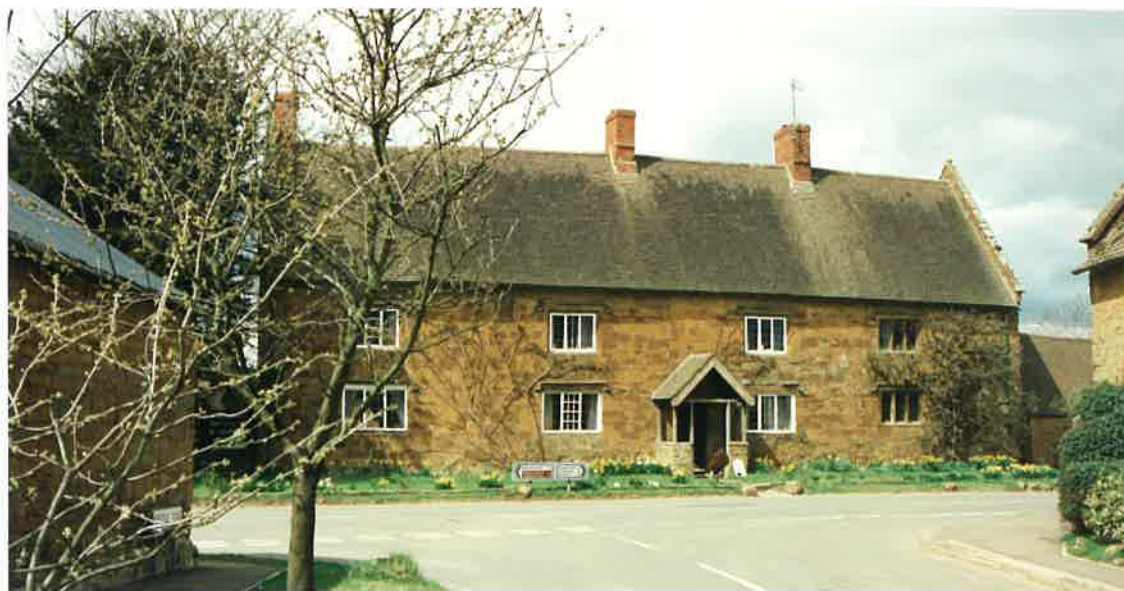
**Contone House, Bridge Street.
(Listed Building Ref. 6/35 - Grade II)**

(Fine house - focal point at end of Memorial Road)

House. 1668. Regular coursed ironstone. Tile roof has gable parapets with remains of finials; brick left end and ridge stacks. 4-unit plan. 2 storeys and attic; 4-window range. Central C20 ribbed door with strap hinges in chamfered stone surrounds. C20 stone and timber open porch. 3-light stone mullioned windows with hood moulds survive in fourth bay; others have mullions removed and C18 leaded casements inserted, 2 with flat arches below hood mould. Datestone between first and second bays on first floor has shaped panel with rosette and fleurs-de-lys. Inscription records that the house was 'reedefied at the charge of Thomas Blicke and Elizabeth his wife'. Right corner chamfered on ground floor. Right return sides have mullioned windows. Irregular rear has small C19 brick wing with slate roof, possibly formerly a granary. External stone staircase. Interior not inspected but V.C.H. records wide open fireplace with chamfered bressumer, and chamfered ceiling beams.(V.C.H.: Warwickshire, Vol.I, p.47; Buildings of England: Warwickshire, p.294).

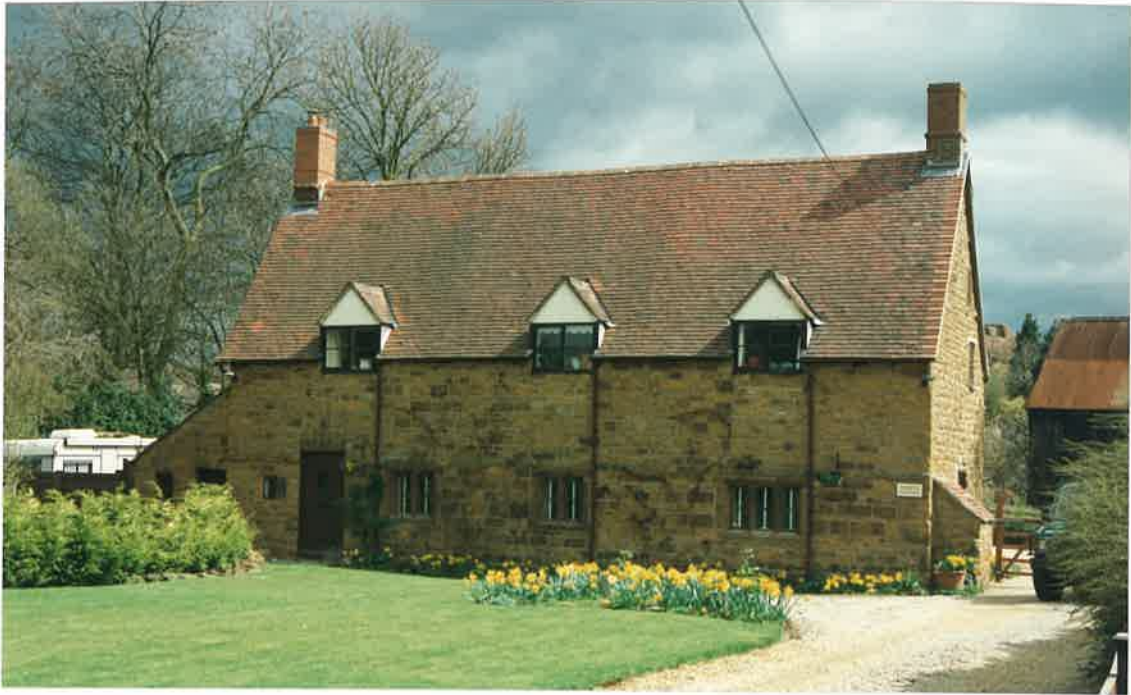
**Knotts Cottages (The Surgery), Bridge Street.
(Listed Building Ref. 6/31 - Grade II)**

(Set back off road - now a private house)

Cottage, now doctor's surgery. Mid C18, altered late C20. Coursed limestone with string course. Late C20 tile roof; C18 and C20 brick end stacks. 3-unit plan. Formerly 2 storeys and attic; 3-window range. Entrance on left has late C20 part-glazed door under stone flat arch. Fire window to left. Small cavetto-moulded stone-mullioned windows, 2 of 2 lights and on the right 3-light. On first floor former windows now blocked, with late C20 half-dormers above. Lean-to on left has old 3-plank door with vent holes, under stone lintel with keystone, and C20 window. Right return side has former bread oven projection. Single mullioned attic light. To rear: late C20 additions. Interior not inspected.

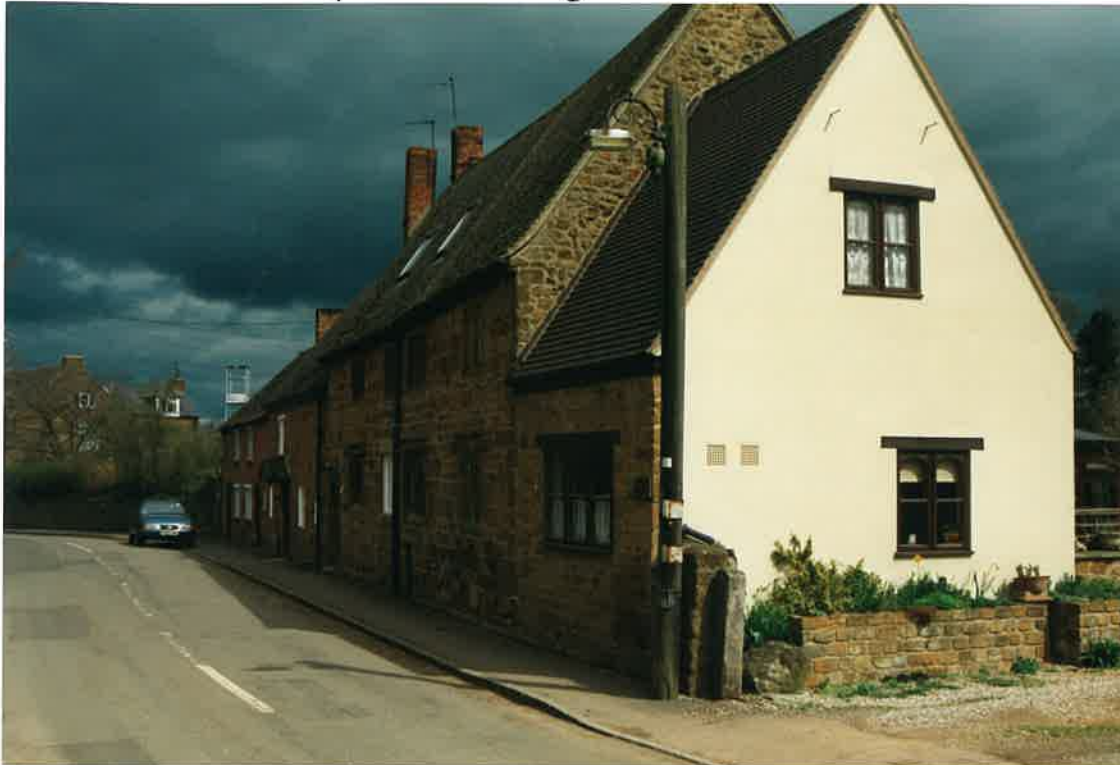
Old Toft and Mary's Cottage, Bridge Street.

House, now 2; part of a row. Mid C17. Regular coursed ironstone. Concrete tile roof; brick end stacks. 4-unit baffle-entry plan. 2 storeys and attic; 4-window range. Old Toft, on left, has entrance at left end with bolection moulded doorway and door of diagonal planks with old strap hinges. Entrance to Mary's Cottage to rear. Cavetto moulded stone-mullioned windows of alternating 3 and 2 lights, on ground floor with hood moulds. Second bay has late C20 casement and concrete lintel in place of window or door. First floor windows are considerably smaller. Old Toft has late C20 skylights. To rear: Mary's Cottage has plank door. C19 casements under painted wood lintels. Old Toft has large late C20 dormer. Interior: Old Toft noted as having large open fireplace with chamfered bressumer.

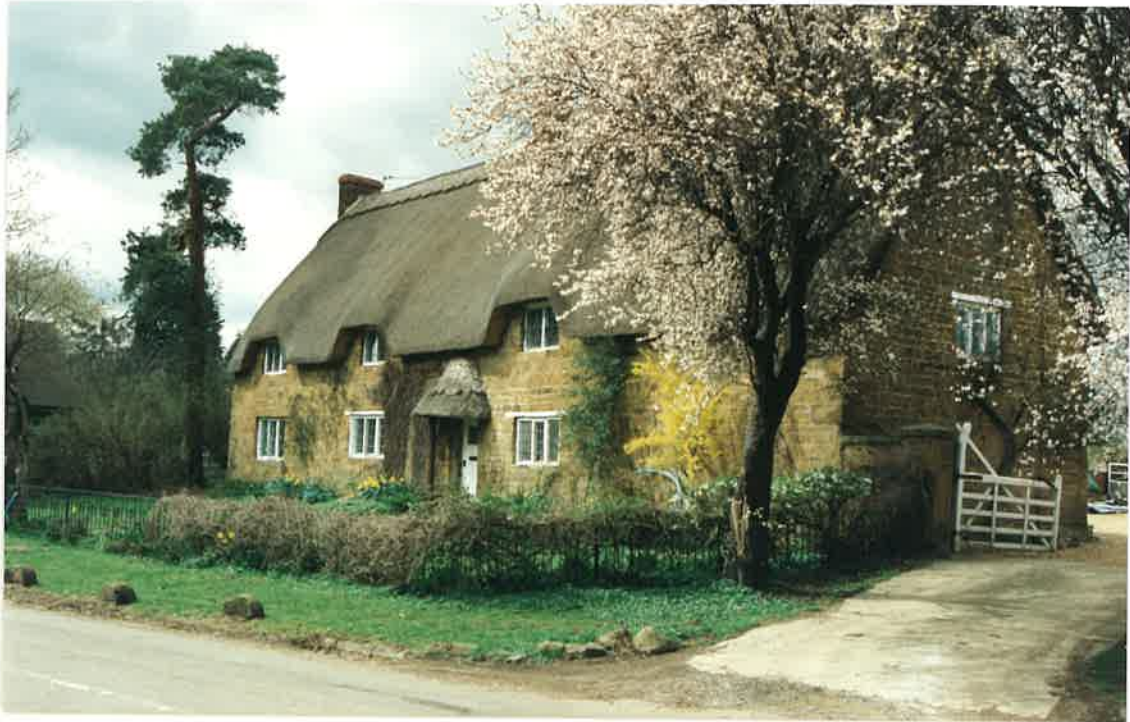
**The Croft, Bridge Street.
(Listed Building Ref. 6/36 - Grade II)**

(only thatch remaining in village - very picturesque)

House. Early C18, with mid/late C18 addition to right. Regular coursed limestone. Thatched roof; brick stacks. 3-unit plan, extended to 4-unit. One storey and attic; 3-window range. Entrance between second and third bays has C20 part-glazed door and open timber porch with thatched roof. Leaded light casements throughout. 3-light windows on ground floor have painted wood lintels. Swept half-dormers with 2-light casements. End stack to left, and 2 ridge stacks. Interior not inspected.

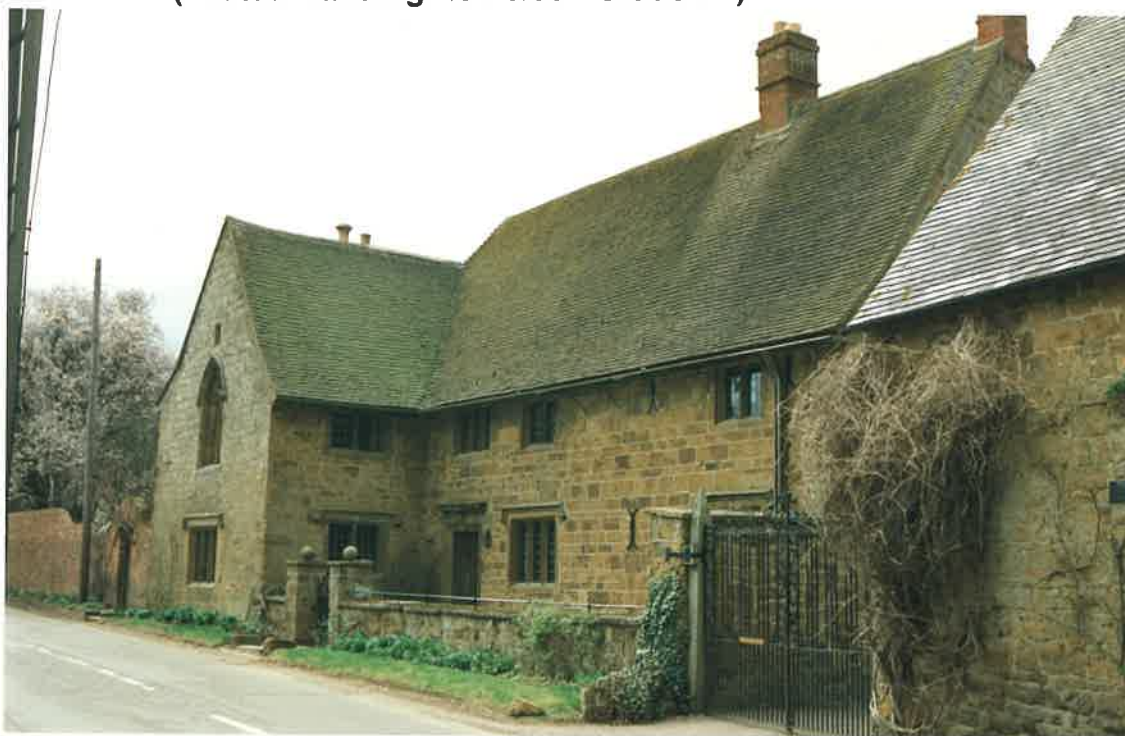
**Woad House, Bridge Street.
(Listed Building Ref. 6/38 - Grade II*)**

(finest and oldest house in village)

House. C14 wing; dated 1593; C18 alterations. Regular coursed ironstone. Tile roof; brick end and ridge stacks. T-plan, with cross wing on left. 2 storeys; 4-window range. Entrance in corner has late C17/C18 doorway, with moulded eared architrave, entablature and central console, and moulded cornice breaking forward in centre. Ribbed door. Stone-mullioned windows, partly renewed, with hood moulds on ground floor. Wing has 3-light windows. First floor has good Decorated window, possibly re-set, of 2 trefoiled lights with mullion continued to apex, and mouchettes. Hood mould with remains of carved stops. Main range has 3-light windows to right and above entrance, and 2-light windows. To rear: wing has datestone, now barely legible, and no windows. Interior: hall has large open fireplace with stop chamfered bressumer. Broad-chamfered cross beams have stops and carving. Stone 4 centre-arched doorway. Old plank doors. C17 open well staircase has turned balusters. Kitchen has wide open fireplace with bread oven. (V.C.H.: Warwickshire, Vol.I, p.47; Buildings of England: Warwickshire, p.294).

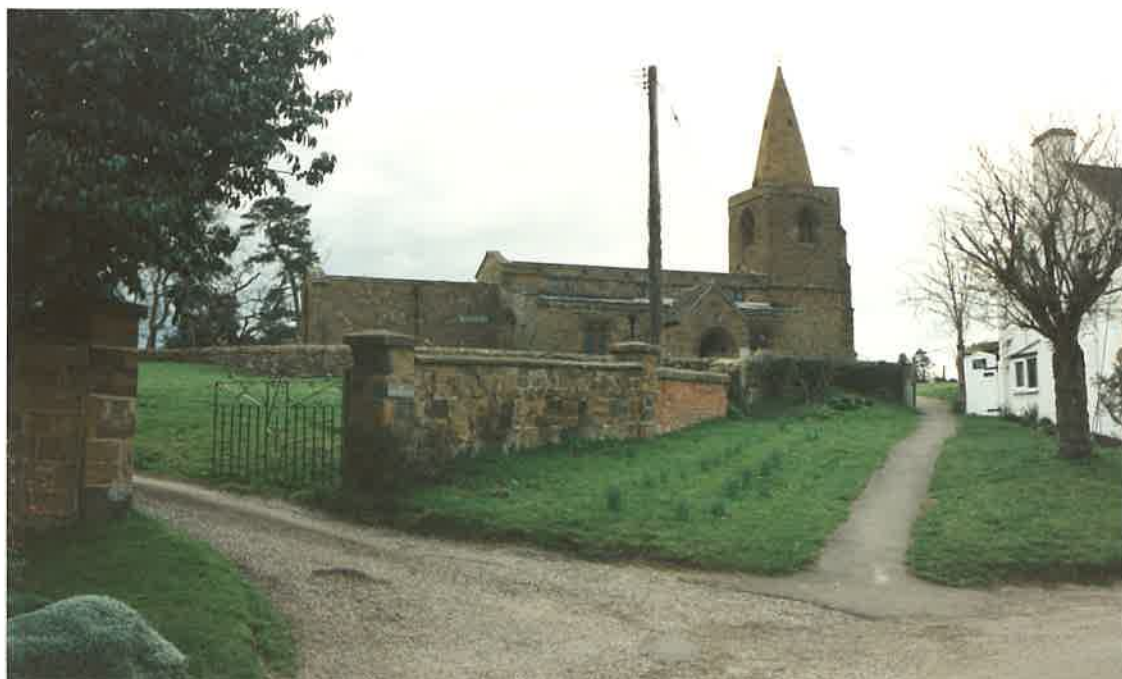
**Church of St Peter and St Clare, Church Street.
(Listed Building Ref, 6/48 - Grade II*)**

Church. Late C13/early C14 chancel, largely rebuilt late C18/C19 and late C19; late C13 nave; late C14 north aisle, west tower and spire, and porch. C16 clerestory. Porch partly remodelled 1675. South aisle, restoration and tracery largely renewed 1879 by T.G. Jackson. Ironstone: chancel, clerestory, north aisle and tower regular coursed; south aisle of coursed rubble. Lead roofs have moulded parapets and shallow-pitched gable parapets. Chancel, aisled nave, north porch and west tower. Decorated style. 3-bay chancel, 3-bay nave. Chancel has plinth, double-stepped to east, and south diagonal and north-east buttresses; aisles have diagonal buttresses. Chancel has 3-light east window with reticulated tracery and hood mould. North side has blocked doorway partly inserted into it. Three 2-light south windows have cinquefoiled lights. North porch has low diagonal buttresses. C14 moulded arched doorway has hood mould with block stops, and C17 double-leaf plank doors. Datestone in gable. Late C14 north doorway of 2 sunk-chamfered orders has hood mould with head stops. Ancient studded 3-plank door. Two north windows of 2 trefoiled round arched lights in square head with moulded jambs and hood mould. 3-light east window has segmental arch and trefoiled lights. 2-light west window has simple cusped reticulated tracery. Hood moulds with block stops. South aisle has 4 buttresses. Central south doorway of 2 chamfered orders with hood mould and foliage stops. Four 2-light south windows have cusped Y-tracery. East and west windows similar to north aisle. 3-bay clerestory has 2-light windows; C16 with 4-centred lights to north, C19 with trefoiled lights to south. Tower of 2 stages. Double chamfered plinth. West diagonal buttresses have 4 offsets up to parapet. Blocked west door. Late

C14 west window of 2 orders, with cinquefoiled reticulated tracery and hood mould with head stops. Similar trefoiled bell openings, but with return stops. North and south gargoyles. Recessed octagonal spire with small lucarnes. Interior: plastered walls. Chancel has C19 south recess with segmental-pointed arch. C19 roof, with one reset medieval head corbel. C14 chancel arch of 2 chamfered orders, the inner on half-octagon shafts with moulded capitals and bases, and hood mould with return stops. Nave has 5-bay C14 north arcade of 2 chamfered orders and octagonal pillars with moulded capitals and bases; easternmost bay has fragmentary foliage carving. Blocked square headed doorway to former roof loft. Similar south arcade of 1879. Low-pitched roof has simply-moulded cambered tie beams with wall posts on stone corbels. Aisles have chamfered cambered tie beams and chamfered rib. Fittings: C17 communion rails with twisted balusters. Font has C19 bowl on old cylindrical stem and square base. Pulpit of 5 late C17 fielded panels. North aisle has plain locker with fielded panel door and H-hinges. C17 chest. Stained glass: north aisle east window c.1883. Monuments: chancel has reset brass with inscription to Richard Willis 1597. Elizabeth Croker 1719: wall monument with flaming urn.(V.C.H.: Warwickshire, Vol.I, pp.48-9; Buildings of England: Warwickshire, p.293).

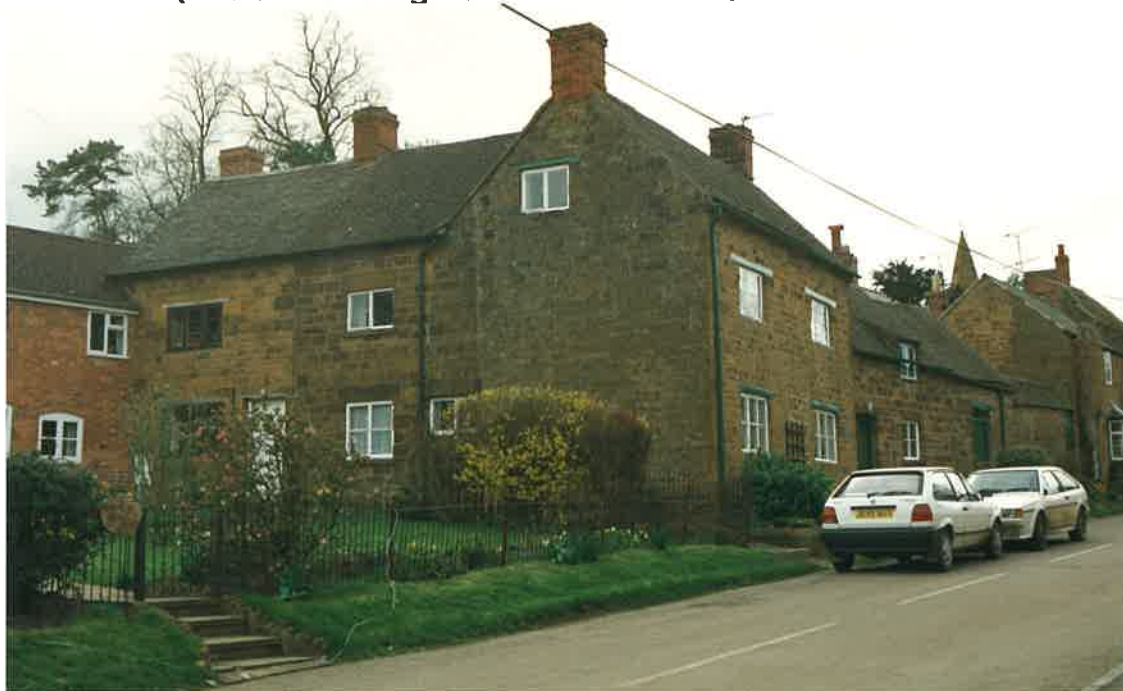
**Corner Cottage, Hill House and attached building, Church Street.
(Listed Building Ref. 6/46 - Grade II)**

Cottage; house, formerly 3 cottages; and attached outbuilding. Corner Cottage at right angles to Church Street, possibly C16, raised and altered C18; C19 rear wing; altered and wing largely rebuilt late C20. Regular coursed limestone; brick wing with brick corbel cornice. Old tile roof; brick ridge and end stacks. One-unit, extended to 3-unit plan. 2 storeys; one-window range. Late C20 part-glazed door and 3-light casements with original wood lintels. Left return side has blocked single chamfered light, and blocked opening with wood lintel. Wing has late C20 casements. Interior: chamfered ceiling beam. Hill House has late C18 range, with lower late C18/early C19 range and outbuilding to right, and early/mid C19 rear range, adjoining Corner Cottage. Coursed ironstone, with regular coursed ironstone range to right, and ironstone ashlar range to rear. C20 tile roofs; brick end and ridge stacks. Main range 2-unit plan, with one-unit ranges. 2 storeys and attic, with one storey and attic wing and 2 storey rear range; 3-window range. Main range has blocked central doorway. 3-light casements with horizontal glazing bars and painted run-out chamfered wood lintels to right and left. Wing has half-glazed door. Fixed light window. Stone lintels. Raked half-dormer with leaded 2-light casement. Outbuilding has flush 4-panelled door and overlight, with large painted wood lintel. Rear irregular. Interior: kitchen has bread oven with original door. Old plank doors. Outbuilding, said to have been a shop, has winder stairs. Included for group value.

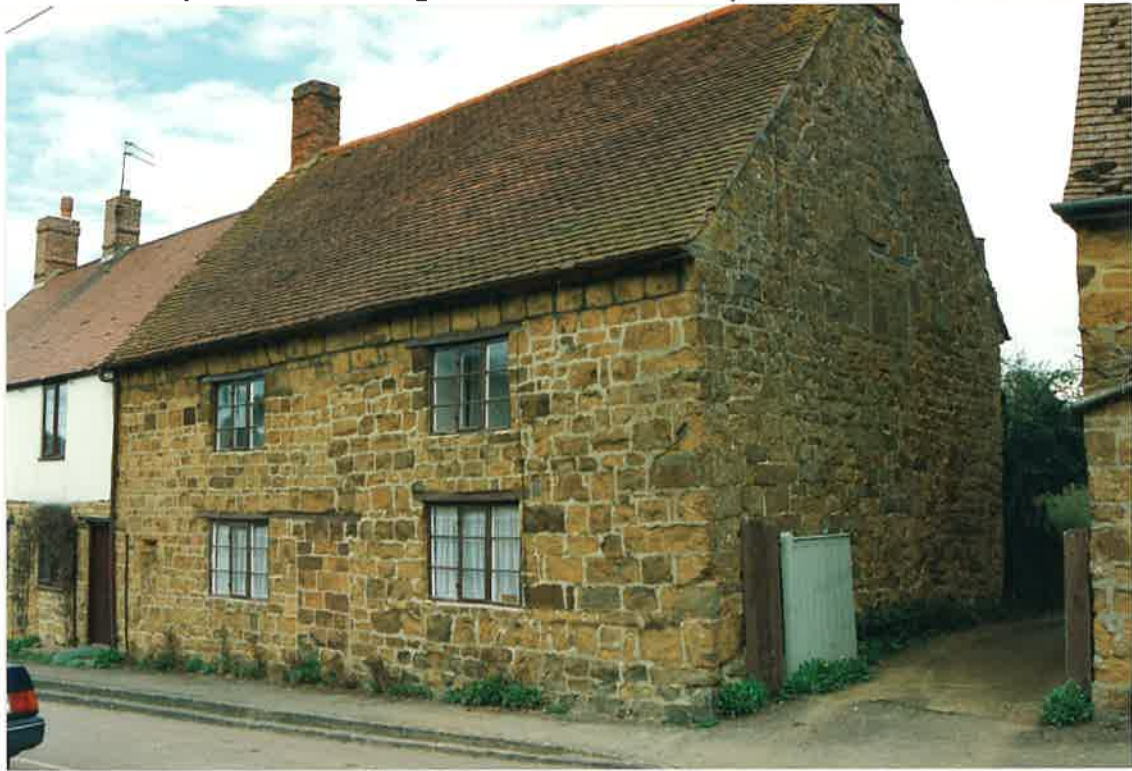
**Hollies, Church Street.
(Listed Building Ref. 6/45 - Grade II)**

House. Late C17/C18 remodelling of earlier, possibly C16, building. Regular coursed ironstone; left half has alternating wide and narrow courses. Simple splayed cornice. Tile roof; brick end stacks. 2-unit plan. 2 storeys; 2-window range. Blocked central doorway. Late C18/C19 casements. Painted wood lintels. Blocked chamfered stone fire window on left. Entry door in adjoining building (not included). Interior not inspected.

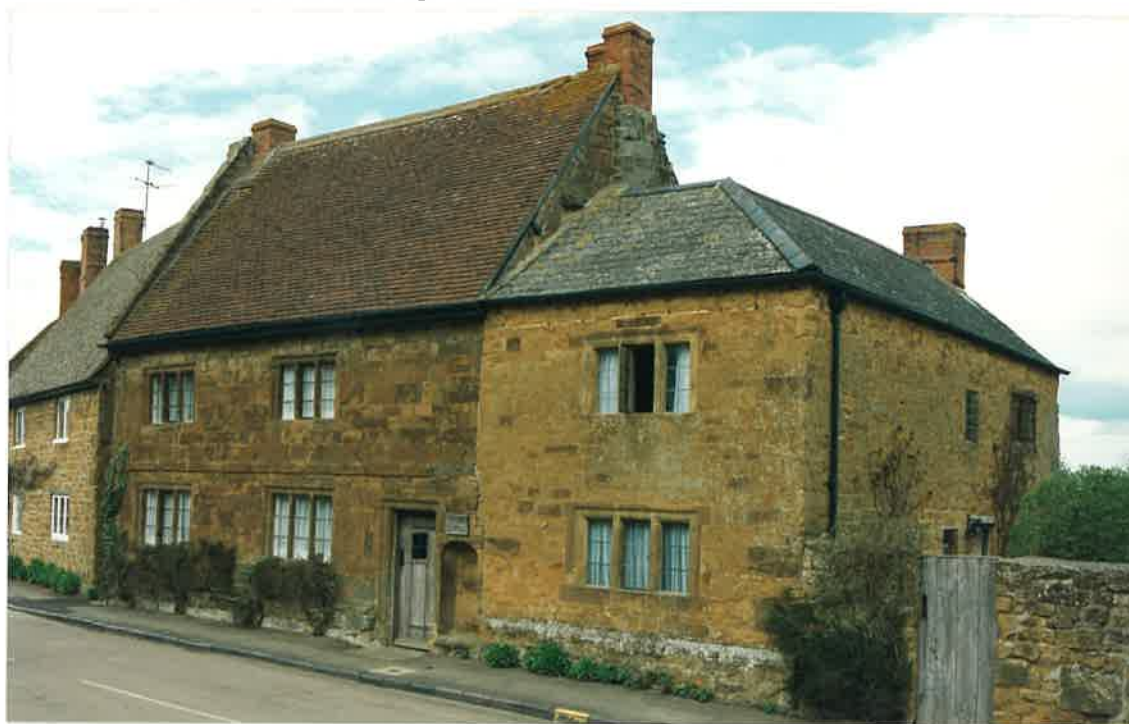
**Hope Cottage and Greenbanks, Church Street.
(Listed Building Ref. 6/43 - Grade II)**

(Prominent building opposite churchyard entrance)

Semi-detached houses. Hope Cottage on left is late C17; Greenbanks probably mid C18. Hope Cottage is of ironstone ashlar, with splayed plinth and string course. C20 tile roof has gable parapet with kneelers on left, and boxed eaves. 2-unit baffle entry plan. 2 storeys and attic; 2-window range. Entrance on right has C20 plank door in moulded stone architrave, with adjoining curved niche seat. 3-light moulded stone-mullioned windows. Left return side has partially-blocked 3-light stone-mullioned attic window with hood mould. To rear: single storey C20 additions. 2 two-light stone-mullioned windows on first floor. Interior: large open fireplace with stop-chamfered bressumer. Stop-chamfered ceiling beams. Former rear doorway and windows exposed inside addition. Doorway possibly re-used C16; hollow-chamfered shallow 4-centred arch and chamfered jambs, with moulded spandrels and fillet at apex. 2 two-light chamfered stone-mullioned windows. Greenbanks is of yellow limestone ashlar with splayed plinth. Artificial slate roof, hipped to right; brick stack. Double-depth plan. 2 storeys; one-window range. Mullioned windows similar to those of Hope Cottage. Entrance in right return side has plank door with wood lintel. 3-light casement set in remains of stone-mullioned window. 2-light casement. First floor has 3-light and small single-light stone-chamfered mullioned windows. To rear: gable with blocked 2-light mullion window and brick stack. (V.C.H.: Warwickshire, Vol.V, p.47). Cottage; house, formerly 3 cottages; and attached outbuilding. Corner Cottage at right angles to Church Street, possibly C16, raised and altered C18; C19 rear wing; altered and wing largely rebuilt late C20. Regular coursed limestone; brick wing

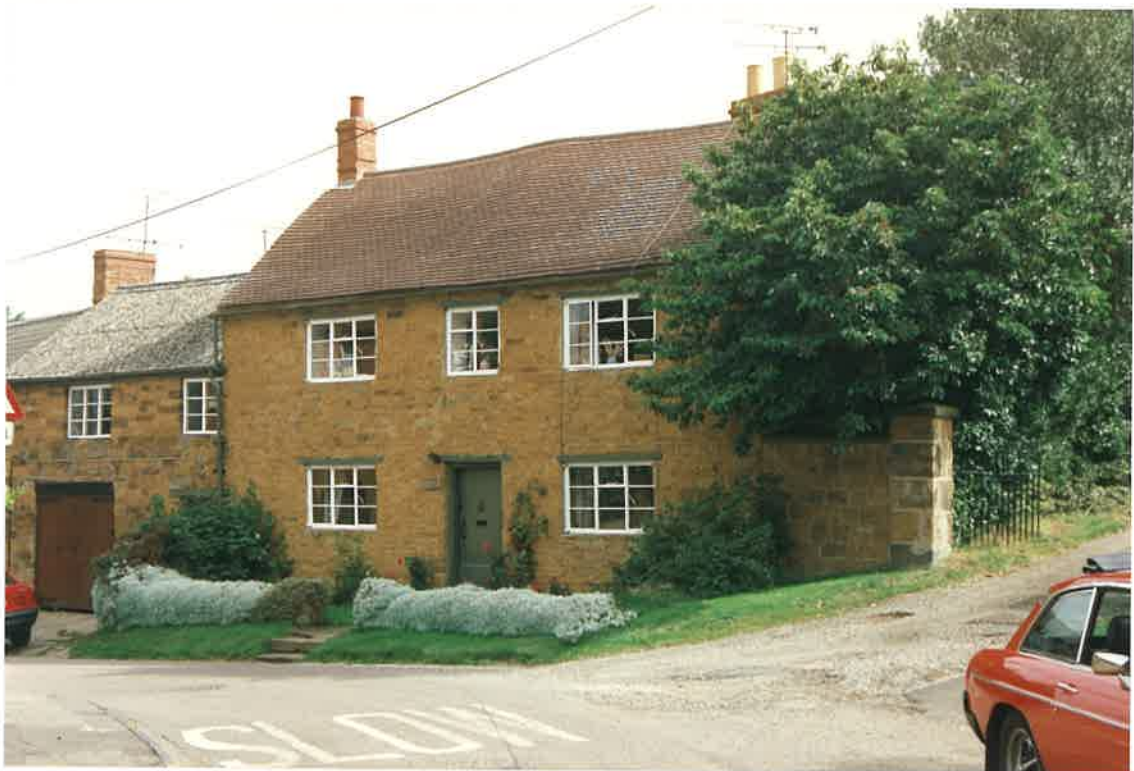
**Rectory Cottage, Church Street.
(Listed Building Ref. 6/47 - Grade II)**

House. Late C18/early C19. Regular coursed limestone with quoins and simple splayed cornice. Rear of whitewashed brick with brick dentil cornice. Old tile roof; brick end and ridge stacks. L-plan, with short wing to rear. 2 storeys; 3-window range. Central old plank door. Mid C20 casements. All openings have painted wood lintels. C19 outbuilding extension on left has corrugated asbestos roof. 2 storeys, but lower than house; 2-window range. Mid C20 garage doors on left. Old plank door. Fixed light windows on first floor. Painted wood lintels. Interior: remains of open fireplace. Exposed ceiling beams. Included for group value.

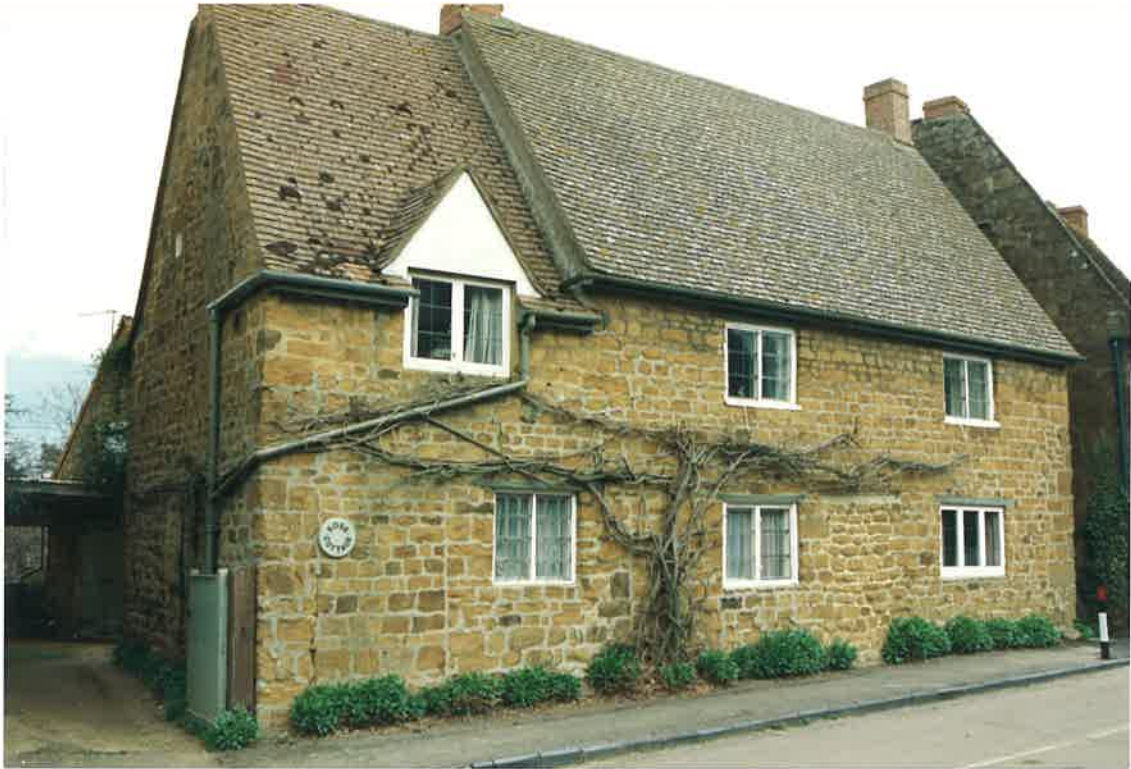
**Rose Cottage and attached outbuilding, Church Street.
(Listed Building Ref. 6/44 - Grade II)**

Cottage, possibly formerly 2. Early/mid C18, of 2 builds; altered late C20. Regular coursed limestone. Concrete tile roof; brick end stacks. 3-unit plan. 2 storeys; 3-window range. Blocked doorway. Leaded light casements, two C20. Openings have painted wood lintels. Left section is slightly lower, with gabled half-dormer. Entrance to rear has old plank door. Old leaded casements, one with original shutter. Outbuilding, formerly separate but now attached, has datestone with monogram EP 1759. Ironstone ashlar. Tile roof. Late C20 garage doors and windows. Interior not inspected. Included for group value.

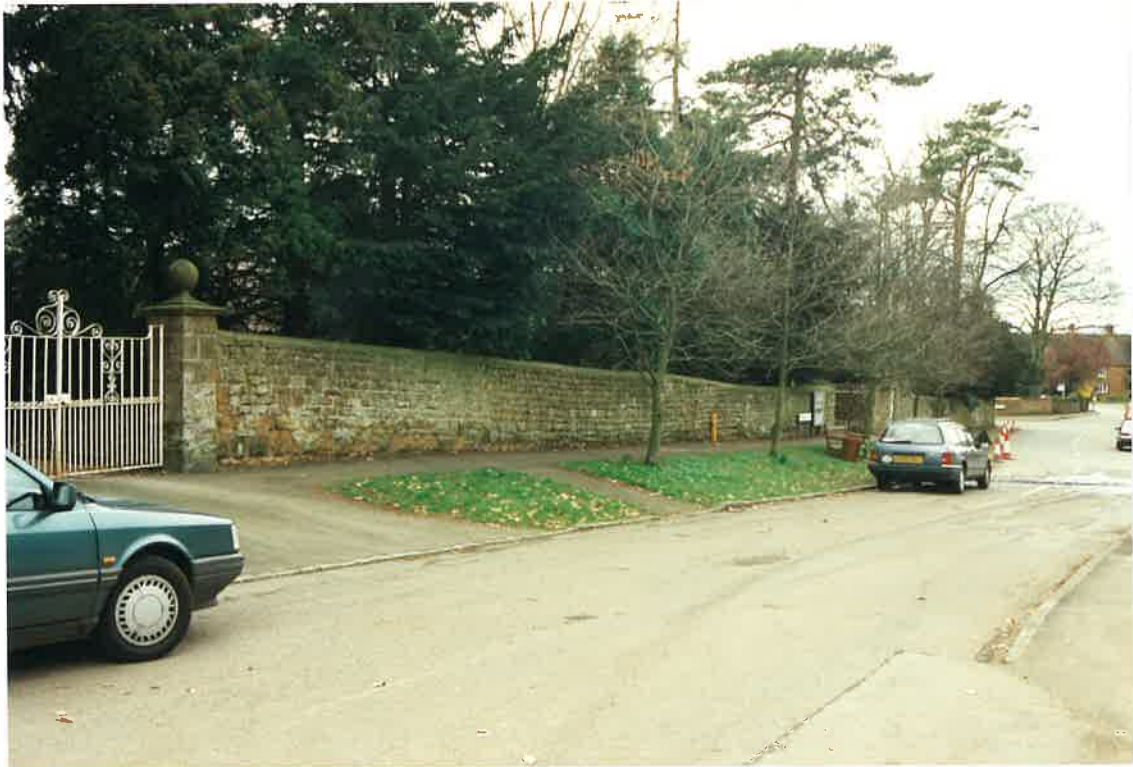
**Garden wall and right Gatepier, Red House, Church Street.
(Listed Building Ref. 6/39 - Grade II)**

Garden wall and gatepier. Wall early C18. Regular coursed drystone ironstone; cemented top. Gatepier possibly early C20. Ironstone ashlar. Moulded cornice and ball finial. Section of wall rebuilt curving back around War Memorial (not included). Forms an important element in the street. Included for group value.

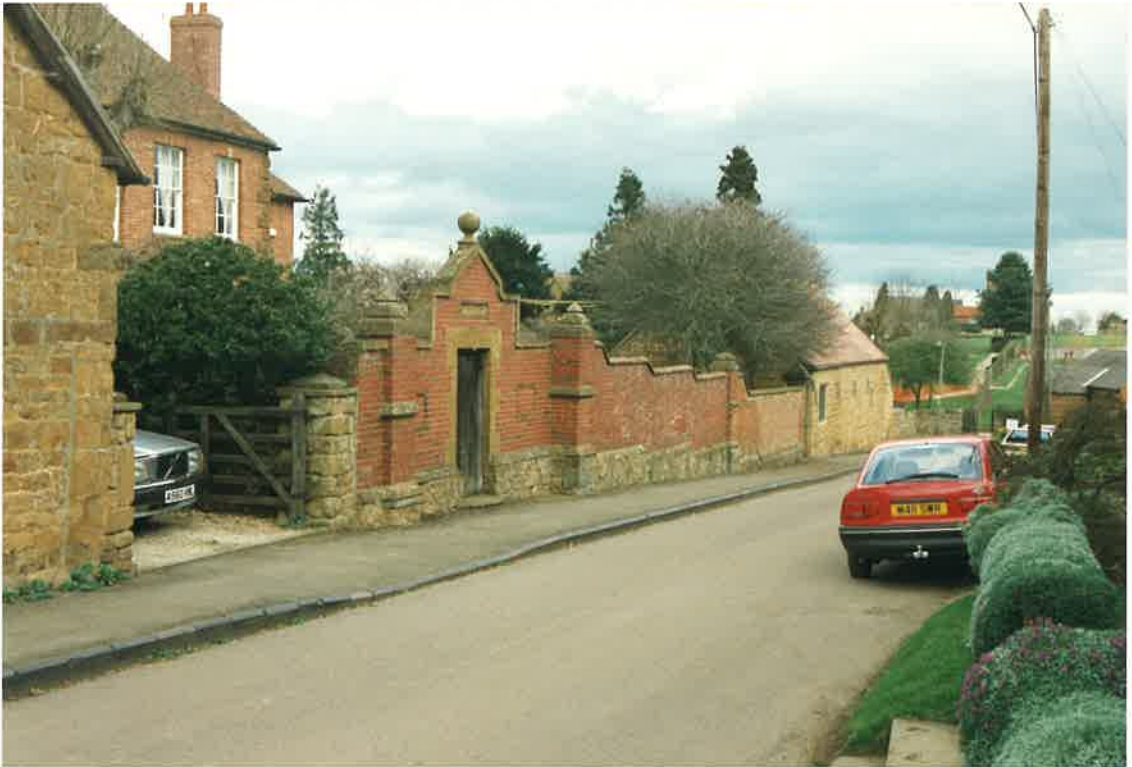
**Stables and Coach House at Red House, Church Street.
(Listed Building Ref. 6/41 - Grade II)**

Stables and coach house. Early C18. Regular coursed ironstone. Simple splayed cornice. Old tile roof. C19 carriage doors on left. 2 stable doors, the second with a small stone round-arched window directly above the lintel. Plank door. Leaded window of 2 fixed lights on right. Painted wood lintels throughout. Mounting block built into front wall. To road: blocked doorway. Leaded windows of 3 fixed lights on left, one light on right. Interior: chamfered beams. Room on right is said to have been used as a butcher's shop.

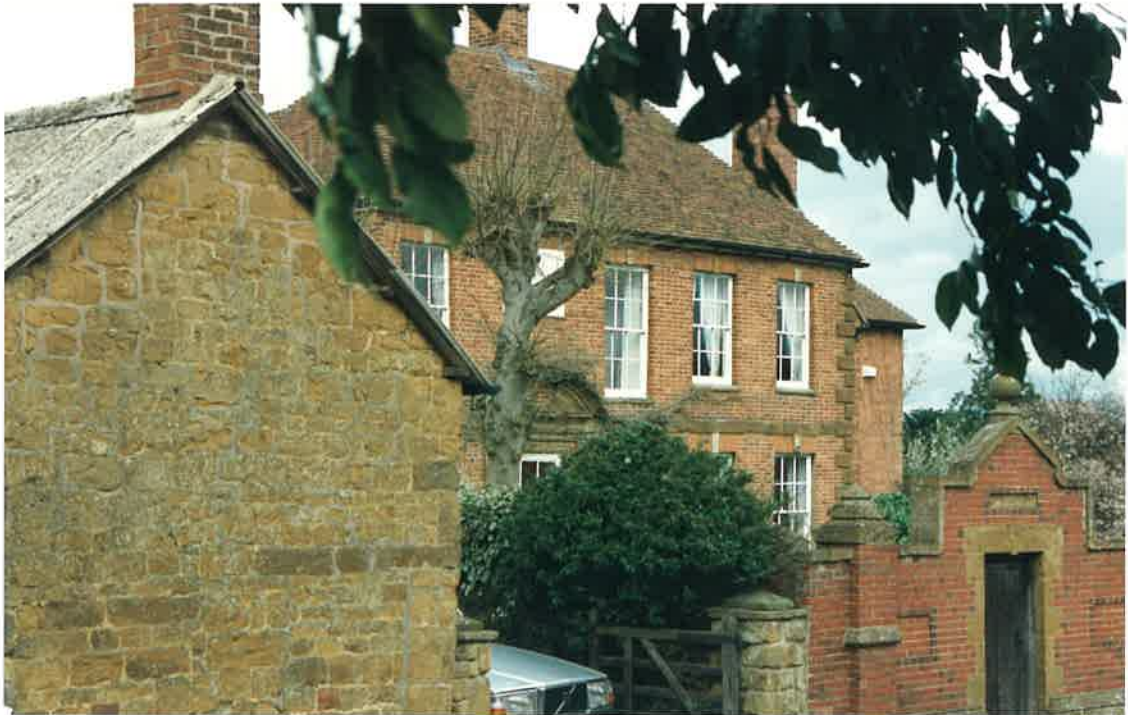
**The Red House, Church Street.
(Listed Building Ref. 6/42 - Grade II)**

(Important 'red brick' house in stone village)

House. Late C16/early C17 origins, remodelled and dated 1707; early C20 alterations and additions. Red Flemish bond brick with moulded stone plinth, quoins, and string course and dressings. Old tile hipped roof with wood coved cornice; brick ridge stacks. Complex L-plan. 2 storeys and attic; 5 bays. Main, formerly entrance, front has large stone doorway on left in second bay. Moulded eared architrave and narrow sunk panels, bolection-moulded entablature breaking forward left and right, and scroll pediment. Sash window inserted in place of door. 2 sashes to right. First floor has raised brick panel and painted wood sundial with moulded frame and date, in place of window. Window openings have gauged brick flat arches with keystones. Rusticated alternating quoins to right corner only. Main entrance now in C20 wing. Left return side has doorway with moulded stone architrave. Glazed door and overlight with fan glazing. C20 wood porch of Tuscan columns with simple, incorrect, entablature and large dentils. Narrow sash to right. Mid/late C20 sash above. Right return side has C20 additions. Garden front: 2-window main range and 2-window wing projecting on left, with additions beyond. Main range has mid/late C19 French windows and loggia with octagonal brick pillars and tile lean-to roof. First floor has sash, and early C20 leaded cross window on right. 2 hipped roofs. Wing stands on high limestone ashlar cellar with chamfered single light. Ground floor has early C20 four-light leaded wood-mullioned and transomed oriel with tile roof. First floor has sashes. Hipped roof. Roof dormer has casement with glazing bars. First floor openings throughout have gauged brick flat arches. Early C20 range has sashes. Interior:

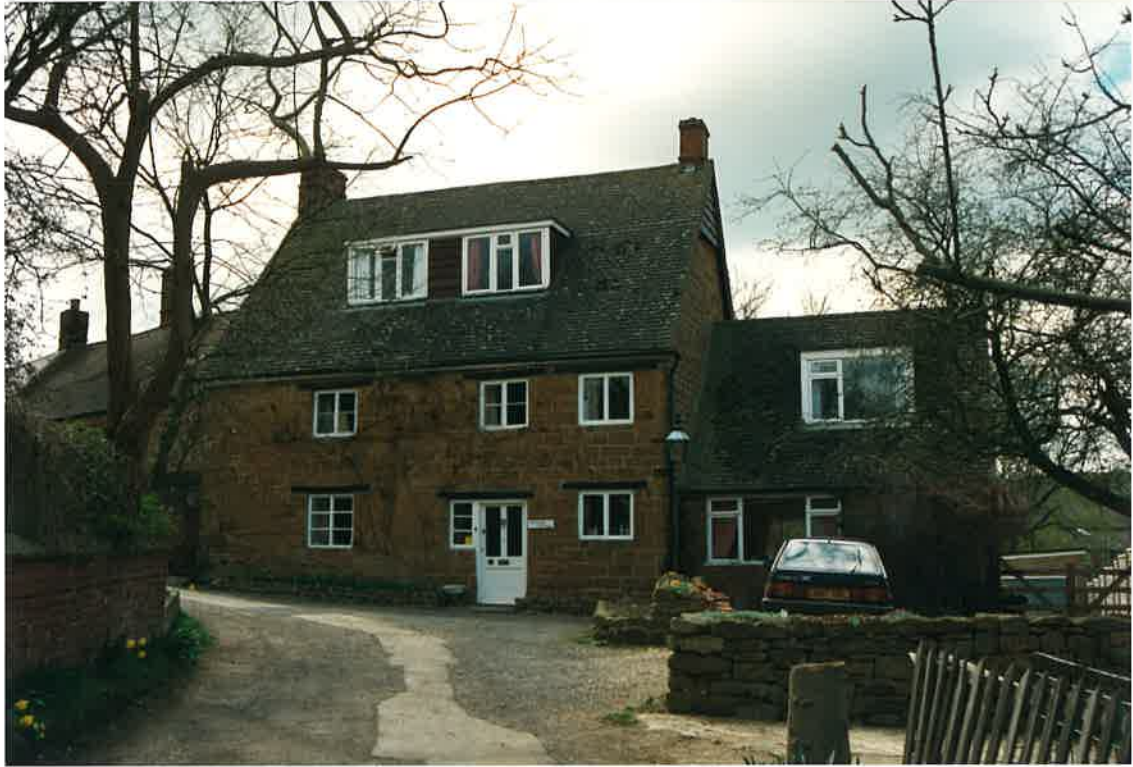
**Ducketts Cottage, Dog Lane.
(Listed Building Ref. 6/69 - Grade II)**

House. Mid C18. Regular coursed stone. Concrete tile roof; brick end stacks. 2-unit plan. 2 storeys and attic; 3-window range. Half-glazed door with adjoining window. Old casements, and windows of 2 fixed lights on right. All openings have painted wood lintels. Mid C20 flat-roofed roof dormer with 2 casements. Interior not inspected.

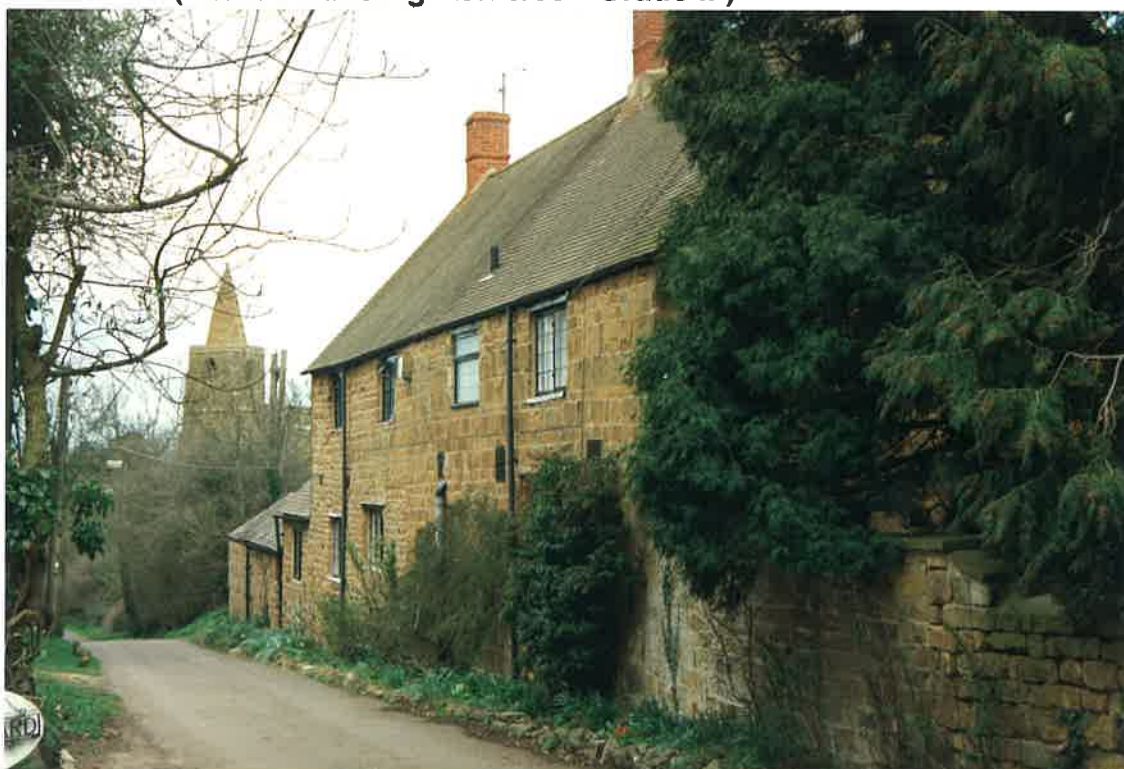
**Gredenton, Dog Lane.
(Listed Building Ref. 6/68 - Grade II)**

Shown on O.S. map as Gredenton Cottage House. Right section C16 with C19 and mid and late C20 alterations and additions to left and rear. Front to Dog Lane of regular coursed ironstone to right, with rougher stonework to left. Mid/late C20 tile roof; brick and stone and brick part-rendered ridge and end stacks, 2 with diagonally set corbels. Formerly through-passage plan, altered and extended to 4-unit L-plan, with wing to rear. 2 storeys. 4-window range. Right section has blocked C16 moulded 4-centre arched doorway. Chamfered fire window to left. Late C20 window above doorway. Leaded casement to right, on ground floor with hood mould. Left section has 3-light casements. First floor has C19/C20 casements with glazing bars and painted wood lintels. One storey and attic range on left has C20 casement. Entrance in low single storey range to left has C19 flush 4-panelled door. Right return side has firemark. To garden: 3-window range, with one-window late C20 wing on right. Central entrance has C16 4-centre arched doorway with large hood mould; C20 glazed door. Very small window just above. Large early/mid C20 three-light stone-mullioned window to left. Smaller 3-light mullion windows, probably original, to right. Right section has string course. Right end has C20 flat-roofed single storey addition. Recessed door and 2 small 2-light mullion windows. First floor has 2-light leaded wood casement with painted lintel on left, and two 2-light mullion windows. Interior noted as having stop-chamfered beams. Said to have large inglenook.
