STRATFORD ON AVON DISTRICT COUNCIL

CONSERVATION AREA REVIEWS 1996 / 97

FENNY COMPTON

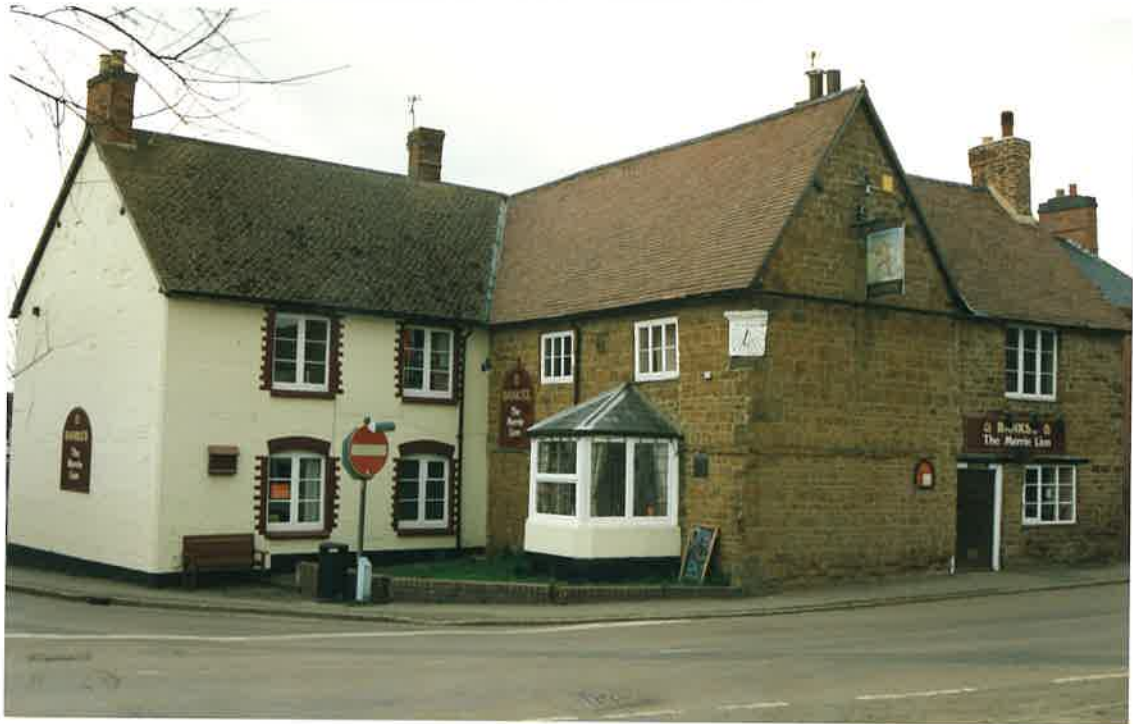
**Merrie Lion Public House, High Street.
(Listed Building Ref. 6/71 - Grade - II)**

(important building on High Street)

Shown on O.S. map as Red Lion Public House Public House. Dated 1710, with mid C19 and late C19/C20 additions. Regular coursed ironstone with string course; colourwashed brick front wing. C20 tile roofs; brick ridge and end stacks. Formerly 3-unit plan, extended to complex L-plan. 2 storeys; 2-window range. Late C20 door with concrete lintel in re-entrant angle. C20 canted bay window has leaded lights and slate roof. C19 three-light casements on first floor. Datestone with cornice has initials TBM. Sundial across right corner has painted panel with moulded cornice and painted numerals. Wing at right angles on left has no windows to front. End stack. Right return side: 2-window range. Casements with some glazing bars, on ground floor under cambered brick arches. Right return side of main range, to High Street, have one-window wing. C20 door, C19 casements. All openings with wood lintels. Interior altered.

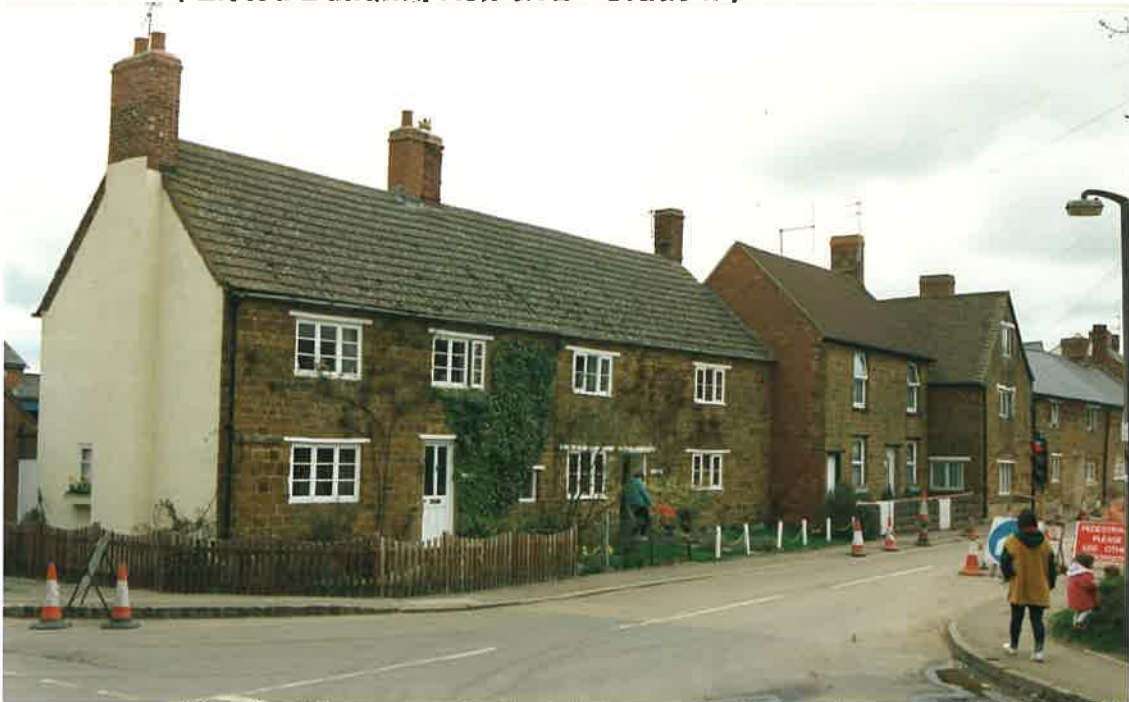
**No.1, Lavender Cottage, and No.2, The White House, High Street.
(Listed Building Ref. 6/72 - Grade II)**

(Key building on main street corner - unfortunate concrete tile roof)

Pair of cottages; part of a row. Late C18. Regular coursed limestone. Concrete tile roof; brick ridge and end stacks. Each 2-unit plan. 2 storeys; each 2-window range. Half-glazed doors. Lavender Cottage on left has fire window to right of entrance, and casement to left. C19 three-light casements. The White House has C20 three-light casements, on left close to door. All openings have painted wood lintels. Left return side and rear of Lavender Cottage have imitation ashlar render. Gable has brick corbelling. Interior not inspected.

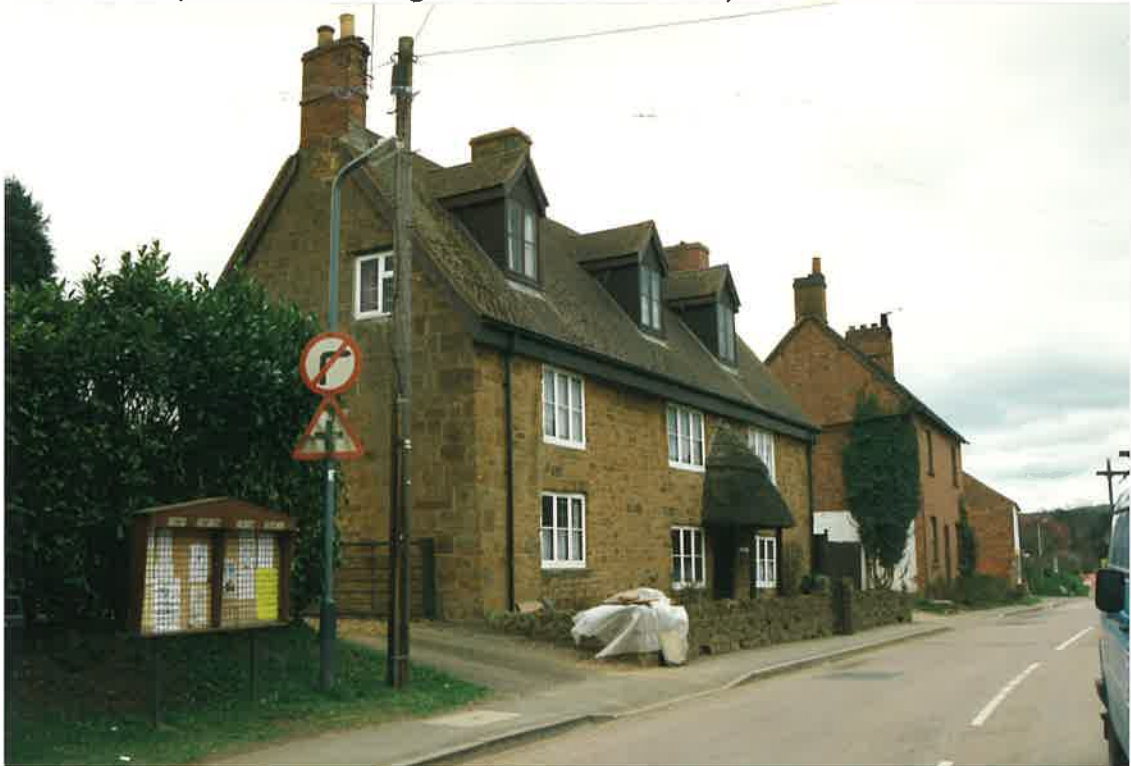
**Saddlers Cottage, High Street.
(Listed Building Ref. 6/70 - Grade II)**

House. Mid C17; repaired late C20. Coursed ironstone. Late C20 tile roof; brick stacks. 3-unit plan. 2 storeys and attic; 3-window range. Old 4-plank door in simple moulded wood surround between second and third bays. Open porch with high straw thatched roof. C19 or C20 casements. Left ground floor window is at a higher level. 3 large late C20 roof dormers. C19/C20 end stacks, and C17 ridge stack of thin bricks. Interior not inspected.

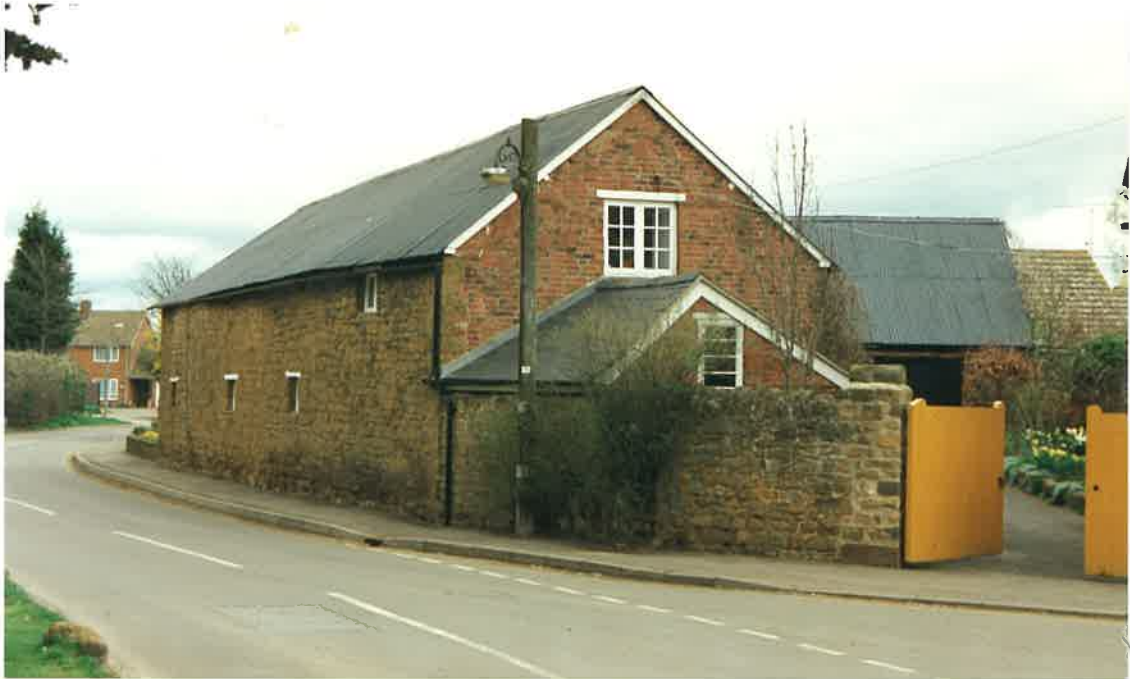
**Outbuildings approx. 4m. north of The Old Bakehouse,
Memorial Road.
(Listed Building Ref. - 6/74 - Grade II)**

Outbuilding. Early/mid C19. Coursed ironstone rubble; left return side of brick. Corrugated iron roof. Front to garden has plank door in wood frame in left corner and double doors to right of centre. 3 fixed-light windows. Painted wood lintels. To road: 3 small 2-light windows. Interior not inspected. Included for group value.

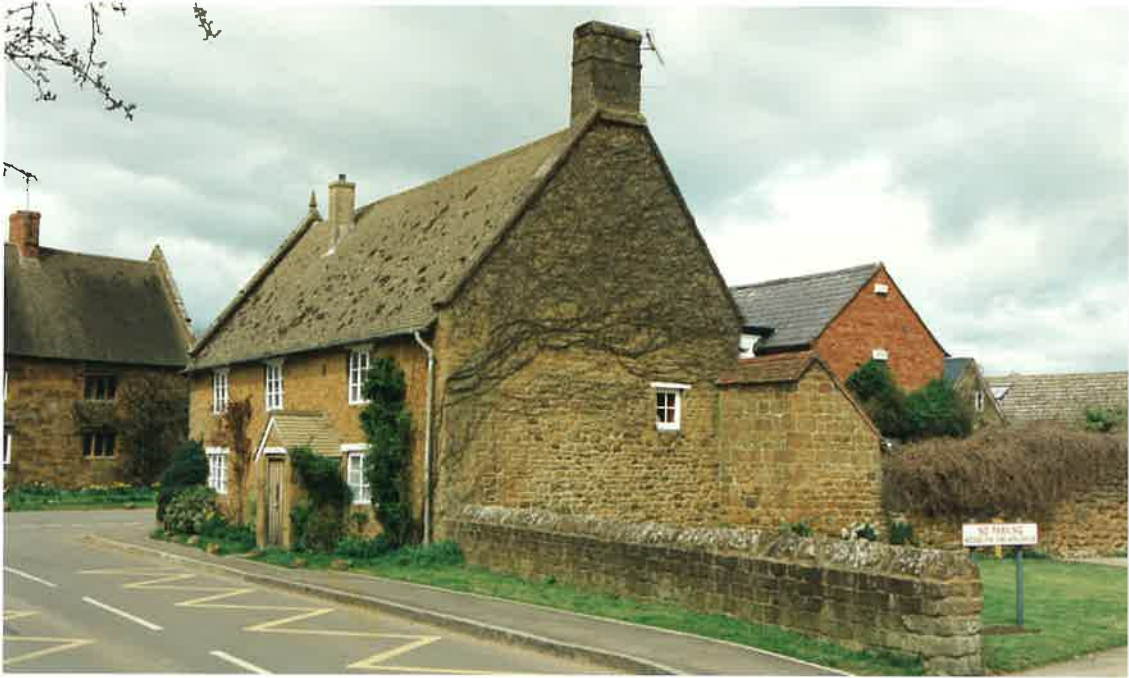
**The Old Bakehouse, Memorial Road.
(Listed Building Ref. 6/73 - Grade II)**

(picturesque group value with Contone Farmhouse)

House. Mid/late C17 with C19 additions to rear. Regular coursed ironstone. Concrete tile roof has coped gable parapets, with remains of finial on left; rendered end and internal stacks. Addition of red brick; slate roof. 3-unit plan extended to T-plan. 2 storeys; 3-window range. C19/C20 porch between second and third bays has ribbed door. 3-light casements with horizontal glazing bars; those on ground floor are old. Painted wood lintels throughout. Firemark above porch. Interior not inspected.

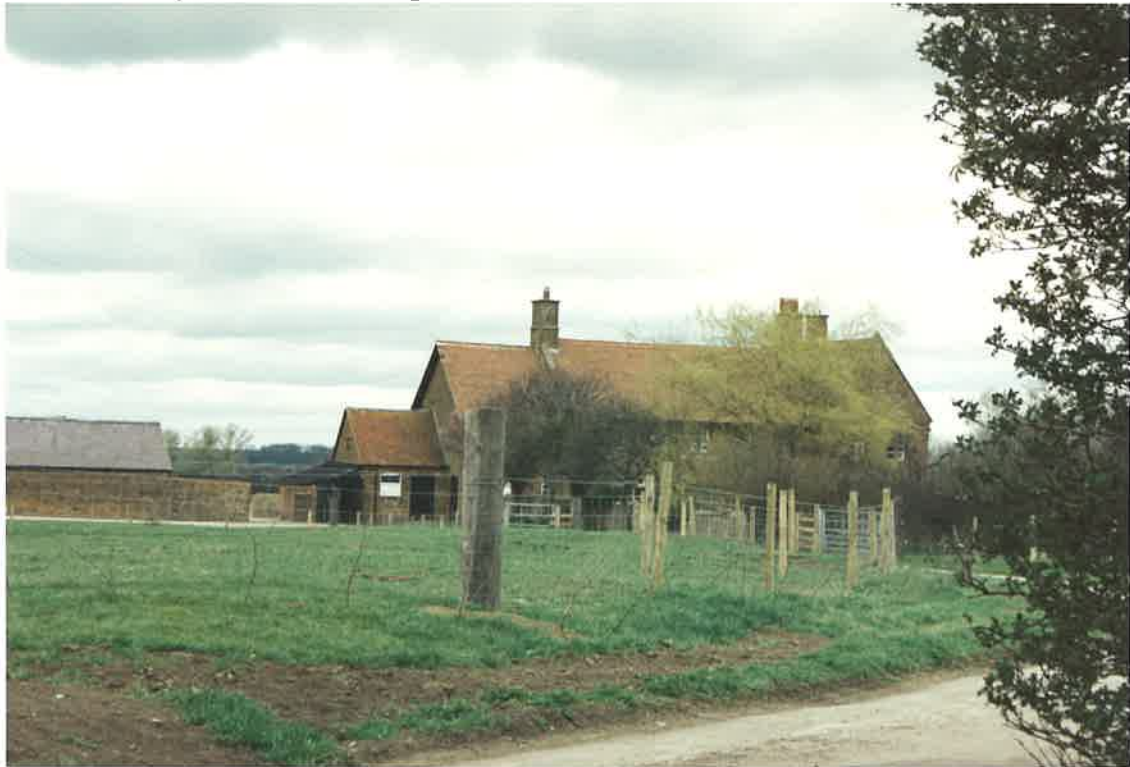
**Manor House and attached Stable, Northend Road.
(Listed Building Ref. 6/75 - Grade II)**

Manor house and attached stable. Mid C17; alterations and additions mid/late C19; stable dated 1829. Ashlar and regular coursed ironstone. Tile roof has coped gable parapets and moulded kneelers; stone ridge and end stacks with string courses and cornices. T-plan, with cross wing on right. 2 storeys; 8-window range. Entrance in central symmetrical 5-window range has doorway with chamfered jambs. Hood mould, stepped up in centre over rounded sunk panel possibly a datestone but now illegible. C19 part-glazed 6-panelled door. Mid/late C19 tile hood with wooden struts interrupting hood mould. C19 three-light stone-mullioned and transomed window and to left and right. First floor and right wing have 2-light stone-mullioned windows. Hood moulds throughout; wing has hood mould continued across wall between ground floor windows. 2-window right wing projects only slightly. Steep gable with cross vent. Mid/late C19 one-window range on left, of rougher stonework. Ground floor has 2 windows with chamfered jambs. First floor has 3-light casement. Left return side has stable door with segmental arch. Right return side of wing: 2-window range. 2-light mullions. Rear irregular. Interior not inspected. Stable attached on left has quatrefoil with chamfered jambs.

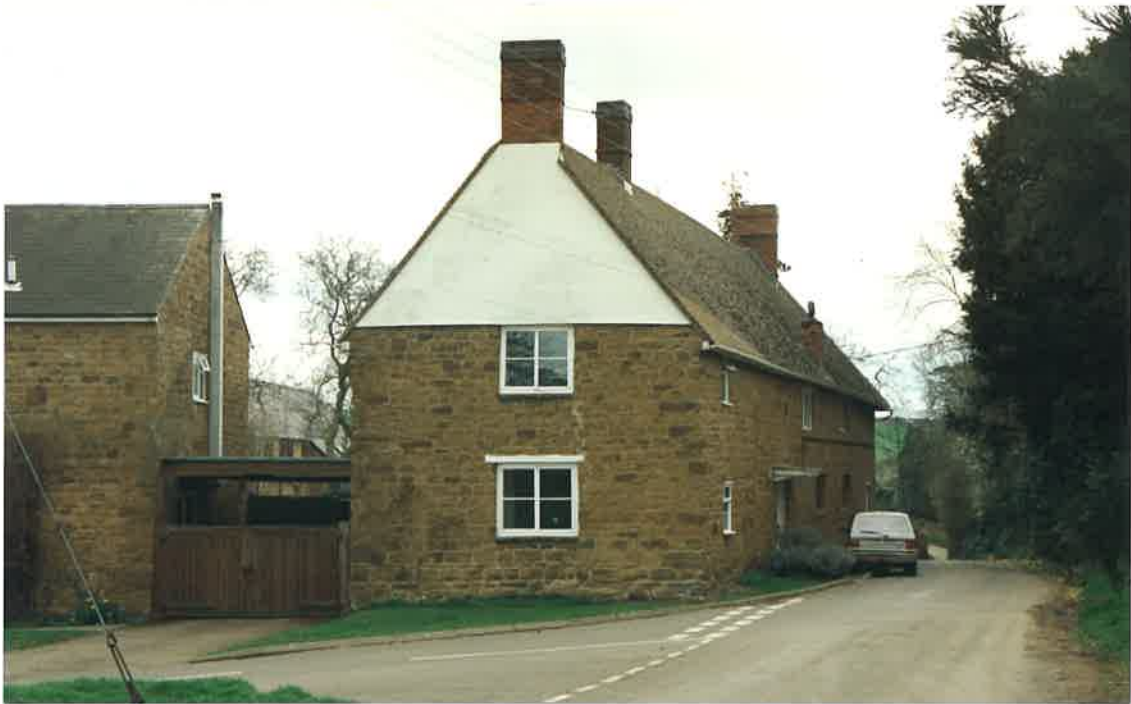
**No.1 Mill Hill Cottages and Cobbers Keep, The Slade
(Listed Building ref.2/76 - Grade II)**

Farmhouse, now 2 houses. Early C18, with early C19 additions at each end, continuing roof line. Coursed limestone. Concrete tile roof; brick end ridge and internal stacks. 5-unit plan. 2 storeys and attic; 3-window range. No.1 Mill Hill Cottages, on left, has mid/late C20 plank door and hood on shaped brackets. Central section has 2 three-light chamfered stone-mullioned windows. Right end has C19 casement with painted wood lintel. Left end has small C20 window on each floor. First floor has 2 old casements. Left return side has rendered gable. C19 casements. Right return side has entrance to Cobbers Keep, with C20 glazed door and hood on shaped brackets. Sash above. Attic window. Rear irregular five C20 flat-roofed roof dormers.

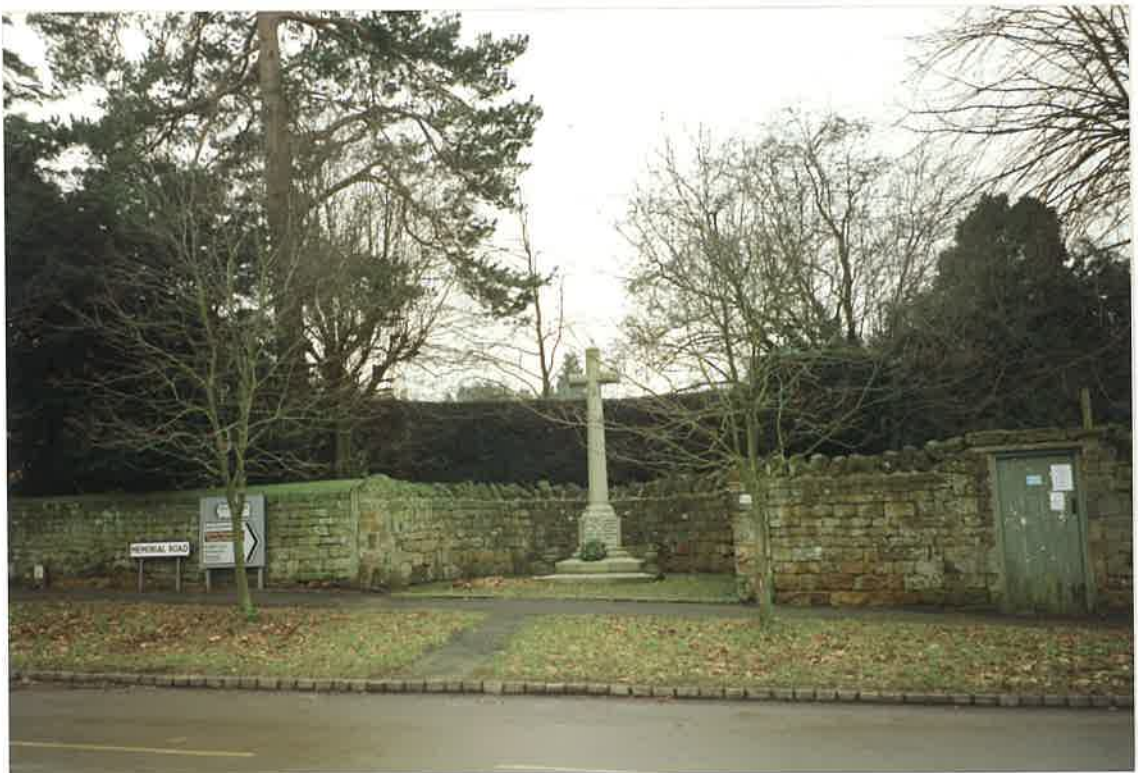
- 11 The War memorial - backed by yew.
- 12 The wall to The Red House, Church Street showing the playing field.
- 13 Gate to the Red House, Memorial Road.
