STRATFORD ON AVON DISTRICT COUNCIL

CONSERVATION AREA REVIEWS

WHICHFORD

February 1994

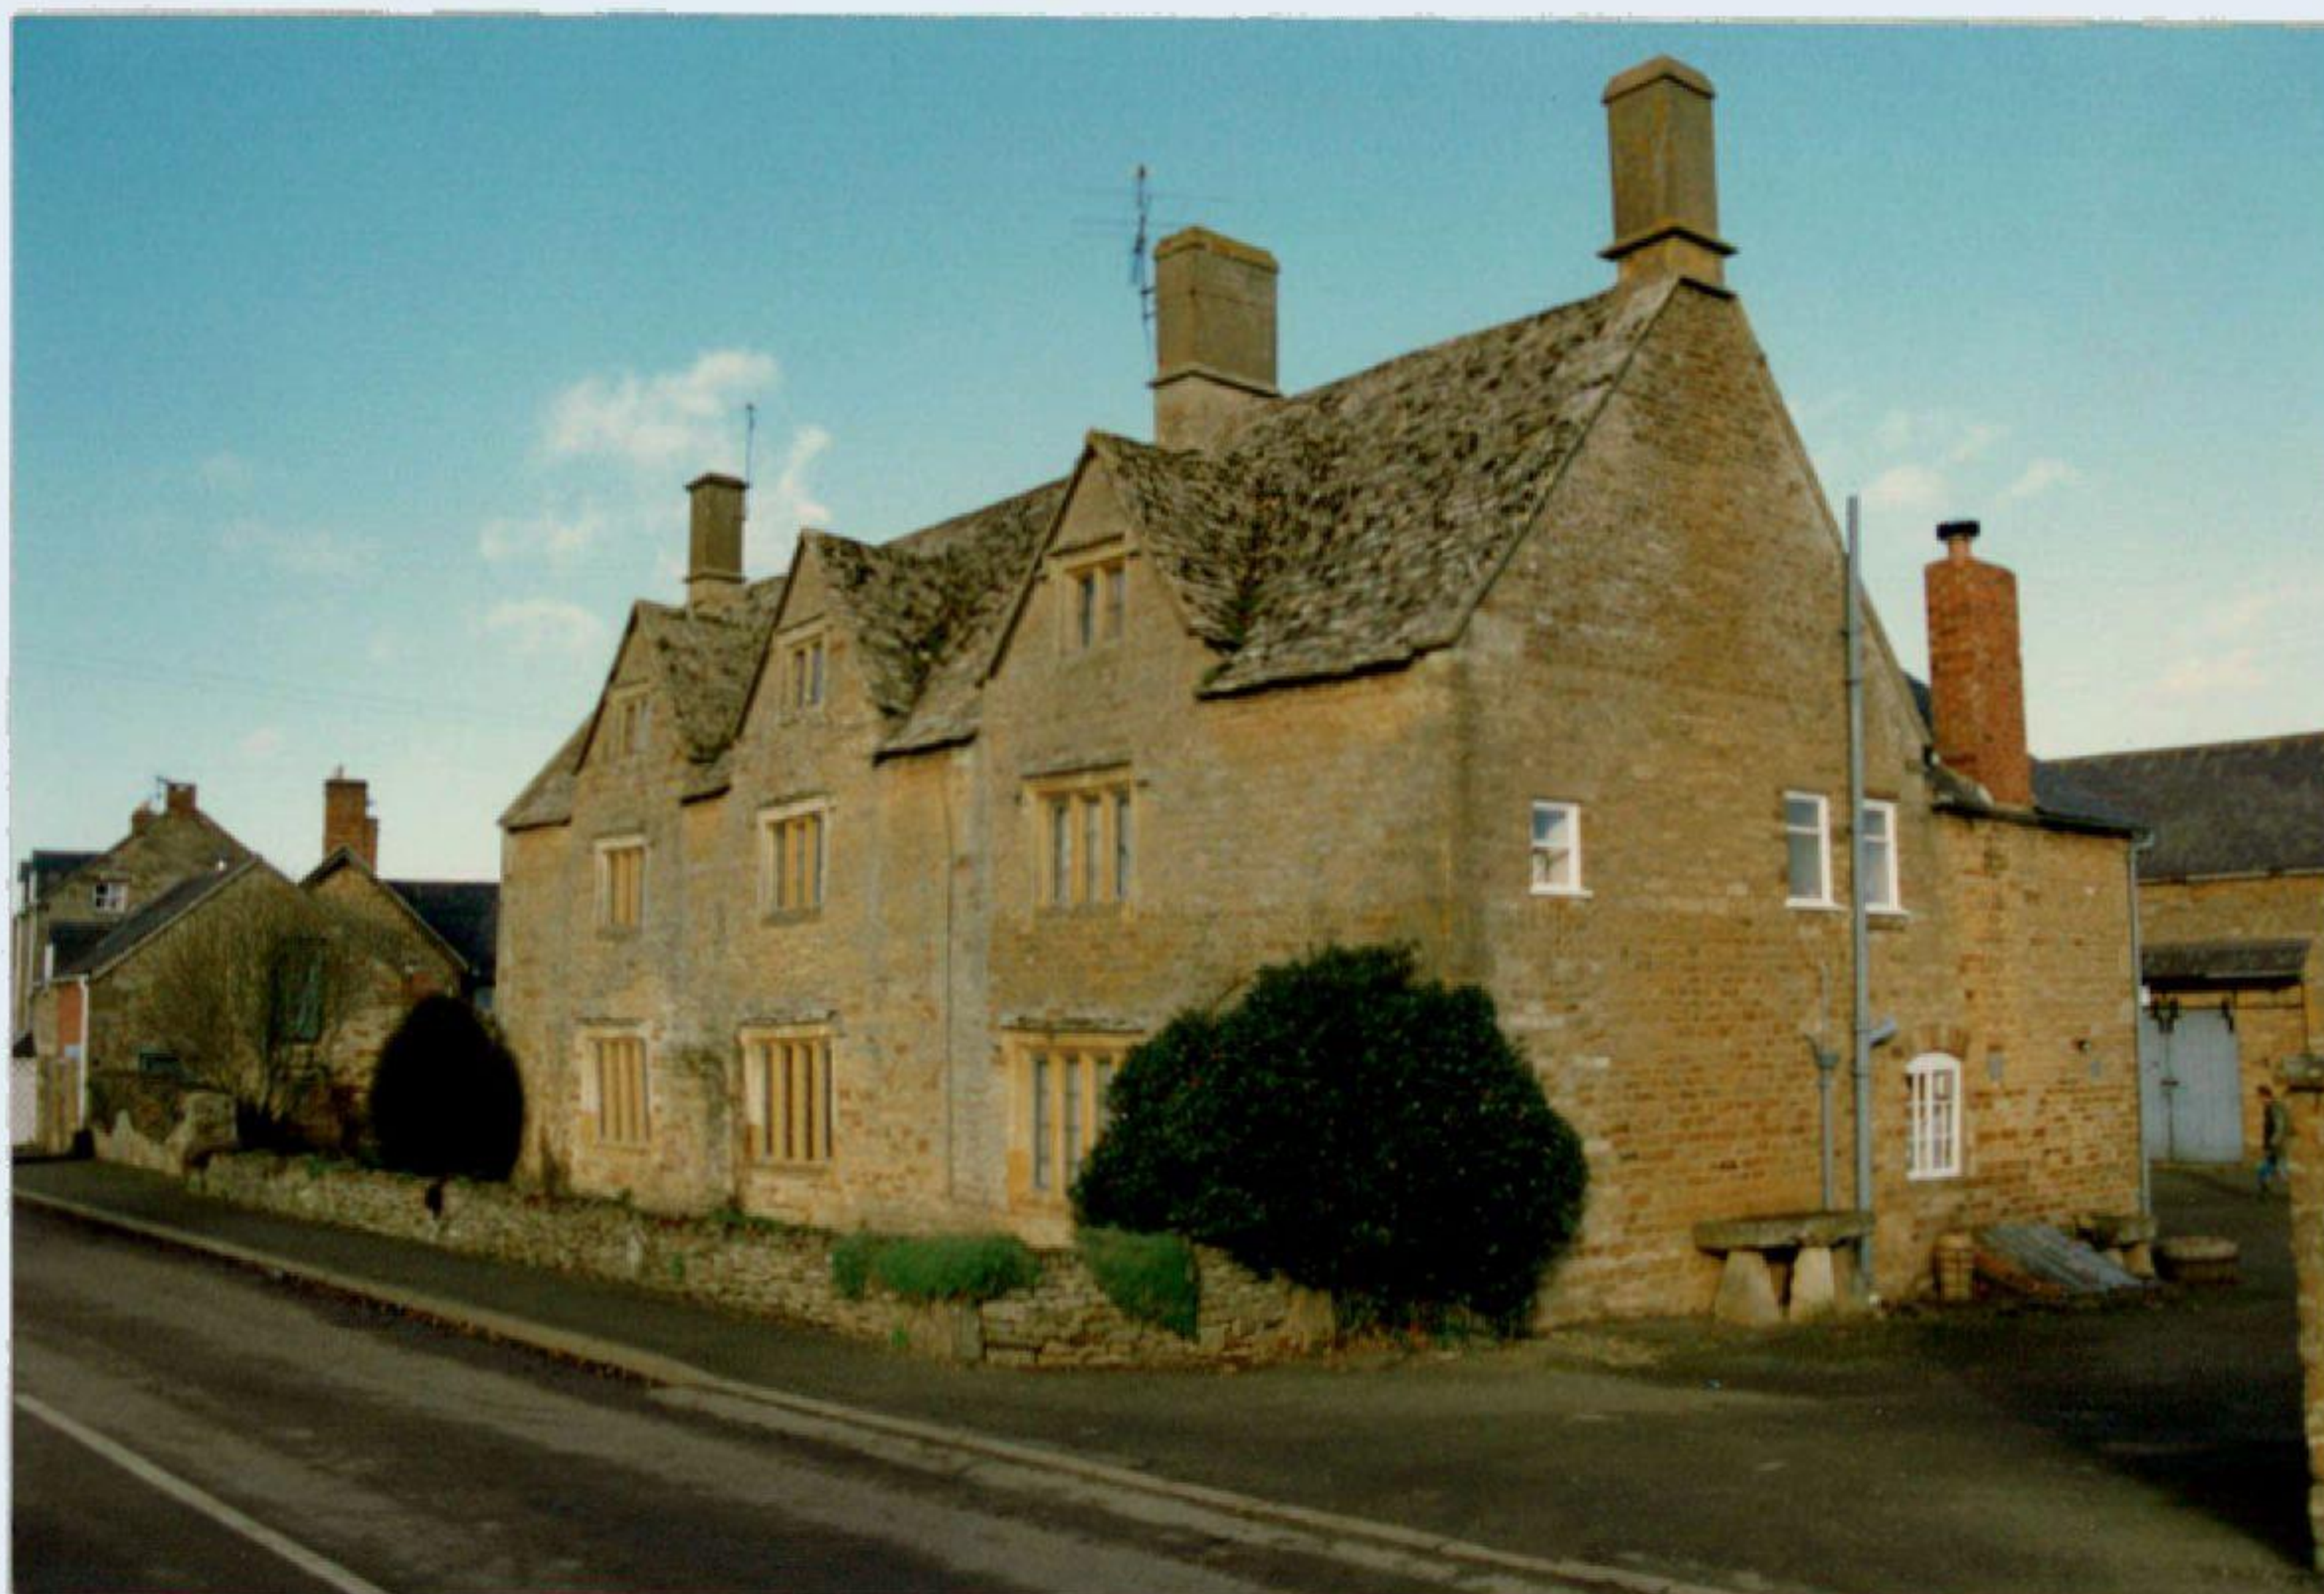
- 9/146. Leasow Farmhouse
(Listed Building Ref 9/146 - Grade II)

(Fine and 'typical' Cotswold manor farmhouse - good dressed stone mullioned windows)

List description : Farmhouse. Mid C17, of 2 stages of building. Squared coursed limestone with quoins and coped gables. Stone-slate roof with rendered brick stacks with original stone bases. 3-unit plan. 2 storeys plus attic; 3-window range. Part-renewed 4-light mullioned windows to ground floor openings, and 3-light mullioned windows to first floor openings. Three C17 full gabled dormers with 2-light mullioned windows. All mullioned windows have hood moulds and labels. To rear a staircase range of 2 storeys plus attic. Further 3-light mullioned windows with hood moulds and labels. C19 two-storey stone range to rear left, with C20 stone extension in angle.

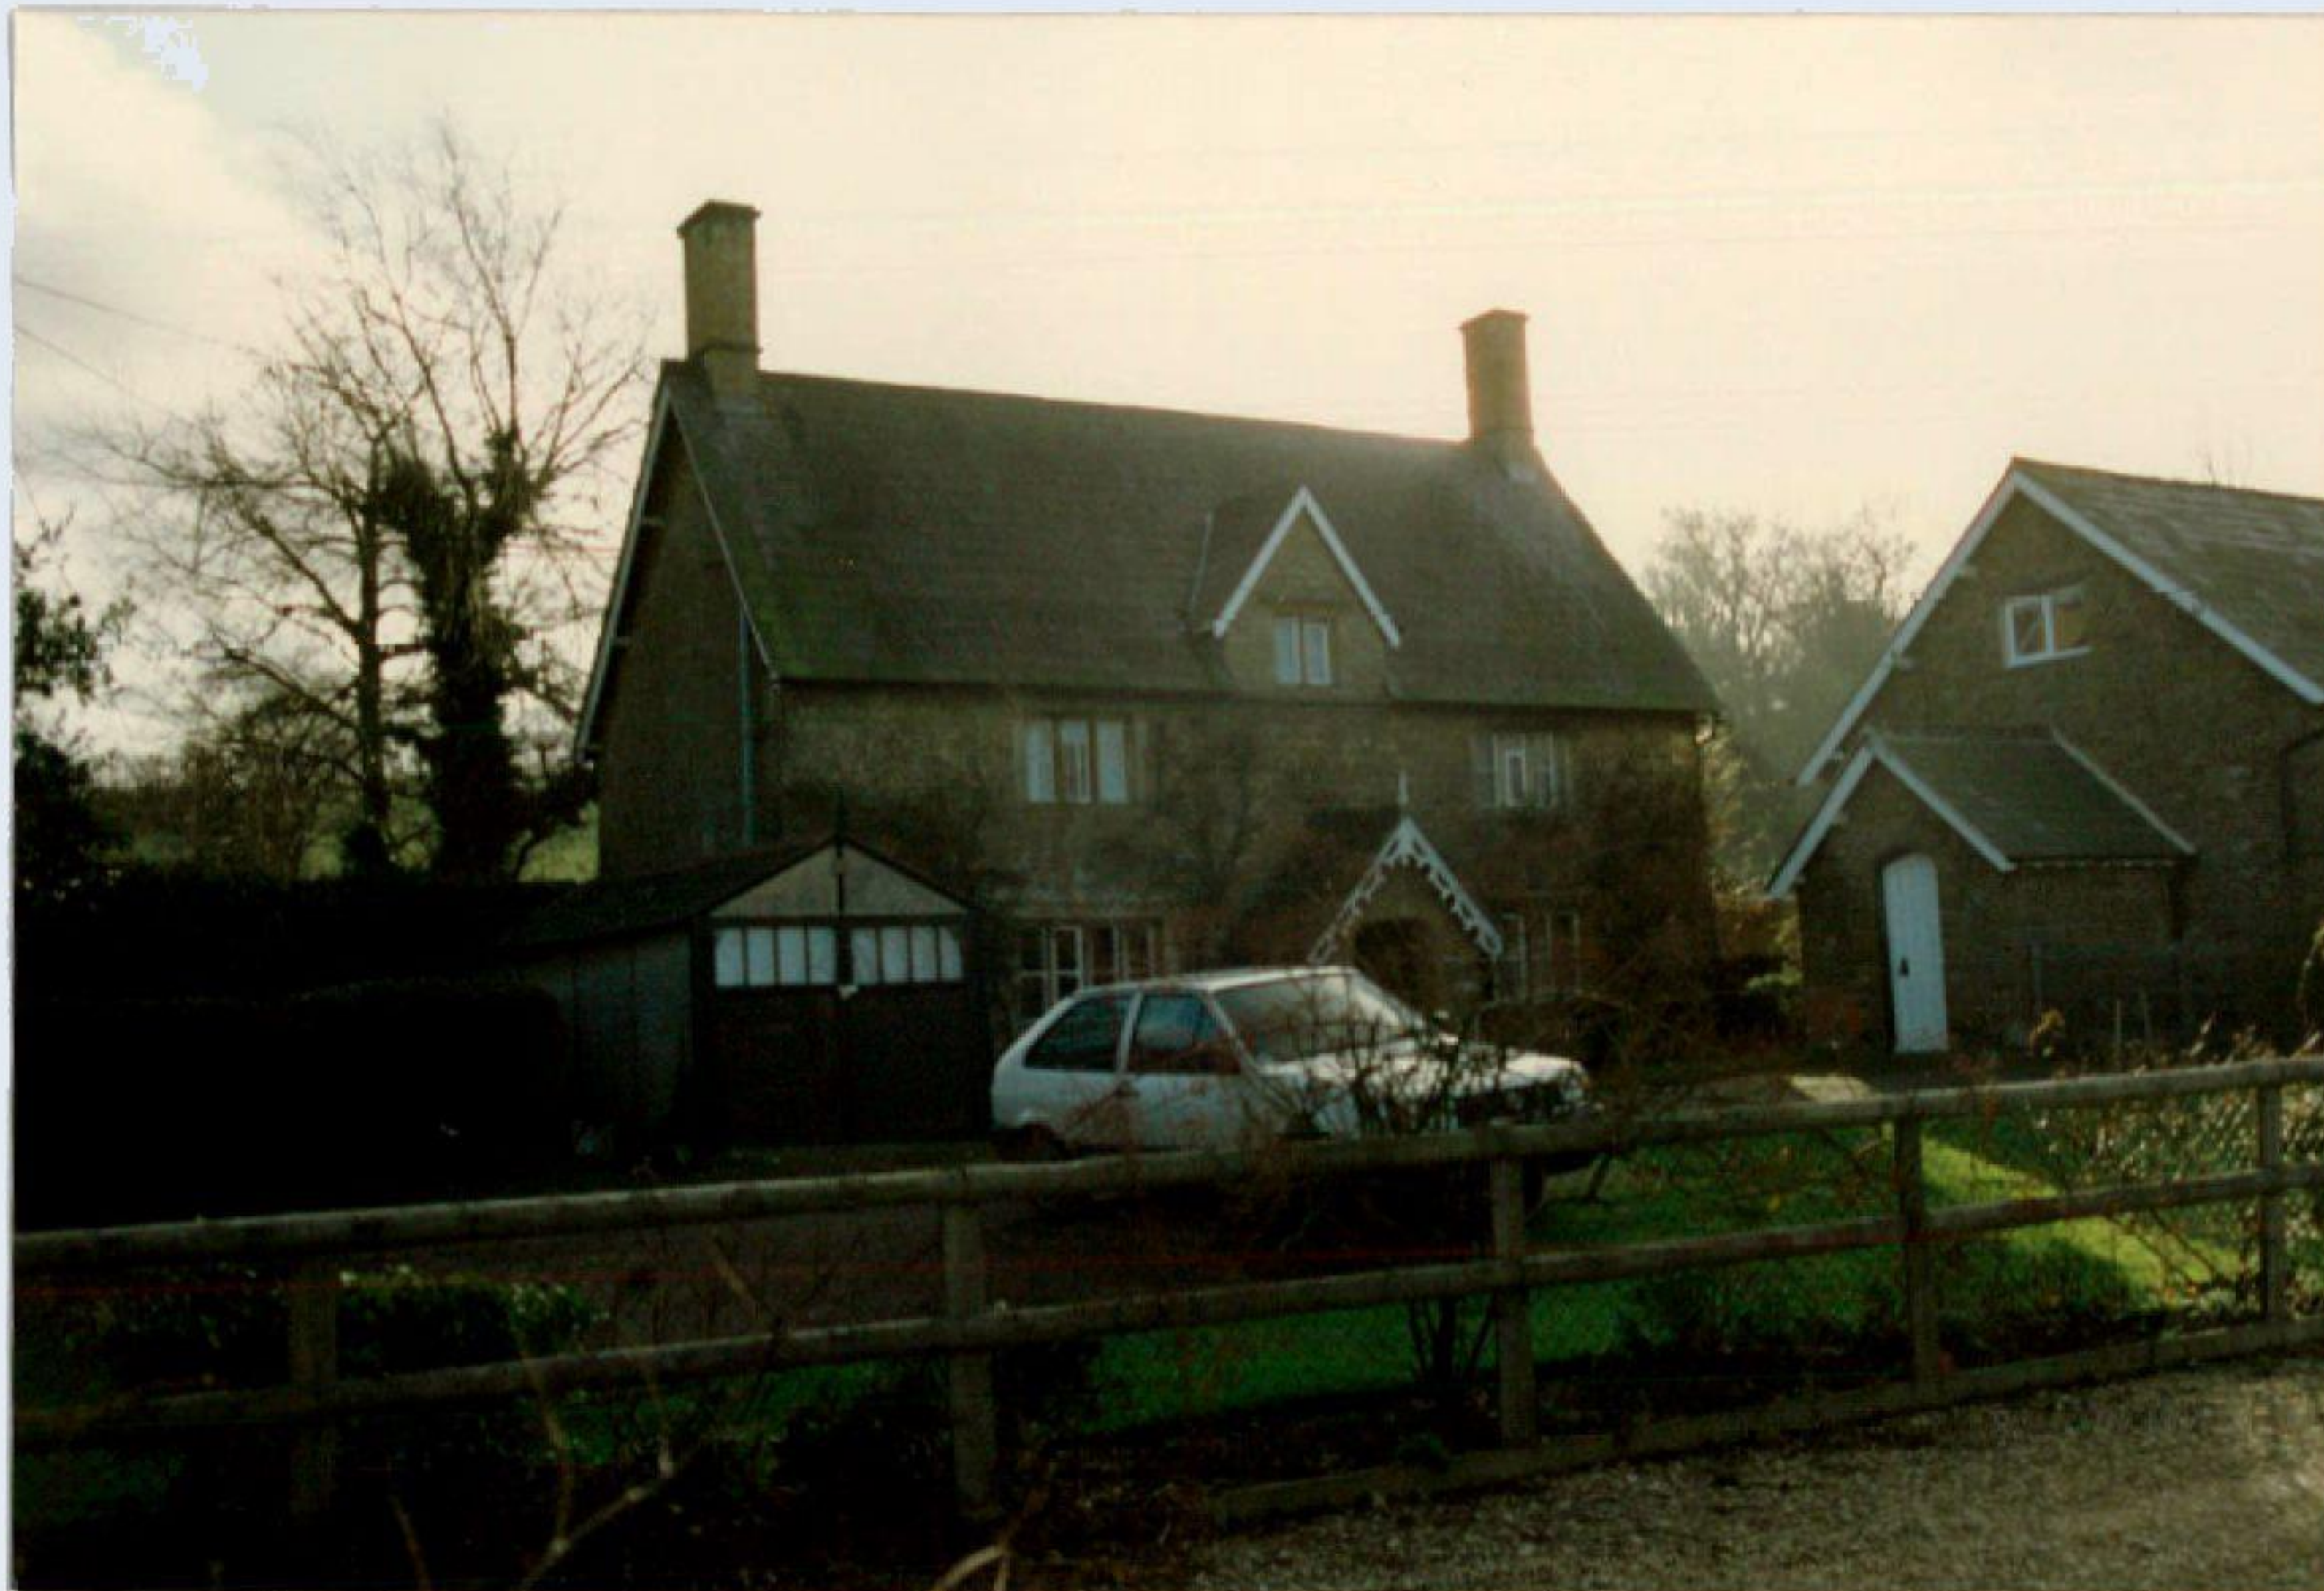
9/148. School House
(Listed Building Ref 9/148 - Grade II)

(Key building end of group value with school at south end of village green)

List description : House. Mid C17, with C19 alterations. Coursed limestone rubble with C19-slate roof and C20 stone end stacks. 2-unit plan. 2 storeys plus attic; 2-window range of 4-light mullioned windows to ground floor with hood mould and labels, and 3-light mullioned windows to first floor. C19 gabled porch to centre, with C20 door. C19 central gabled dormer with 2-light mullioned window and moulded hood. Small chamfered light to ground floor left.

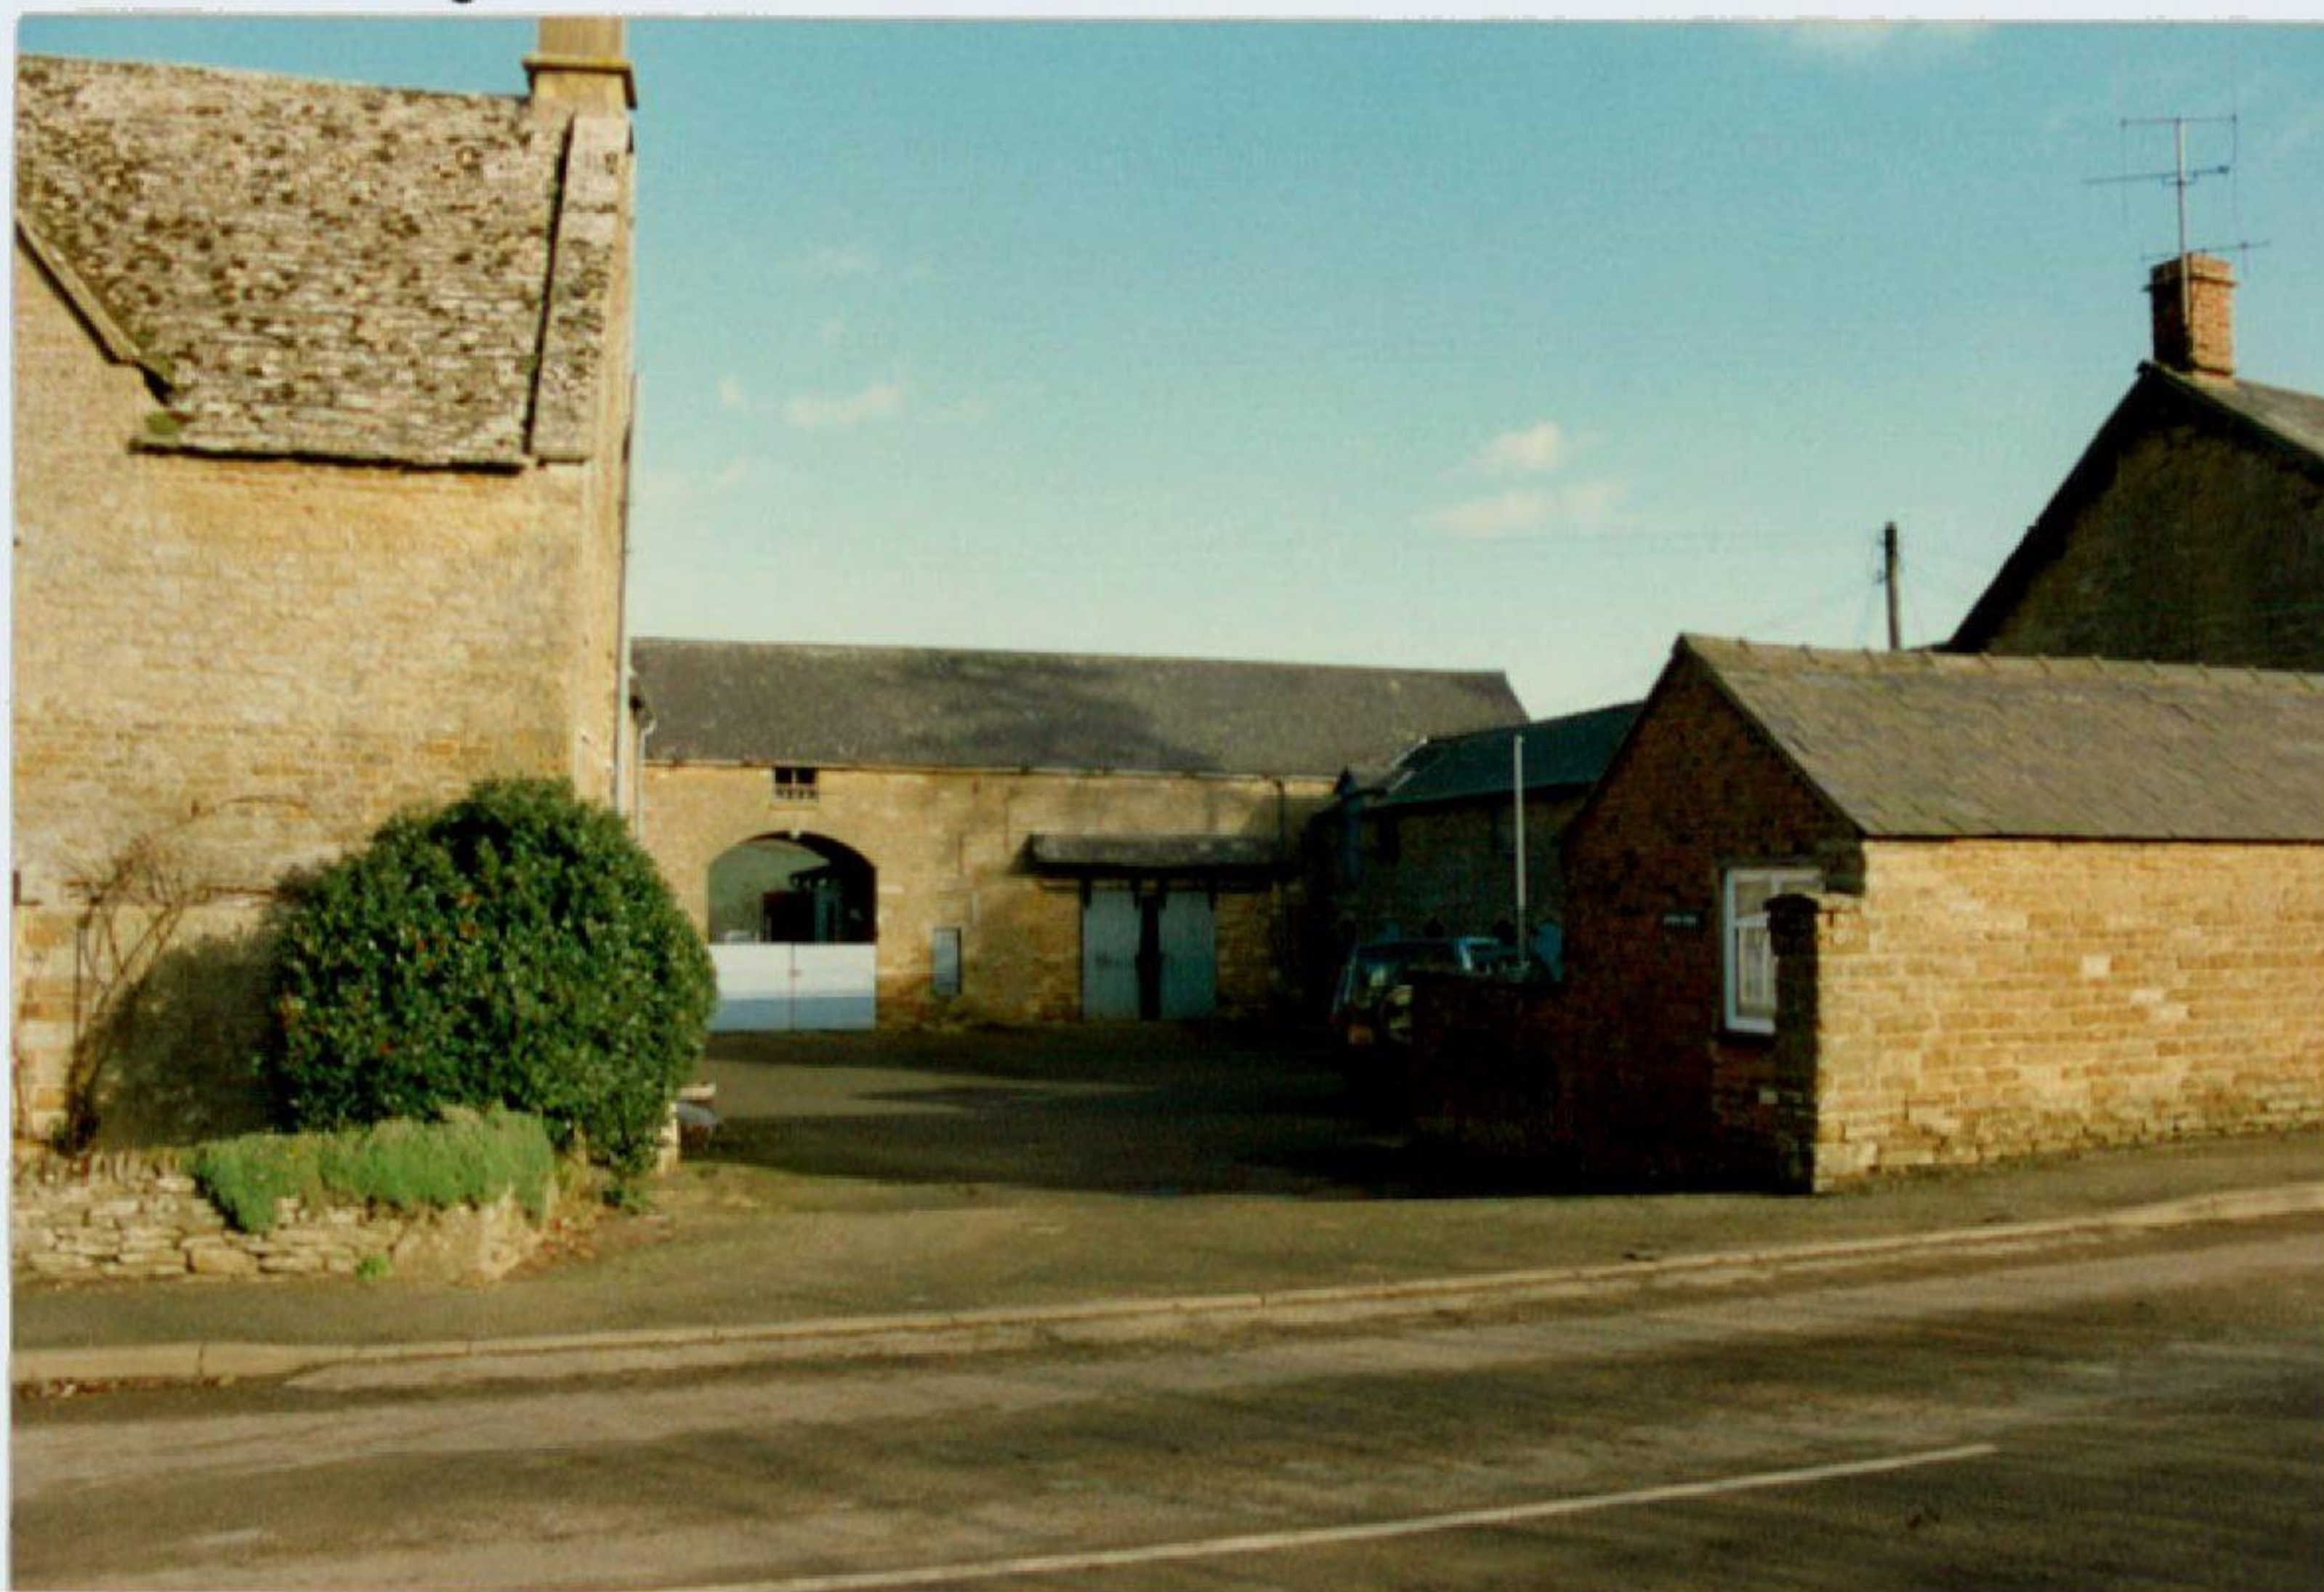
**9/147. Outbuilding range approx. 20m NE of Leasow Farmhouse
(Listed Building Ref 9/147 - Grade II)**

(Key farmstead group on east side of village)

List description : Outbuilding range, including barns, stables, loose boxes and cartshed. Mid C19. Squared coursed limestone with ashlar dressings. Slate roofs with brick end stack. Large segmental-headed archway to centre with a barn to either side, each with double plank doors in segmental-headed openings with pentices. Stable to left has plank door in segmental head. Extending forward from left a coach-house, wood shed and lavatory range with plank doors. Extending forward from right a cow byre and cartshed range with plank doors and 2 segmental-headed arches to right. Granary above. Interior: rubbed brick lined, with some stone-flagged floors. Some original fittings including wooden mangers, coachman's fireplace and wooden 2-seater lavatory. Included for group value.

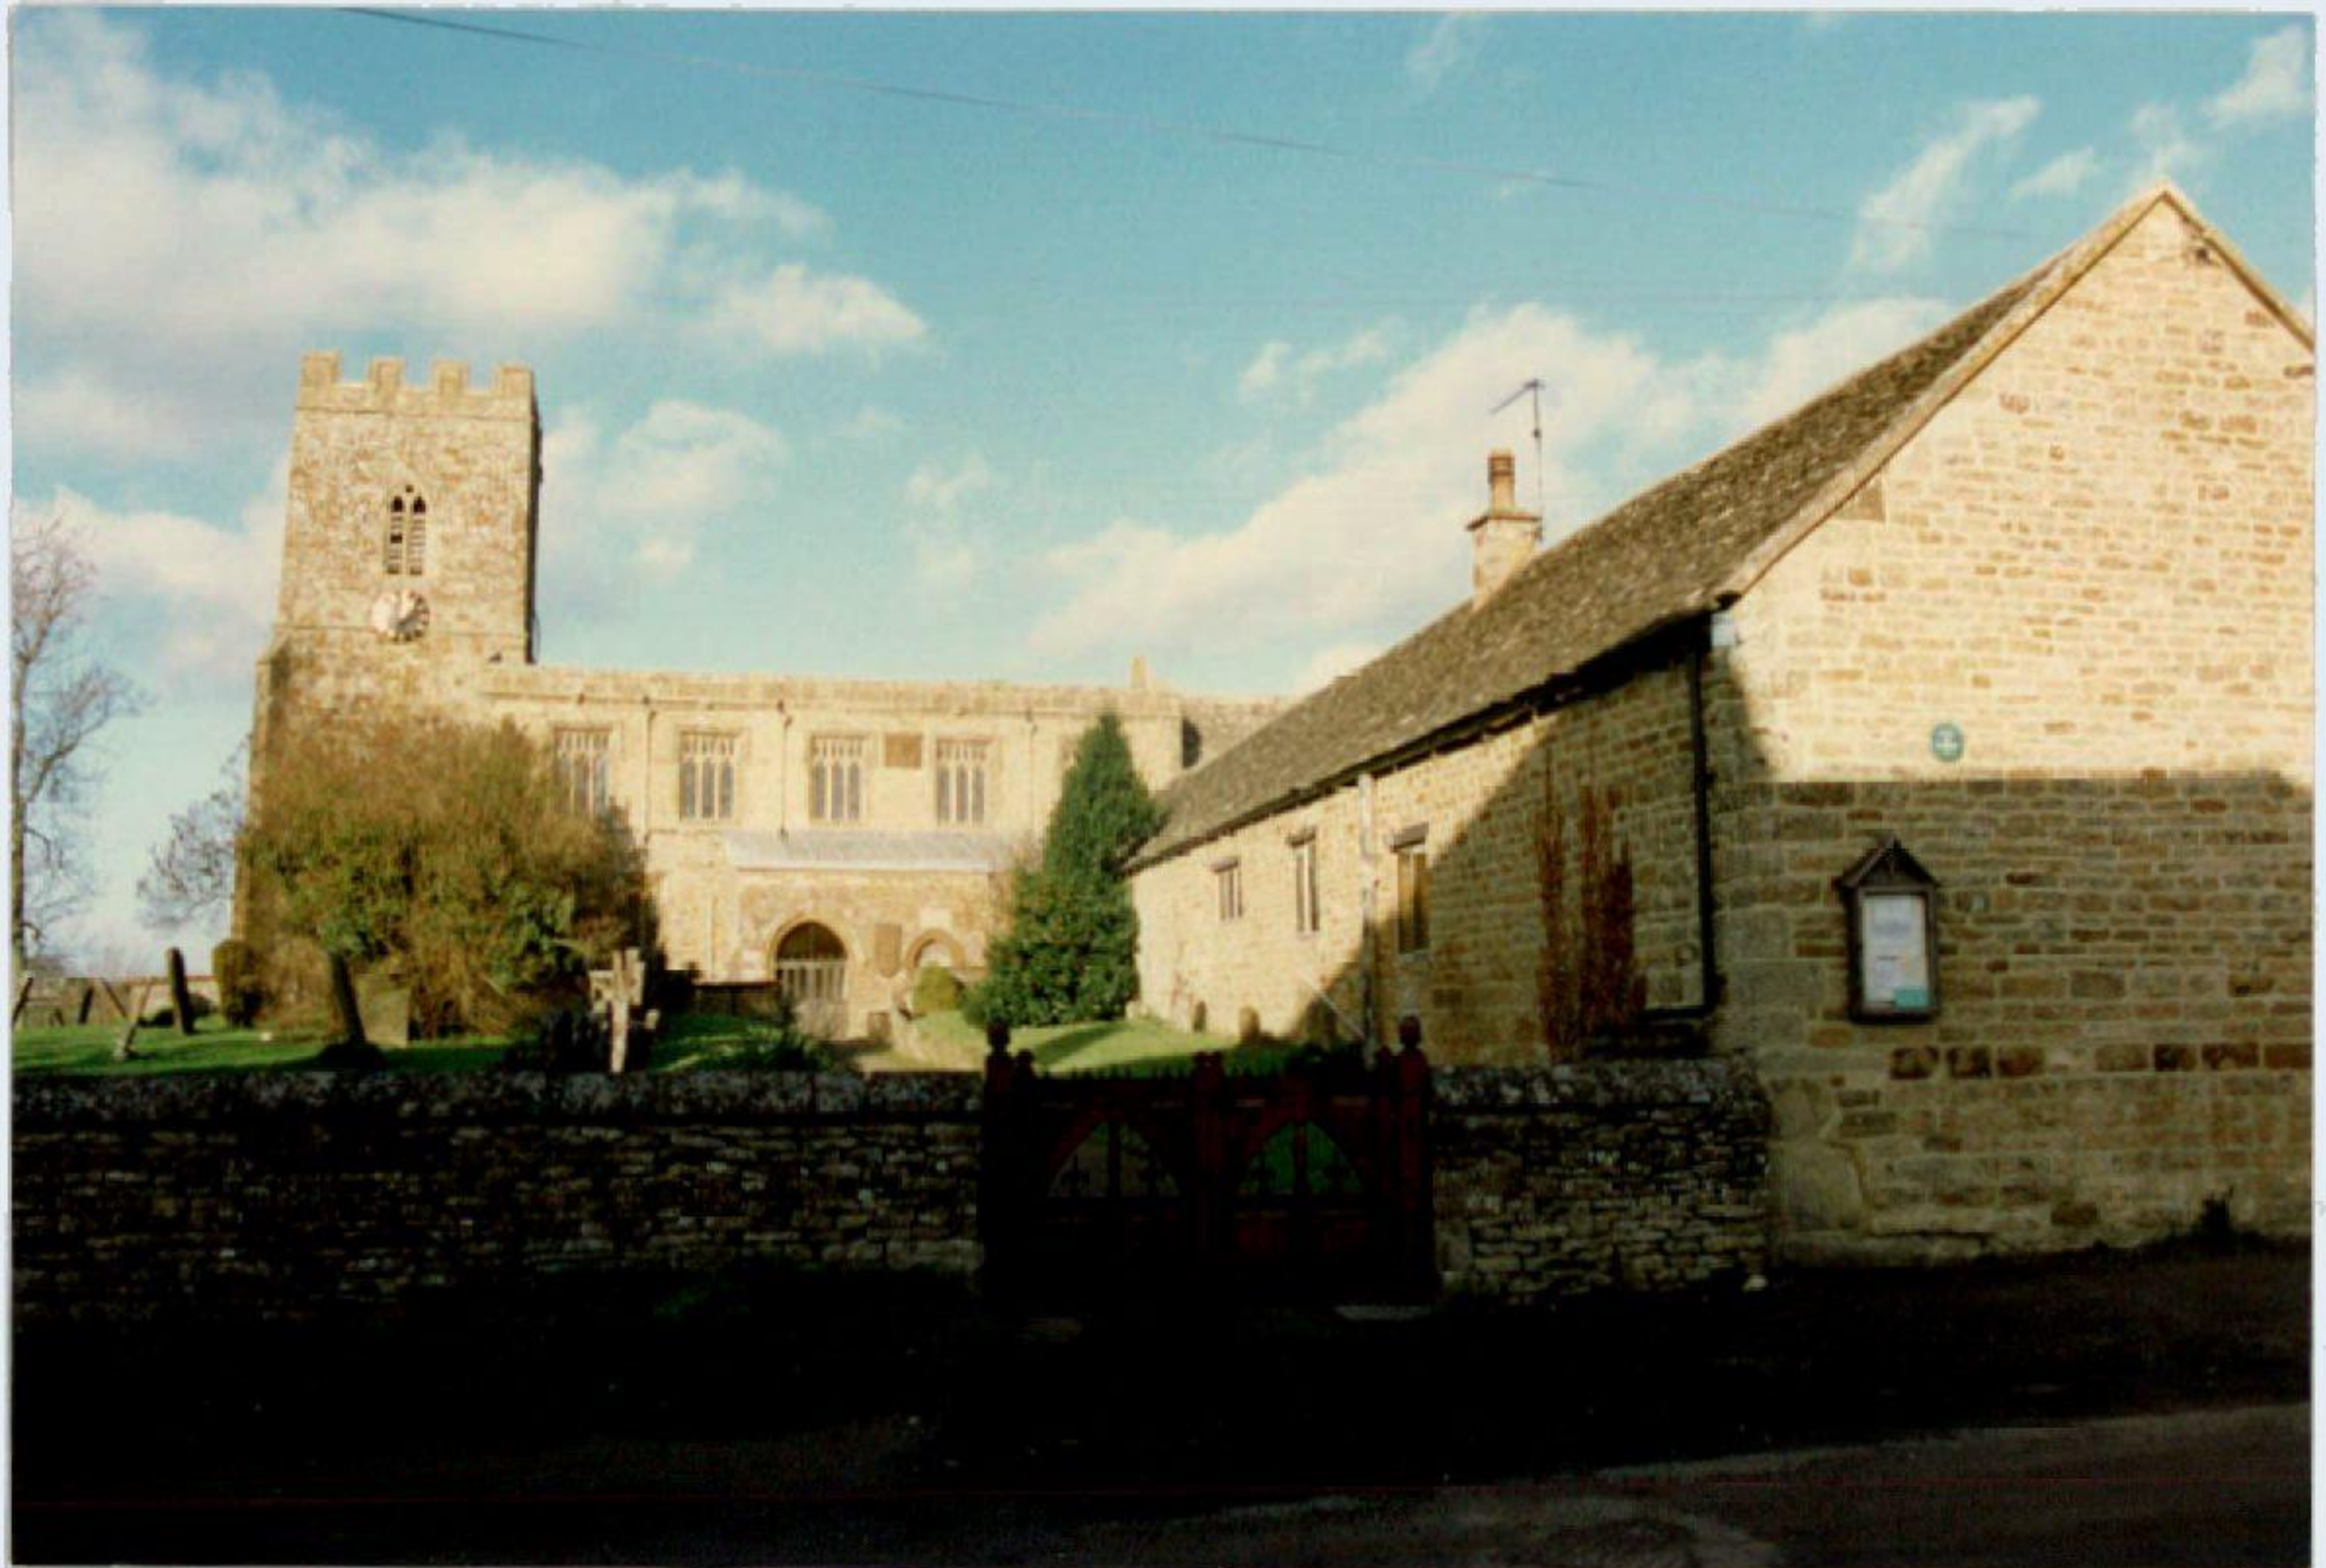
9/161. Church of St. Michael, Church End
(Listed Building Ref 9/161 - Grade II)

(Prominent feature in the landscape - especially from Stourton Road)

List description : Church. C12 origins, with C13, C14 and C15 alterations and additions. C19 restorations. Coursed and squared coursed limestone rubble with ashlar dressings and parapets. Stone-slate chancel and aisle roofs. Lead nave roof. Chancel, nave with north aisle, and north-west tower. C12 chancel enlarged C13 and part rebuilt C14. 2 bays, with quoins and coped parapet to east with cross at apex. C14 east 6-window of 3 ogee-headed cusped lights with reticulated tracery, and to north and south, two similar C14 windows, each of 2 lights. Hood moulds with labels. Between south windows a C13 priest's doorway with edge-roll surround. Hood mould with worn labels. Plank door. To west of south wall a small C13 lancet with chamfered surround and hood mould with labels. C12 nave with C13 north aisle and C14 south chapel and porch. C15 clerestory. 3 bays with chamfered plinth to chapel, quoins, moulded eaves cornice (the south side has a carved-head corbel table) and coped parapet to west, south and east. North aisle has coped gable to east with moulded kneelers. C13 east window to north aisle of 3 trefoiled and staggered lights within an unpierced segmental-pointed arch. Chamfered surround with damaged hood mould and label. Three C13 north aisle windows, that towards east similar to east window with either side of head of taller middle light, a small quatrefoil piercing with some carving in small spandrels below. The central and westernmost windows are of 2 trefoiled lights with quatrefoil piercing within a pointed head.

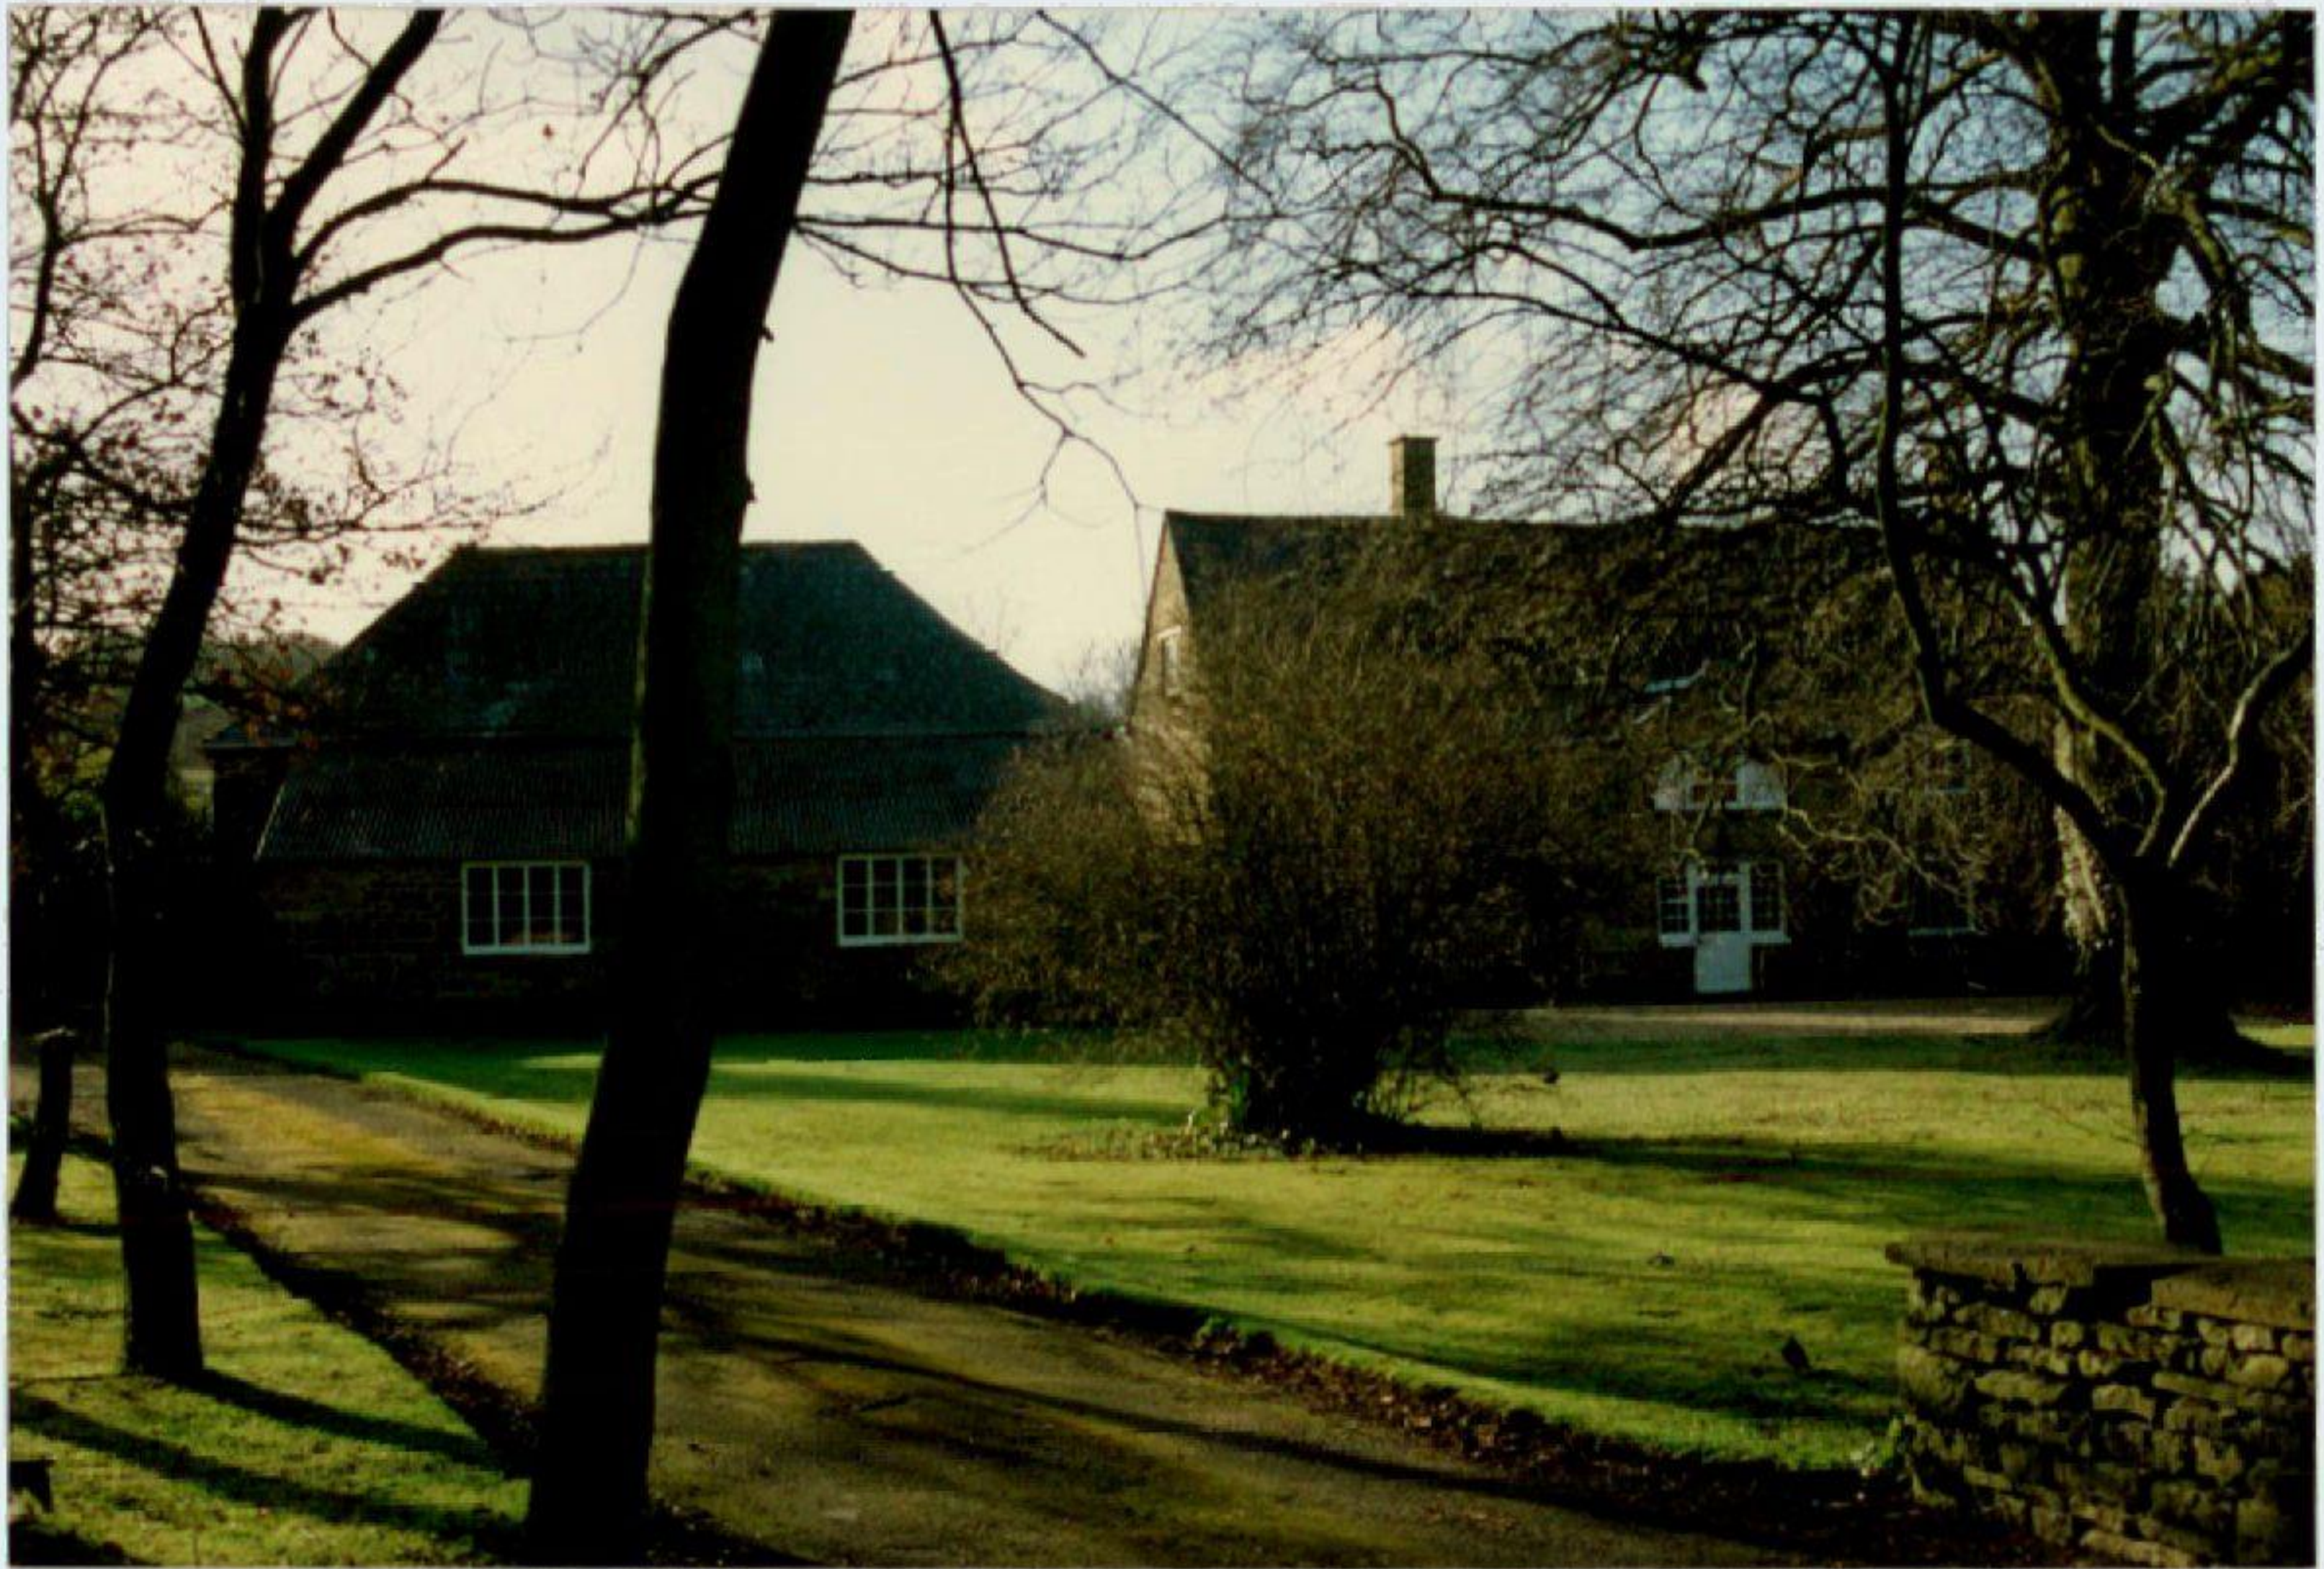
**9/169. The Manor and attached outbuilding conversion
Church End
(Listed Building Ref 9/169 - Grade II)**

(Key building group on north-west corner of village green)

List description : House. Early C18. Squared coursed limestone, rendered to front. Slate roof with coped gable to right and ashlar end stack. C20 ridge stack. L-plan. 2-storey, 4-window range of C19 one and three-light casements. To centre a part C18 two-storey stone porch, part rebuilt C20. C18 panelled, part-glazed door with paned flanking lights. Further C19 and C20 casements to rear. C18 stone range to rear of one storey and attic with brick ridge stack. C20 door and casements, with one C18 window with quoined surround and lintel with keyblock.

Interior: noted as having spine beams. Attached to left by a wall and gate a C18 stone outbuilding with hipped slate roof, converted into a room. C19 casements to front, within later lean-to. C20 French doors in large opening to rear, with original lintel. C18 plank door with original hinges and wood lintel to right. Noted as having spine beams and chamfered joists.
