STRATFORD ON AVON DISTRICT COUNCIL

CONSERVATION AREA REVIEWS

WHICHFORD

February 1994

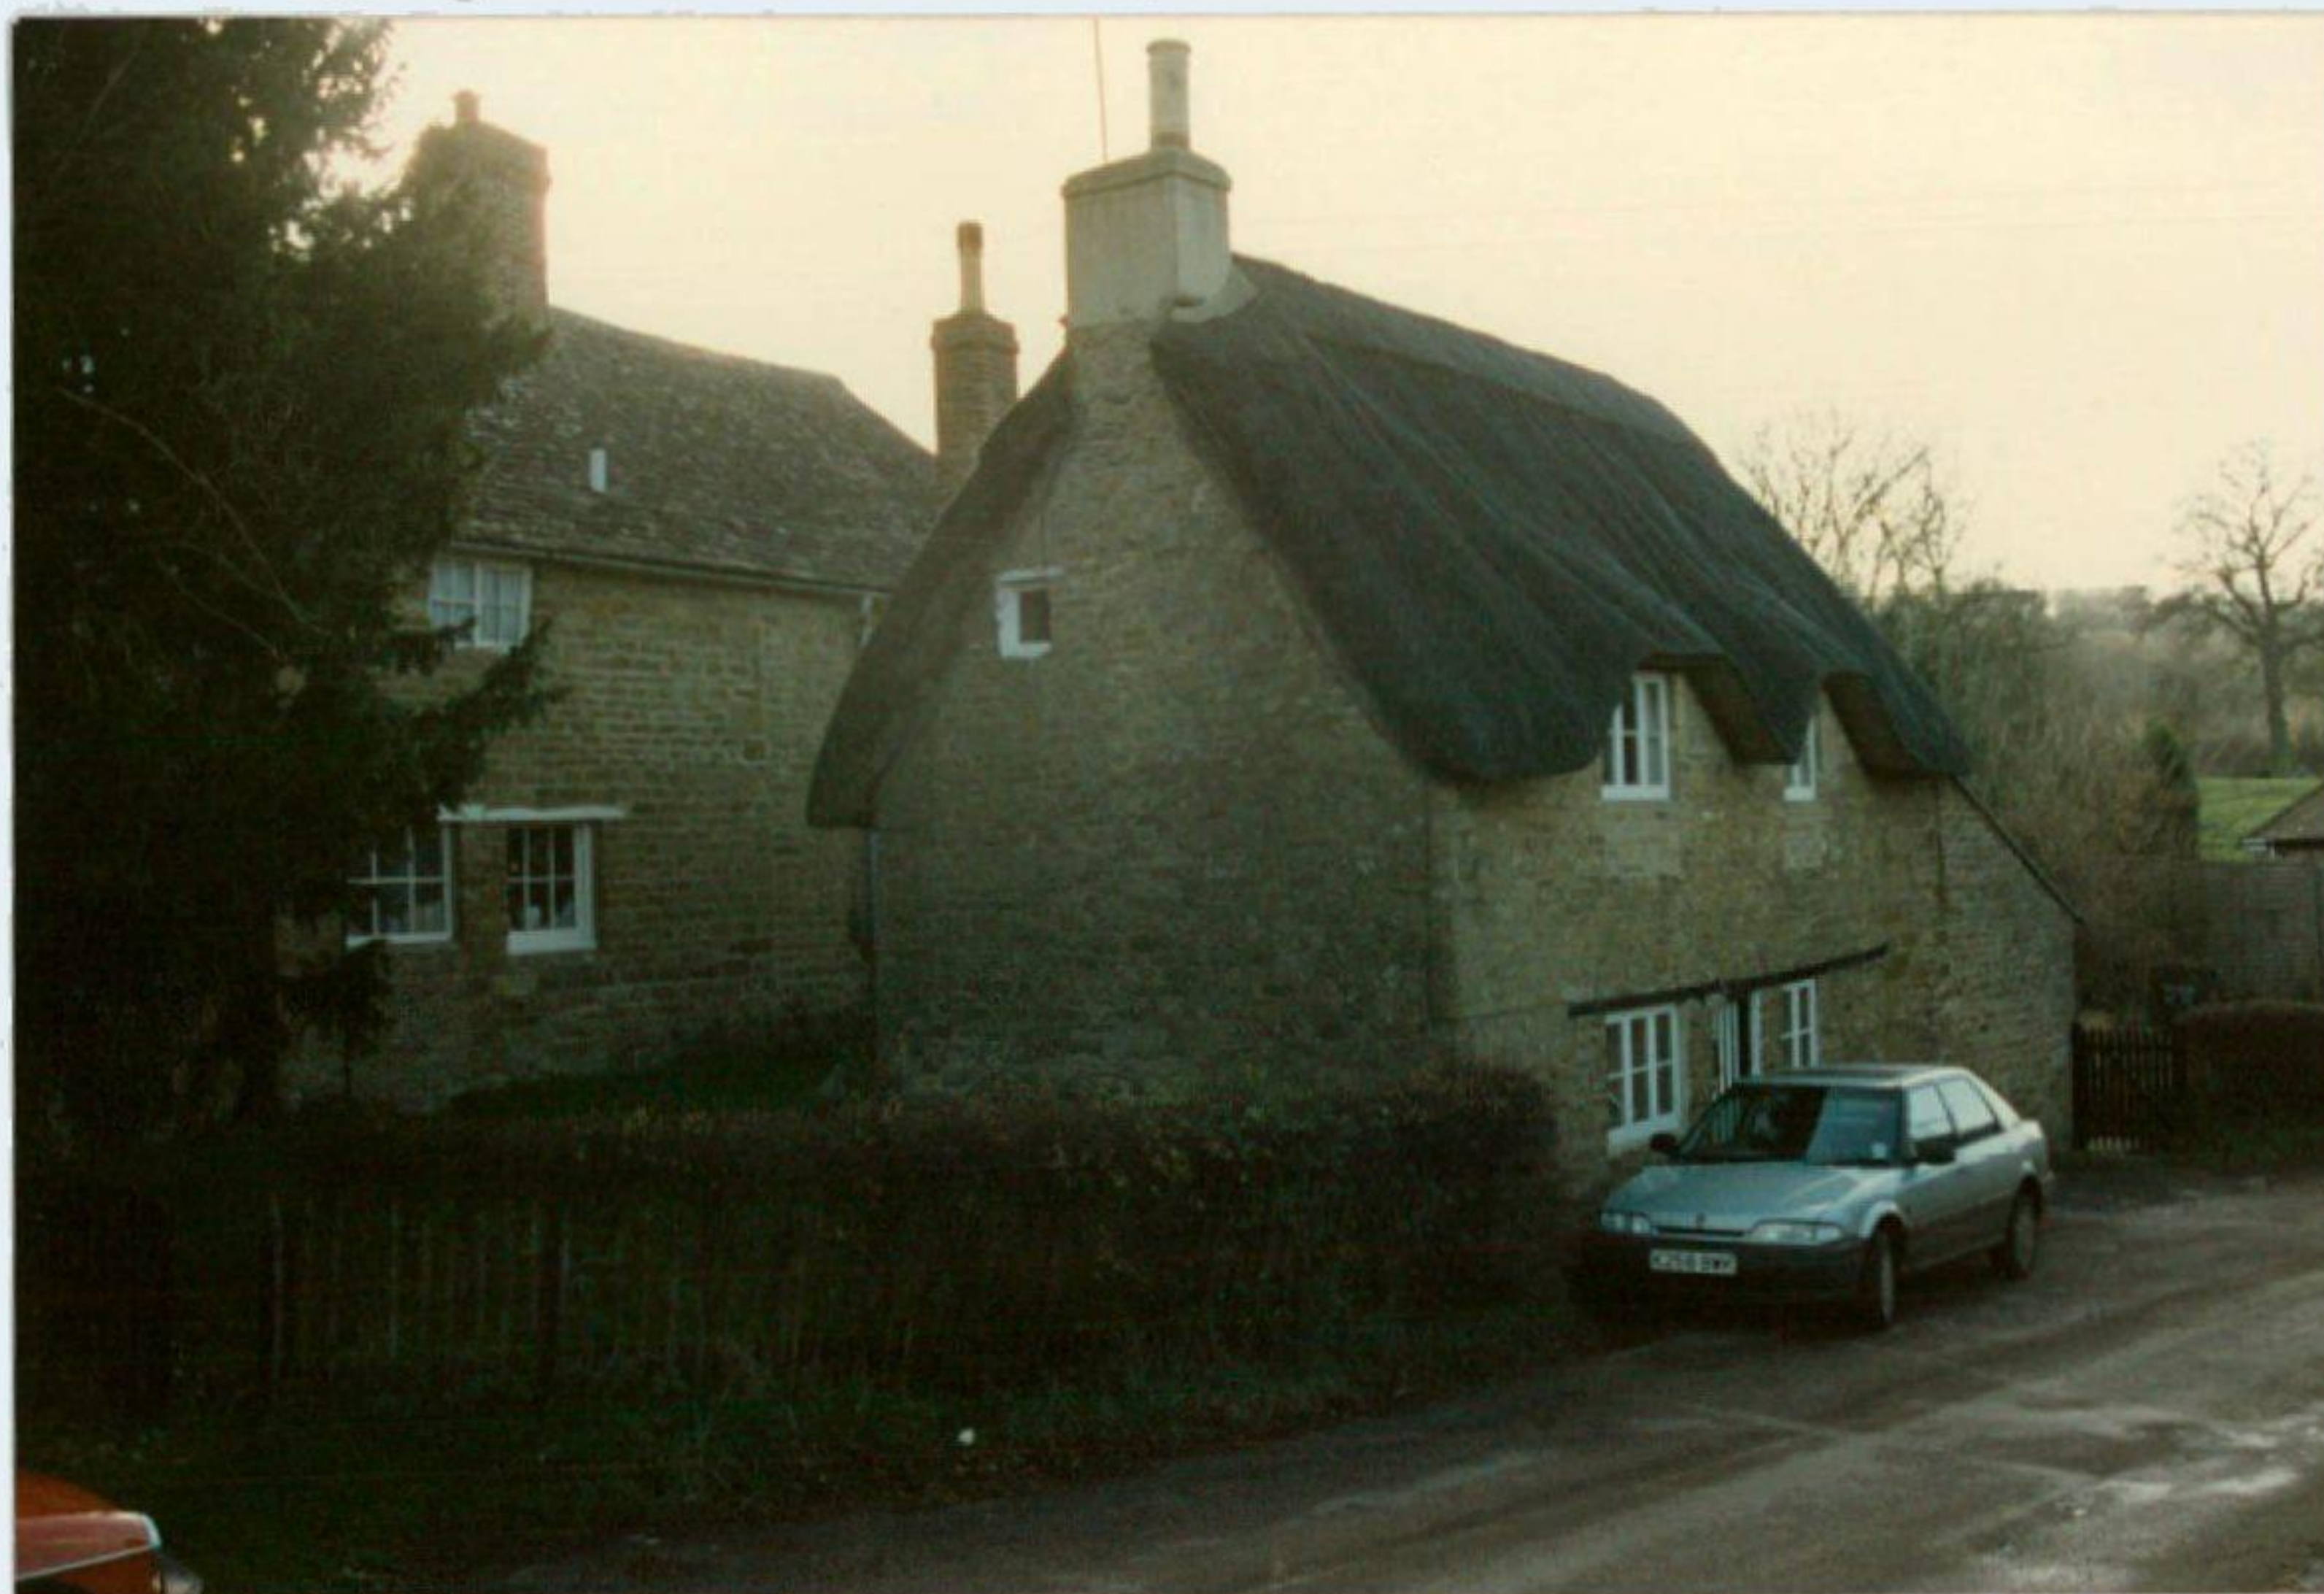
9/170. Thatched Cottage, Church End
(Listed Building Ref 9/170 - Grade II)

(Small thatched cottage on road-side - group value with Old Manor House)

List description : Cottage. Early C18. Coursed limestone rubble with quoins and thatch roof with rendered end stacks. 2-unit plan. 2-storey, 2-window range of C18 and C19 two- and three-light casements, those to first floor with original leaded lights. C19 central plank door with wood lintel continuing over ground floor casements. C19 stone lean-to to right. Interior not inspected but likely to be of interest.

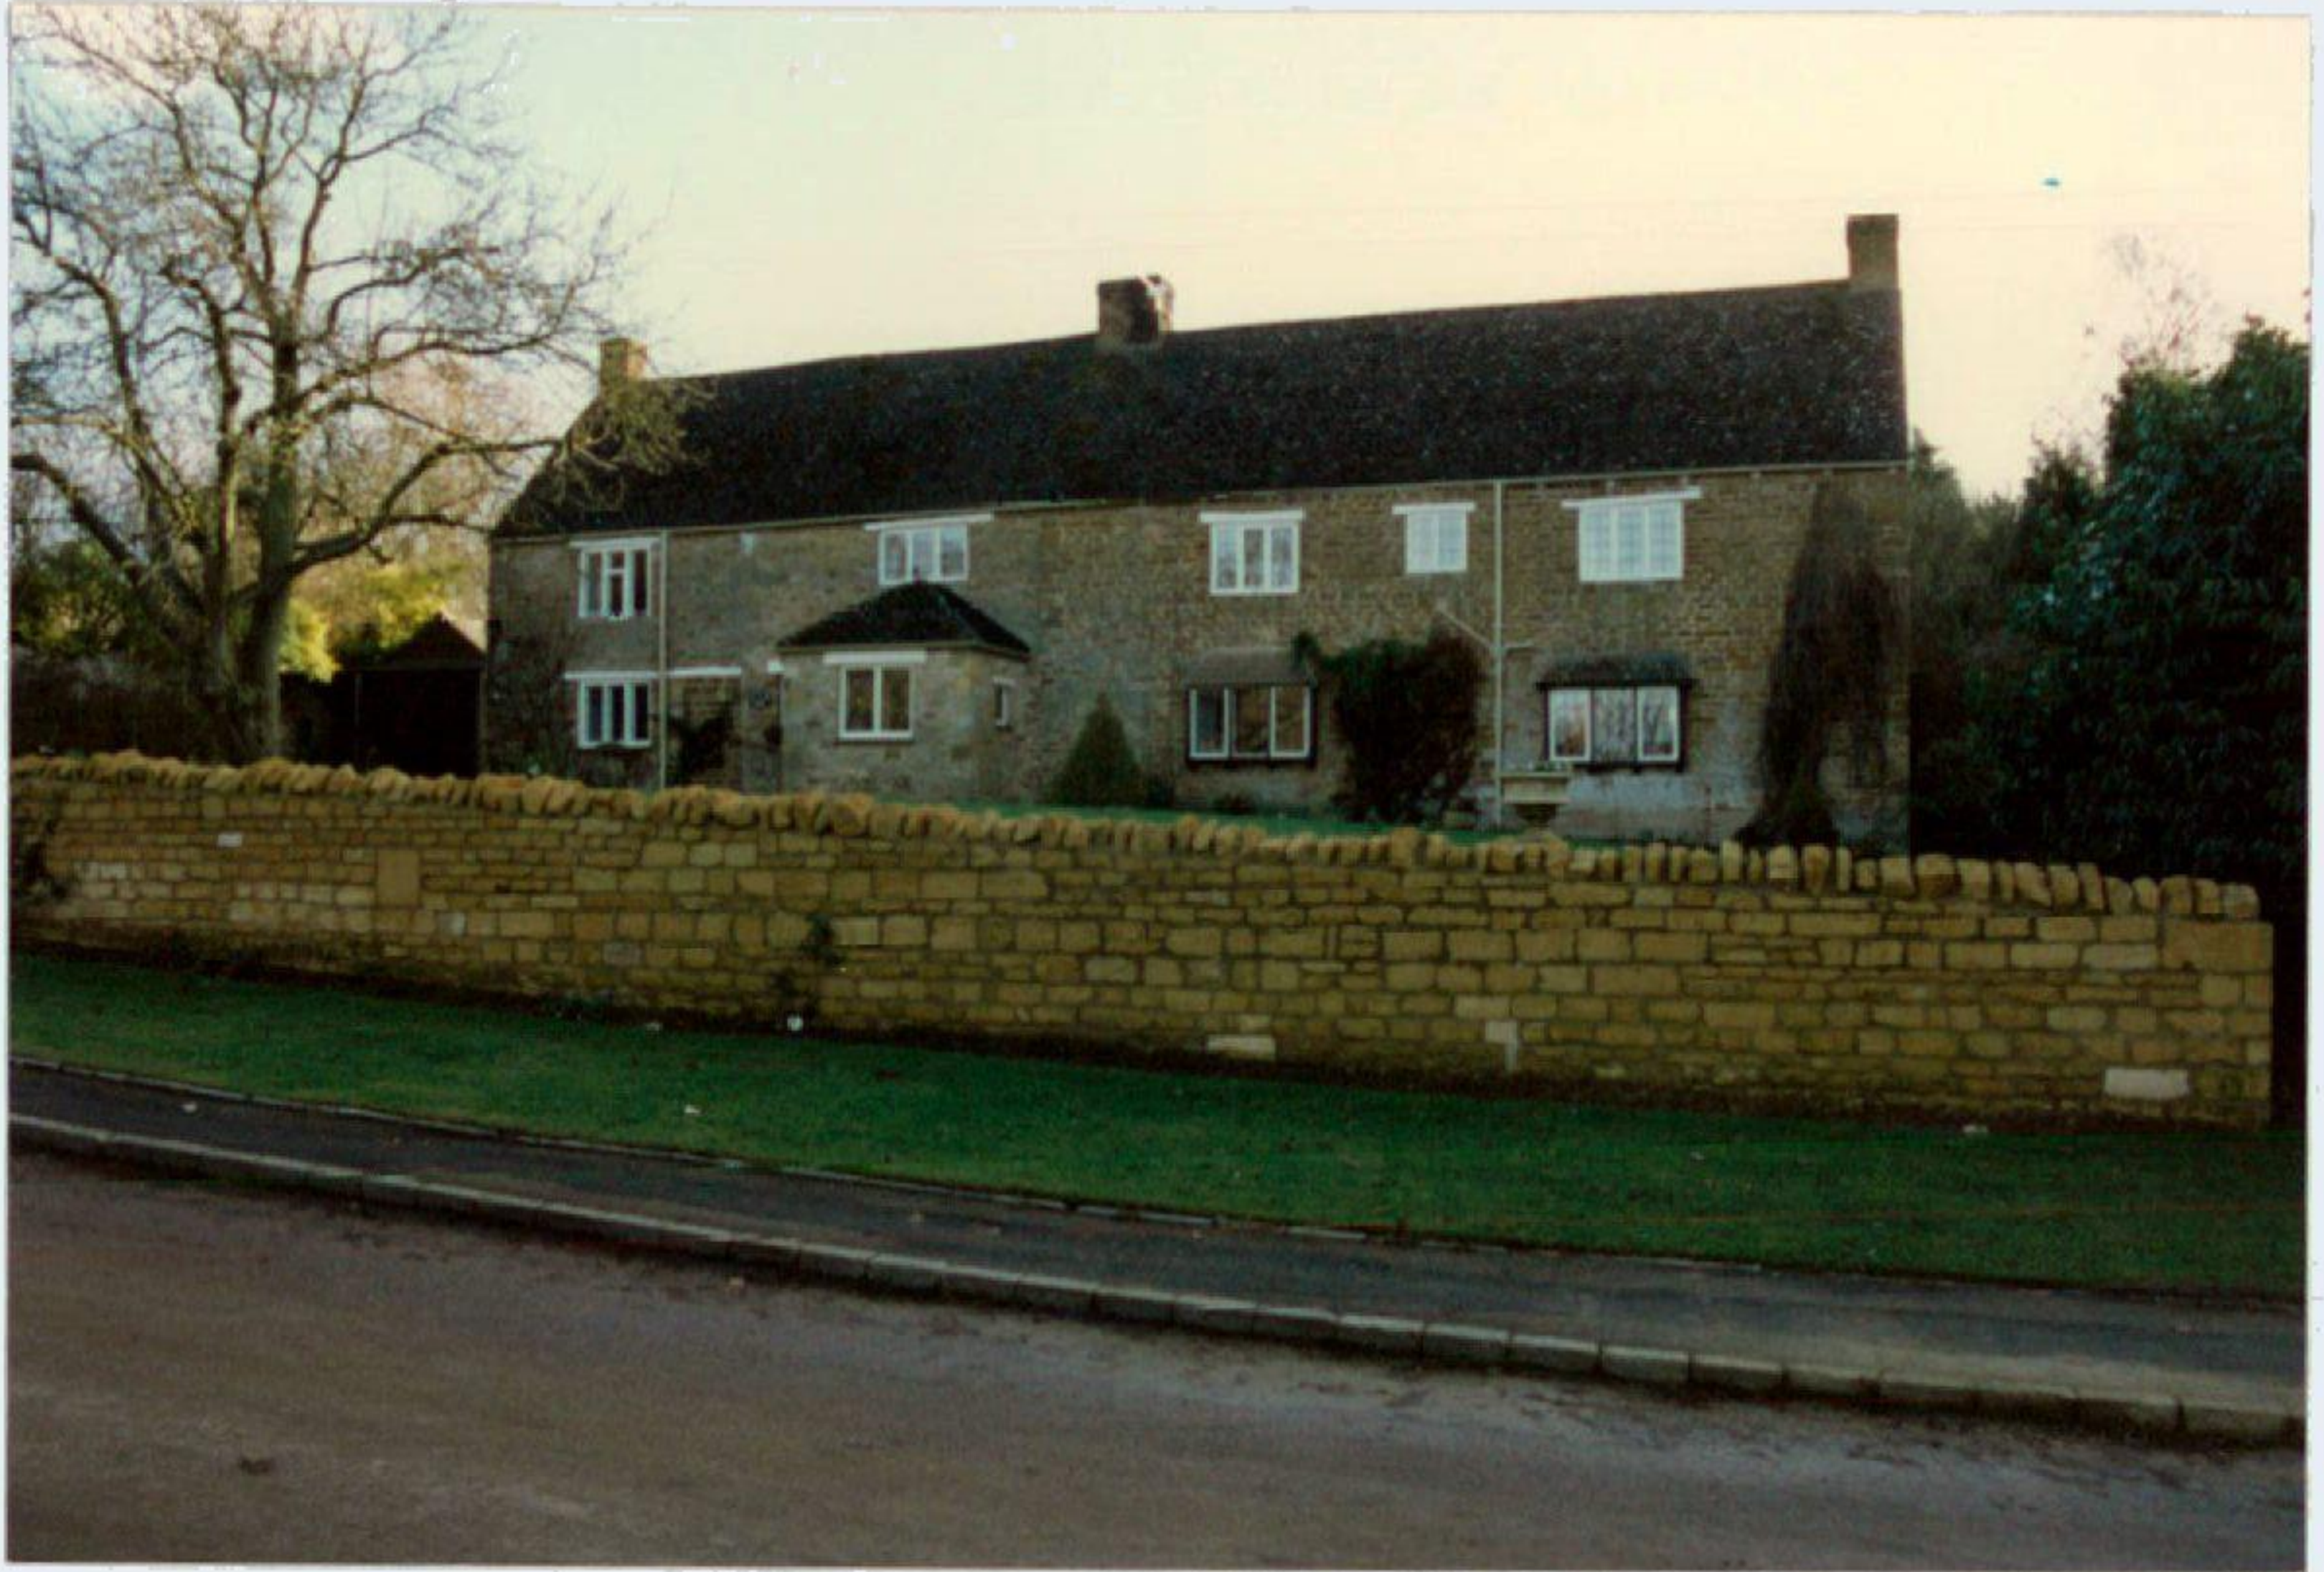
**9/171. Church End House, Church End
(Listed Building Ref 9/171 - Grade II)**

List description : House. C17 and mid C18 to left. Coursed limestone rubble with quoins, and C20-tile roof with C20 brick ridge and end stacks. 4-unit plan. 2-storey, 4-window range of C20 two and three-light casements with old wood lintels. Further C20 casement to left of C20 stone porch. Original blocked doorway to centre left.

Interior: chamfered spine beams with ogee stops to both floors of C17 range. Chamfered spine beams with plain stops on C18 range. Some partition framing visible in first floor.

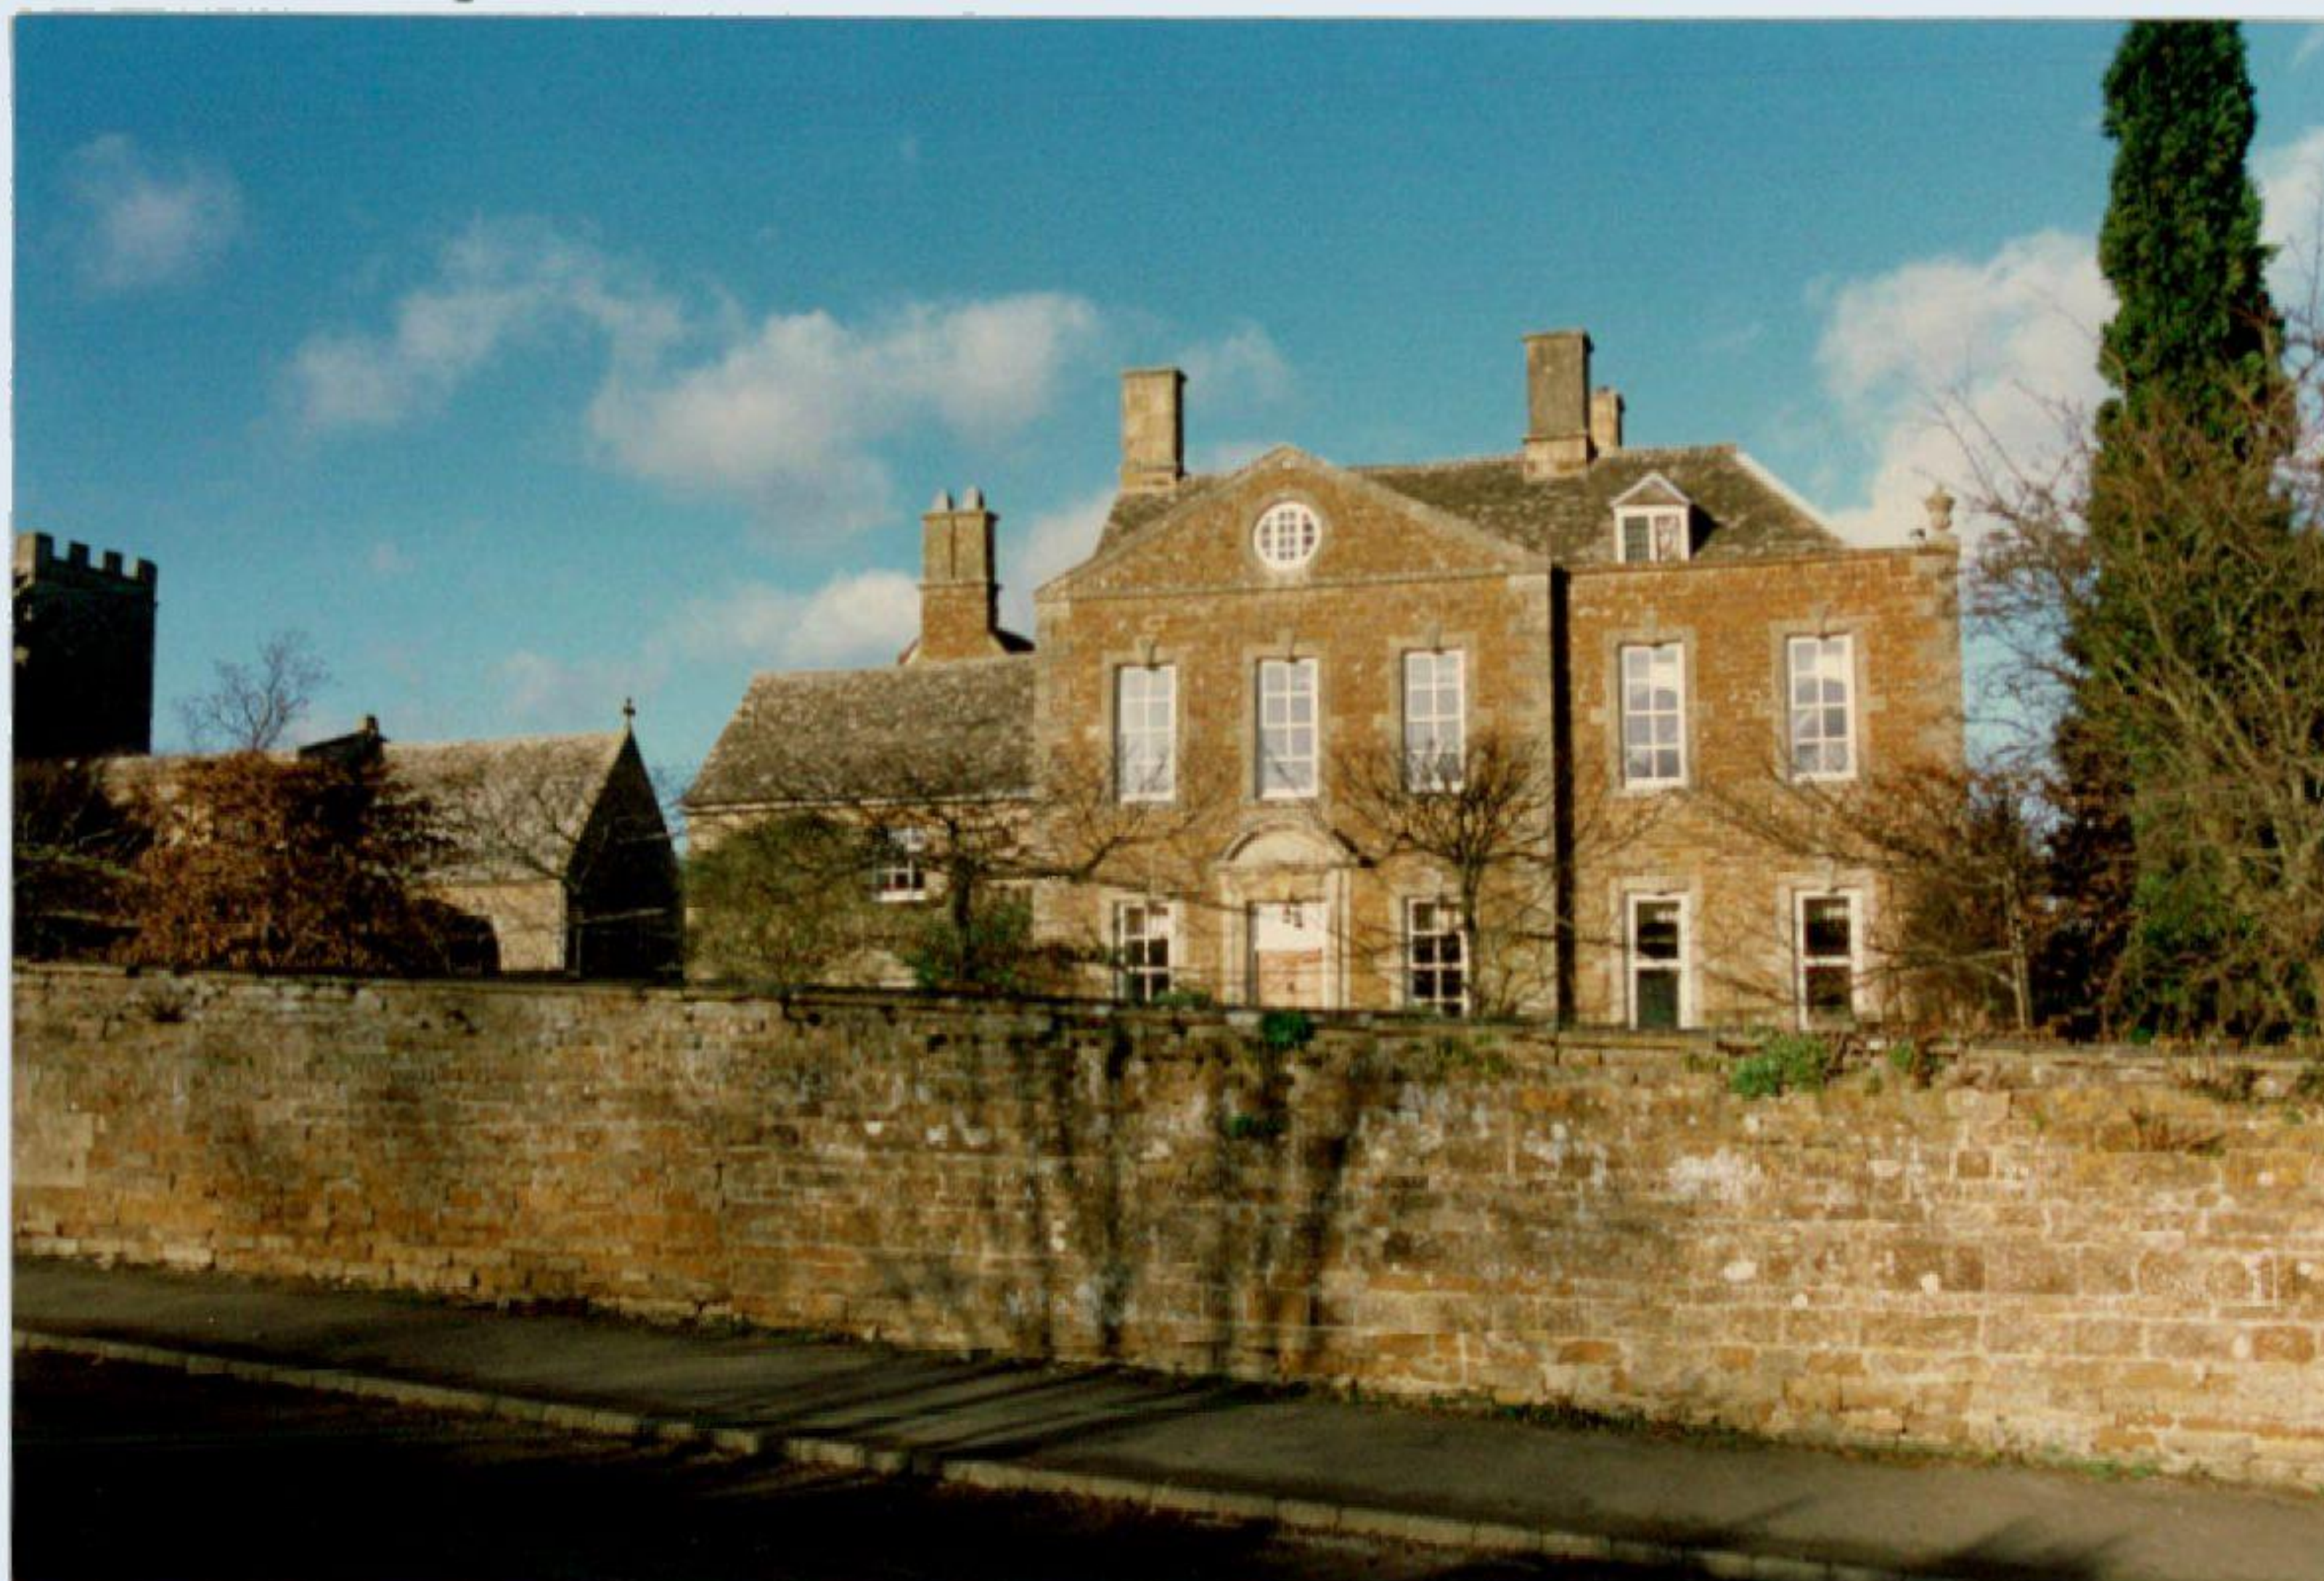
- 9/158. Whichford House and attached balustrades,
Church End [Formerly listed as Rectory]
(Listed Building Ref 9/158 - Grade II*)

(Fine house of classical proportions. Key building in Church End - group value with church)

List description : House, formerly rectory. Late C16/17, with early C18 additions. Squared coursed limestone with ashlar dressings, and coursed limestone rubble to rear. Stone-slate roofs with stone ridge and end stacks. Coped parapet with urns to corners. Double-depth plan. 2 storeys plus attic; 6-window range, with slightly projecting 3-window central section. 6-panelled door with moulded stone surround and keystone. Segmental moulded pediment. Windows of central projecting section, section to right and right facade have moulded stone surrounds and keyblocks. Some original 8-pane sashes, with some C20 hinged casements. Pediment above central projecting section has moulded surround, with circular window to centre. C18 gabled range to left of central projecting section has part-glazed panelled door. 9-pane sash to first floor. C17 gabled range to rear with one 3-light mullioned window with hood mould and labels. Leaded casements. Also to rear a 2-light mullioned and transomed window with hood mould and labels, and a 4-light wood-mullioned window with wood lintel. Further C18 panelled and glazed door.

Interior: 3-bay entrance hall with a mid C18 richly moulded 6-panel door, moulded architrave, acanthus frieze and broken pediment in each side wall; moulded dado rail. Arched doorway to stairwell at rear.

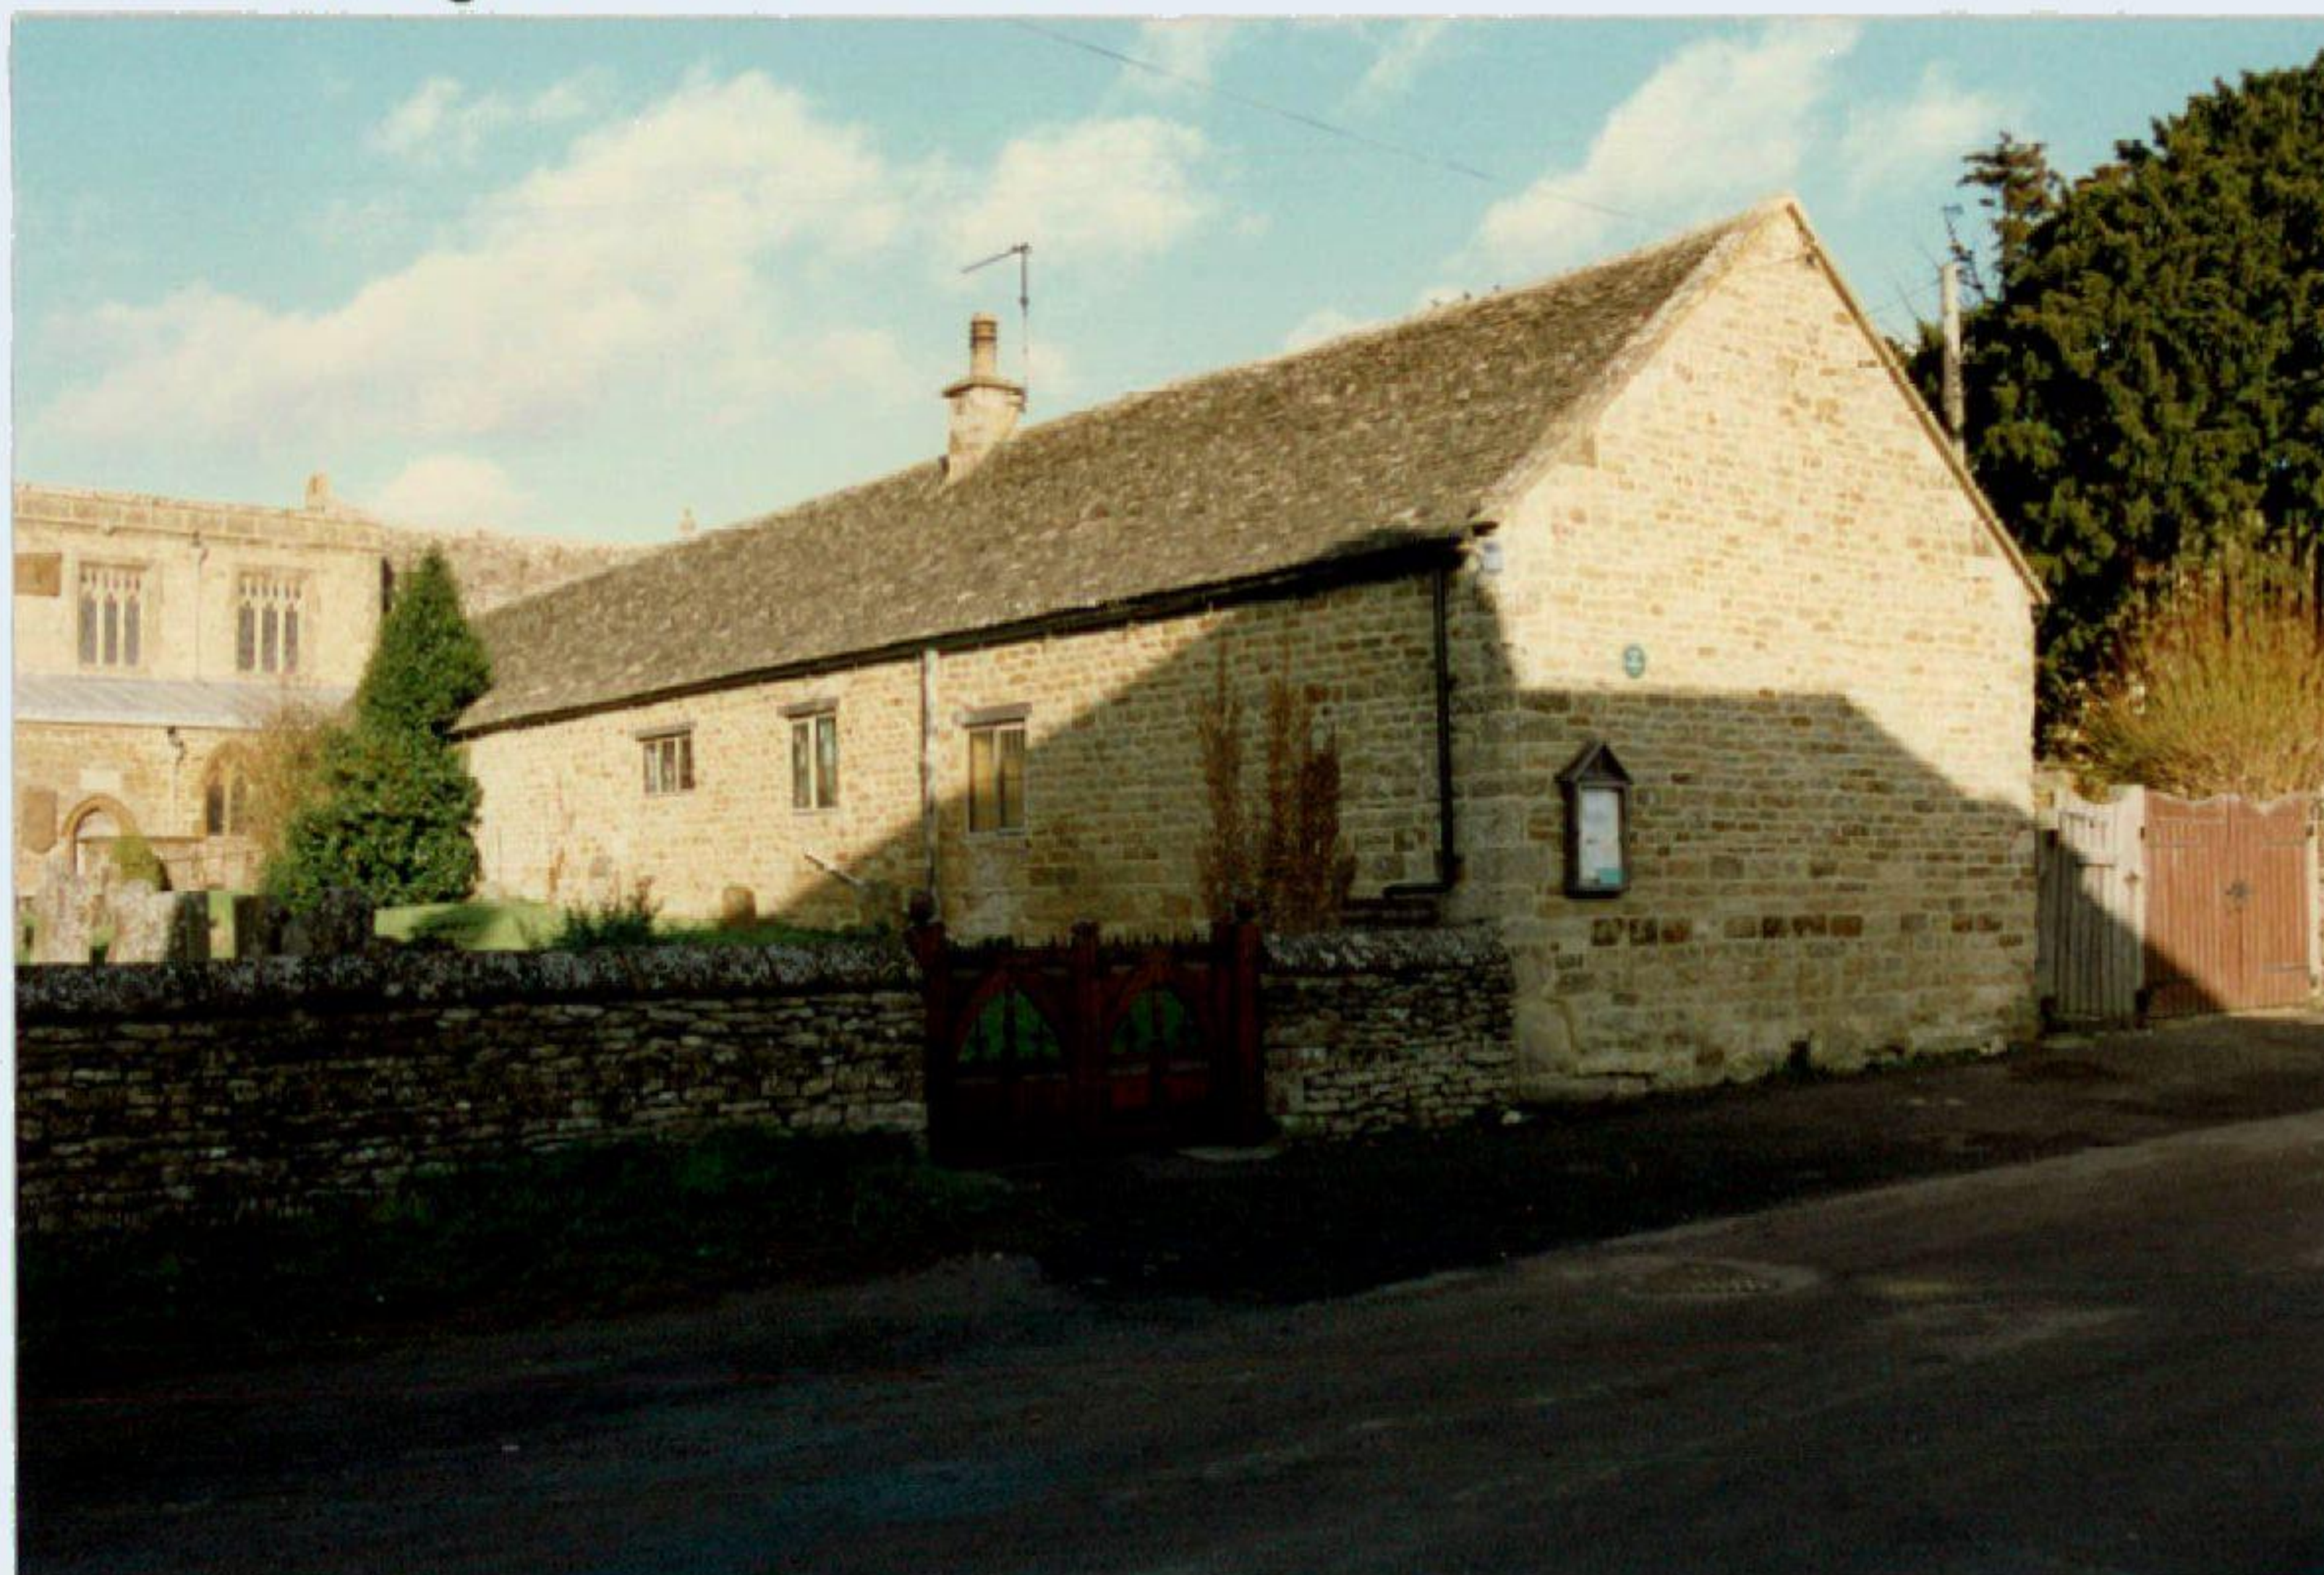
- 9/160. Little Whichford, Church End
[Formerly listed as outbuilding 50m. SW of Whichford House]
(Listed Building Ref 9/160 - Grade II)

(Gable end on road frontage - group value with church)

List description : House, formerly outbuilding range. C18 with C20 alterations. Squared coursed limestone with stone-slate roof with coped gable to left. C20 stone ridge stack. One-storey, 6-window range of C20 two-light casements. C20 linen-fold panel door to left, with C20 plank door to right. One C20 gabled dormer to centre. Further C20 door in right gable end, and C20 casements to rear. Interior not inspected.

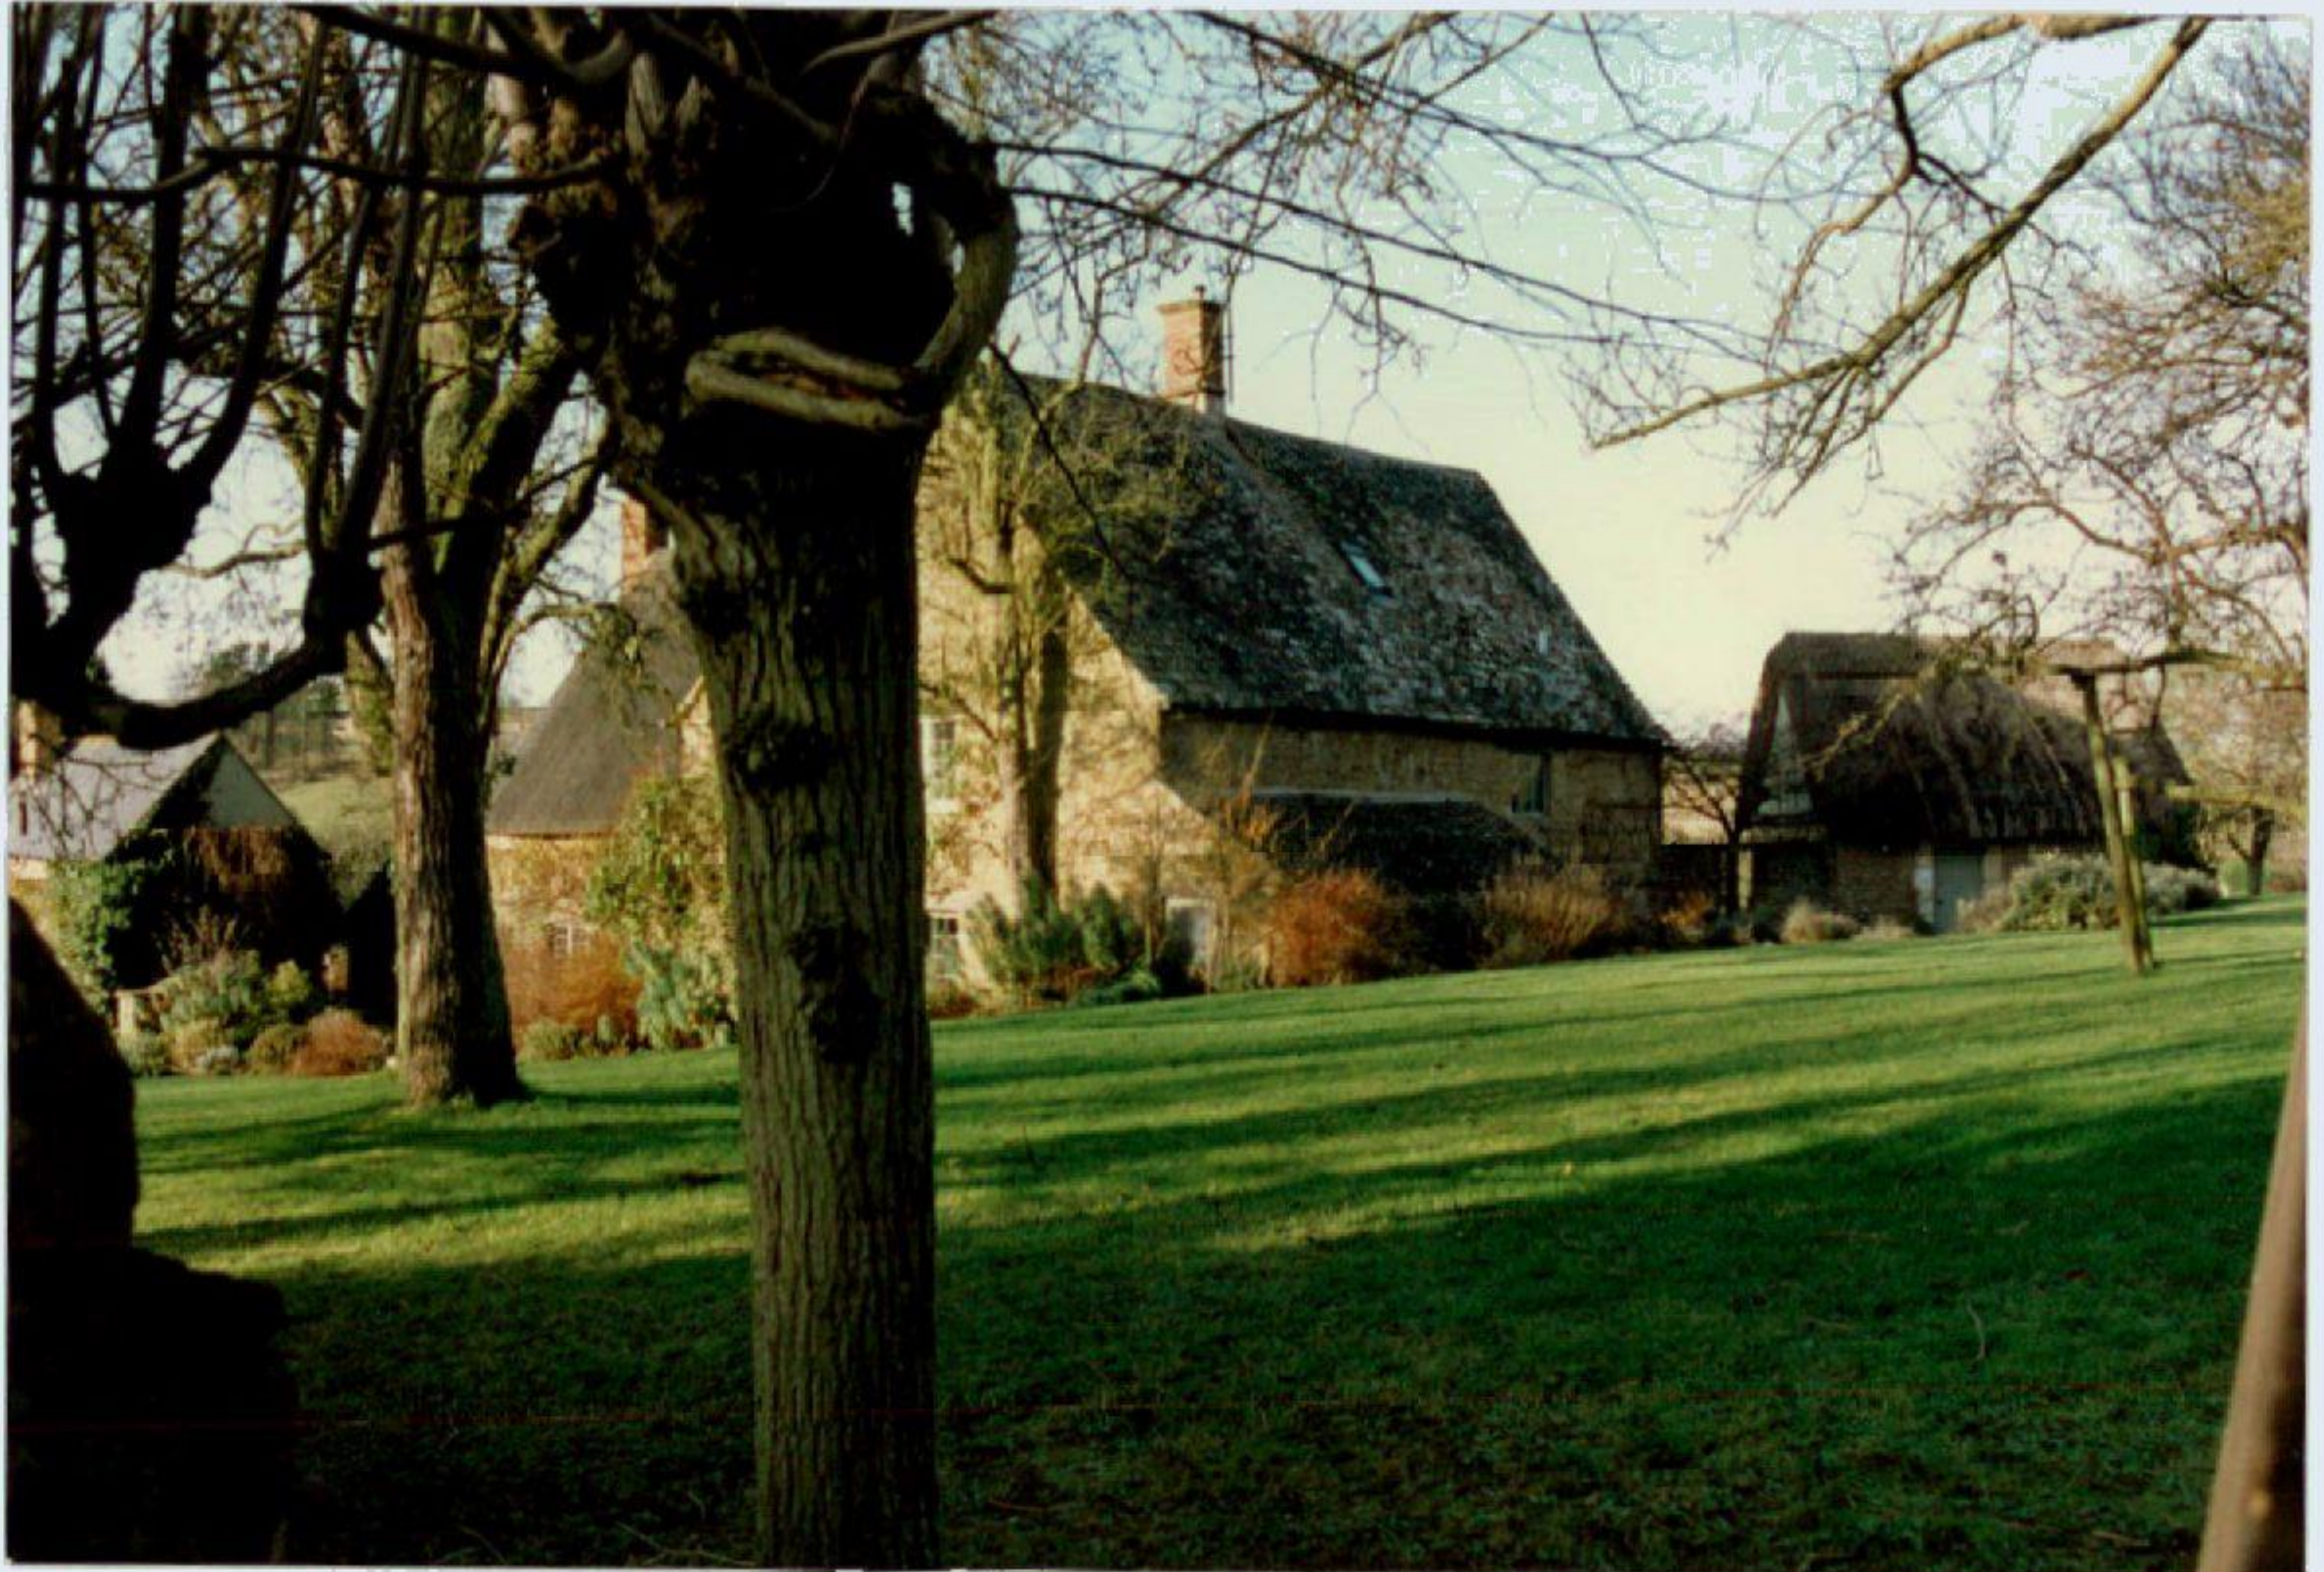
9/166. The Old House, Church End
(Listed Building Ref 9/166 - Grade II)

(Group value with church)

List description : House. Possible medieval origins. C17 with early C18 additions. Squared coursed limestone with quoins. Partly uncoursed rubble to rear. Thatched C17 range, with stone-slate roof to C18 range to right. Brick ridge and end stacks, that to C18 range with original stone base. T-shaped plan. One storey plus attic and 2 storeys; 4-window range of C18 and C19 three-light casements with wood lintels. C18 plank-and-rail door to centre of thatched range. Wood lintel. C20 French doors in left facade of C18 range. One-storey stone and thatch range to left. Further C18 and C19 three-light casements to rear with, to right, a C16 window with hollow-chamfered surround and moulded head, perhaps re-set. Above, in earliest fabric, a round medieval window with mouchette tracery in a square block of stone. Interior: said to have a pair of cruck blades.
