STRATFORD ON AVON DISTRICT COUNCIL

CONSERVATION AREA REVIEWS

WHICHFORD

February 1994

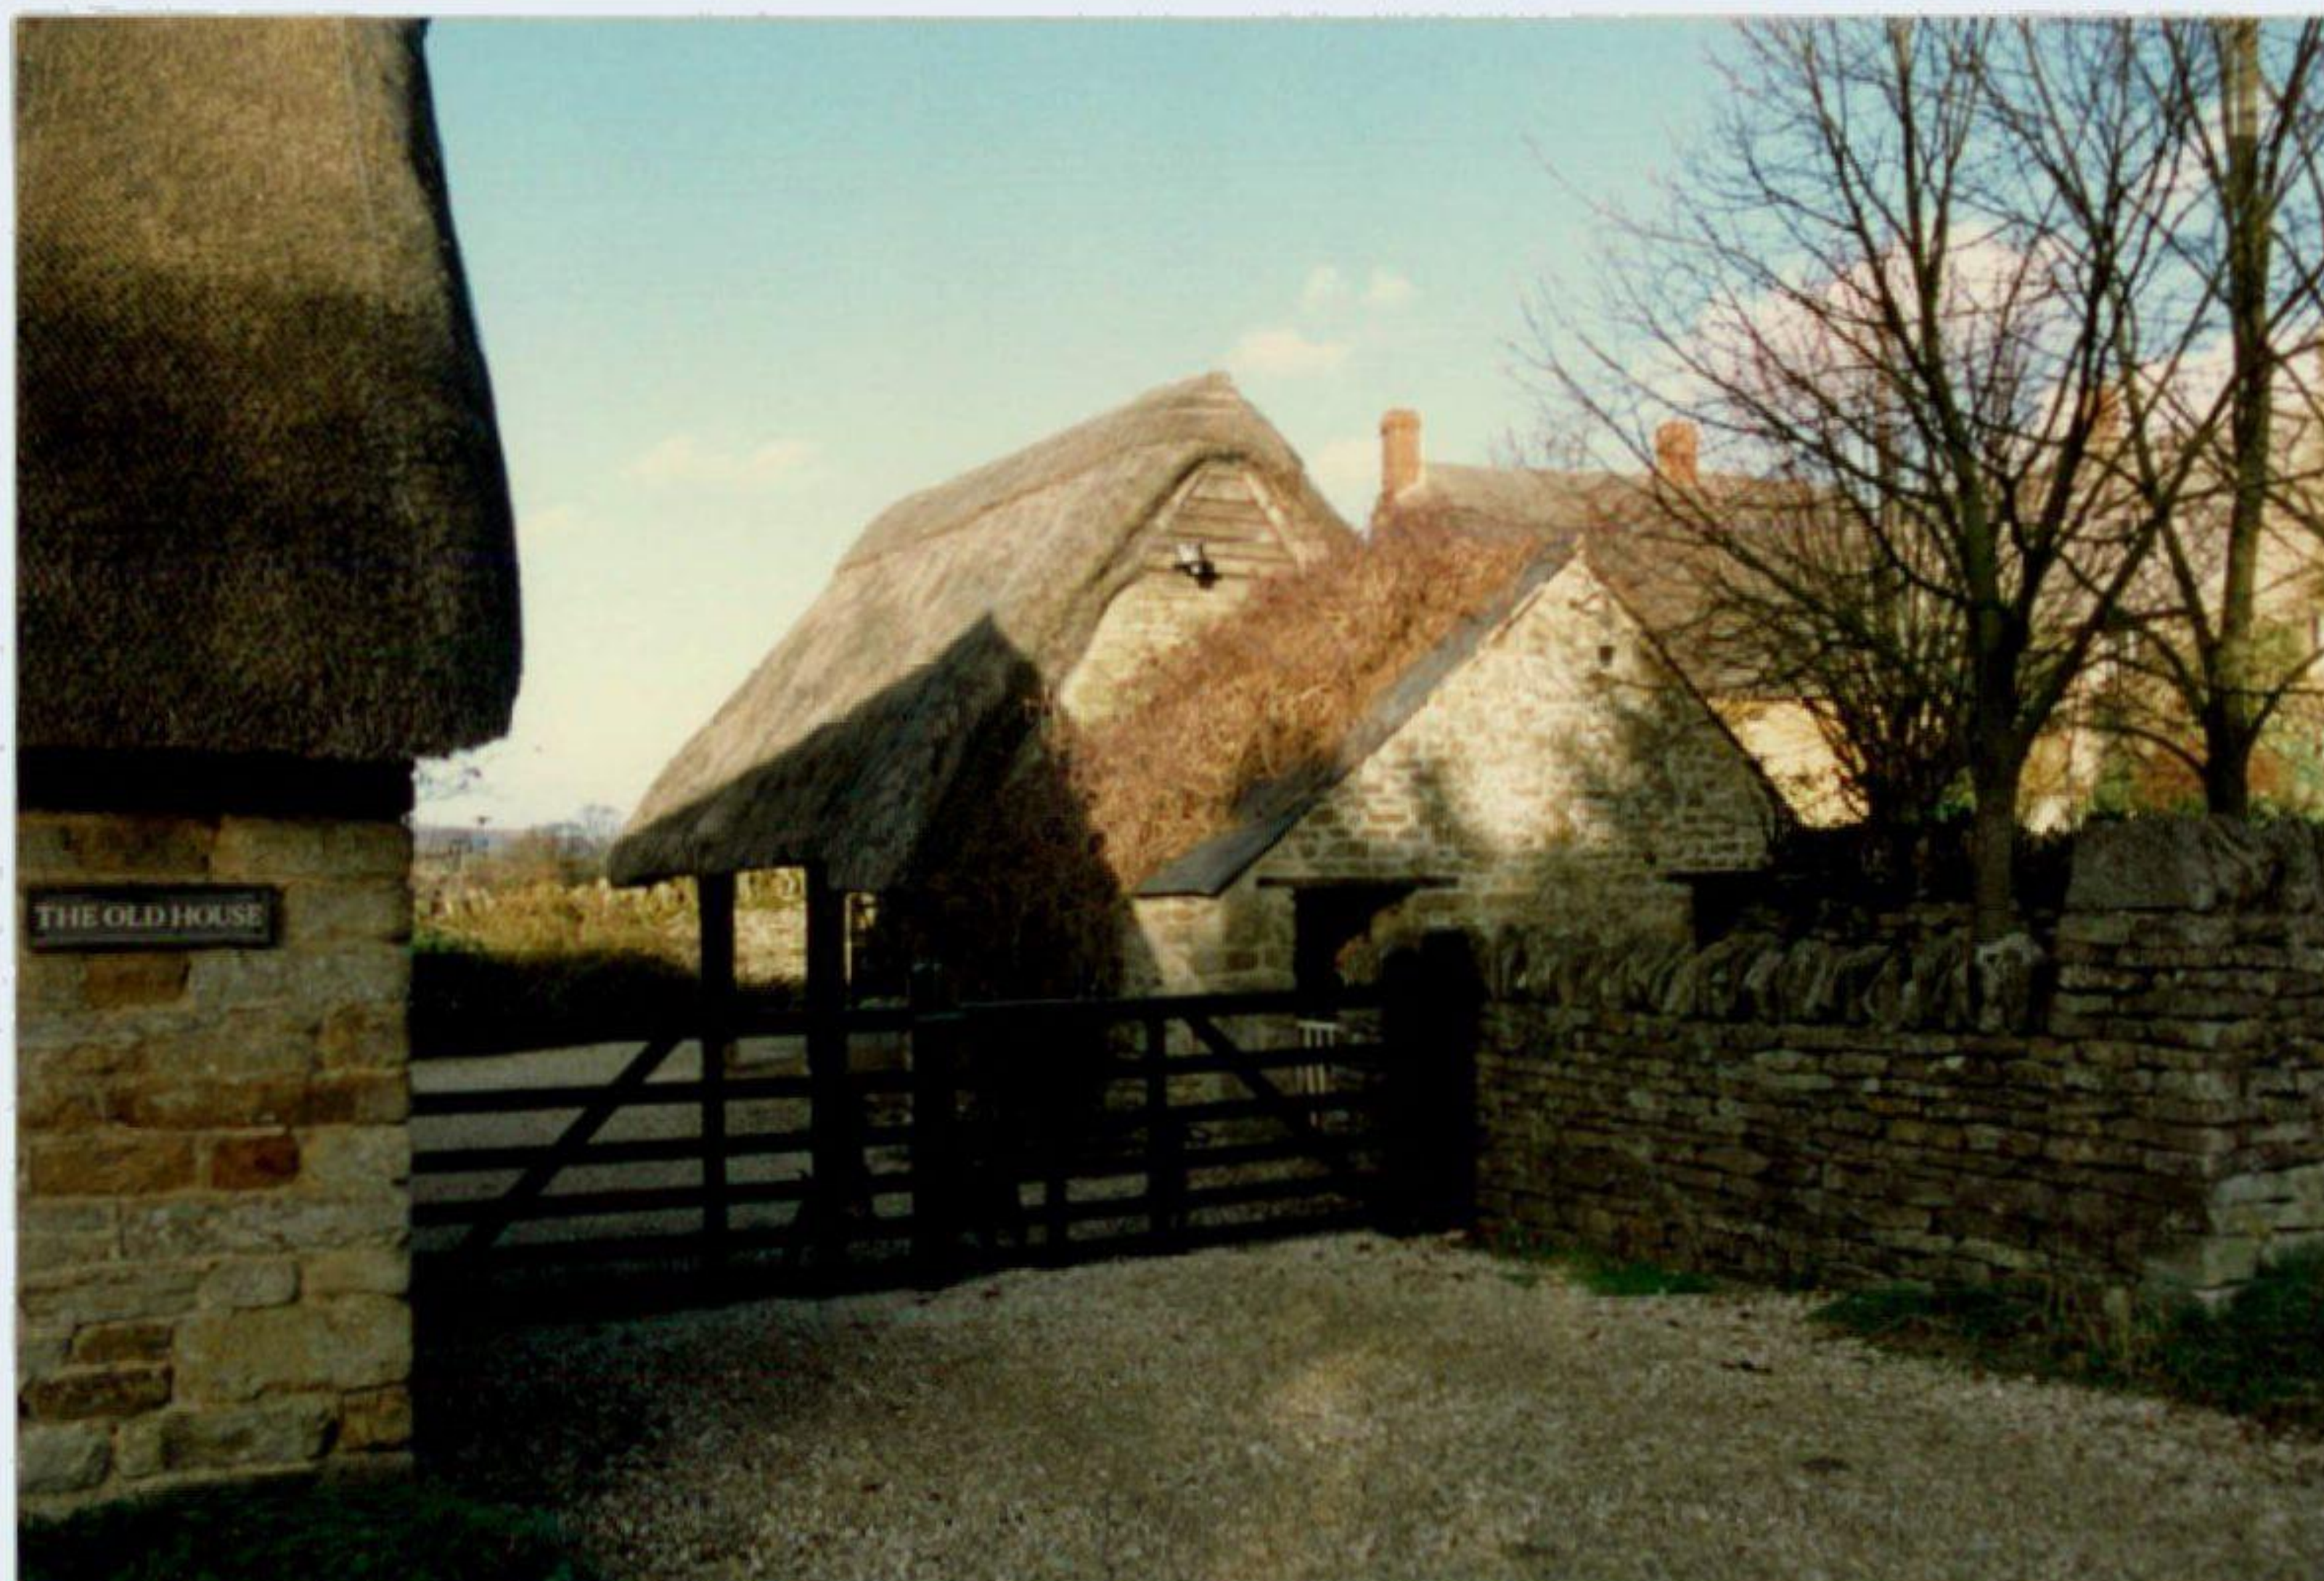
- 9/167. Cartshed approx. 20m. SW of The Old House,
Church End
(Listed Building Ref 9/167 - Grade II)

List description : Cartshed. C18. Coursed limestone rubble with thatch roof, supported to front on C20 wood pillars. 2 bays. Interior: noted as having original trenched purlin roof. Included for group value.

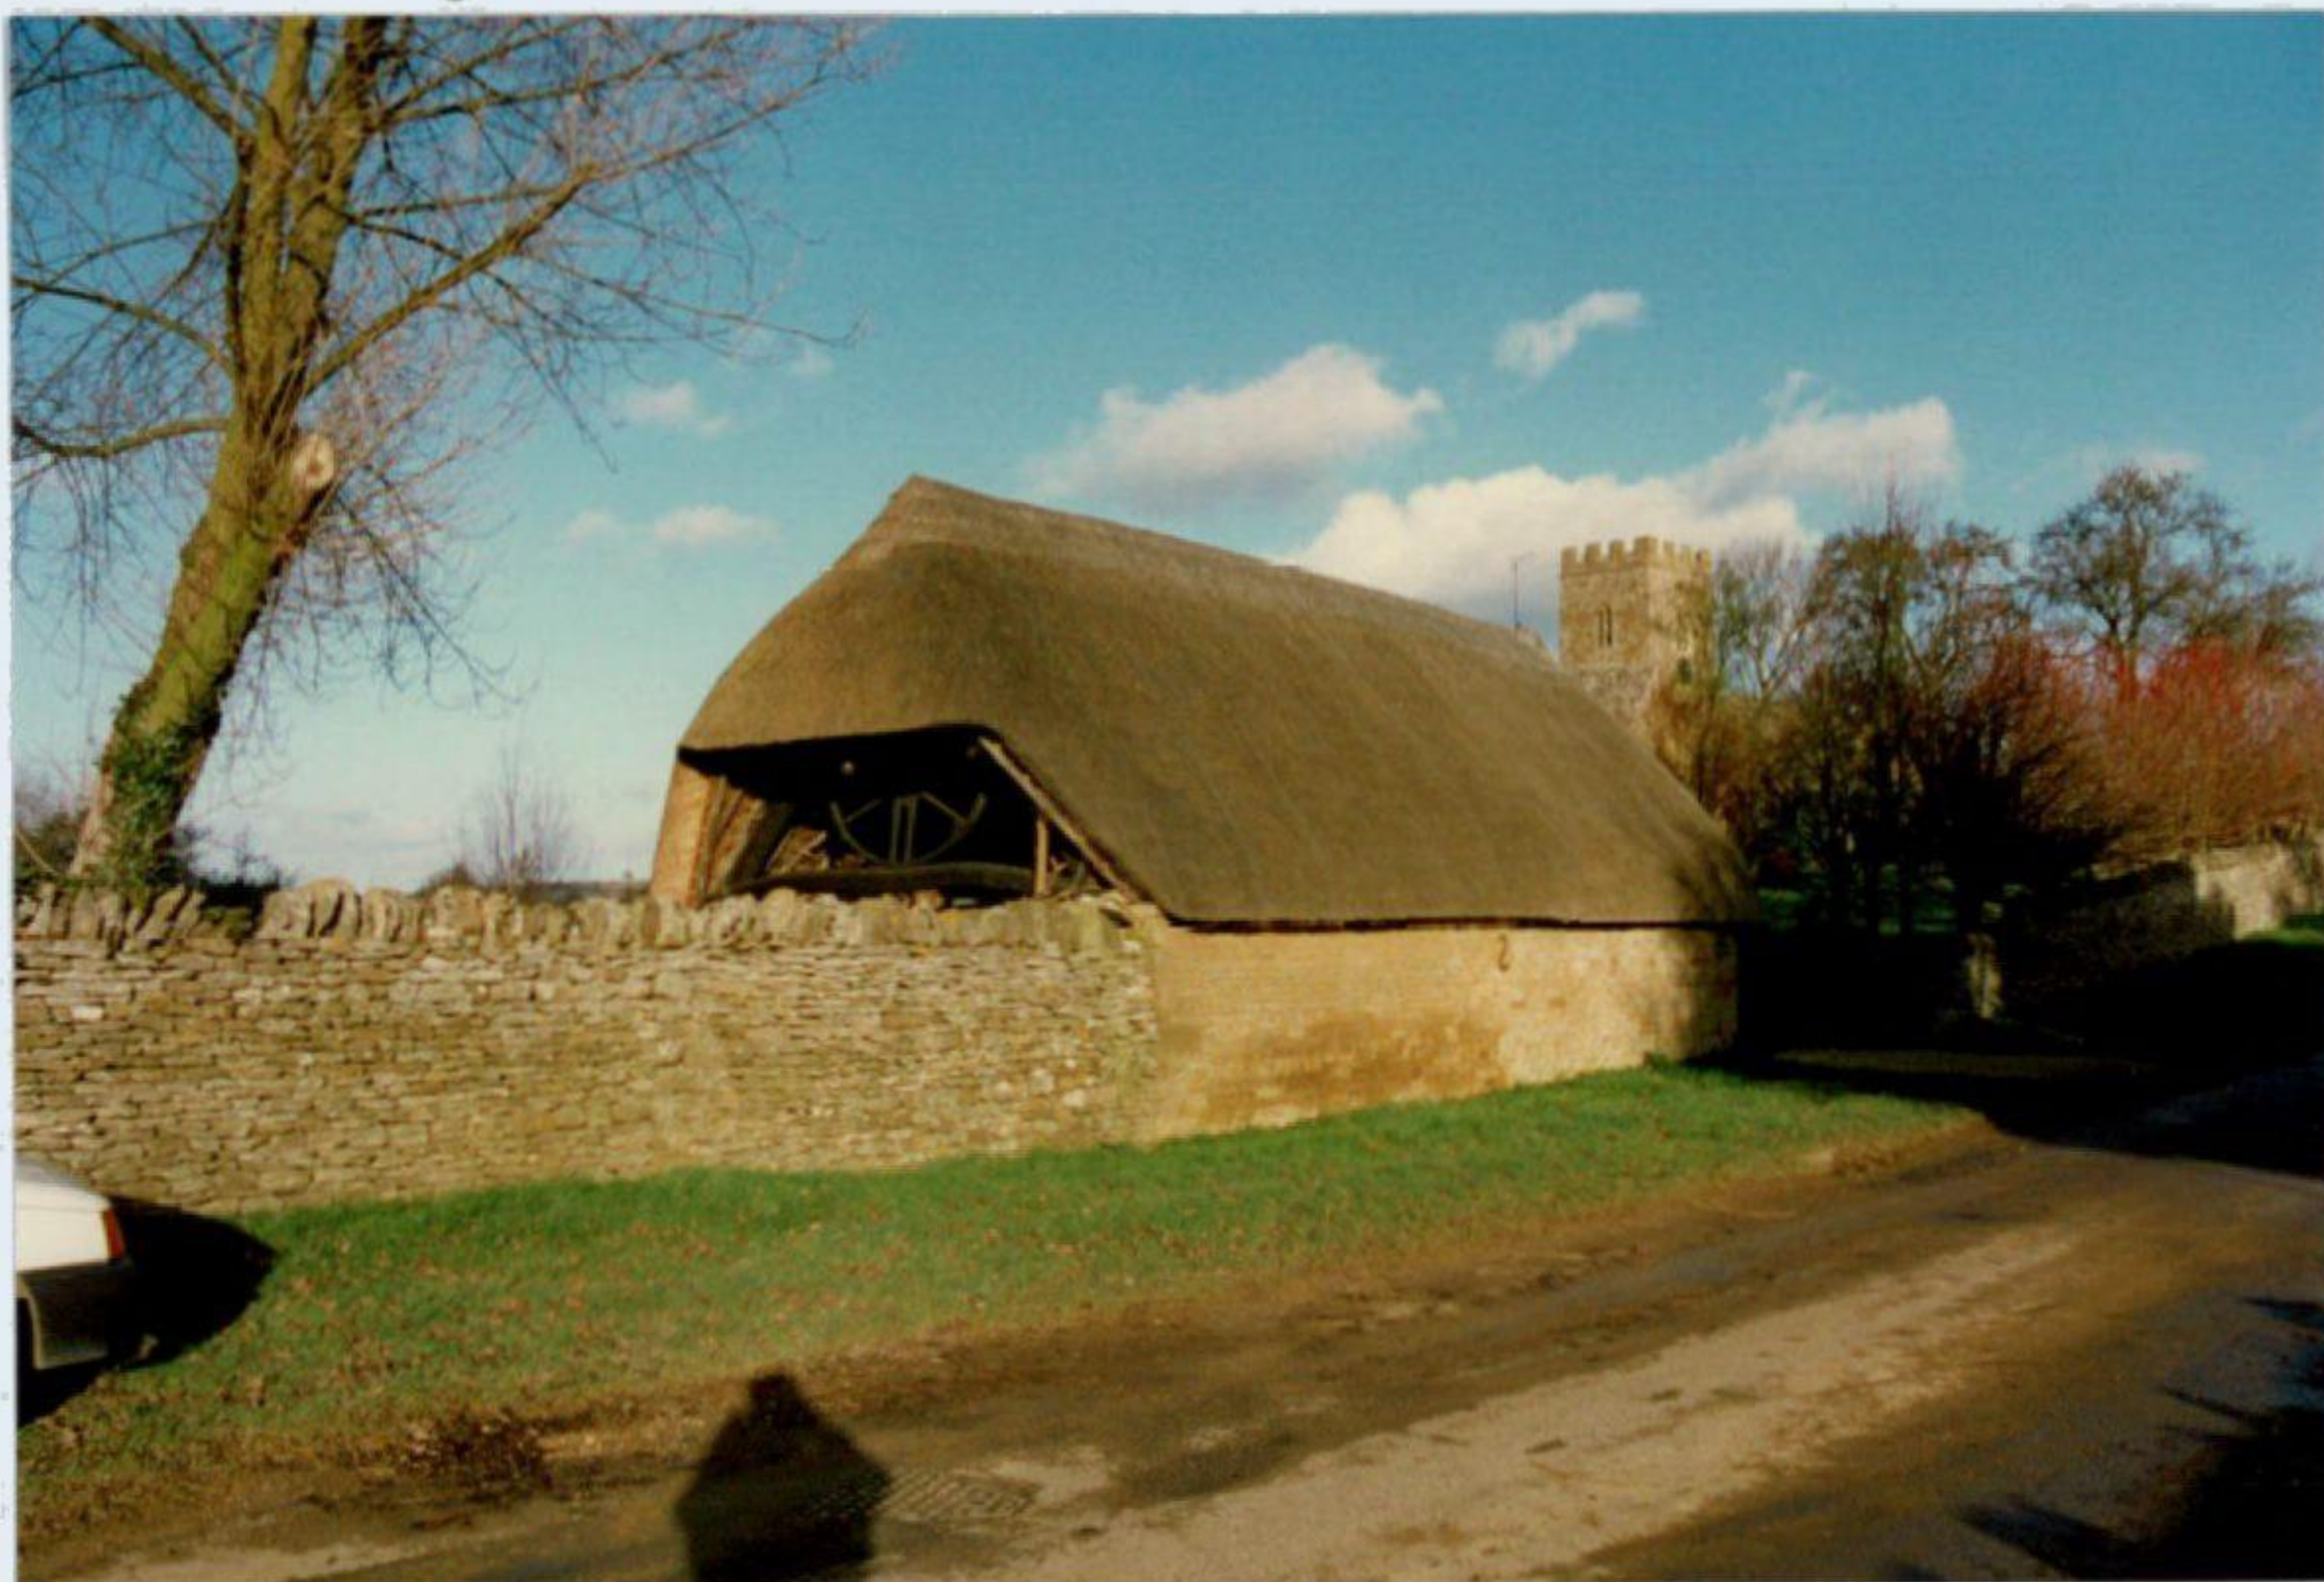
- 9/168. Stable and outbuilding range approx. 25m. SW of
The Old House, Church End
(Listed Building Ref 9/168 - Grade II)

('Cartwheel' feature in gable end truss)

List description : Stable and outbuilding. C18. Squared coursed limestone with thatch roof, hipped to right. Probably 4 bays, with plank door to left and stable door to right. Right gable end now gone. Interior: noted as having original tie-beams and purlins. Included for group value.

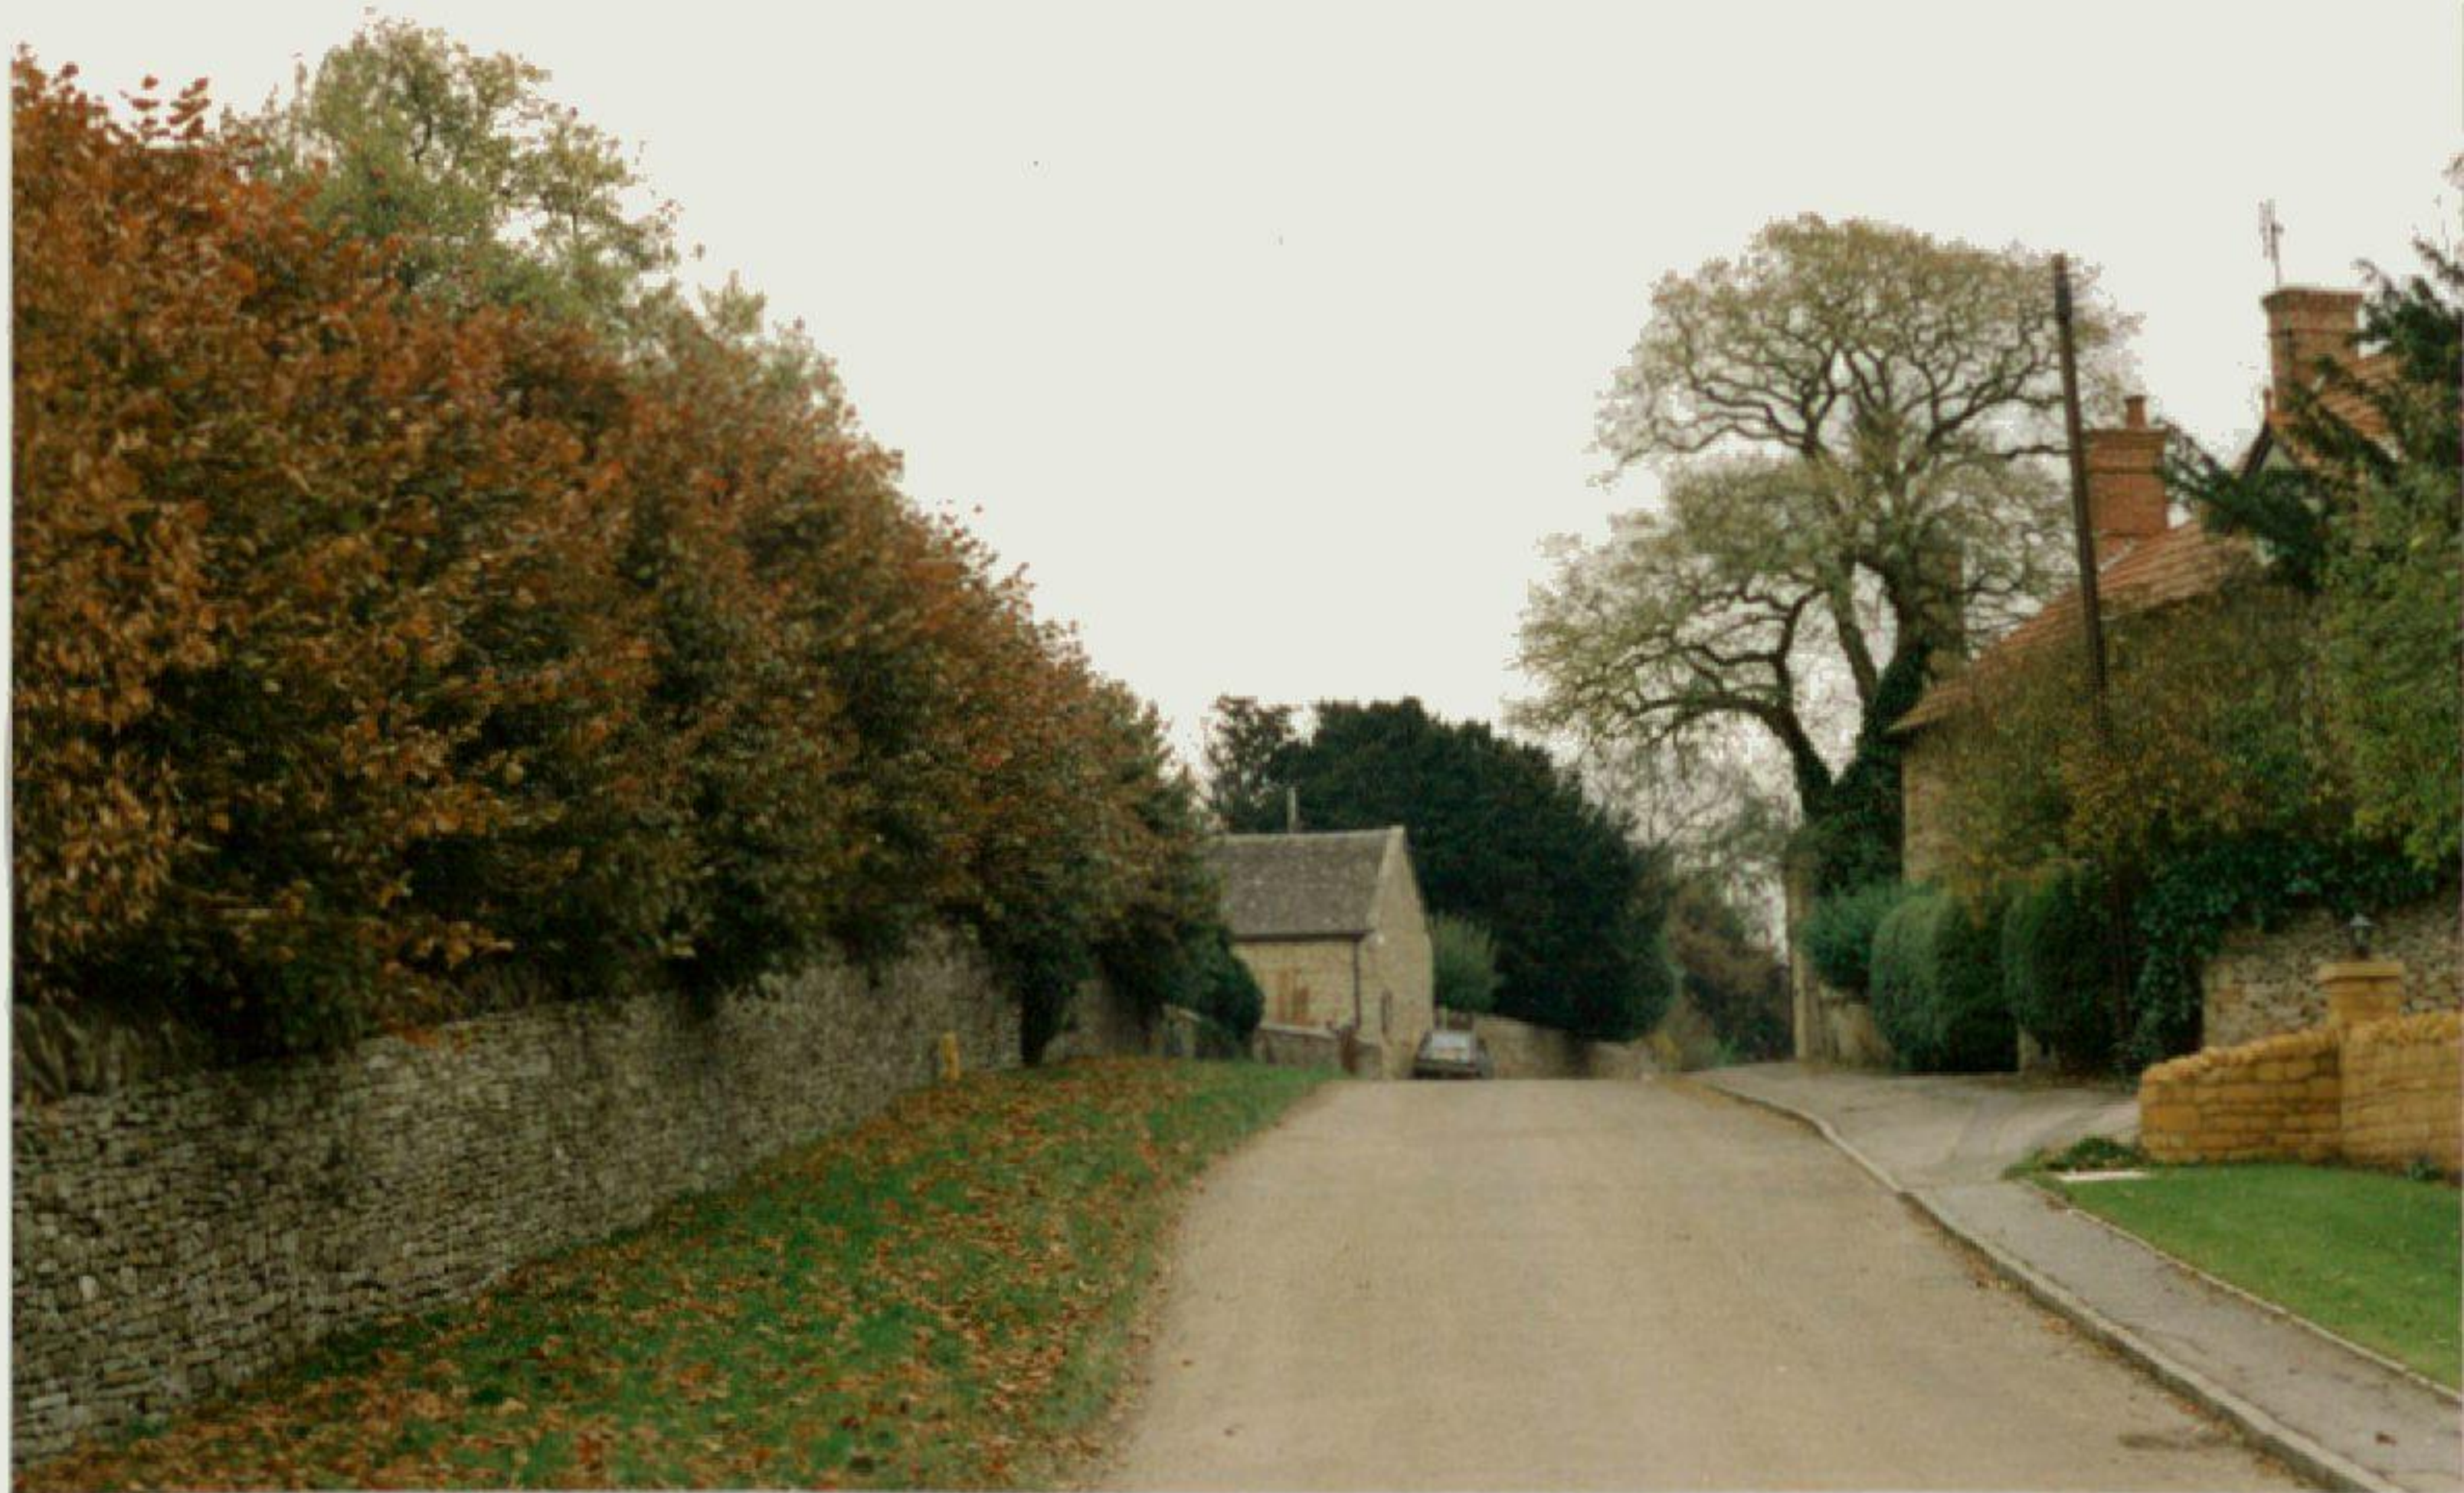
4

The view eastward approaching the Church and rising is particularly attractive (Photo 4) and is dominated by the acacia tree at Windcott House. Whilst the stone wall is again of different type, with a vertical stone coping and backed by pollarded limes, the whole scene with gently sloping grass verges is only marred by the insensitive treatment of a new stone wall opposite. Behind the pollarded limes lies a good piece of orchard, one of few left in the village.

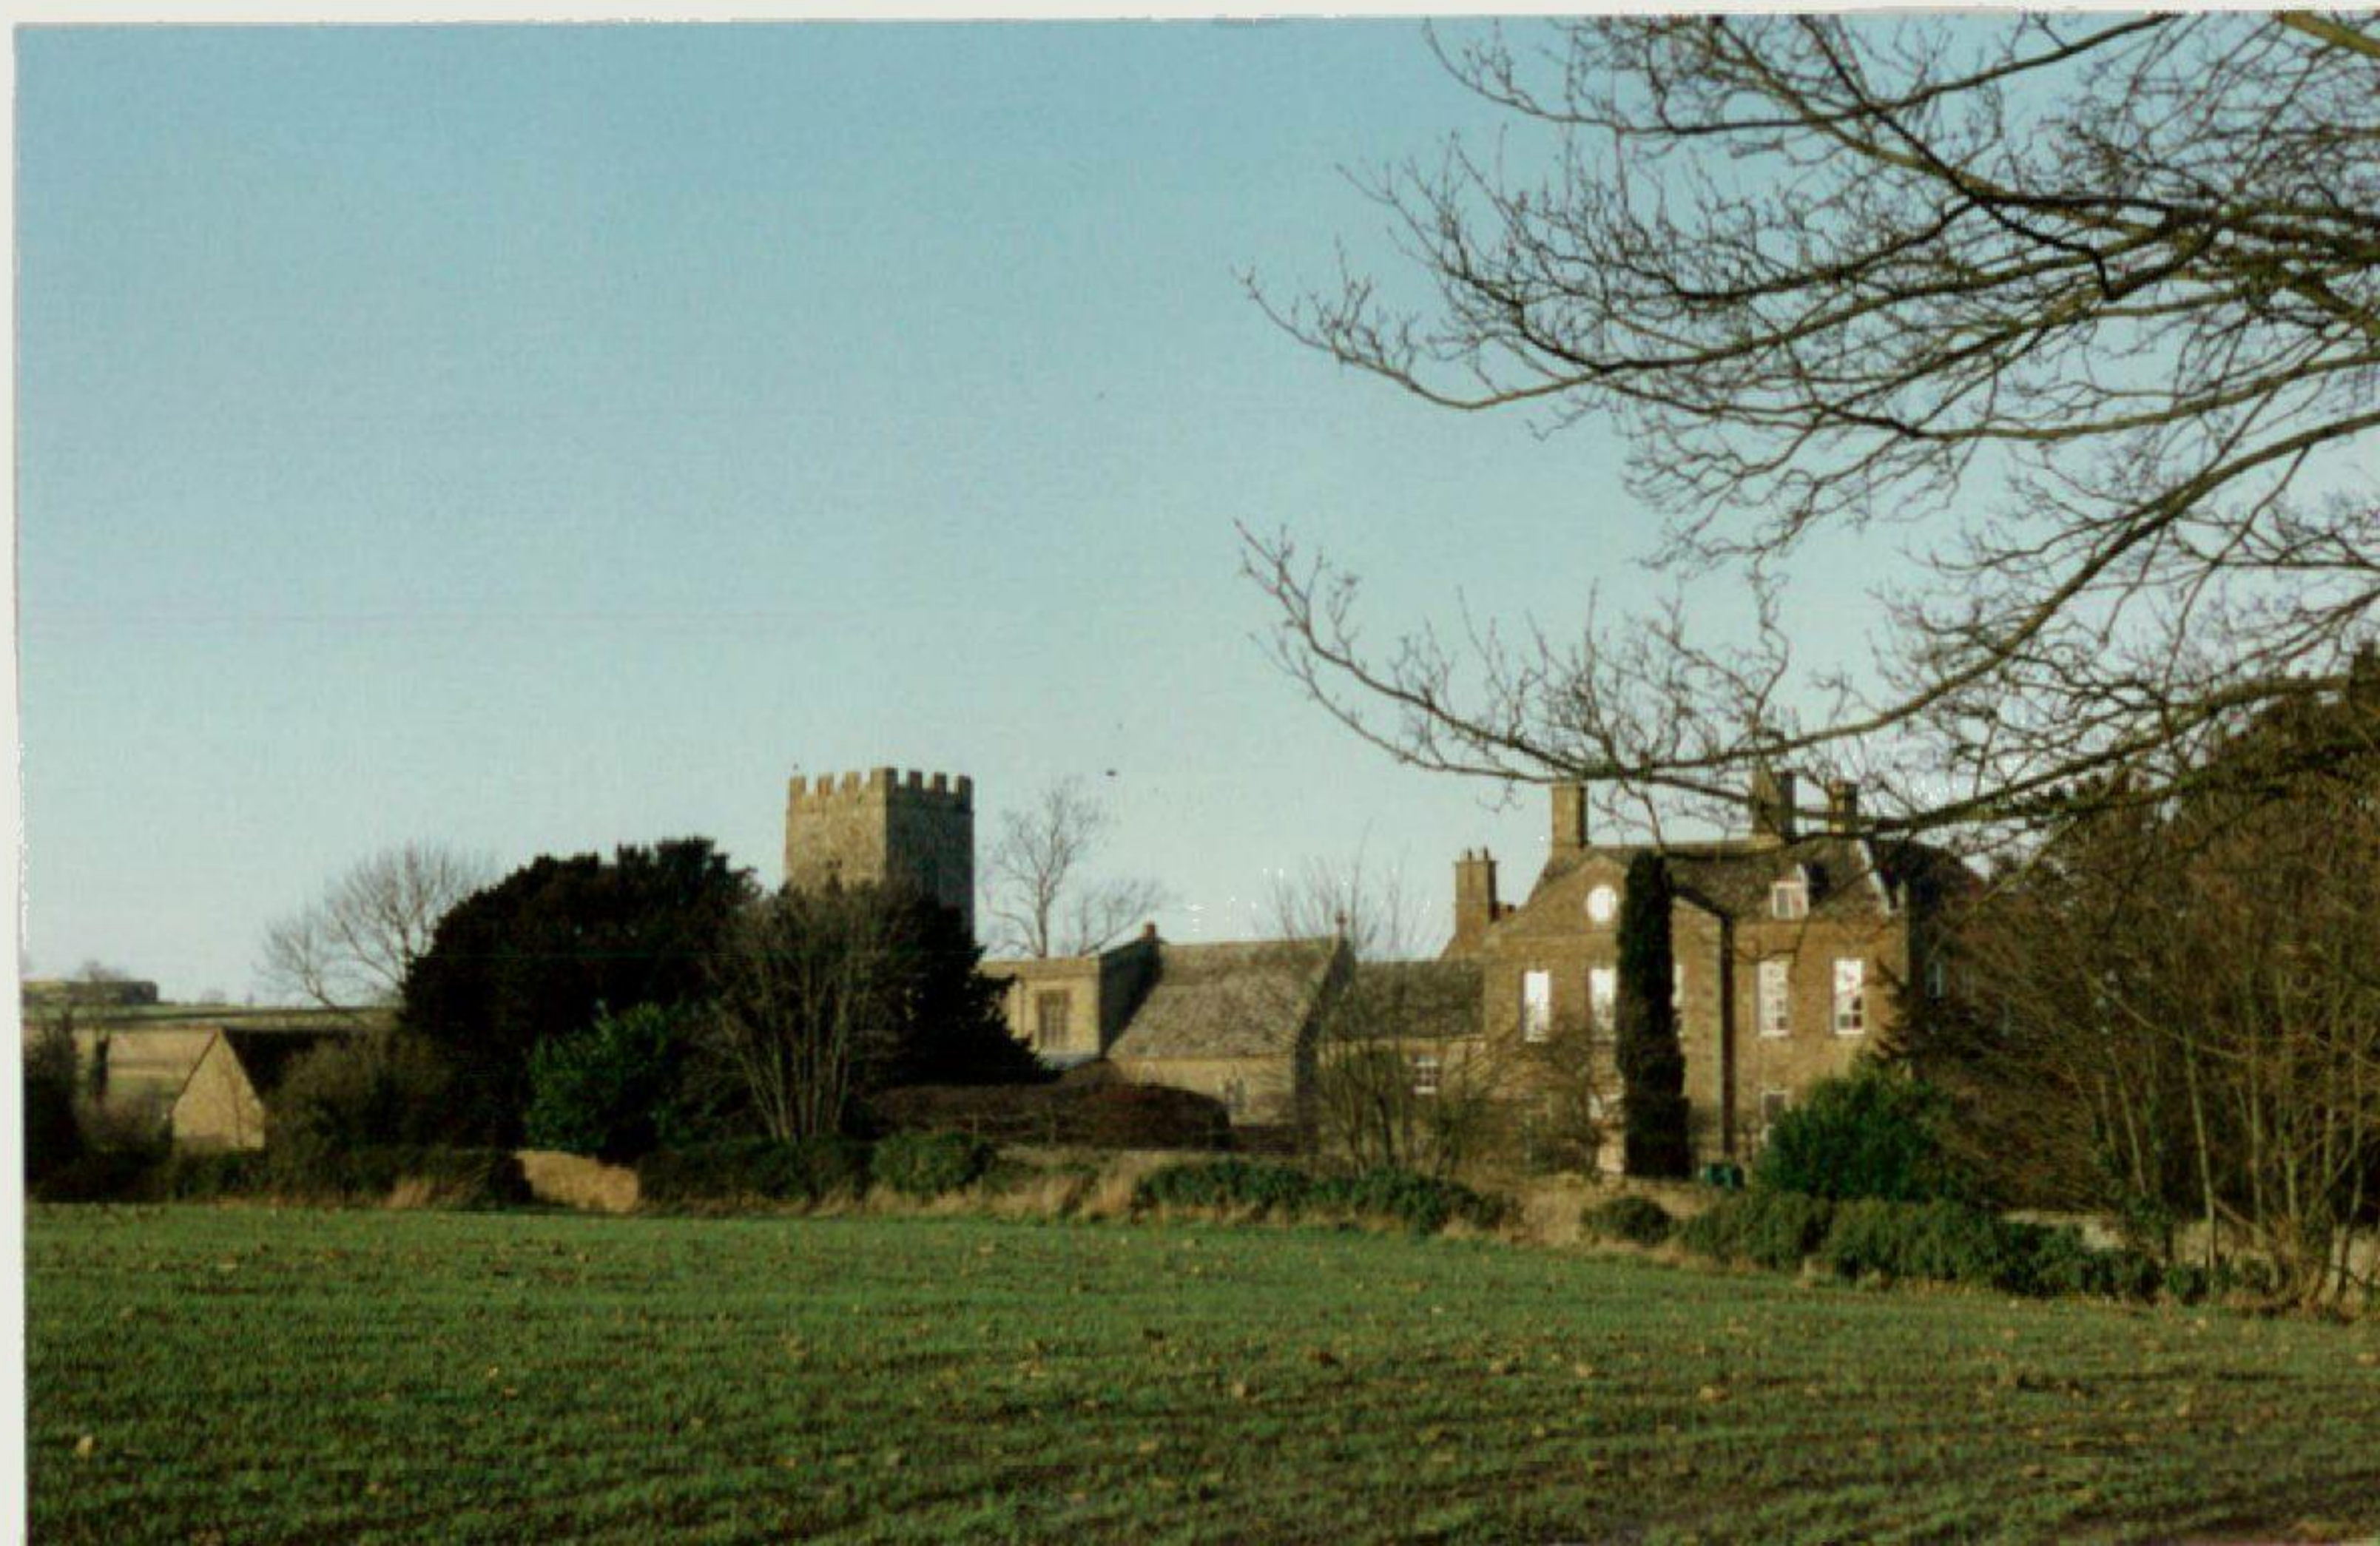
6

This area around St Michael's Church and Whichford House (Photo 6) is well treed, with a bold group of yews on the roadside and a belt of yew, sycamore and beech alongside the House (Photo 7). The wall to Whichford House is of a coursed stone with a flat stone coping (Photo 8) which changes at the Church to a dry stone wall with a pitched stone coping and nice pair of timber entrance gates (Photo 9). These gates lead to an approach path slightly sunken and flanked by headstones on one side (Photo 10).

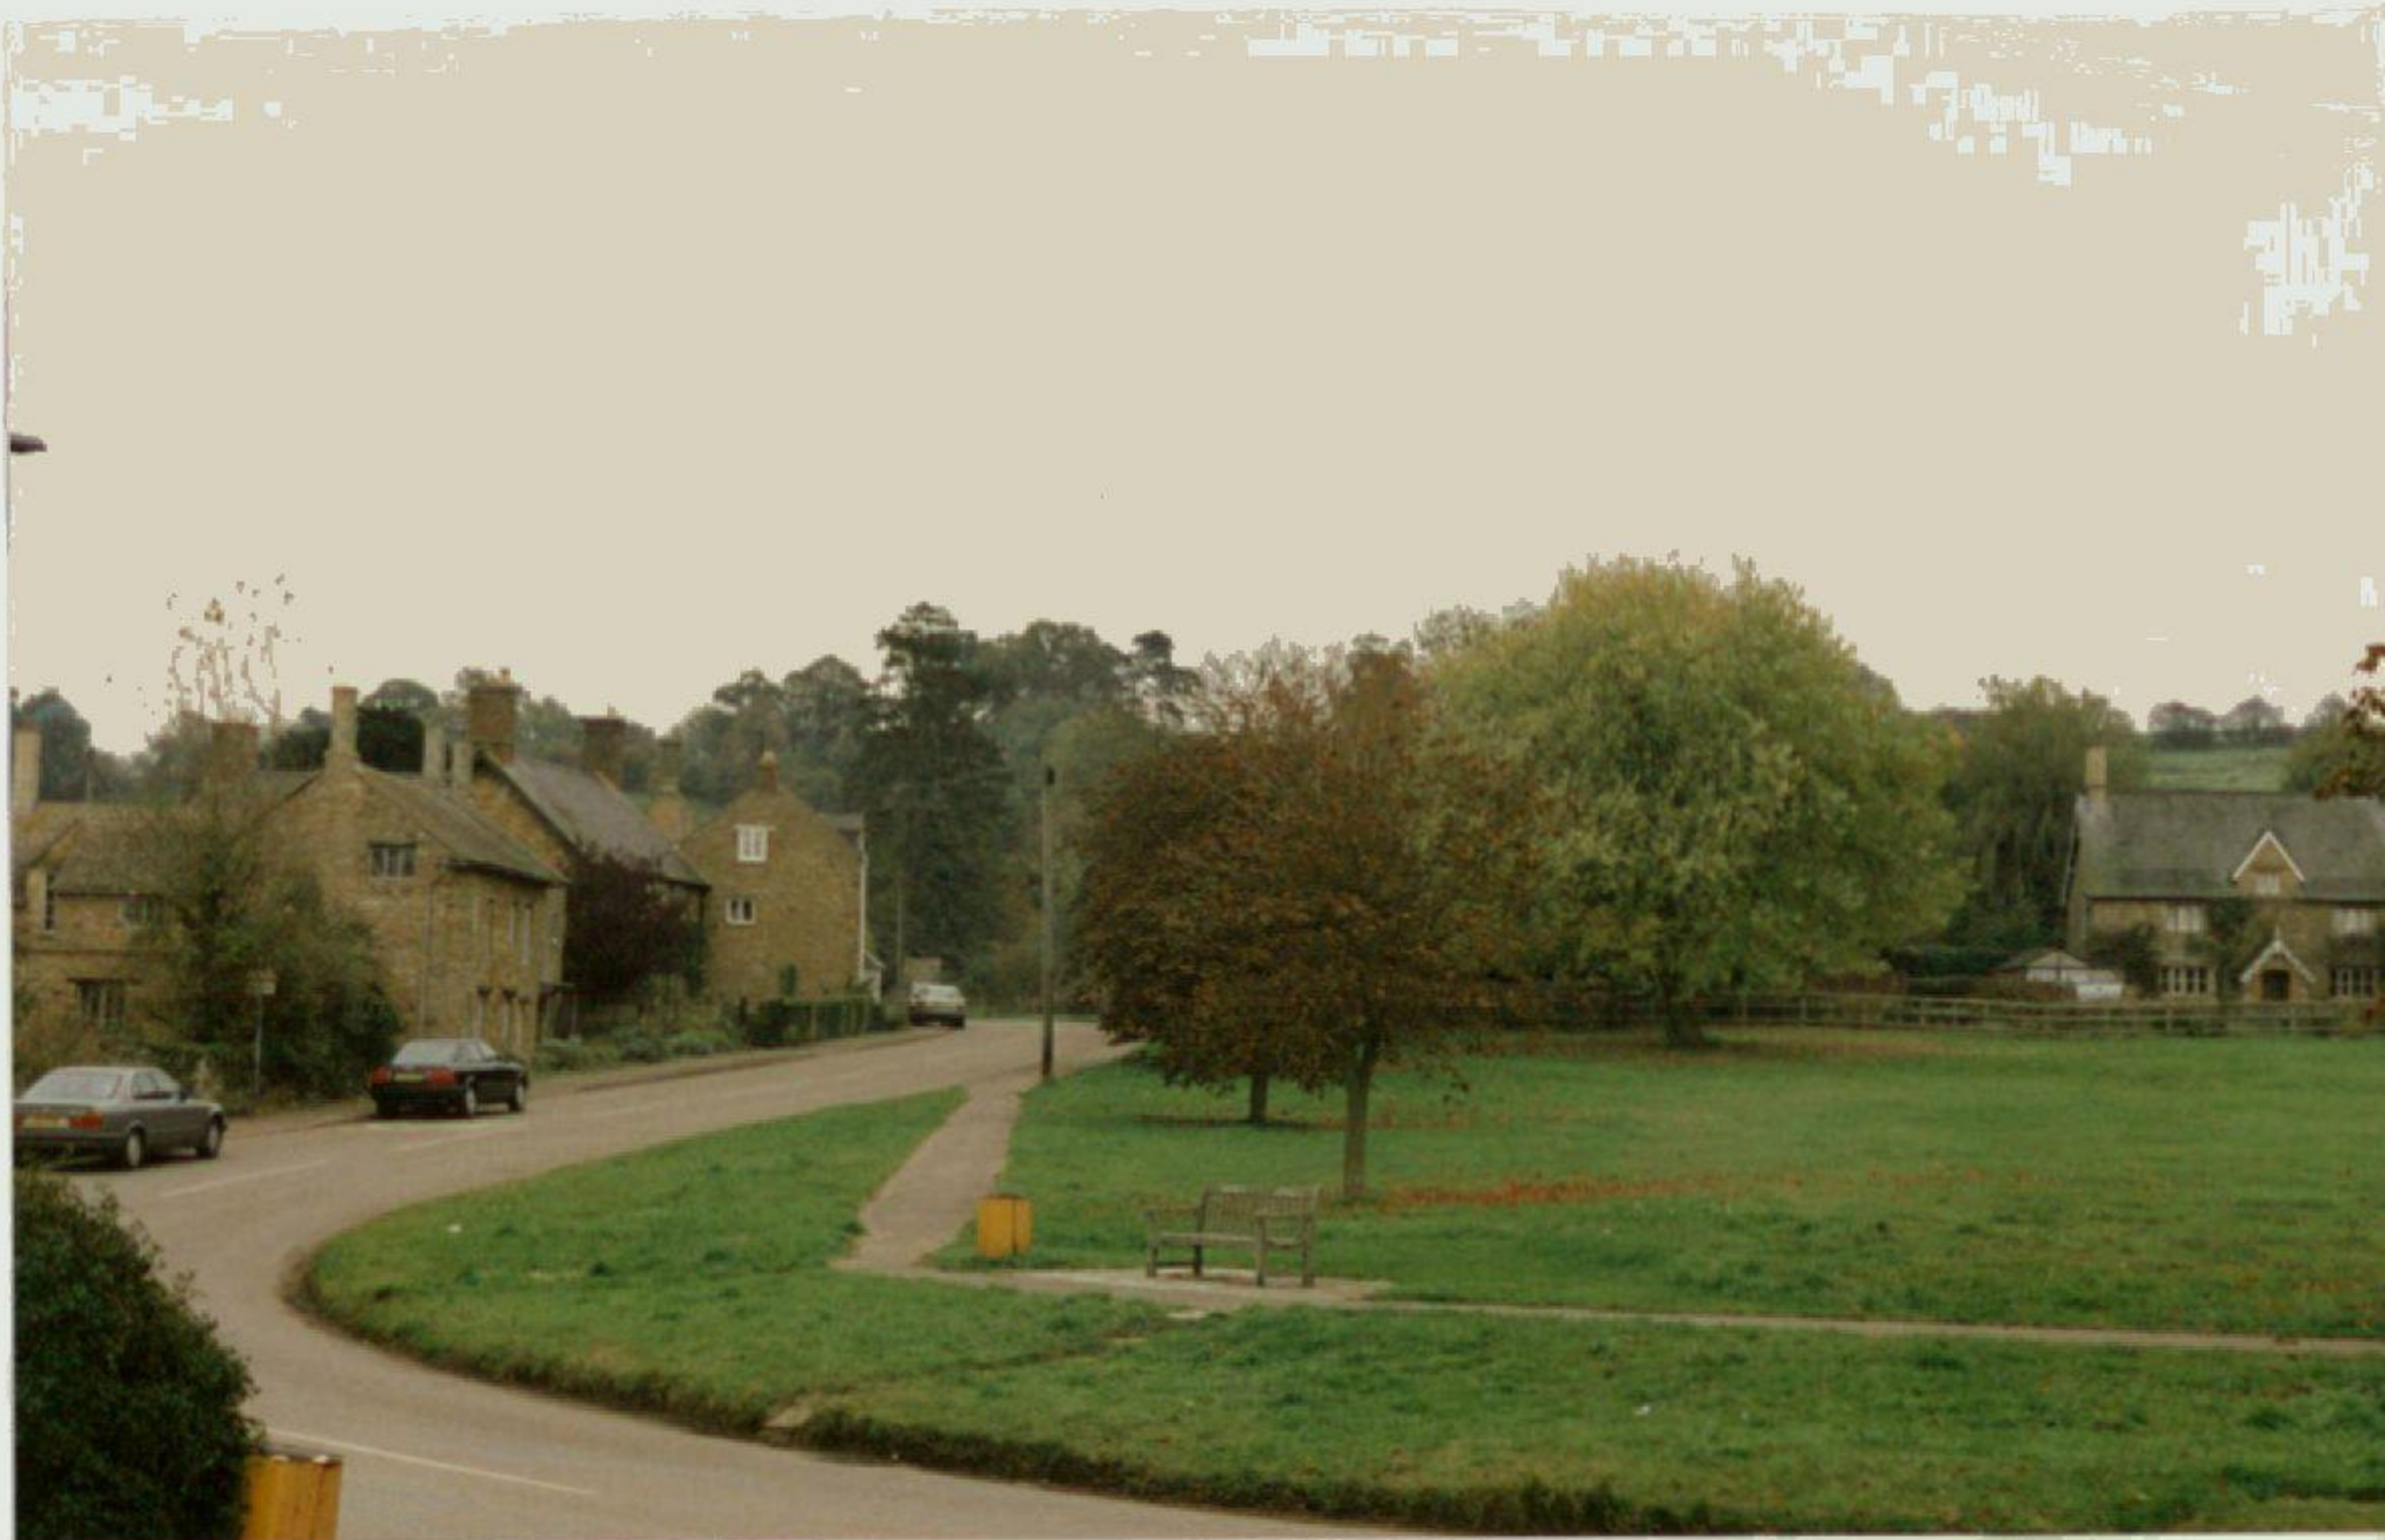
11

This is essentially the open space centre of the village; it gives the feeling of arrival and an opportunity to relate to the surrounding rising landscape (Photo 11).

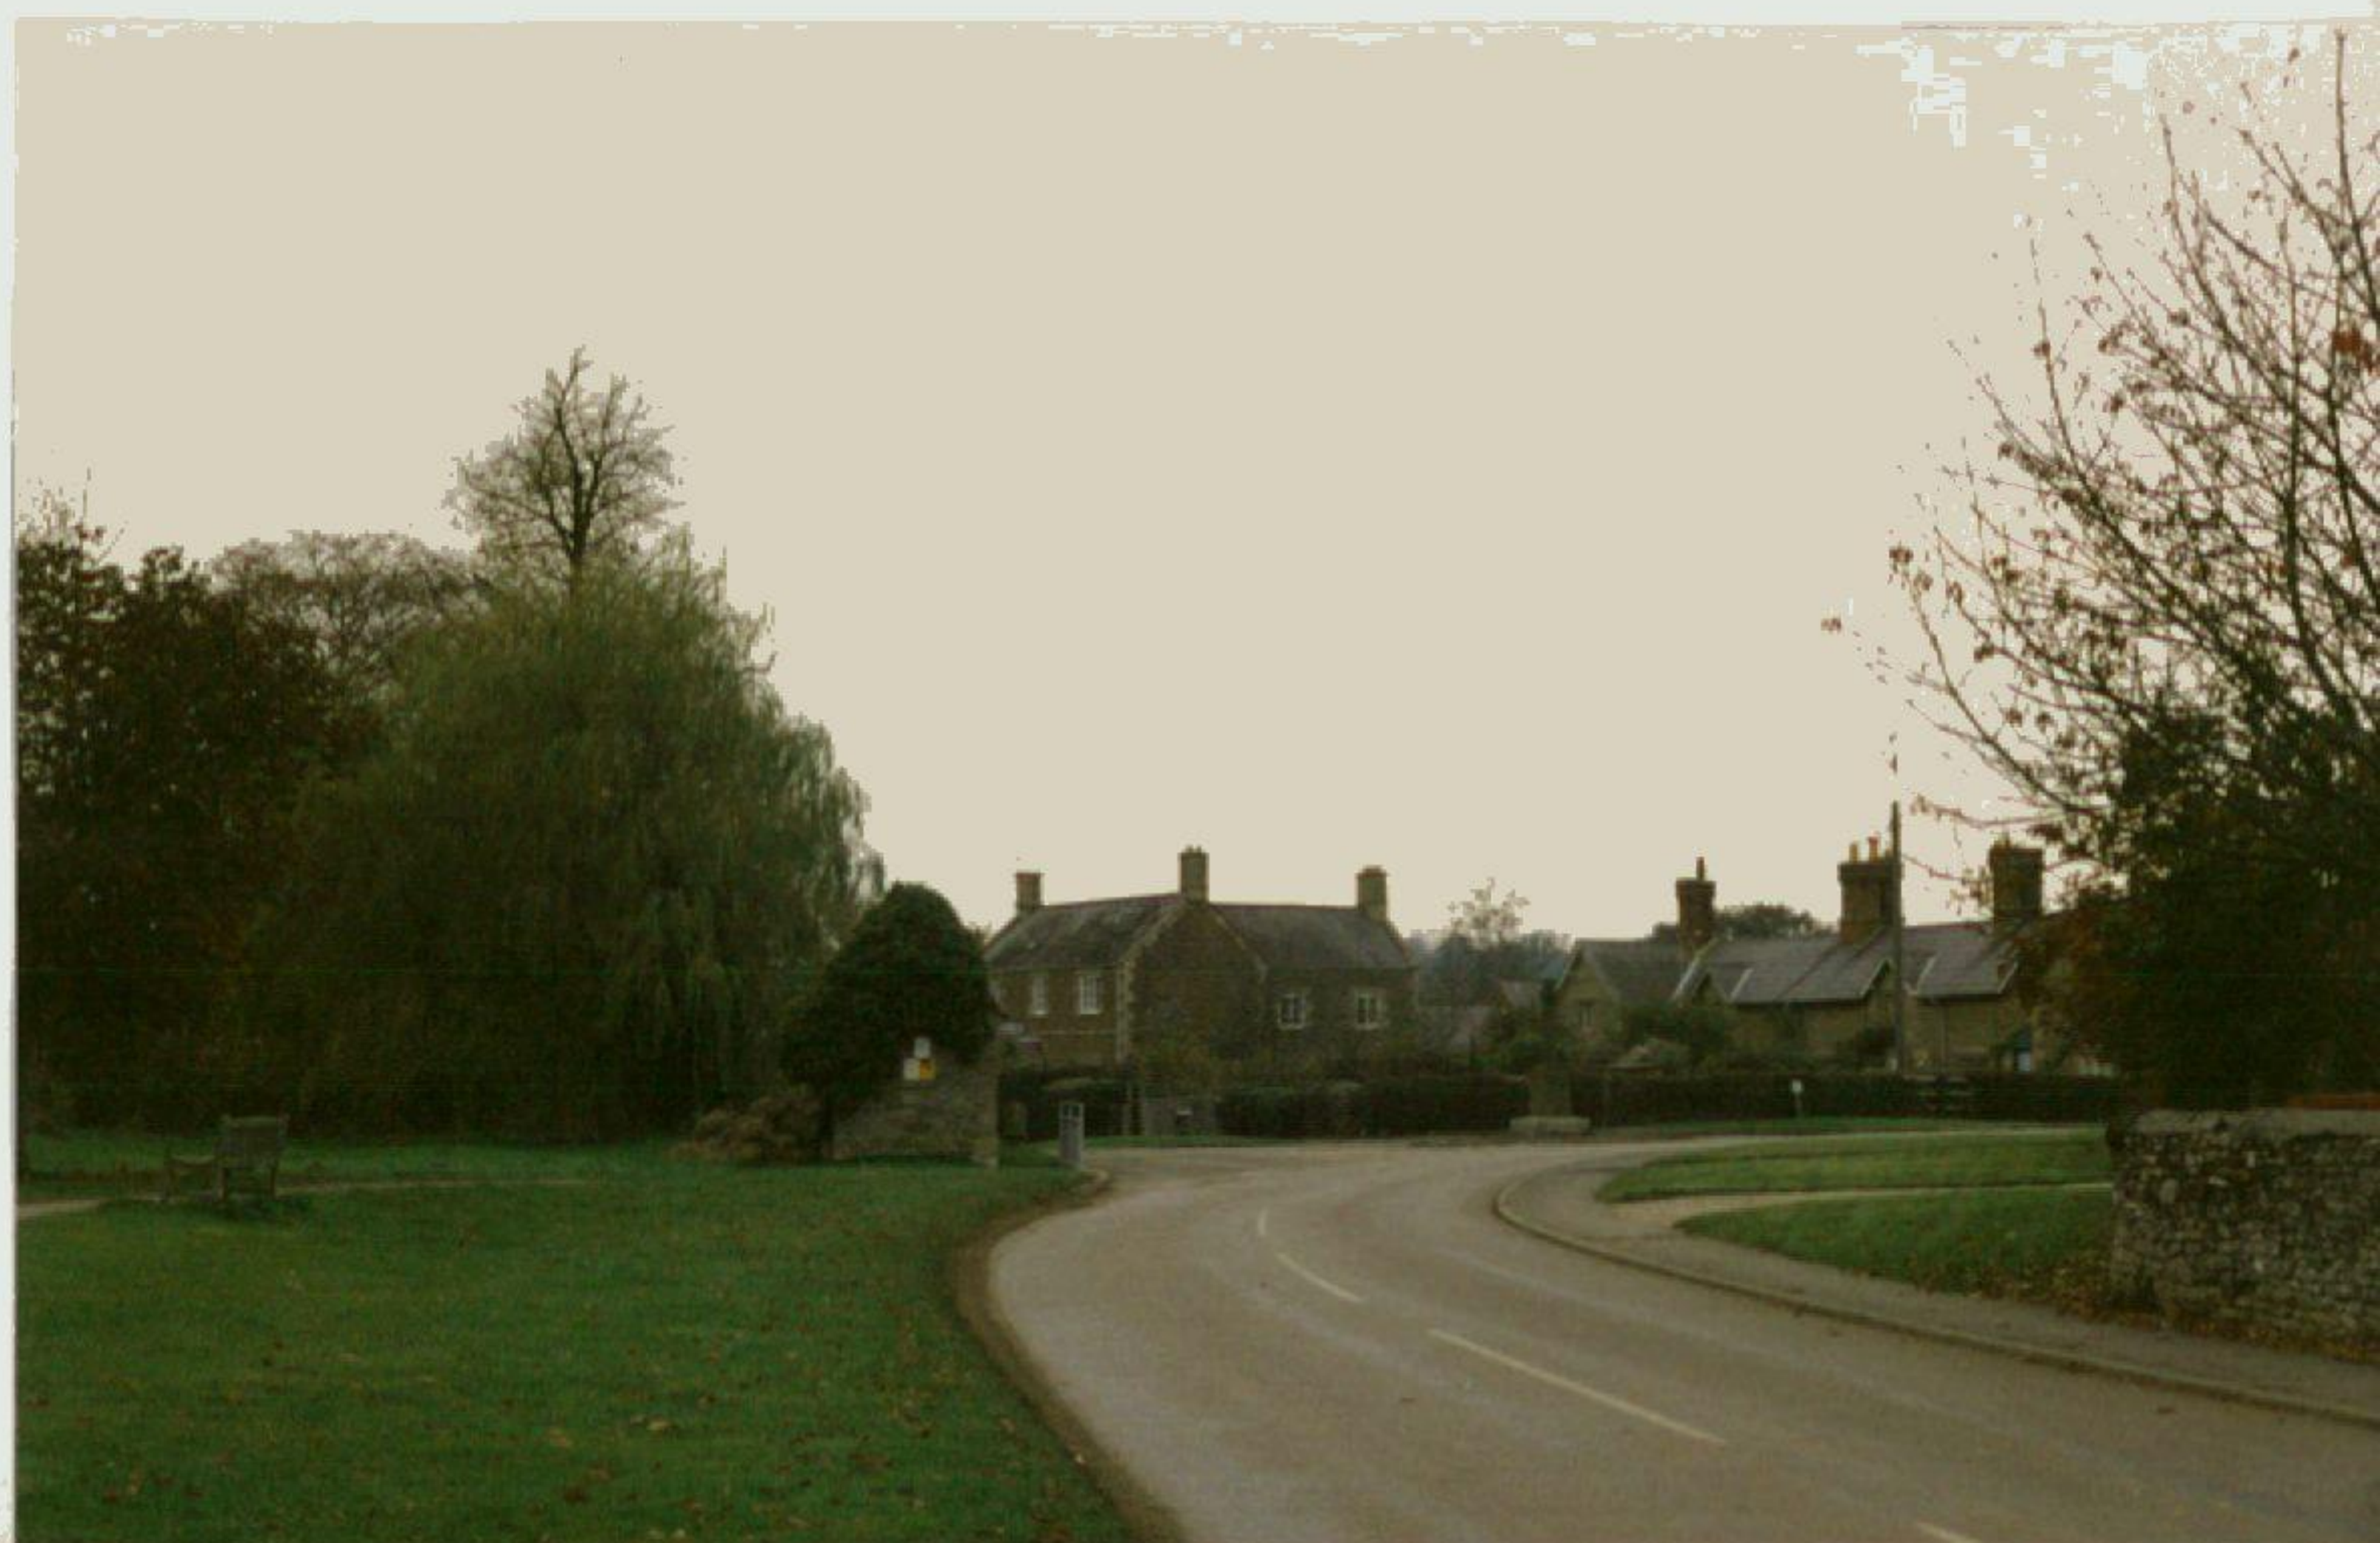
12

Apart from the War Memorial, which sits in its own triangle of grass at the road junction, and the bus stop which sits on the green (Photo 12) there is also a stone built well which is an attractive feature (Photo 13) near the School, and another of slightly different design higher up the hill (Photo 14). Trees around the School are listed at TPO's and some other tree planting has been carried out around the periphery of the green space - not as yet developed into significant features.
