STRATFORD ON AVON DISTRICT COUNCIL

CONSERVATION AREA REVIEWS

WHICHFORD

February 1994

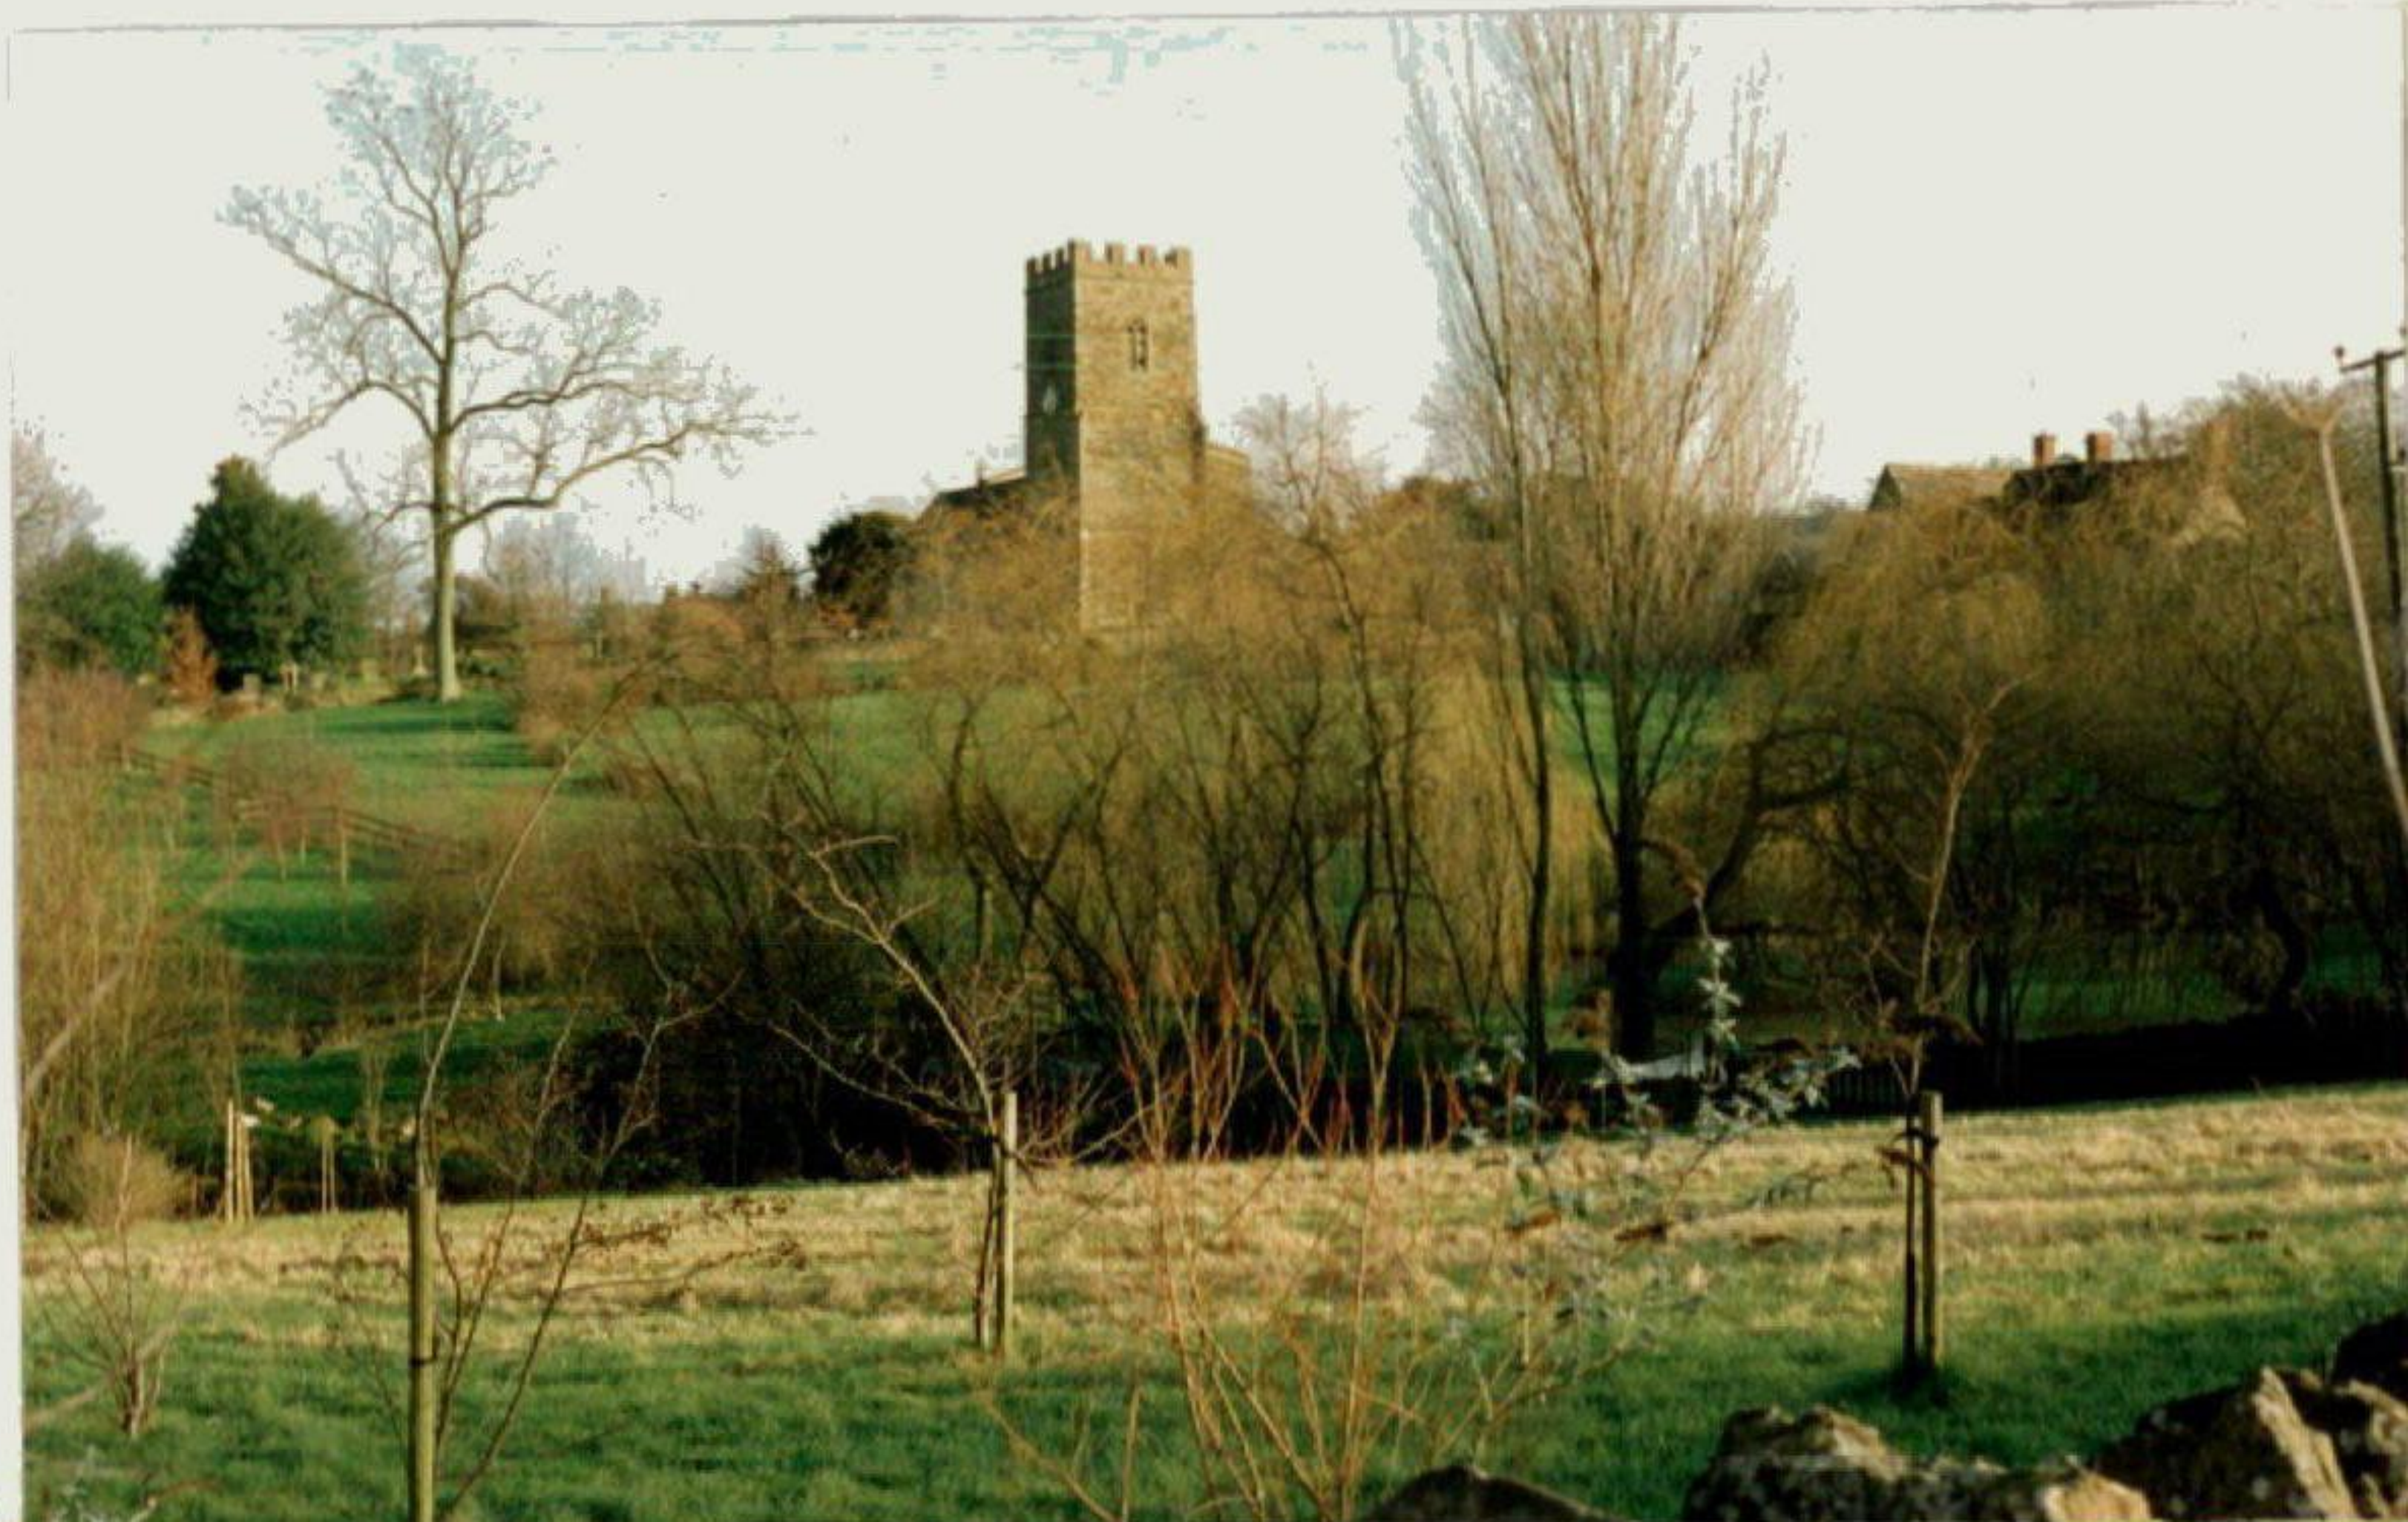
15

Apart from the two areas identified as being especially important in the general fabric of the village, there are some parts which detract from the overall quality, one of which is the moated castle site which is given over to livestock and yet has such potential in affording views of the church. The open space opposite with its pools should be safeguarded to allow this view to remain (Photo 15).
