*Shotteswell
Conservation Area*

Shankland Cox

April 1994

Shotteswell Conservation Area

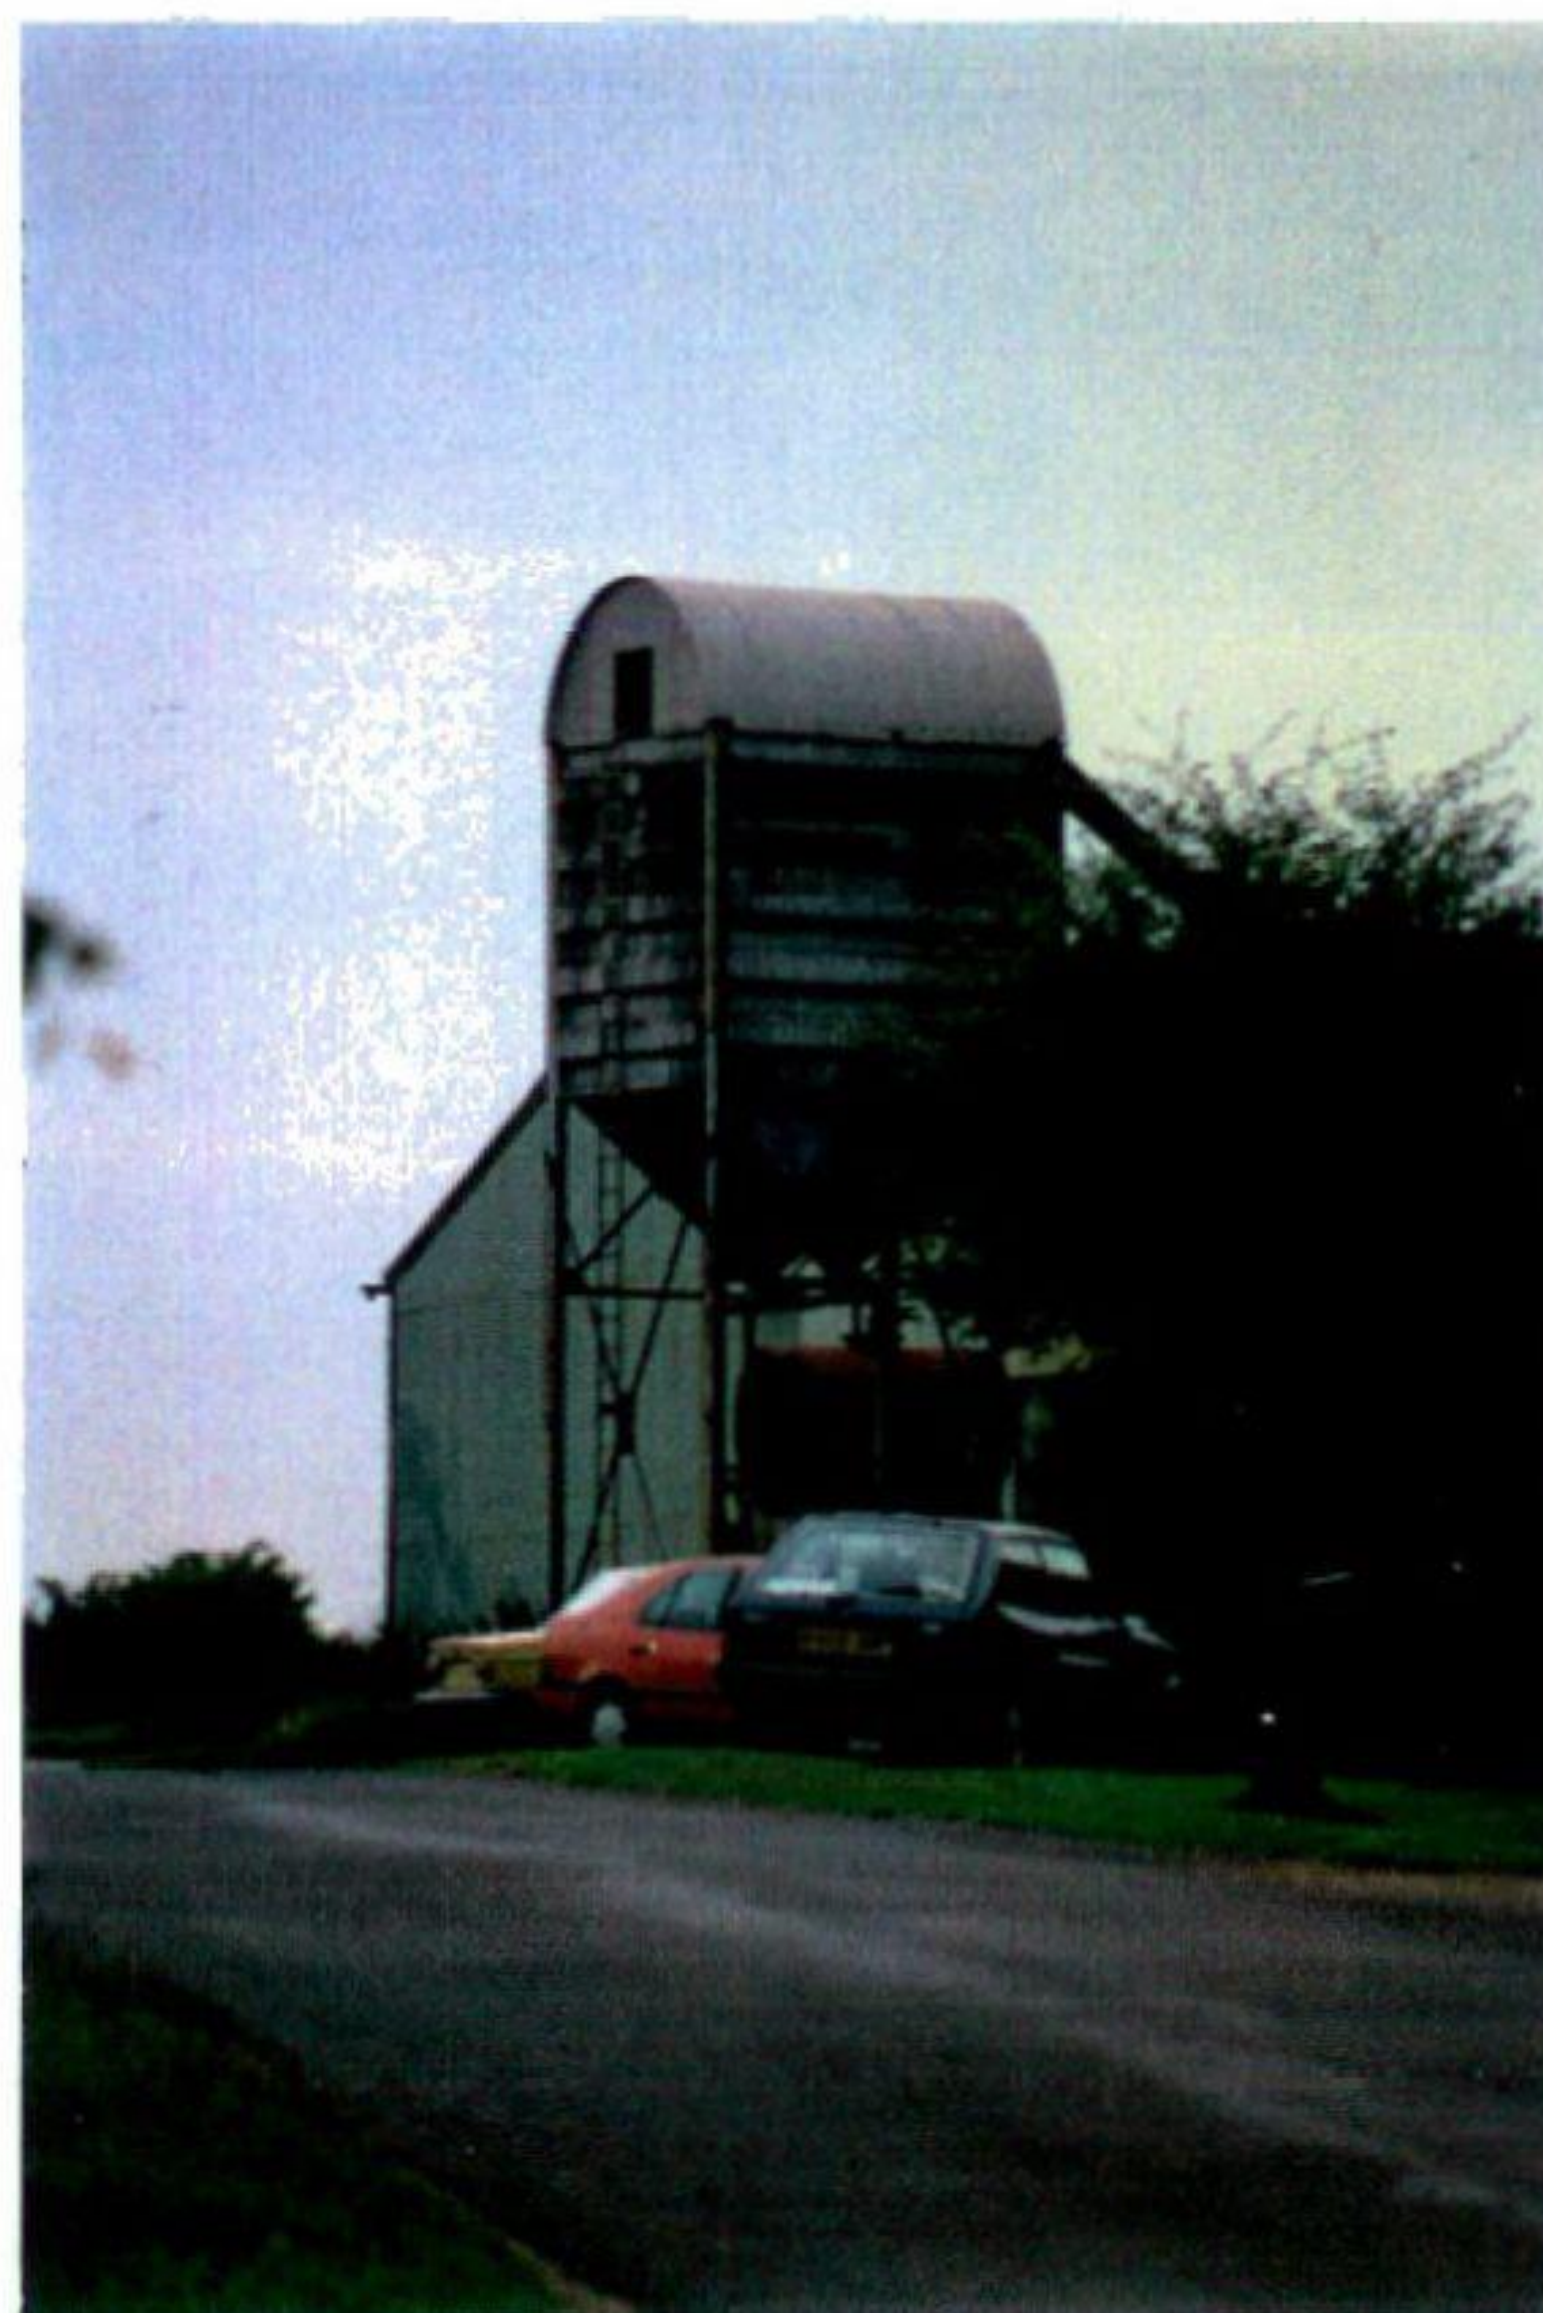
Intrusive agricultural structures,
Warwick Road.

- Planting to screen agricultural buildings on the western approaches to the village.
- Reclamation of the grounds and railings of the old Methodist Chapel.
- Restoration of the stone and timber bus shelter on the green.
- Replacement of the blue plastic drums, which are used throughout the village for road salt and grit, with visually more sympathetic containers.
- Improvements to paving and hedgerows in the churchyard.

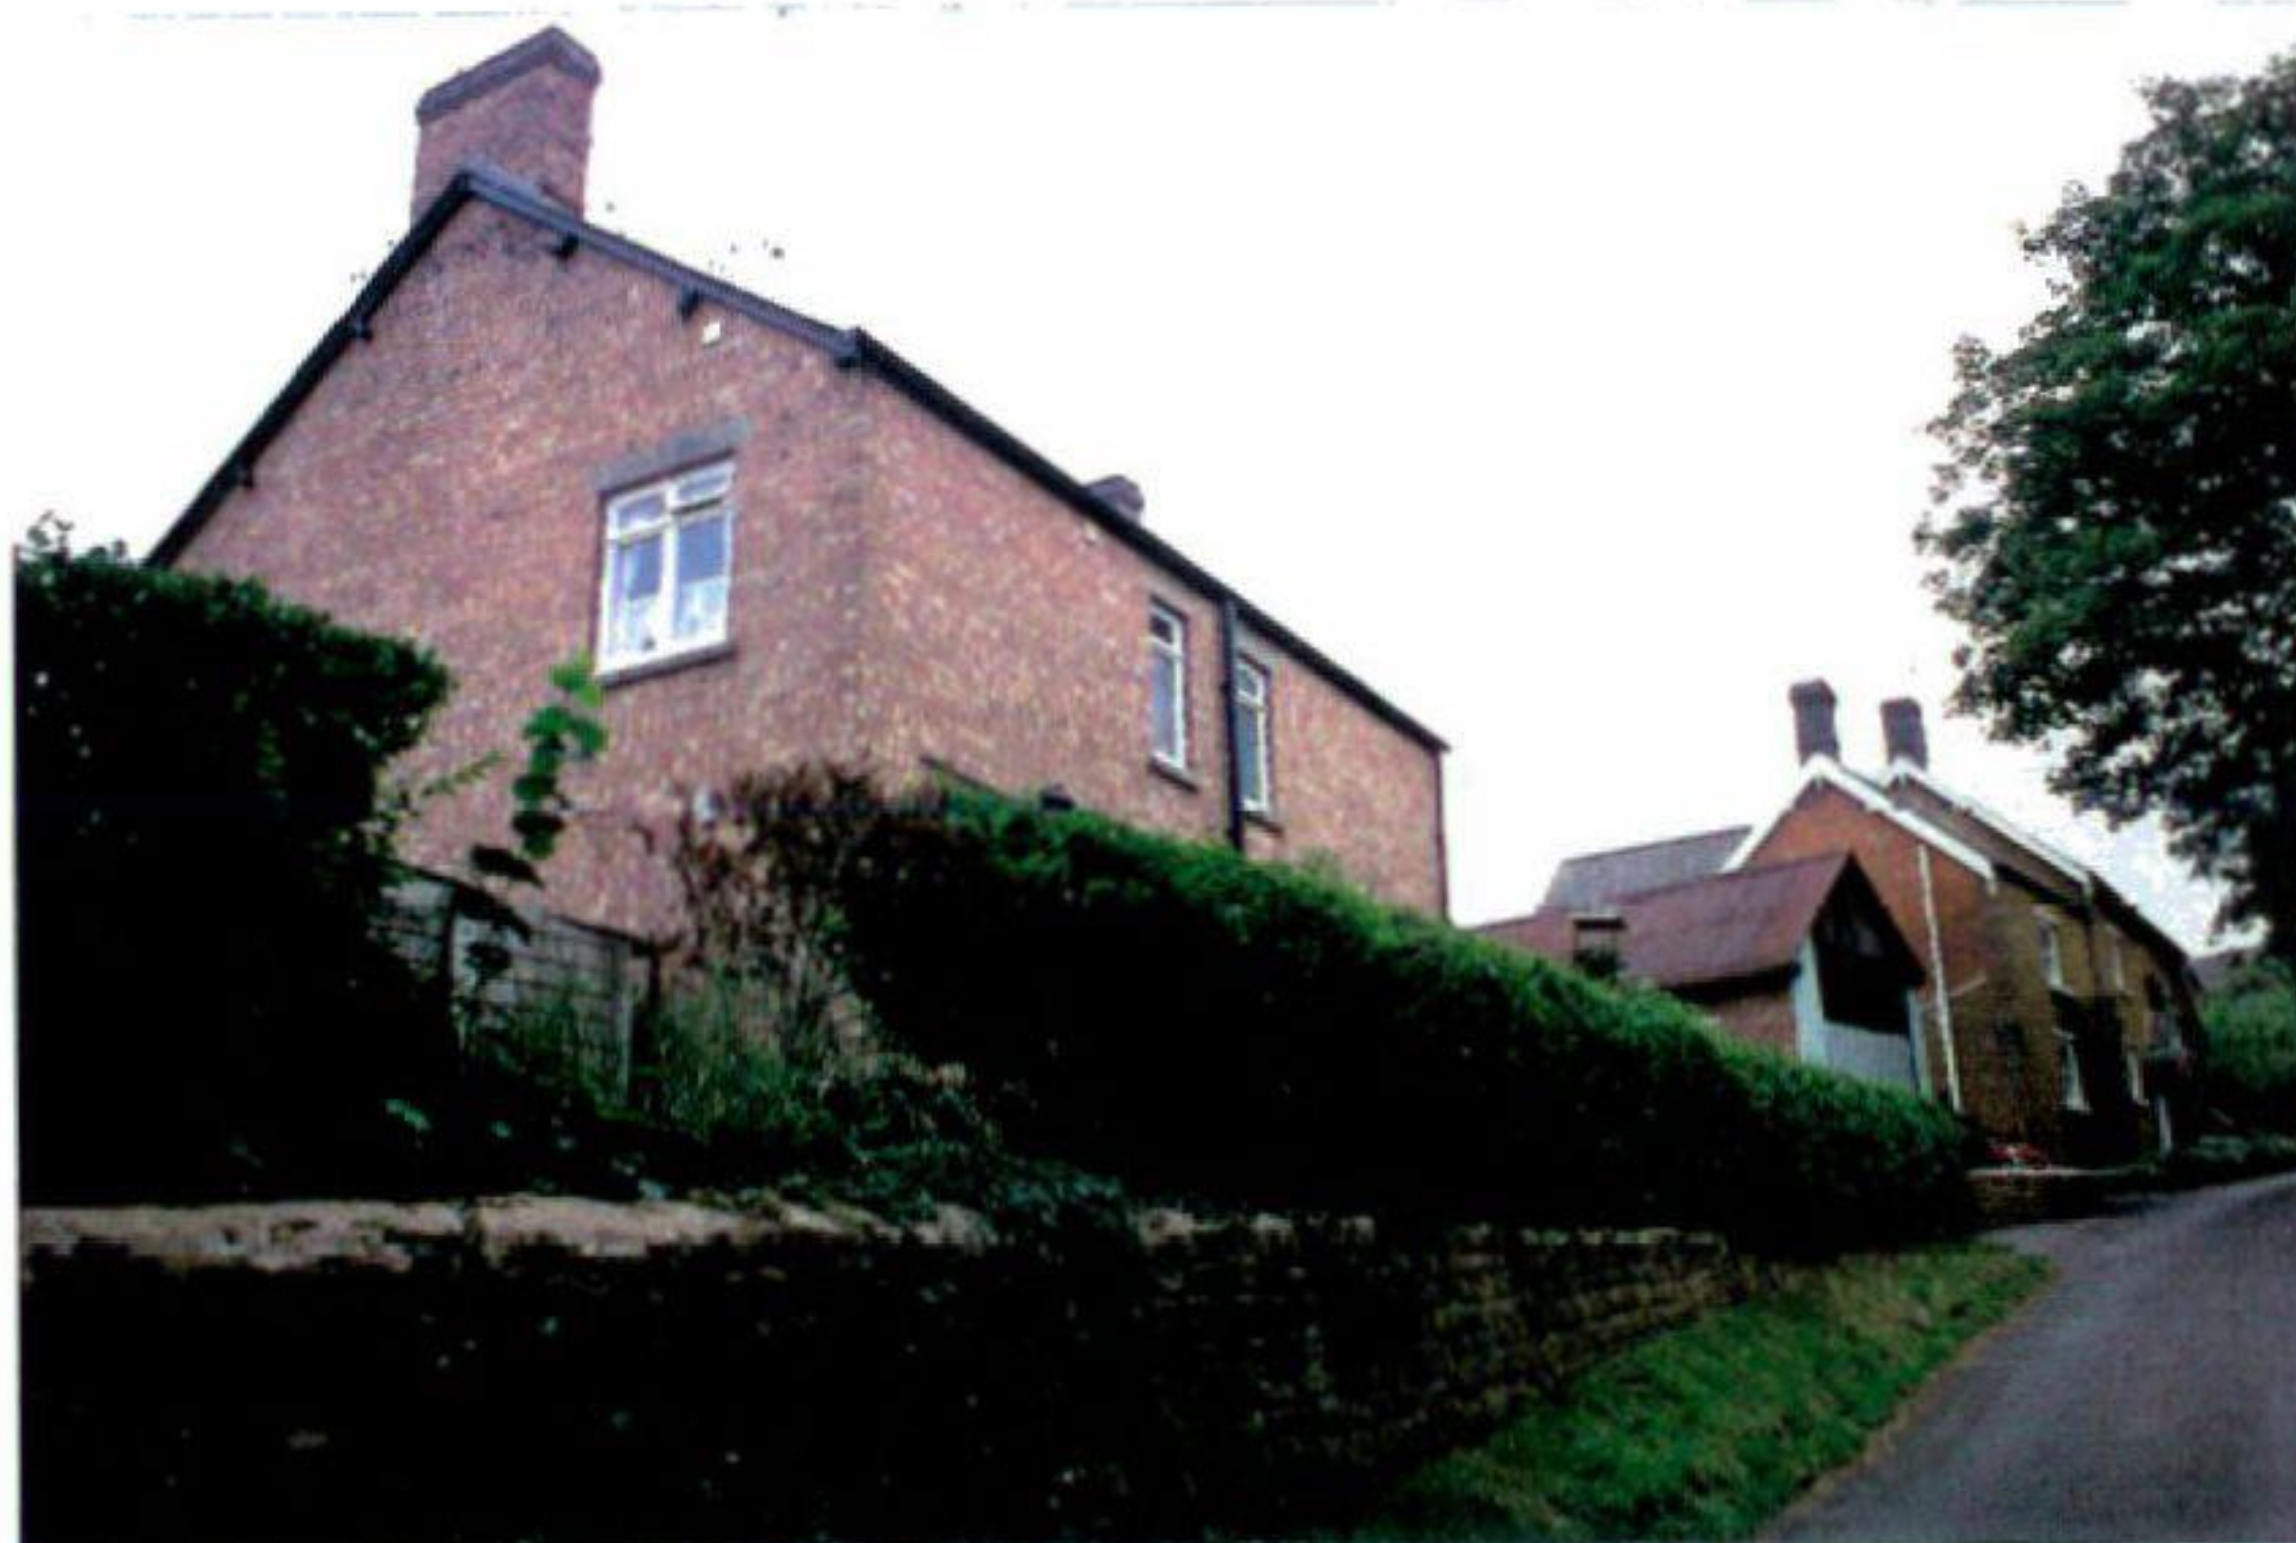
Unsympathetic materials,
Mollington Road.

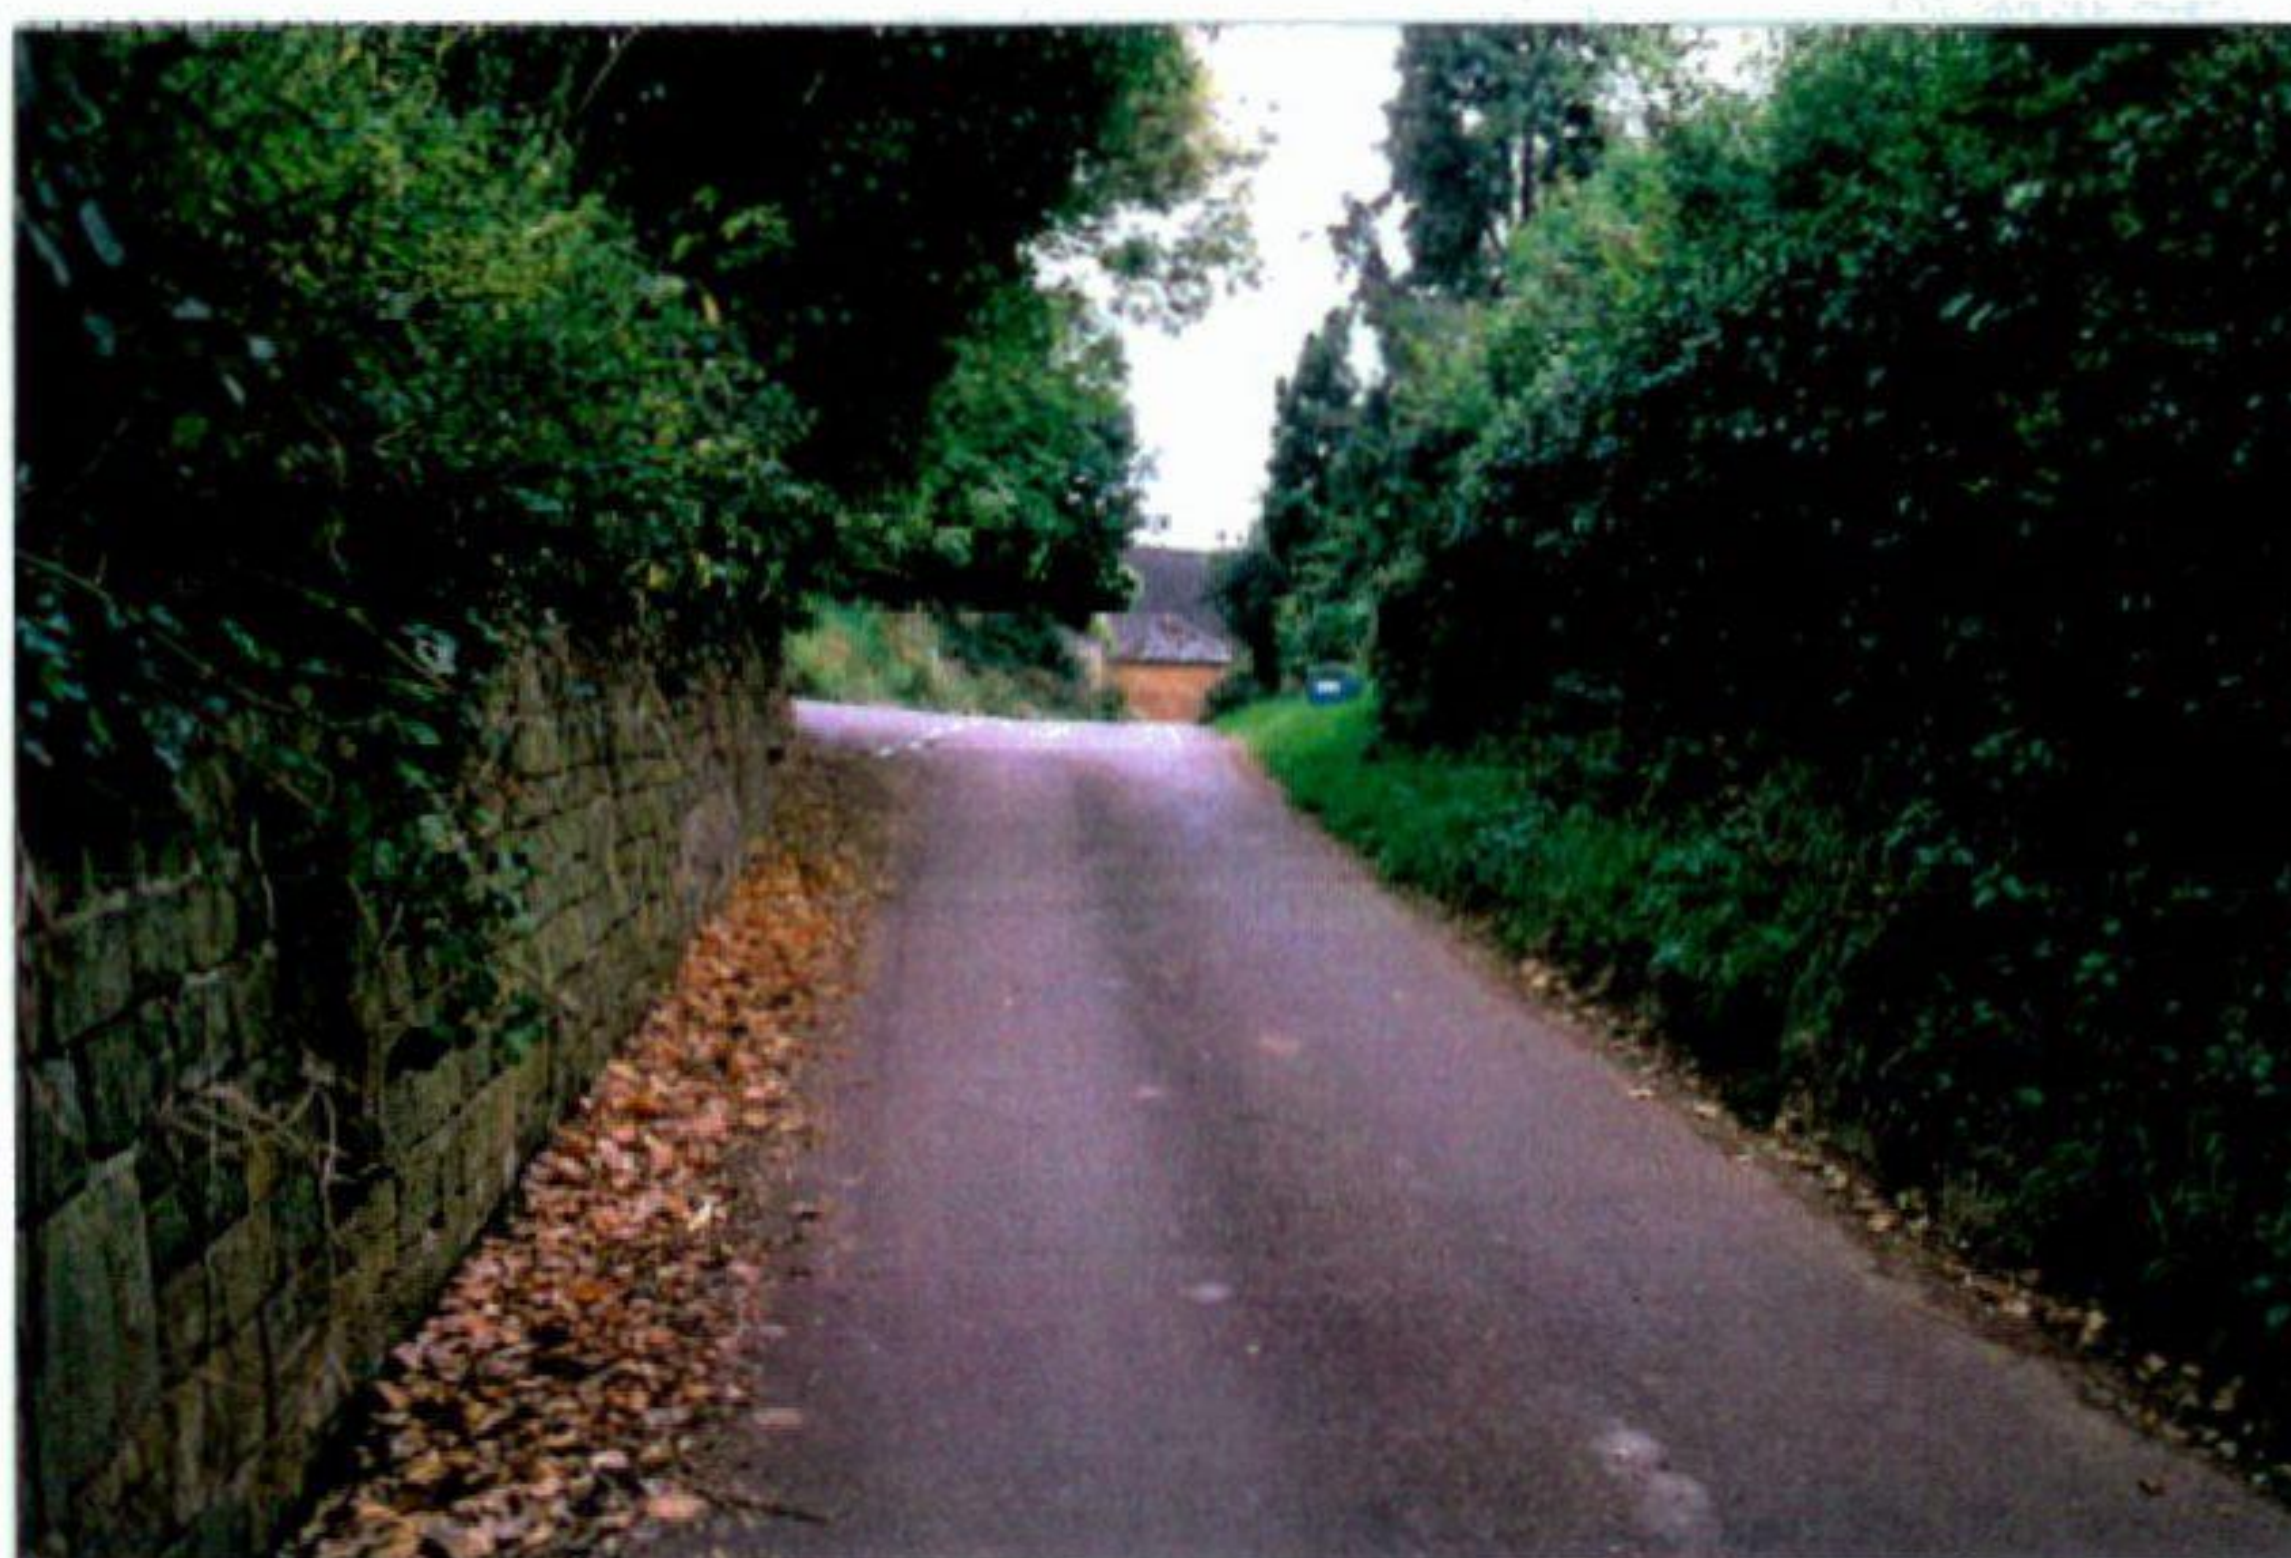
Coursed stone walling and green banks,
Middle Lane.

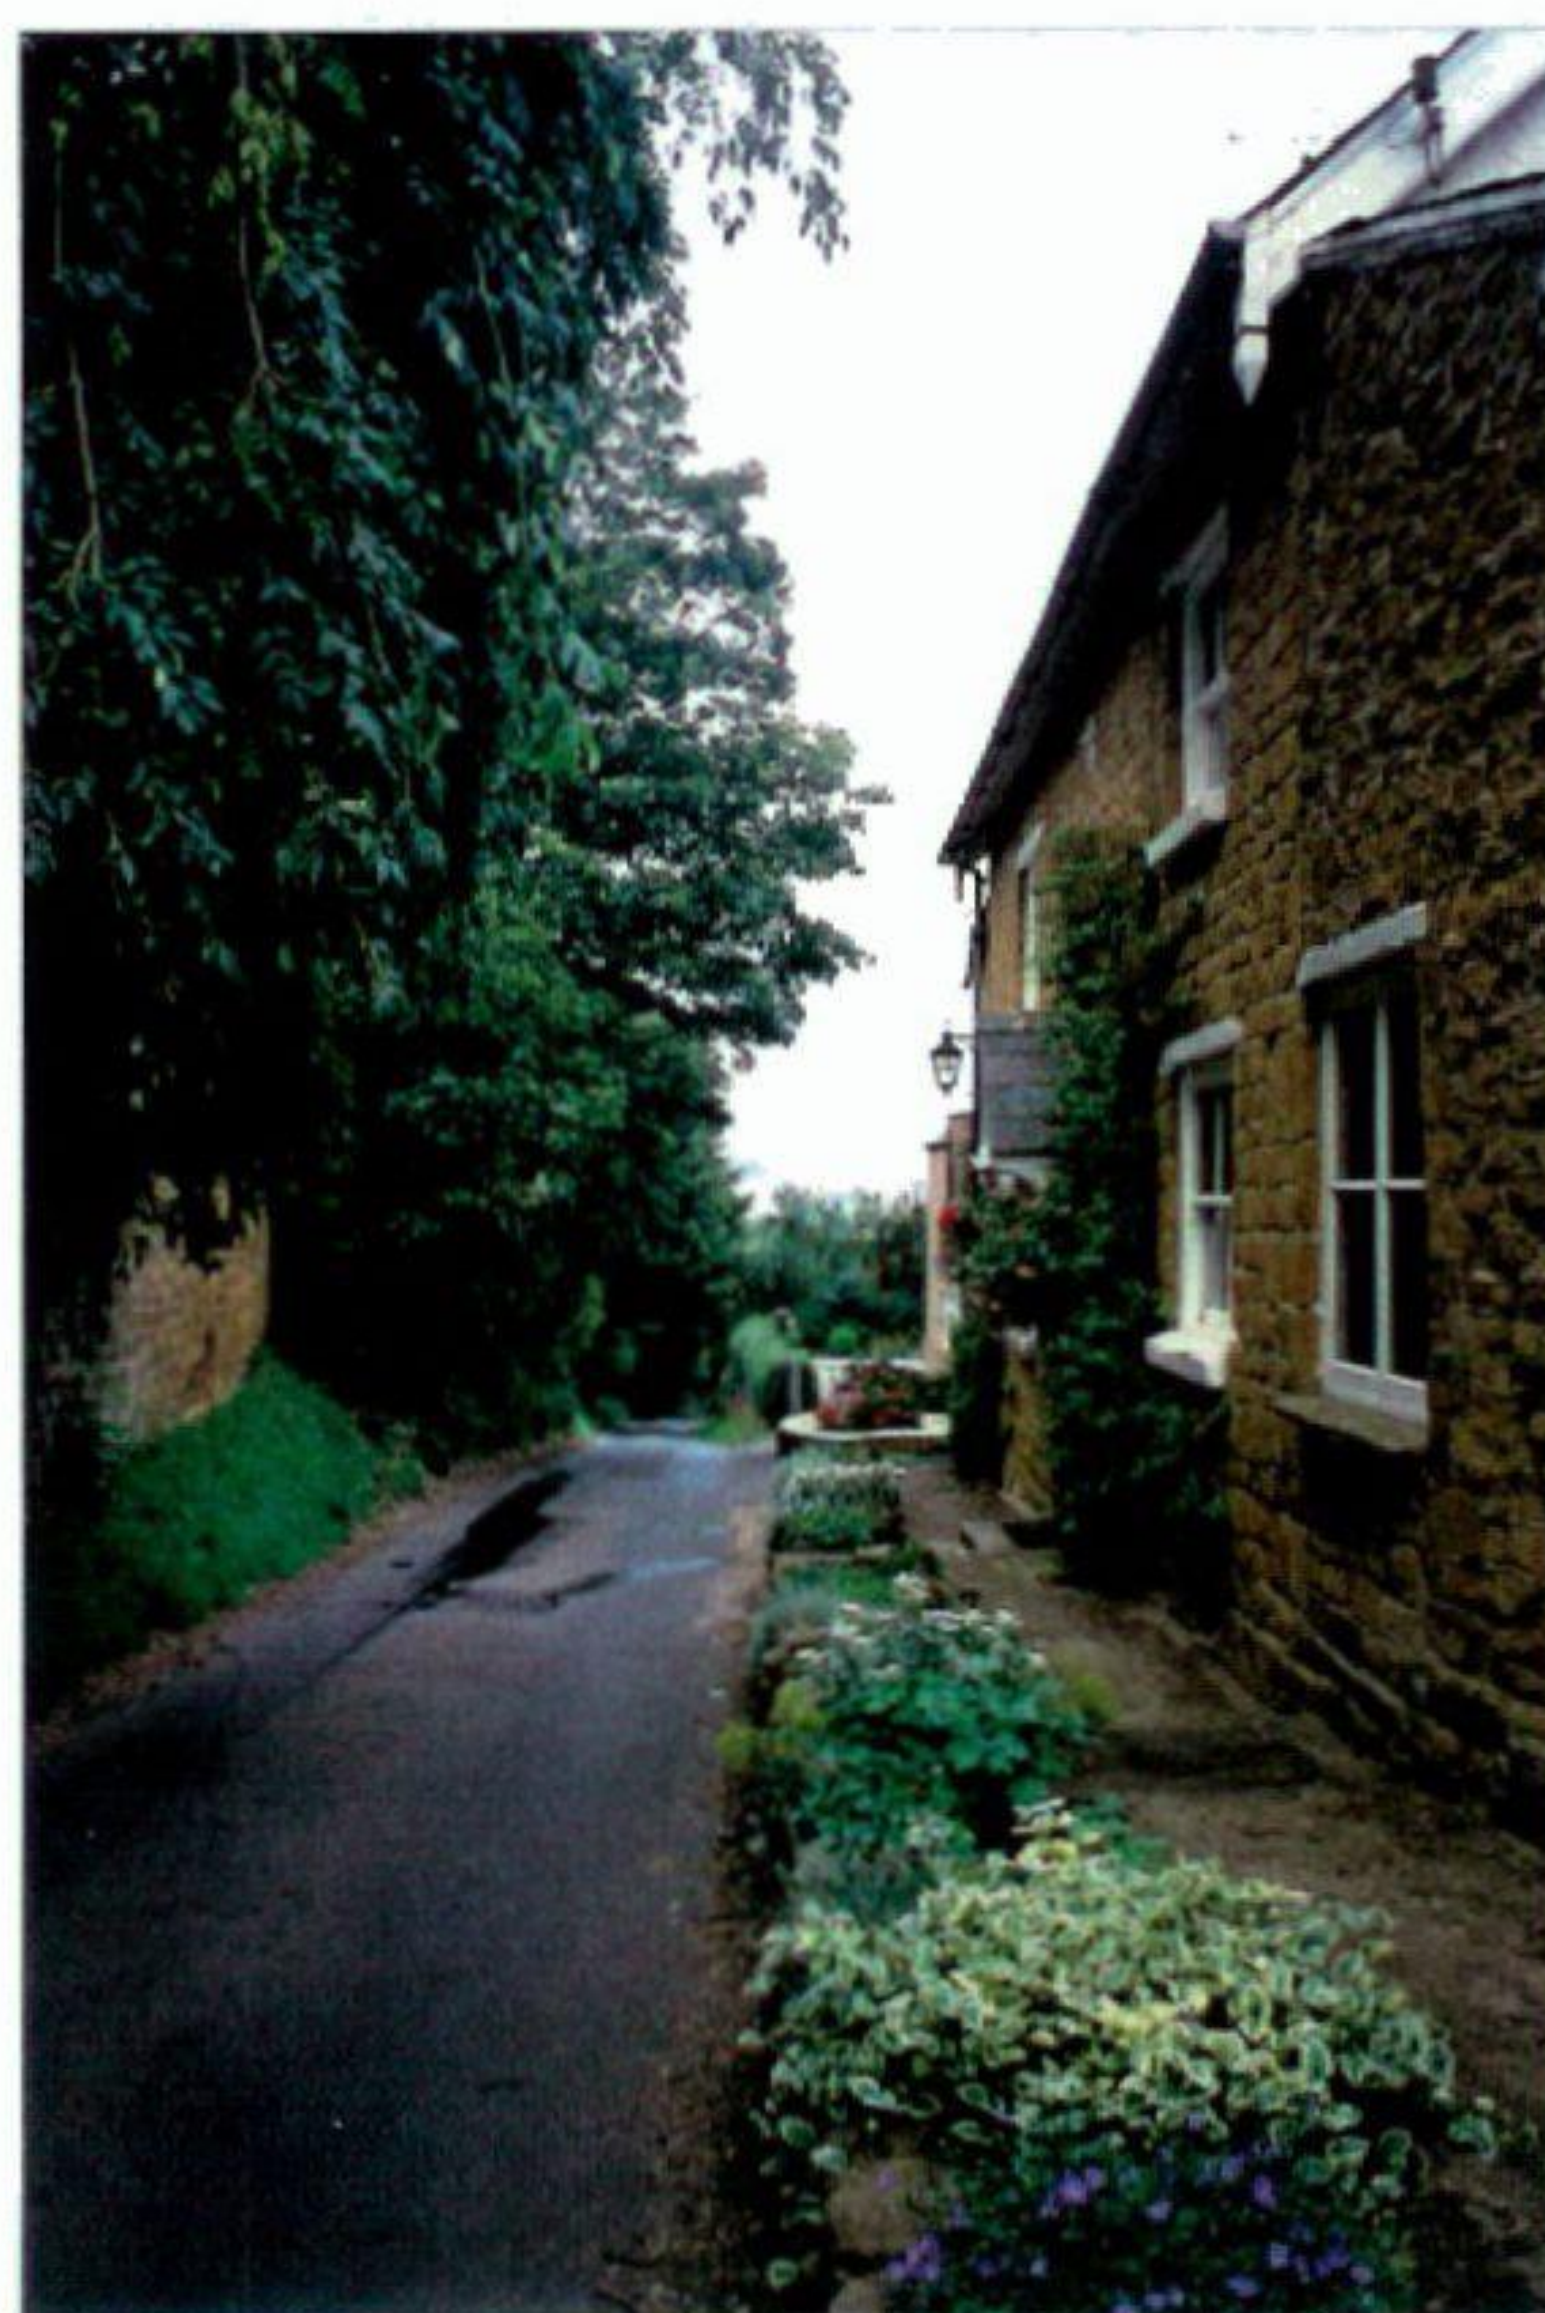
Roadside buildings and verges,
White Cottages, Mollington Road.

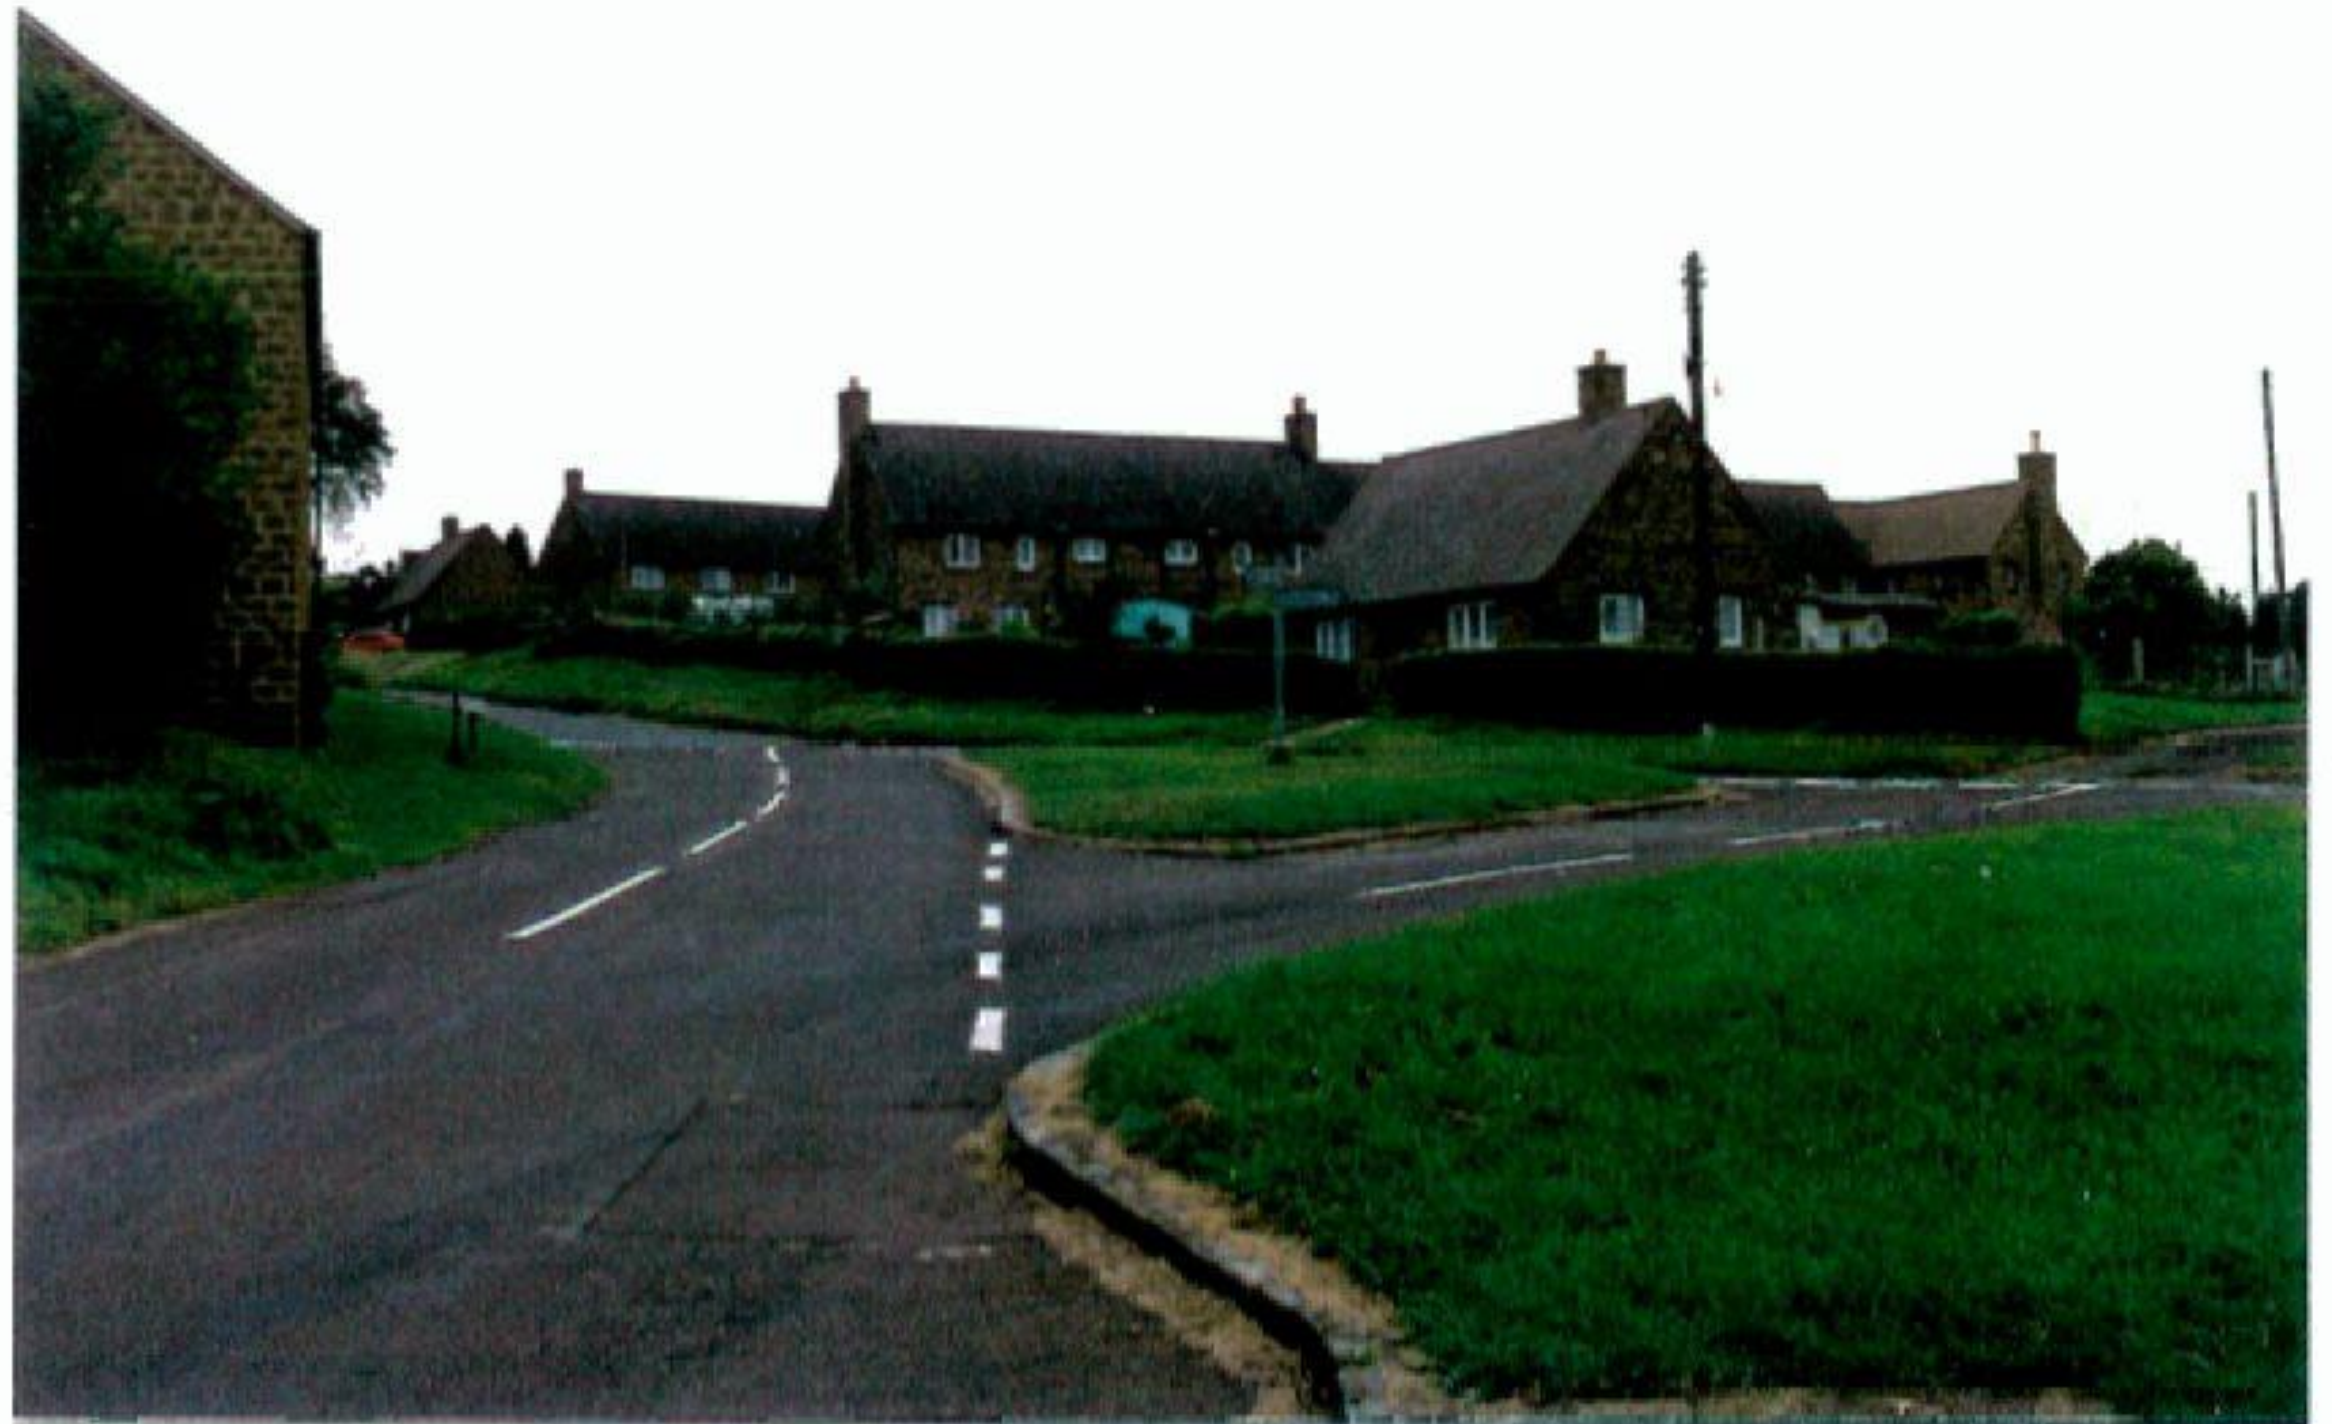
New Road council housing.

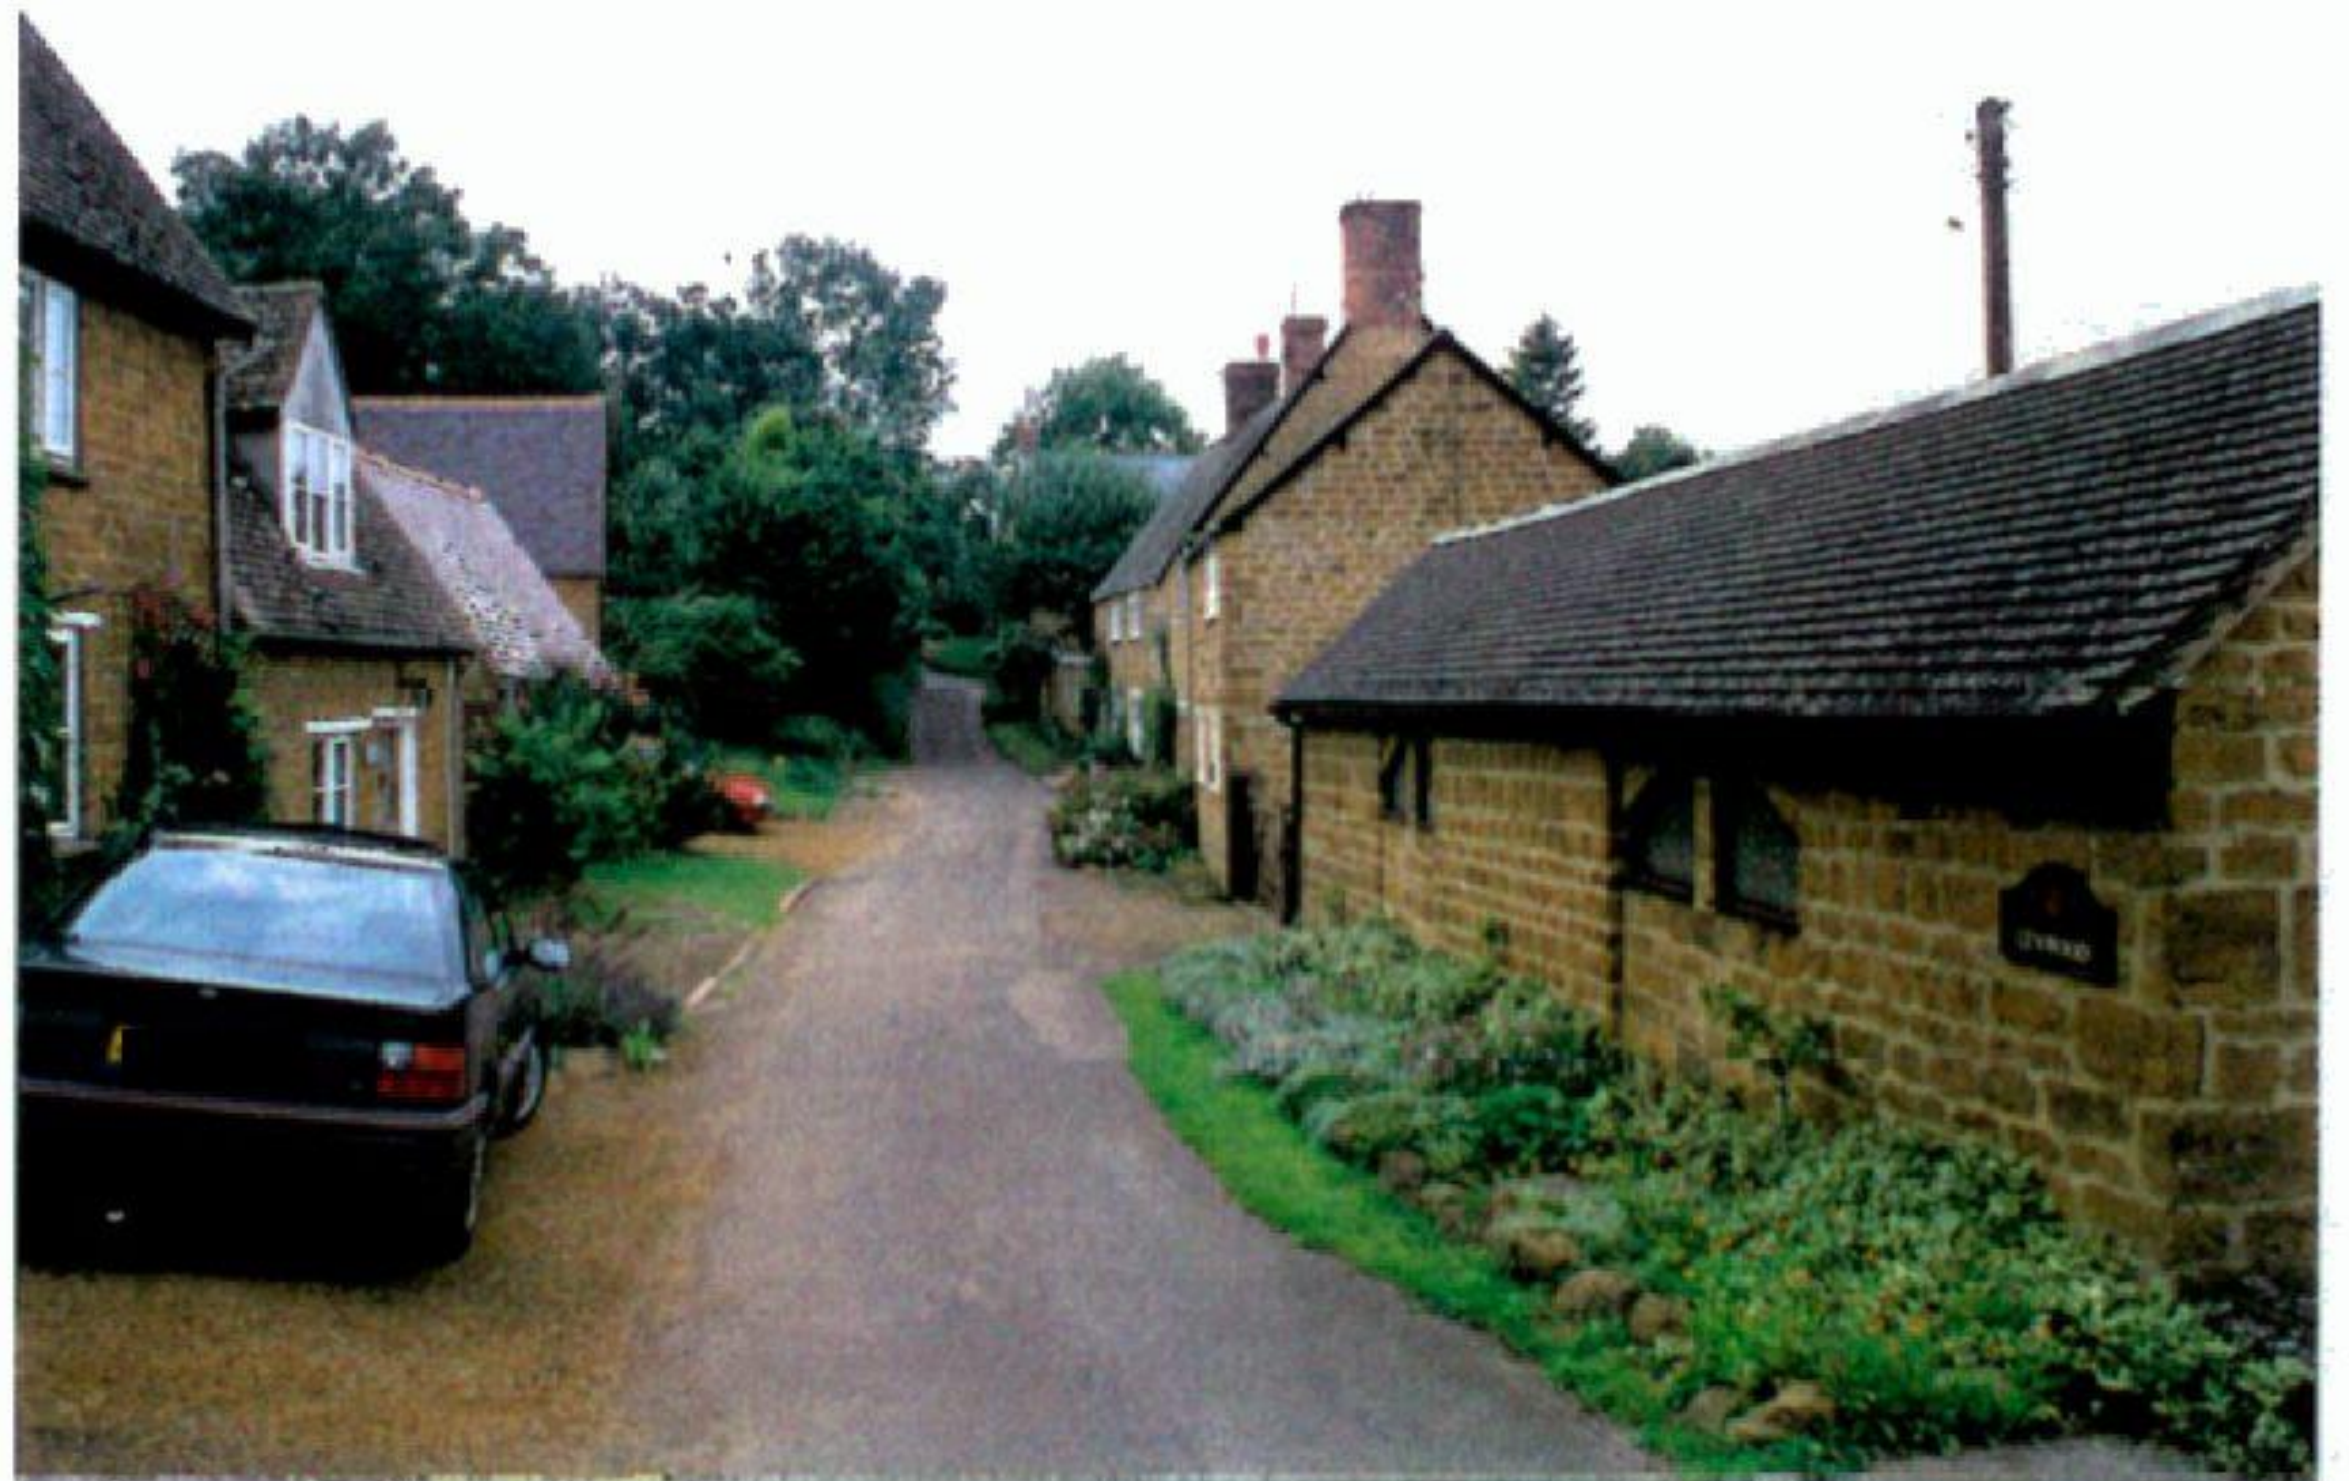
Infill and conversion, Snuff Lane
