*Shotteswell
Conservation Area*

Shankland Cox

April 1994

Shotteswell Conservation Area

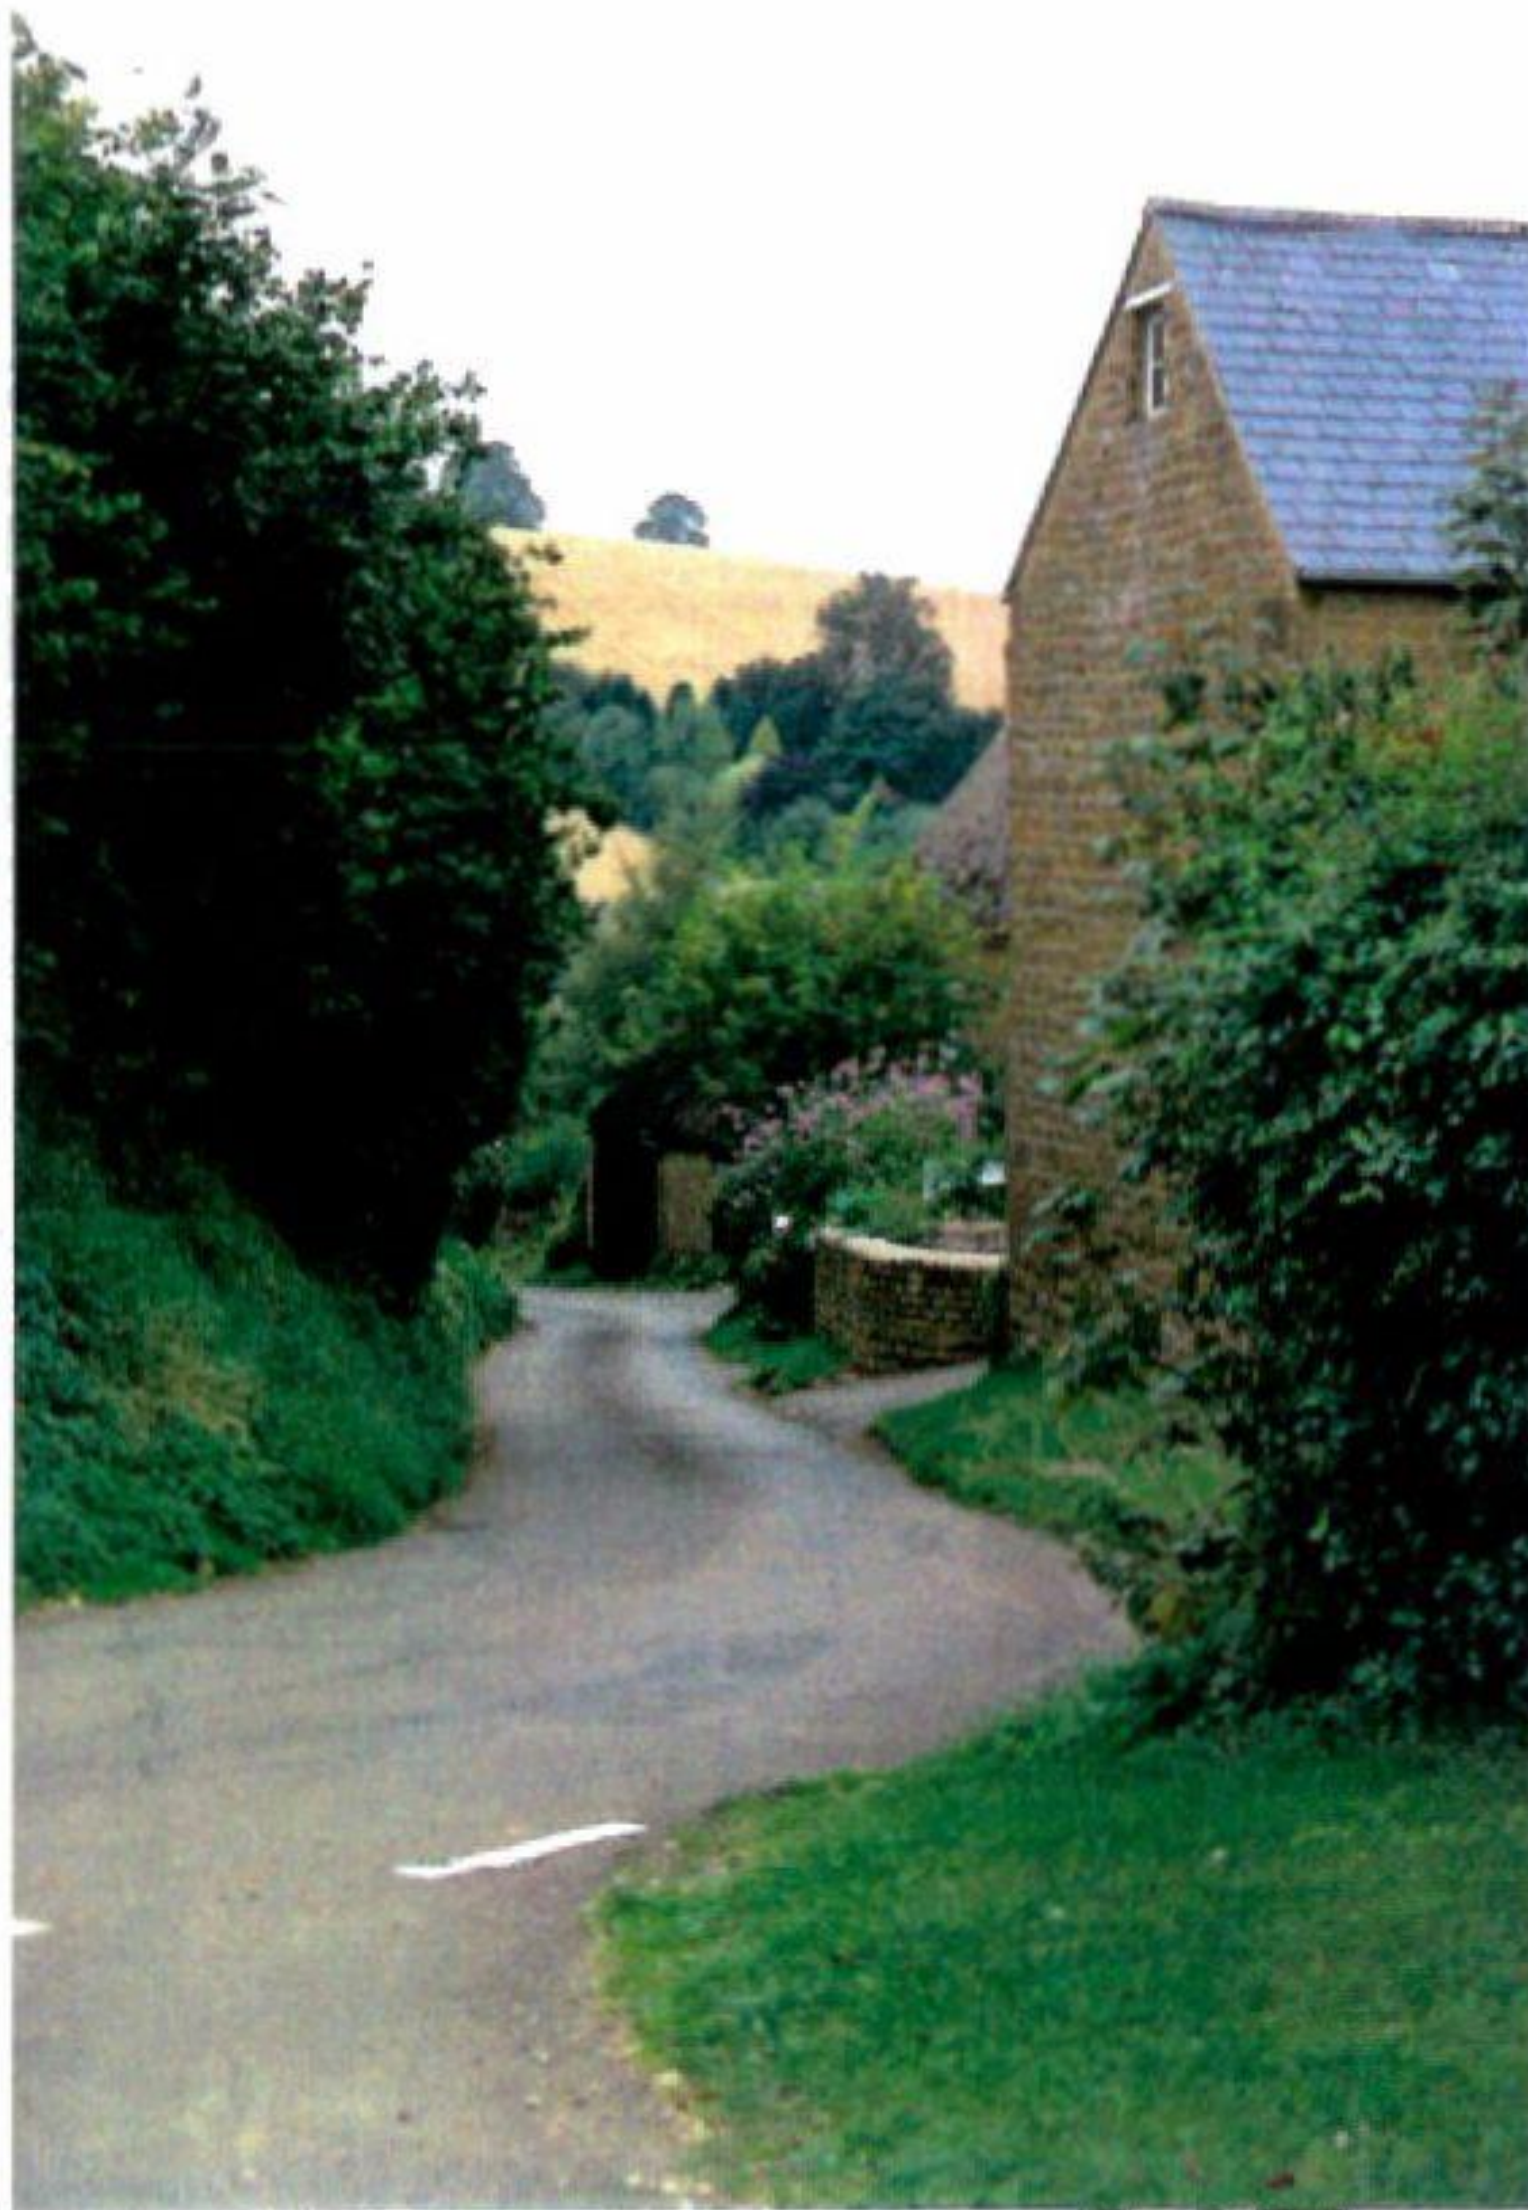
Views and Vistas

Bakehouse Lane.

Middle Lane drops steeply eastwards from the green, down into the lower half of the village where Bakehouse Lane connects it with Mollington Road. Rather like Mollington Road, it is characteristically winding and very steep, bounded by banks, walls and lush foliage. Entry into the upper end of the lane is undramatic, as the green gives way to verges and open gardens, passing a rustic stone bus shelter which could benefit from a little care. Then at Pedlars Cottage, the buildings set forward almost onto the road, the banks opposite steepen, and the gradient increases.

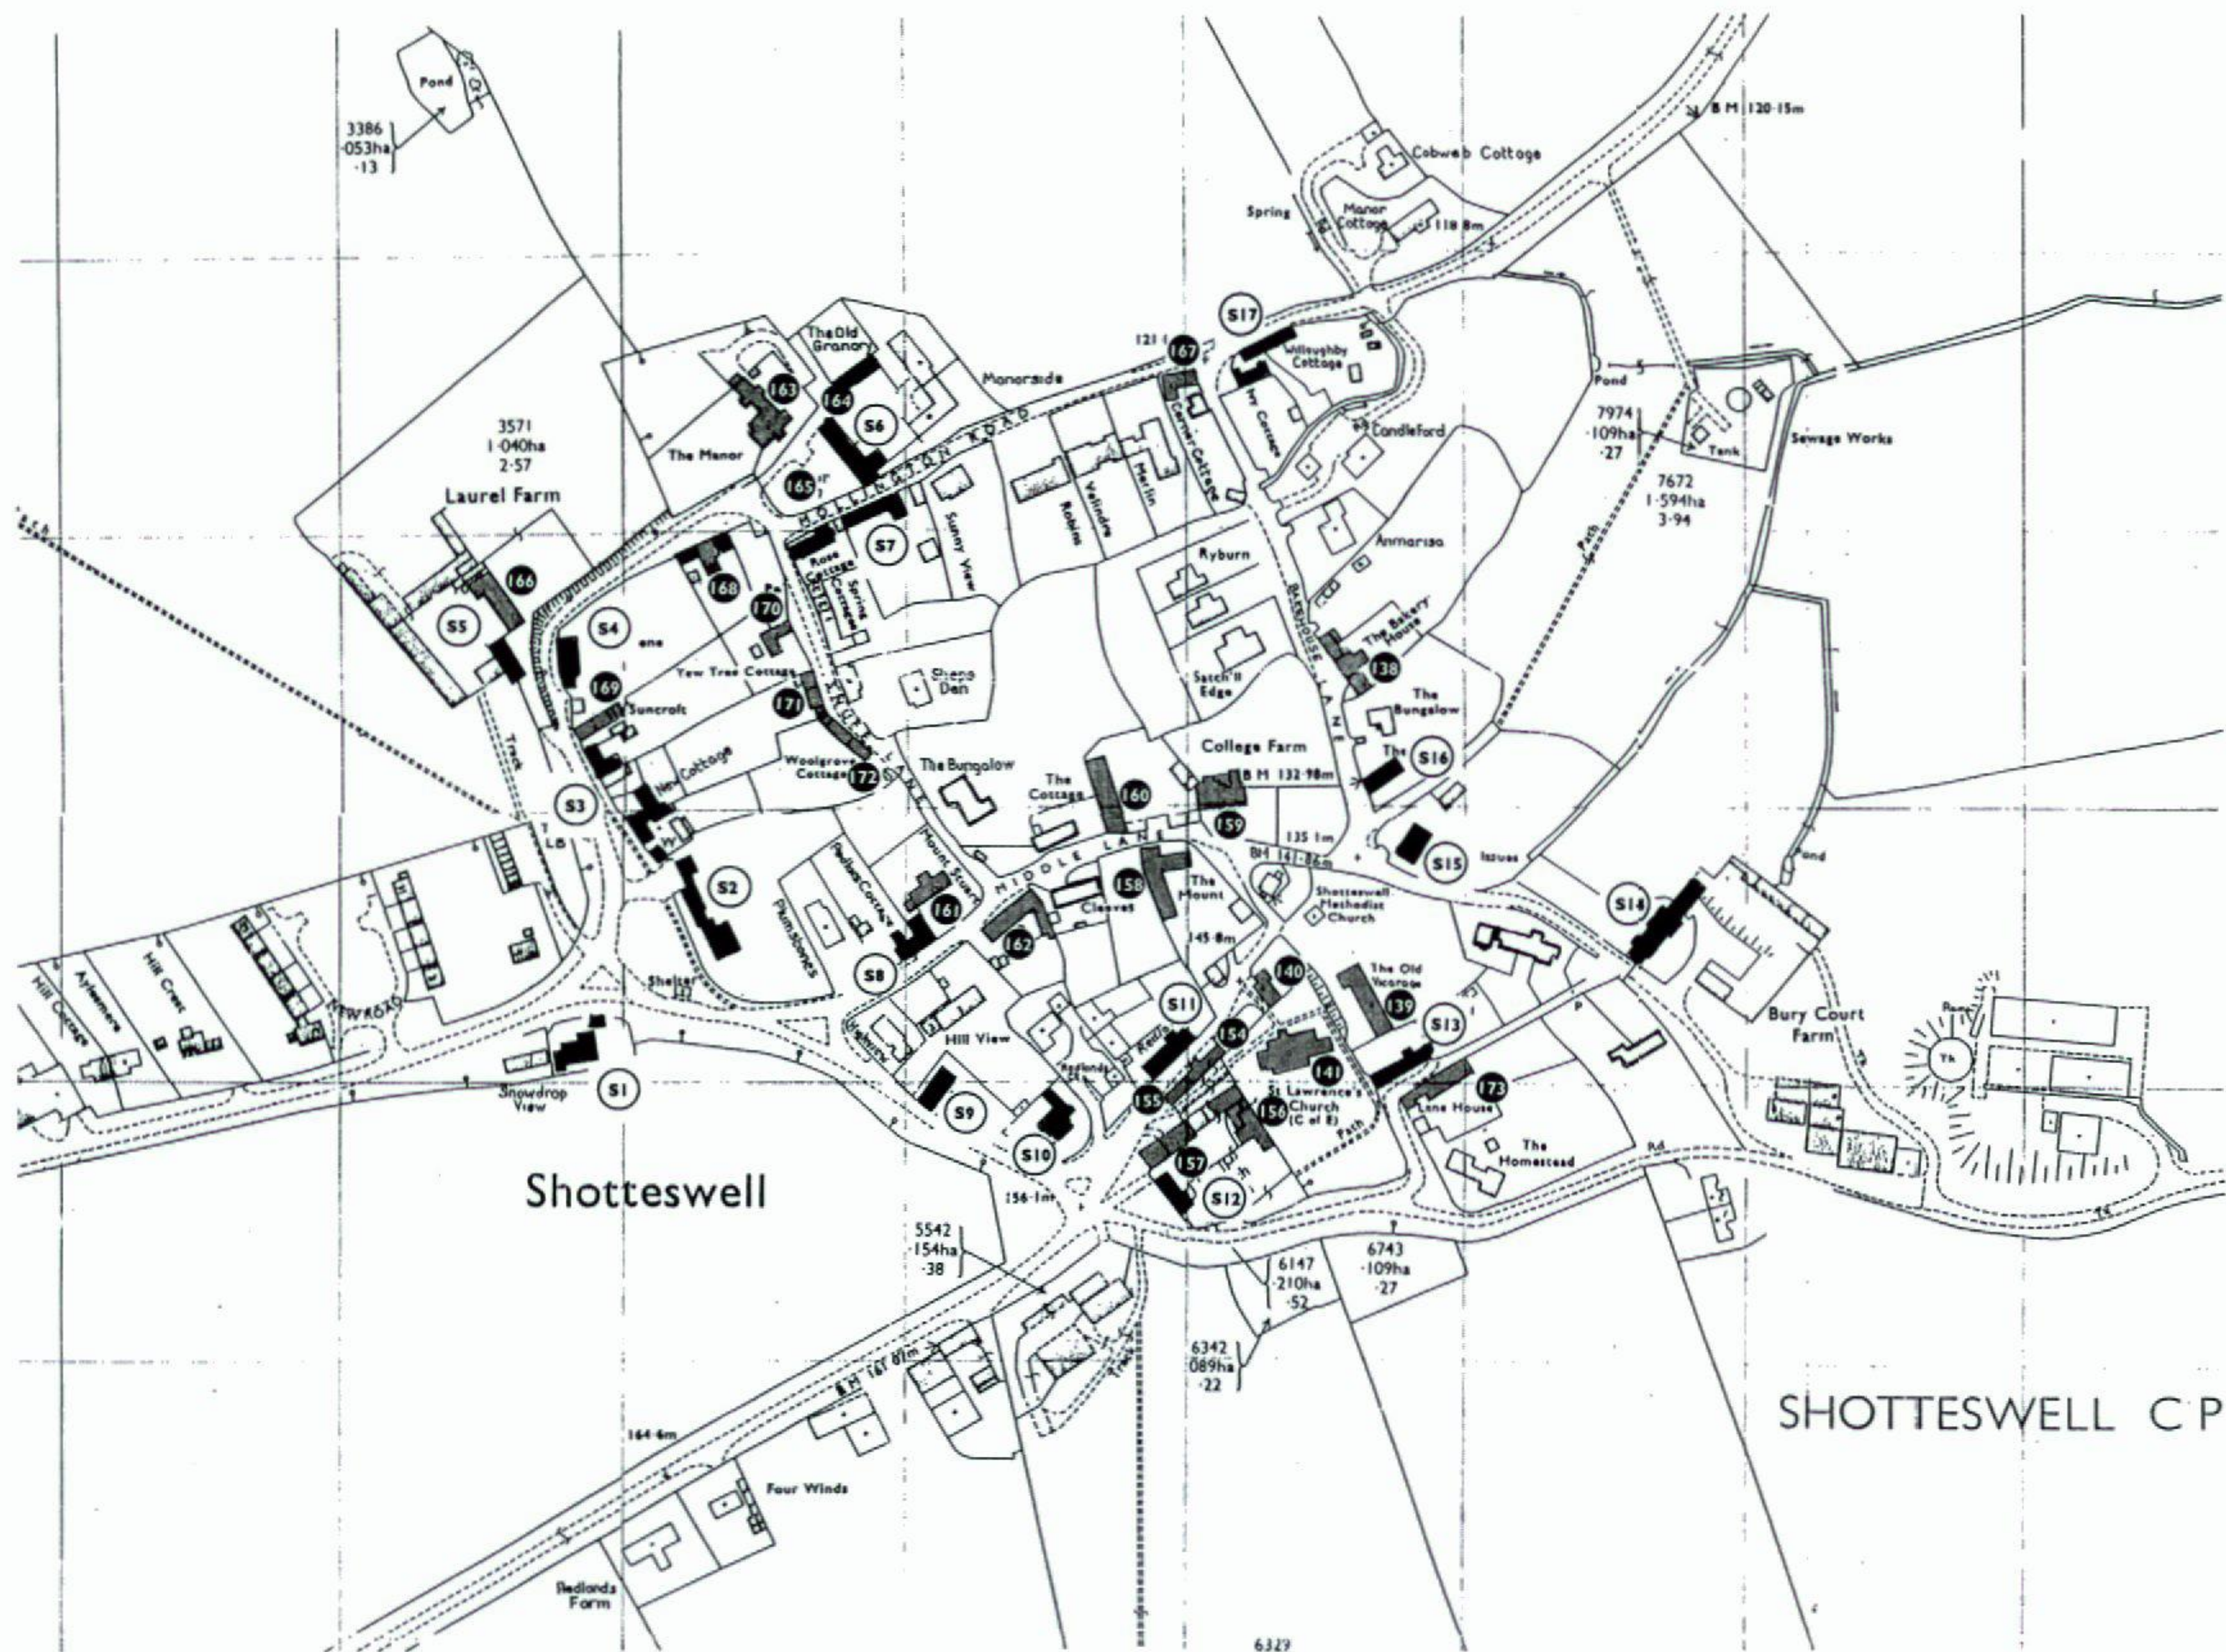
- Listed Buildings
- Listed Building Schedule Number
- Buildings of Group Value
- Group Value Schedule Number

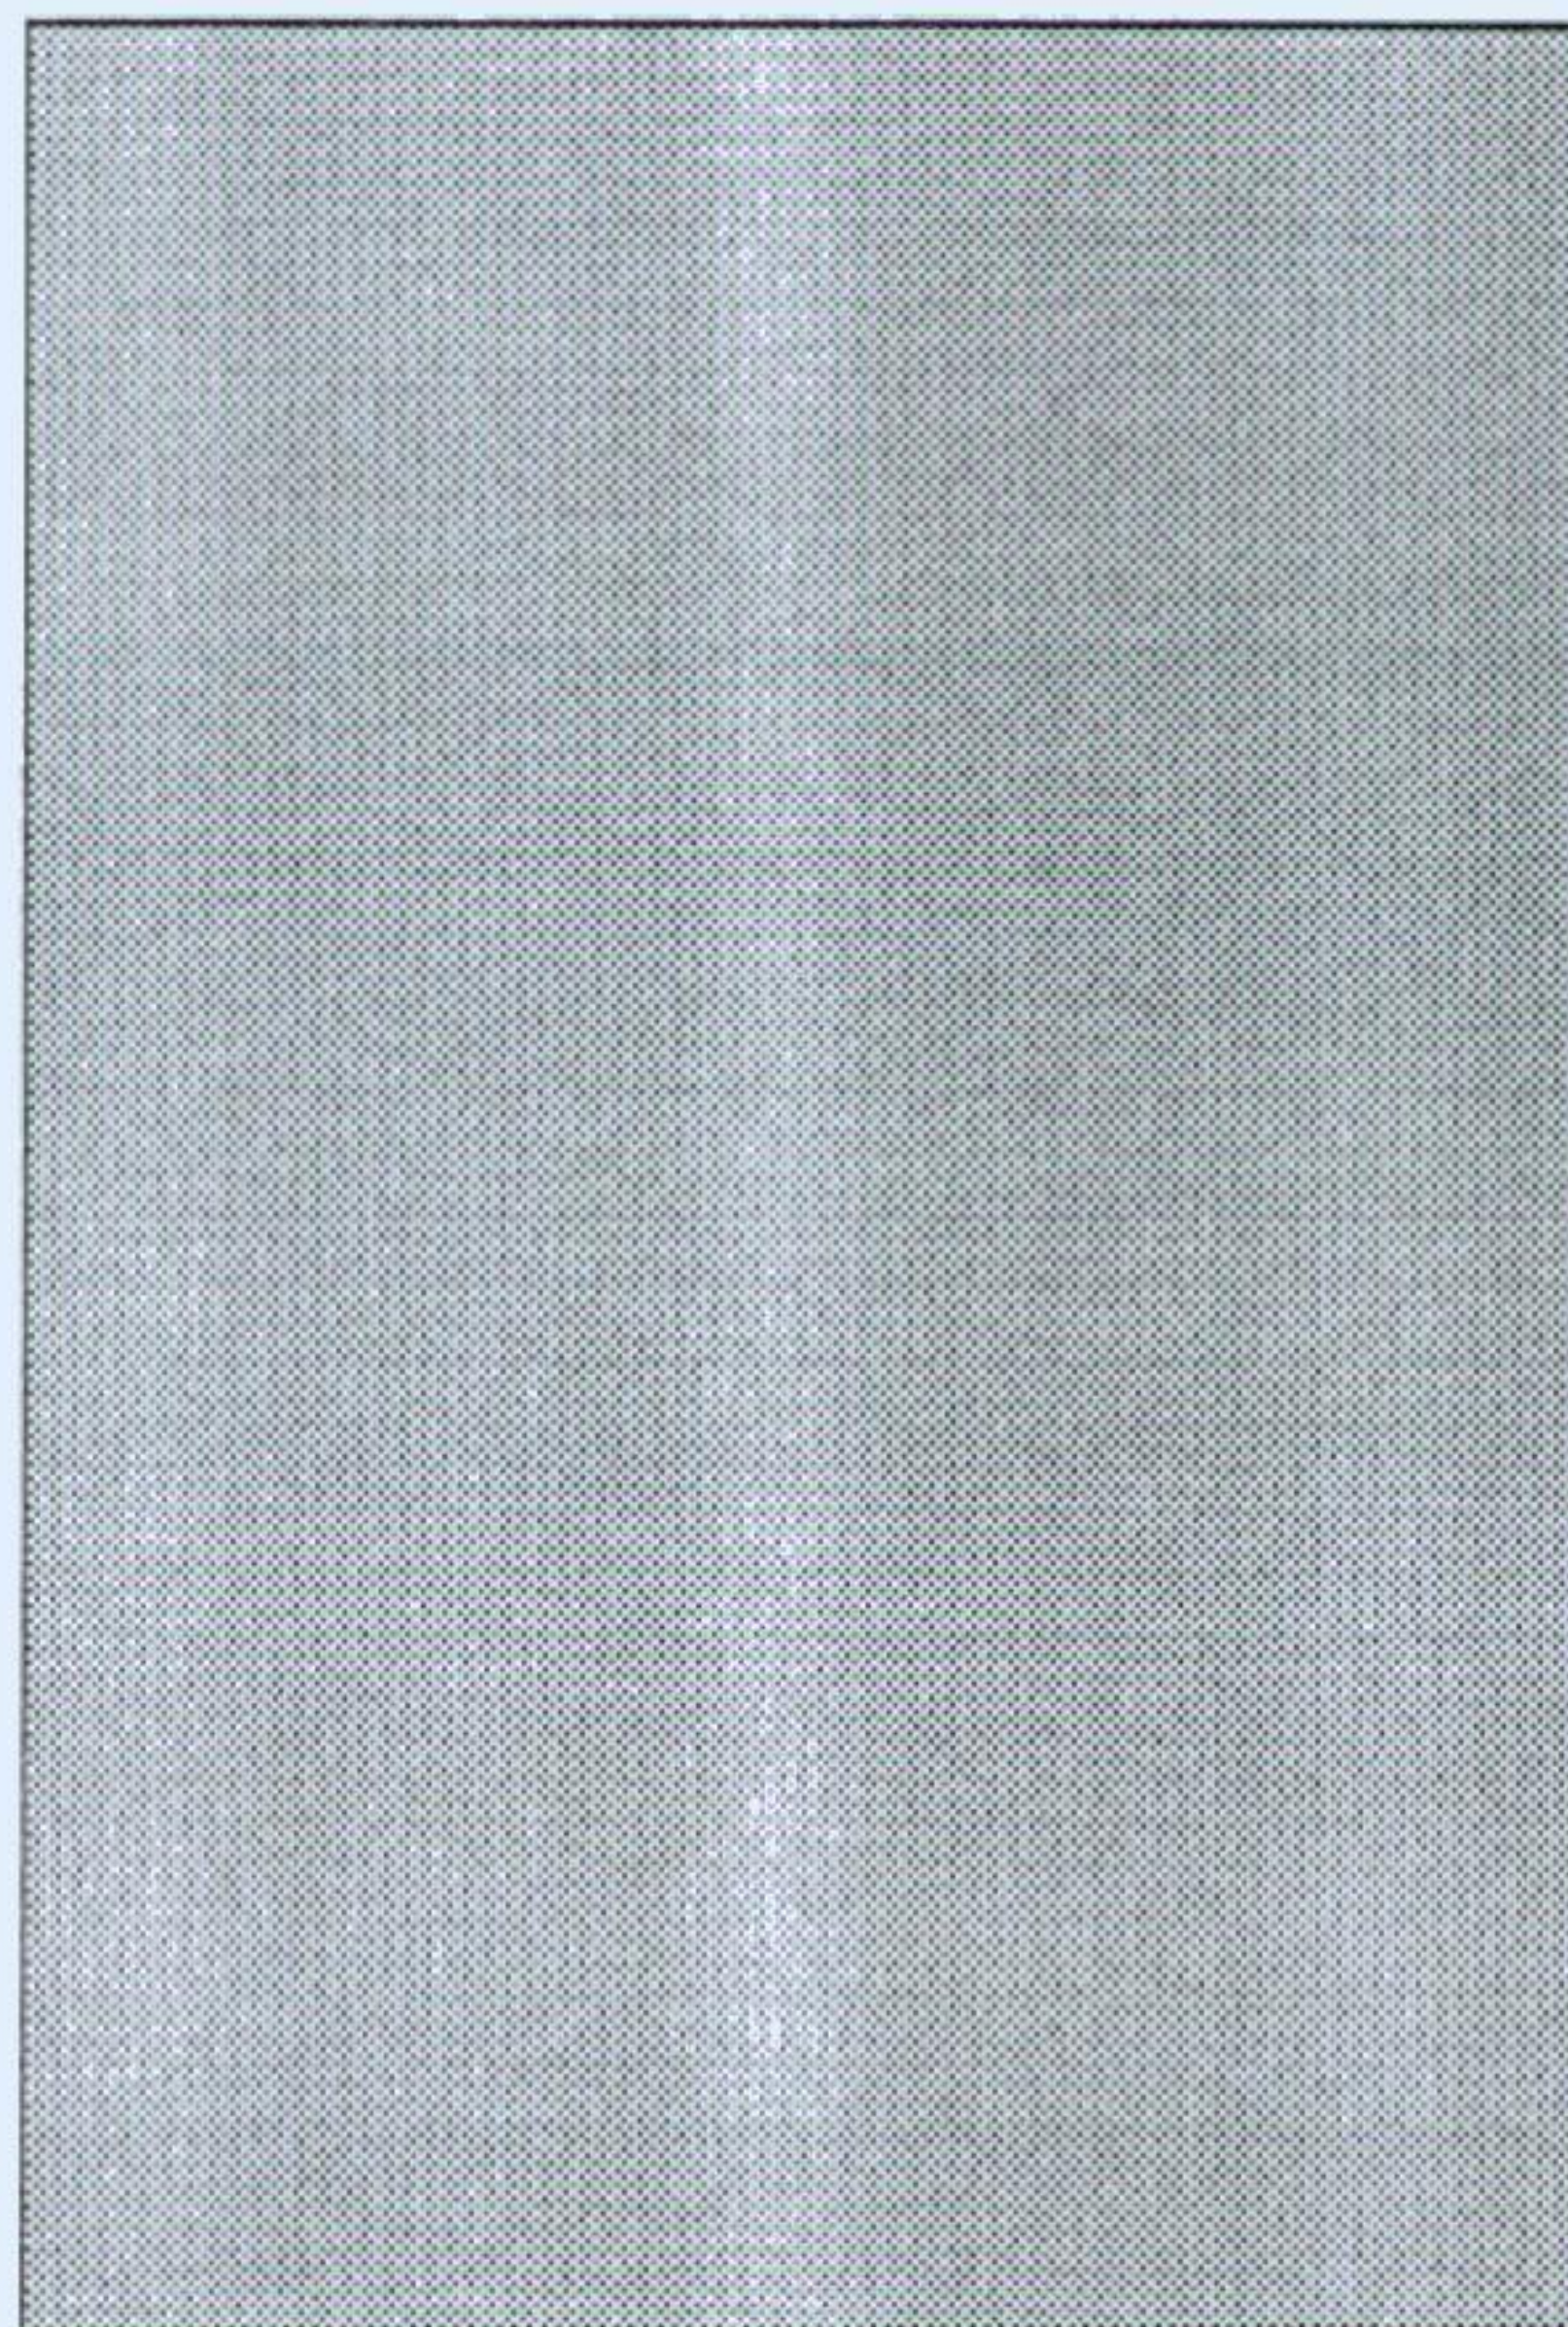
Address: Fairview Cottage
Ref No: 140
Grade: II

Shown on O.S. map as Fair View. Cottage. C18 with C19 and C20 alterations and additions. Coursed ironstone. C20 tile roof; stone and brick end stack to right. One-unit plan. 2 storeys and attic. One-window range. Gable end to road. Entrance side has porch on left with window, and half-glazed 4-panelled door in right return side. Late C20 casements; wood lintels. Left return side to churchyard has windows of 3 fixed lights. Simple 2-light chamfered stone-mullioned attic window. Right return side largely hidden by single-storey additions. Bricked-up door to rear. Interior not inspected. Prominent position adjacent to Churchyard and path to Church. Included for group value.

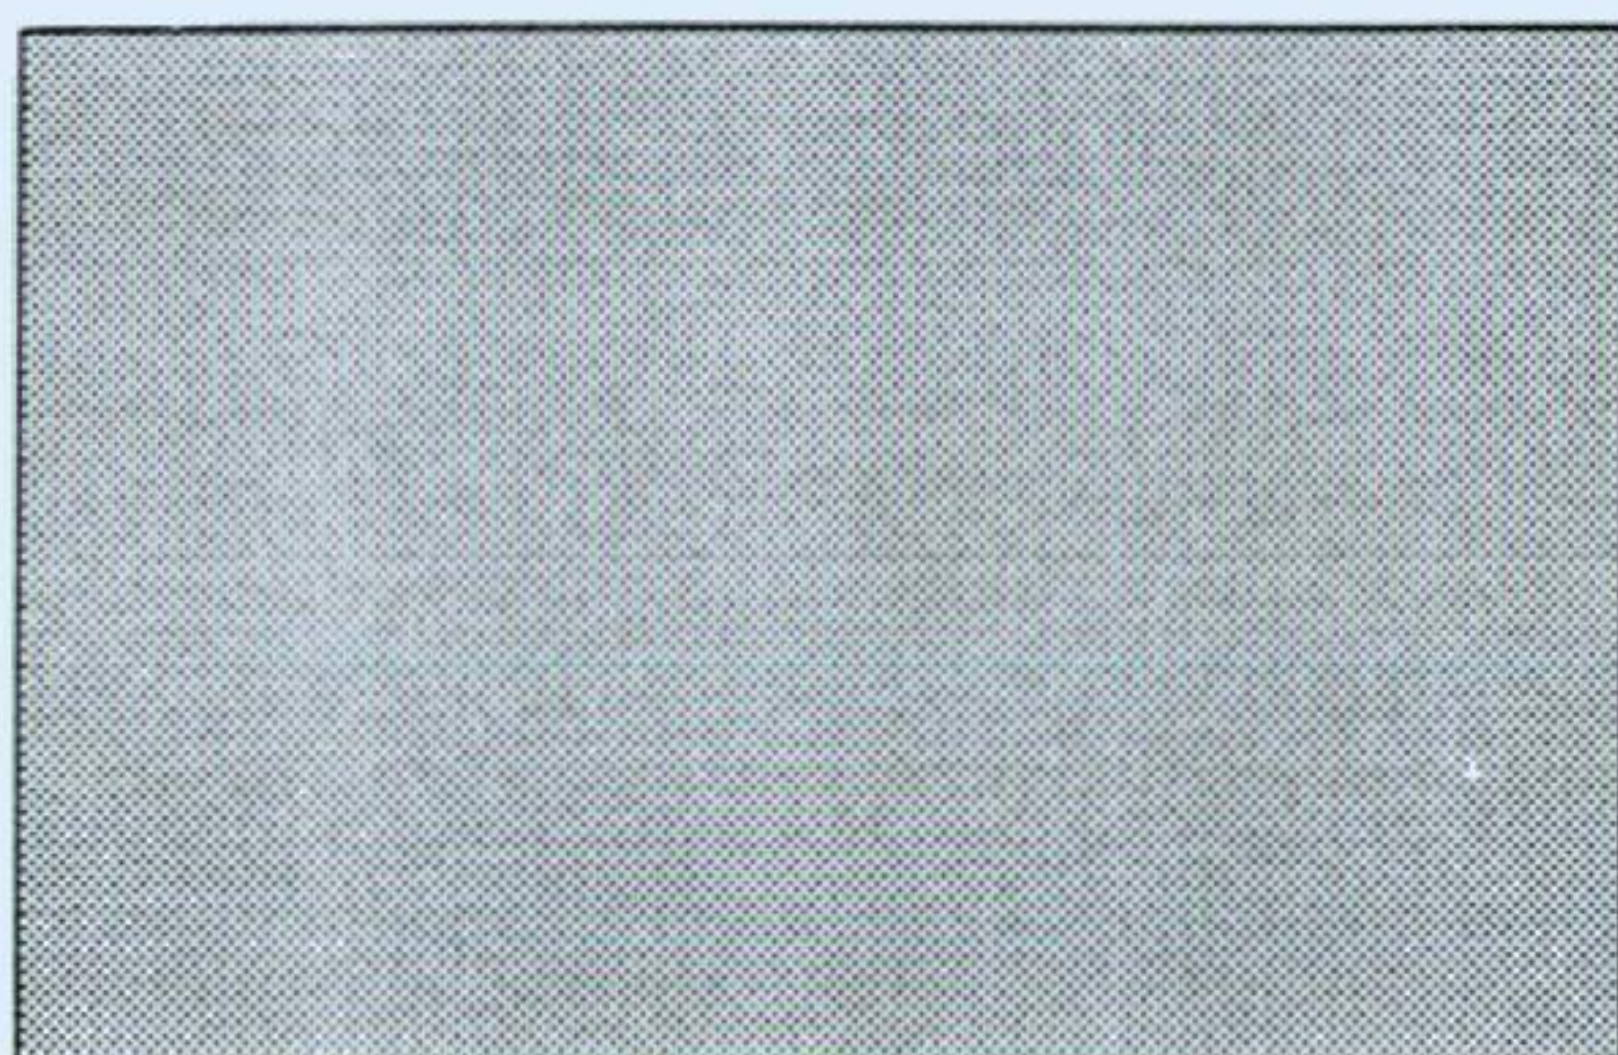
Address: Barn approx. 10m. SW of
Church Farmhouse
Ref No: 157
Grade: II

Barn. Late C17/C18. Regular coursed ironstone. Corrugated asbestos roof with coped gable parapet. 5 bays. Front to road has central doorway, without doors. Fourth bay has doorway with wood lintel above ground level. Right return side has pitch opening and gable parapet. Front to farmyard has central sliding door. Plank door on left. Wood lintels. Interior: stone wall, probably later, dividing off 2 bays, possibly used as stable. Collar and tie beam trenched purlin roof.

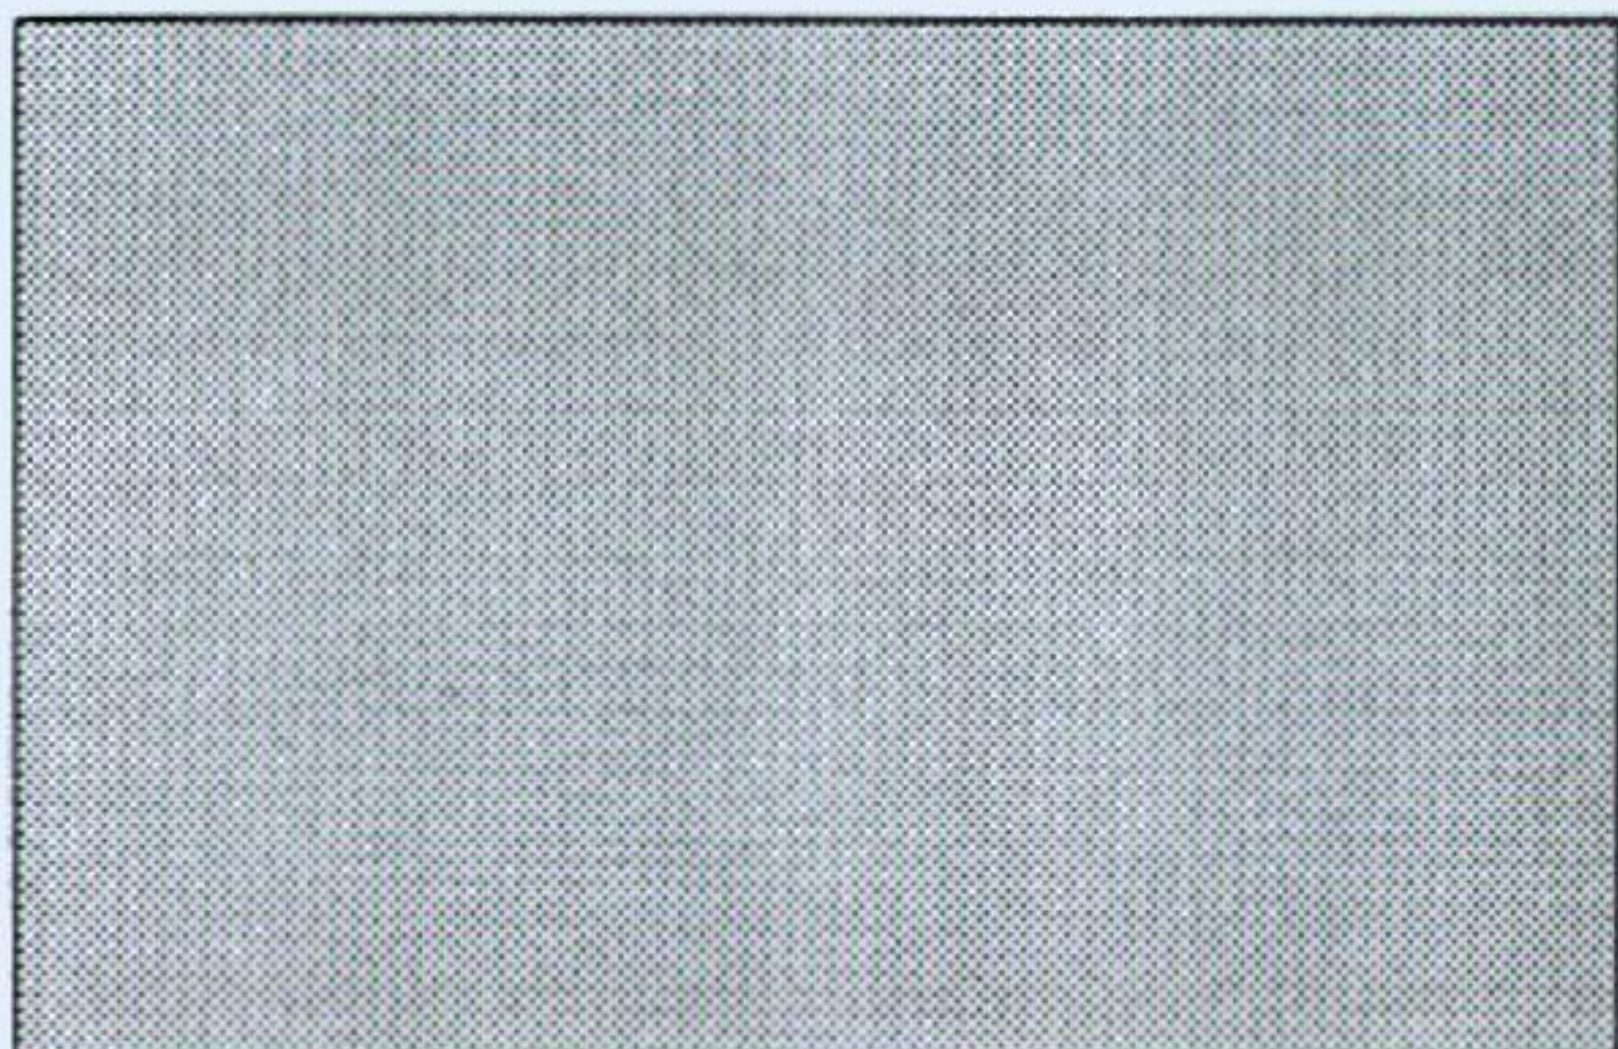
Address: College Farmhouse
Ref No: 159
Grade: II

Farmhouse, now house. Early C17, with C18 and C19 additions to rear. Regular coursed ironstone. Mid/late C20 tile roof; stone ridge stacks have rebuilt ashlar stacks, with splayed string course and cornice. 3-unit lobby entry plan. 2 storeys and attic; 3-window range. Entrance between second and third bays has chamfered Tudor-arched doorway with large lintel and hood mould; C20 door. C20 entrance inserted between first and second bays has stable door and wood lintel. 3 and 4-light stone-mullioned windows with hood moulds. Mid C20 roof dormer. Return sides have 4-, 3- and 2-light windows. To rear: C17/C18 staircase projection. C18 wing on left has slate roof. Cellar with door to garden and 2-light mullioned window. 3-light casement above. Right return side has door. C19 brick lean-to on right has slate roof. Interior: stepped-stop-broad chamfered ceiling beams. Open fireplace with bressumer, and C20 fireplace inserted. Some old plank doors. Winder stairs.

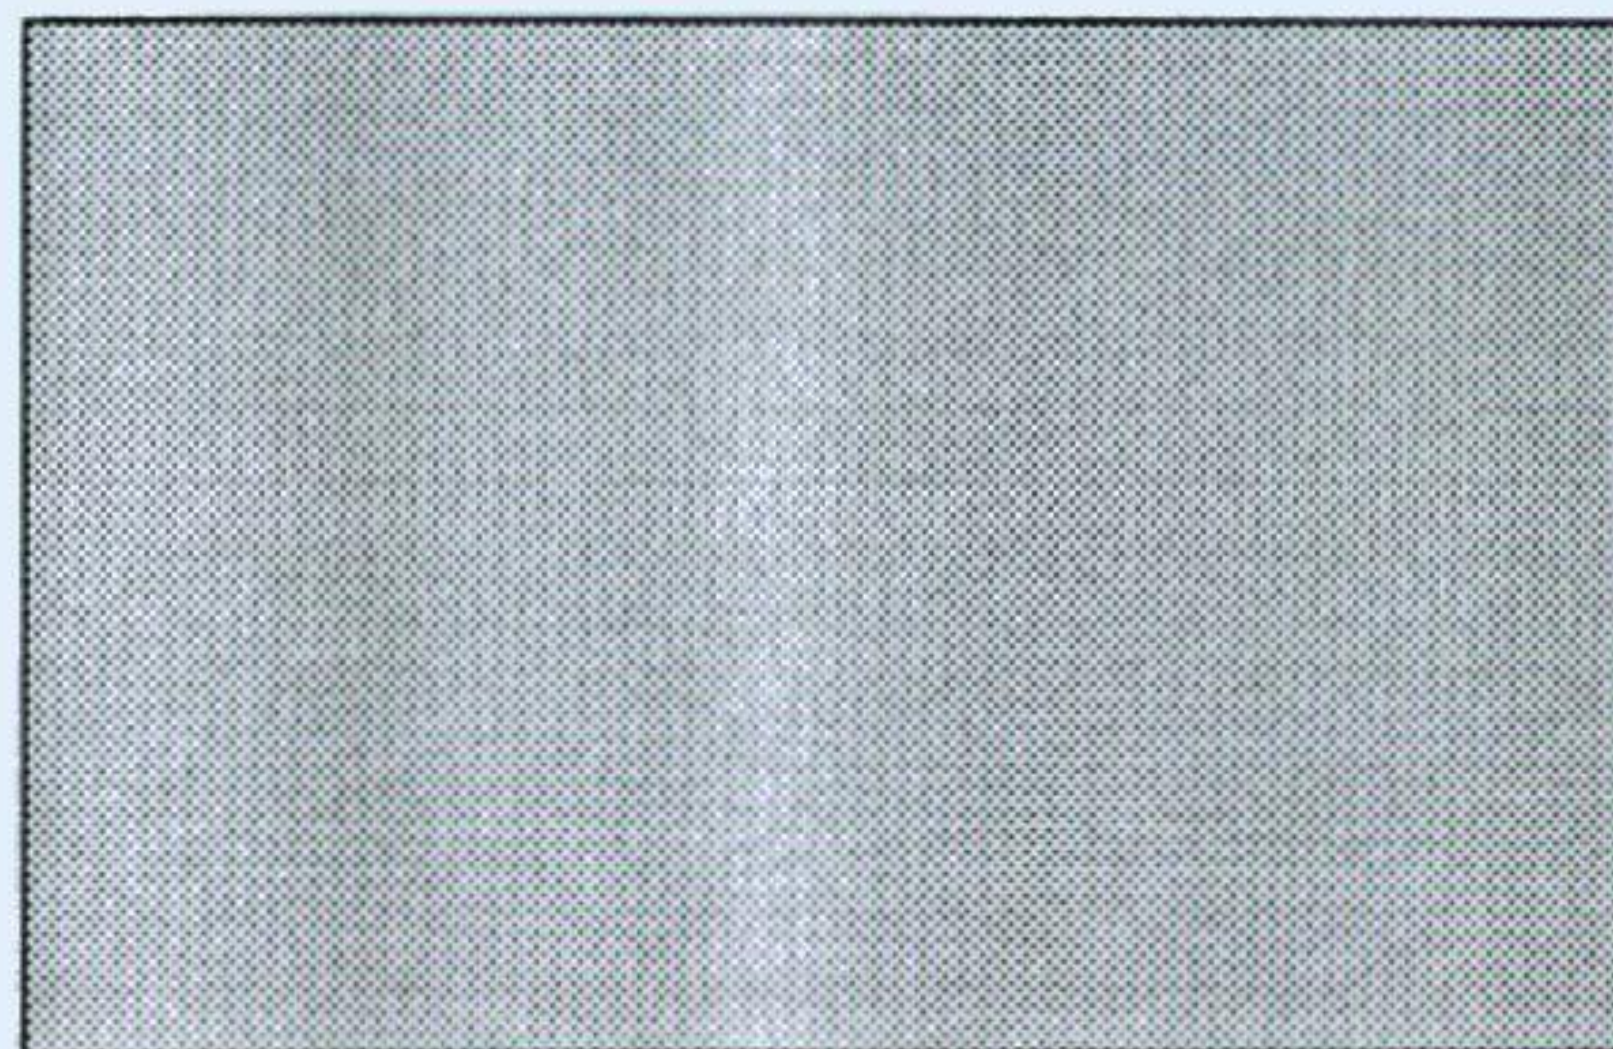
Address: Barn, stable and loosebox approx.
30m. W of College Farmhouse
Ref No: 160
Grade: II

Barn, stable and loosebox; barn converted to house. C17/C18. Coursed ironstone. Wood shingle roof has coped gable parapet on left to road. 8 bays. Stable and loosebox on left have stable doors. Vent. Double doors in fifth bay with large window inserted behind. Mid C20 half-glazed door with wood lintel inserted to left. Painted wood lintels. Left return side has pitch door. Interior: loosebox has hayrack. Barn has imported C19 panelling. Collar and tie beam trusses. Included for group value.

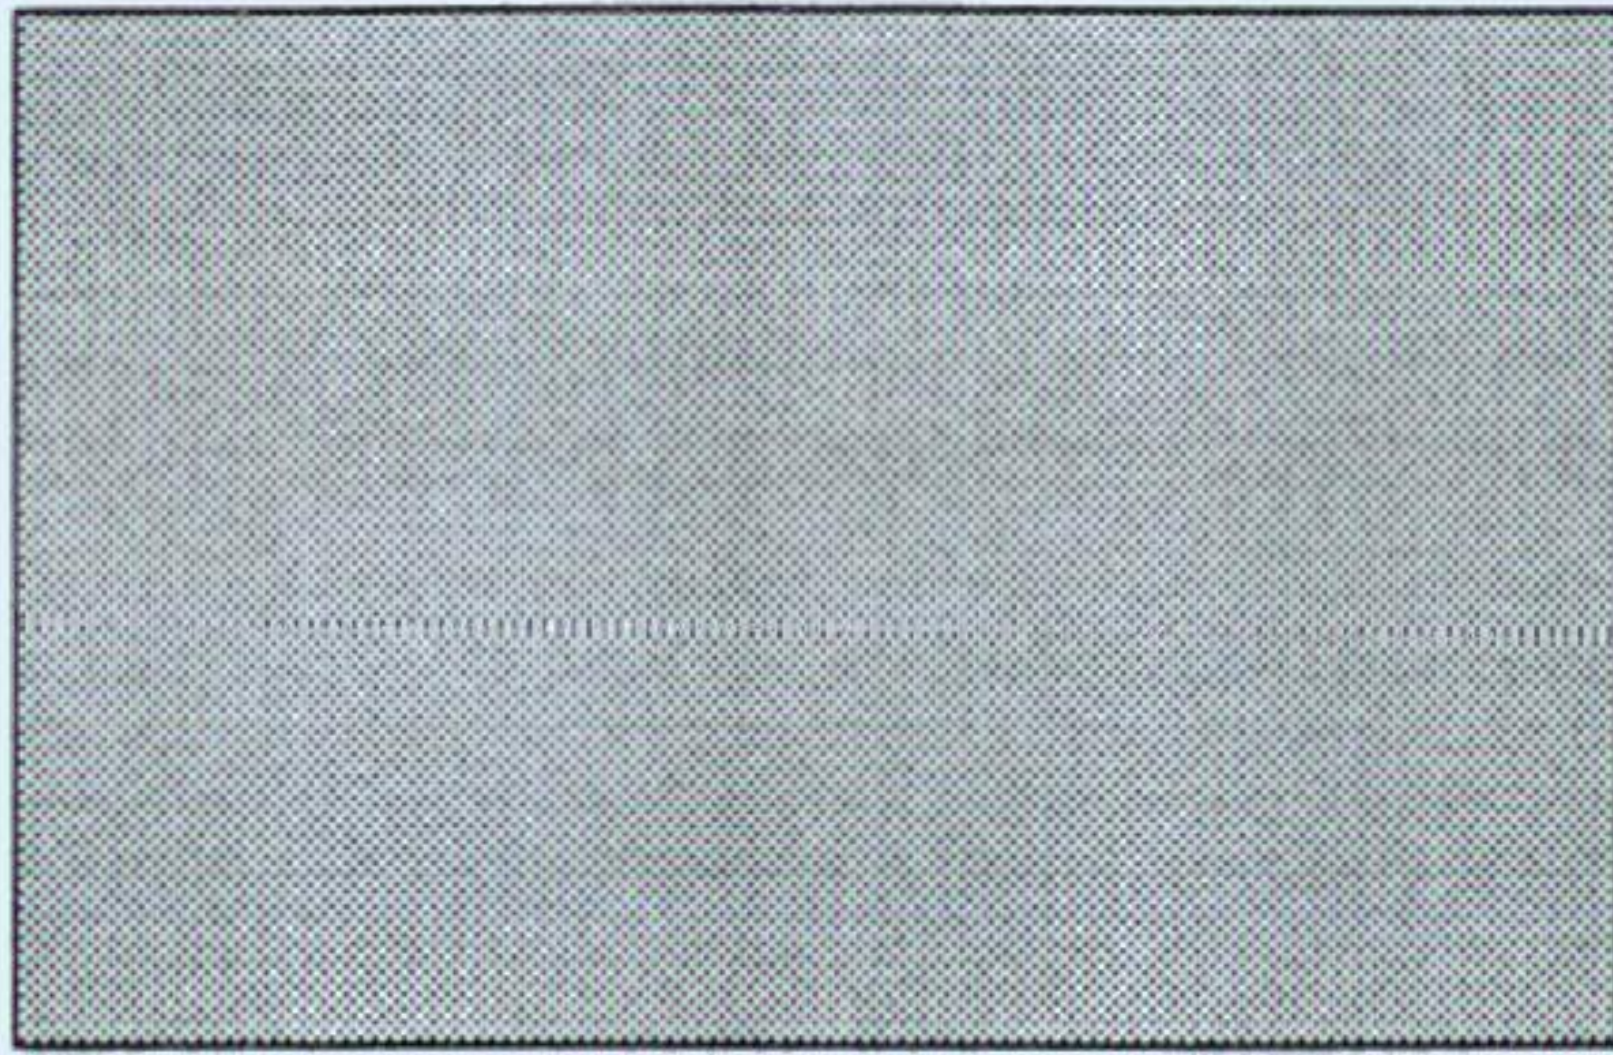
Address: Mount Stewart Cottage
Ref No: 161
Grade: II

Cottage, formerly 2. Late C18. Coursed ironstone. Concrete tile roof; brick end stacks and stone ridge stack with brick shaft. 5-unit plan. 2 storeys; 4-window range. Each former cottage has central flush 4-panelled door and C19 trellis porch with shaped fascia. Left half has 2 and 3-light casements with horizontal glazing bar on ground floor, and 3-light leaded casements above. Right half has 3-light casements with glazing bars. Painted wood lintels throughout. Windowless range to left. Interior not inspected.

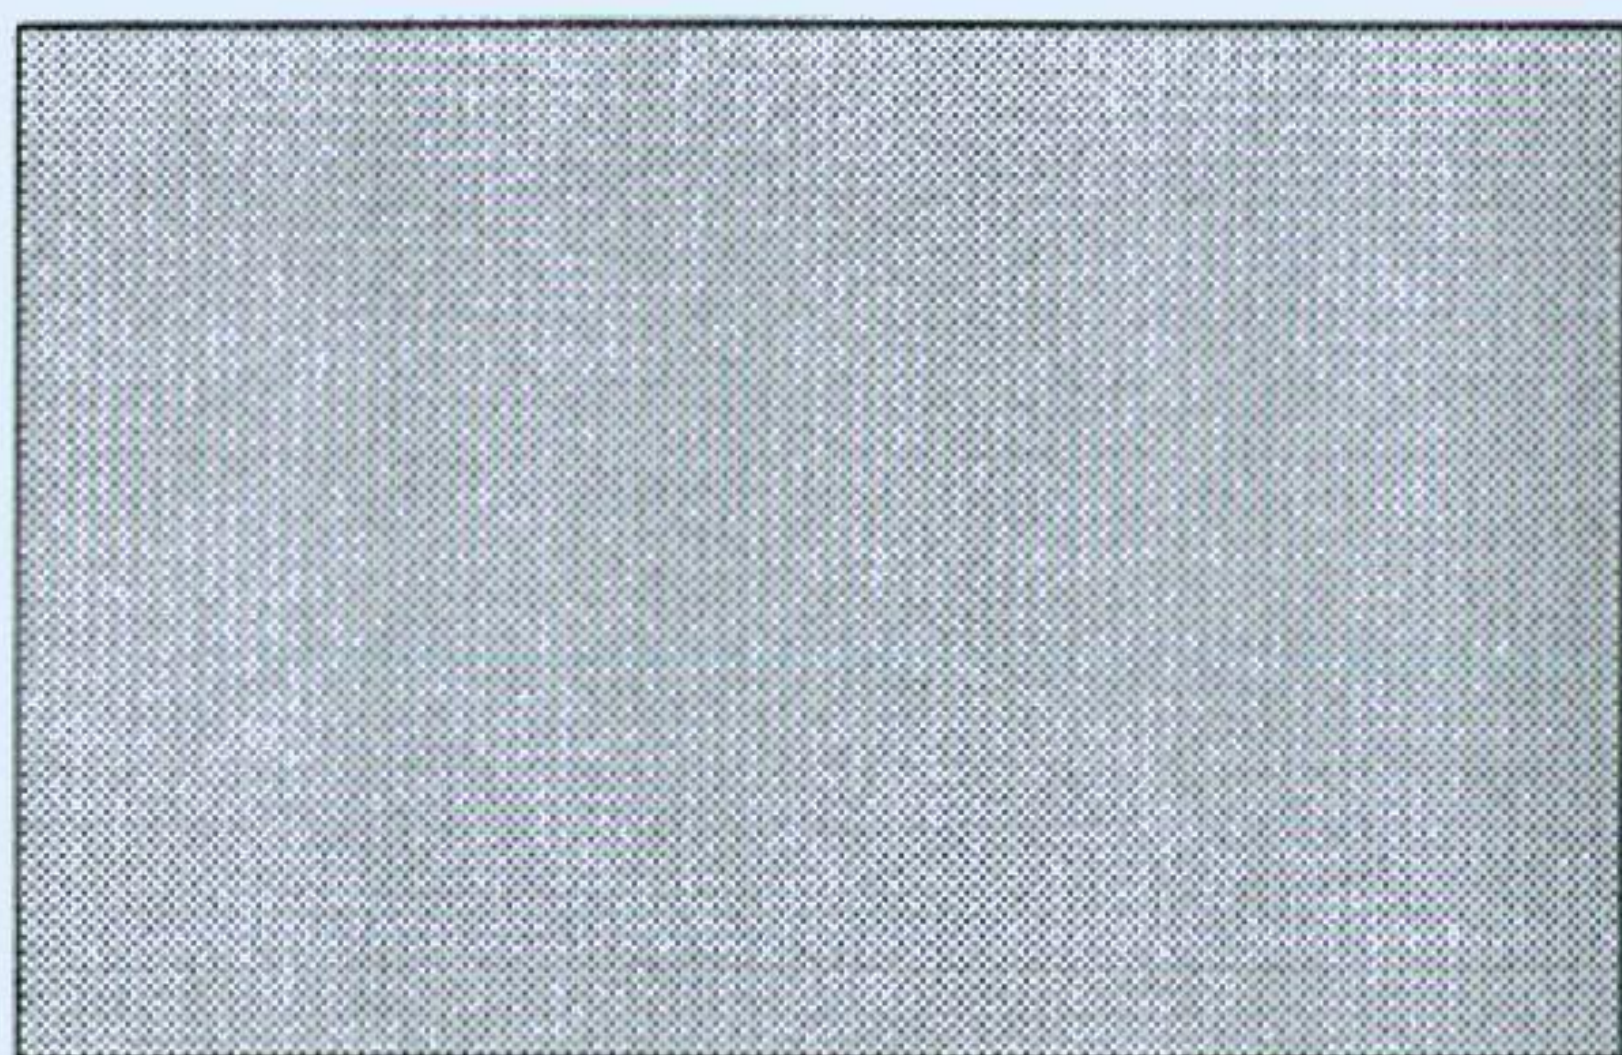
Address: The Manor
Ref No: 163
Grade: II

Manor house. C16/C17; raised and altered C19. Regular coursed ironstone. Tile roof; stone end stack to left, and brick ridge stack. L-plan with wing on left to rear. 2 storeys and attic; 3-window range. Central mid/late C19 porch has chamfered 4-centred archway. Return sides have small ogee lancet. Half-glazed door inside stone chamfered mullioned windows with hood moulds, 5-light on ground floor and 4-light above, with 2-light central window. Return sides have 2-light mullioned attic windows. Right return side: 4-window range. Wing has 2-storey, 3-light bay windows to left and right. Sides have small single lights. Moulded cornices and tile roofs. 2-light windows. Stone mullions with drip moulds. Interior said to have large stone moulded 4-centre arched fireplace, with late C18 fluted Doric pilasters supporting shelf. C19 straight flight staircase. (V.C.H.: Warwickshire, Vol.5, p.148).

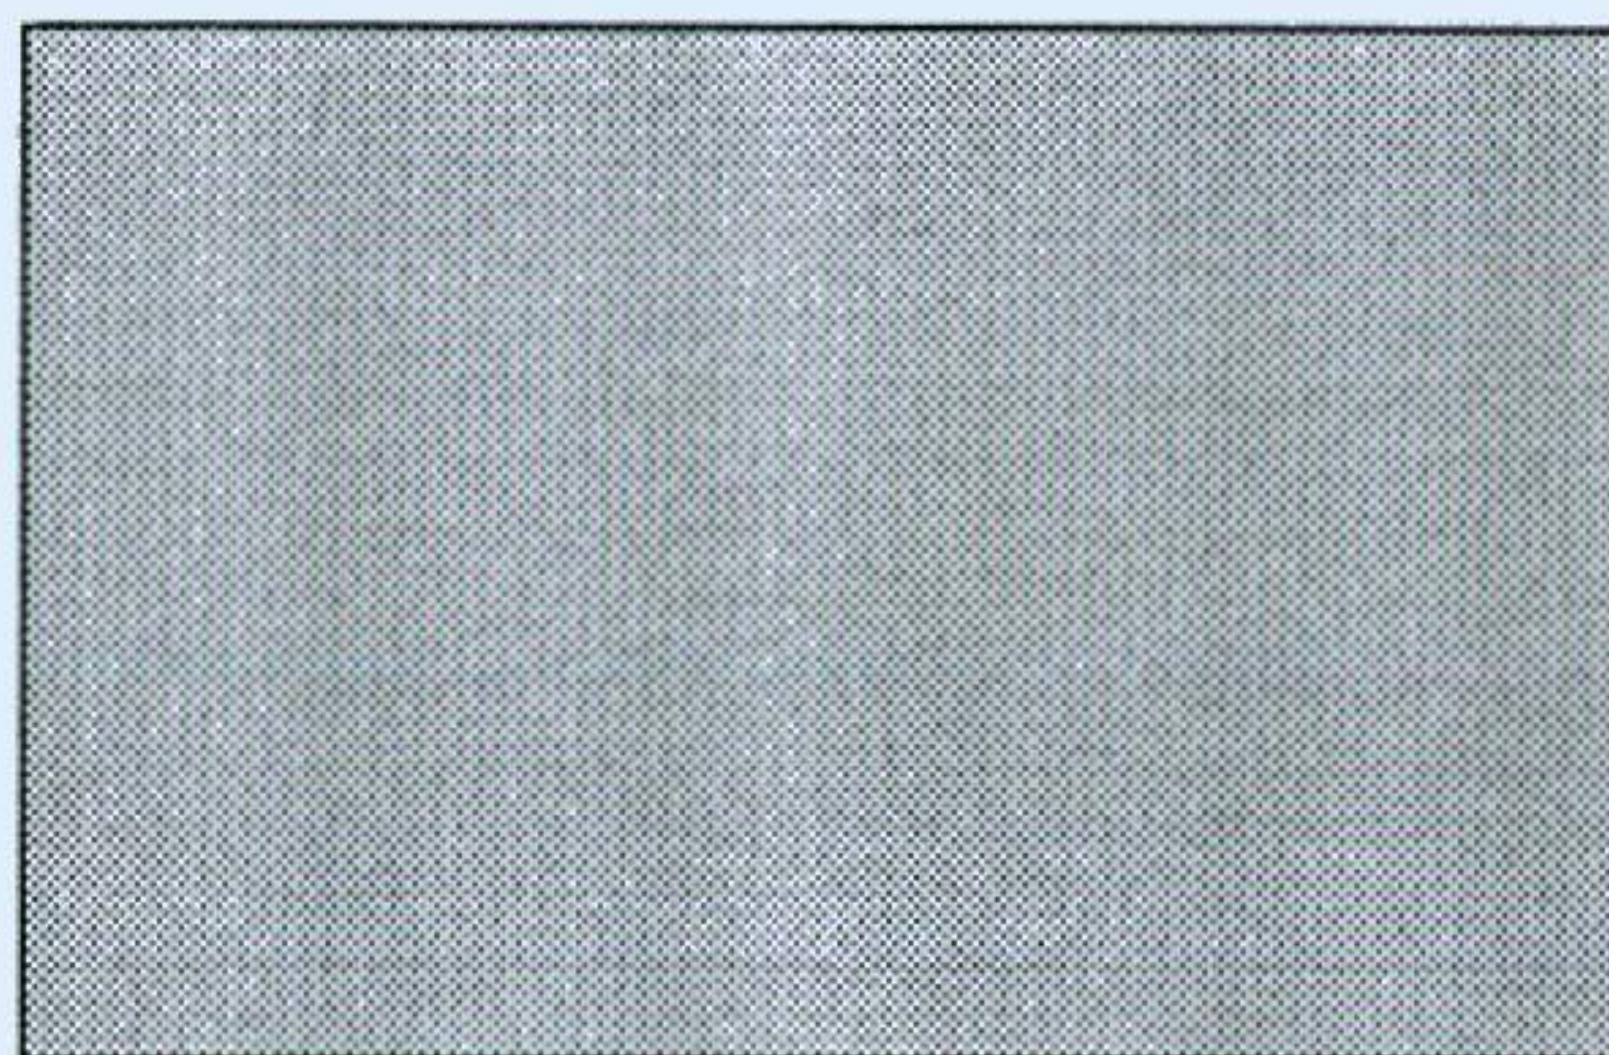
Address: Terrace walls at The Manor
Ref No: 164
Grade: II

Terrace walls. Early/mid C19. Regular coursed dry ironstone with coped top. Central steps. Included for group value.
