*Shotteswell
Conservation Area*

Shankland Cox

April 1994

Shotteswell Conservation Area

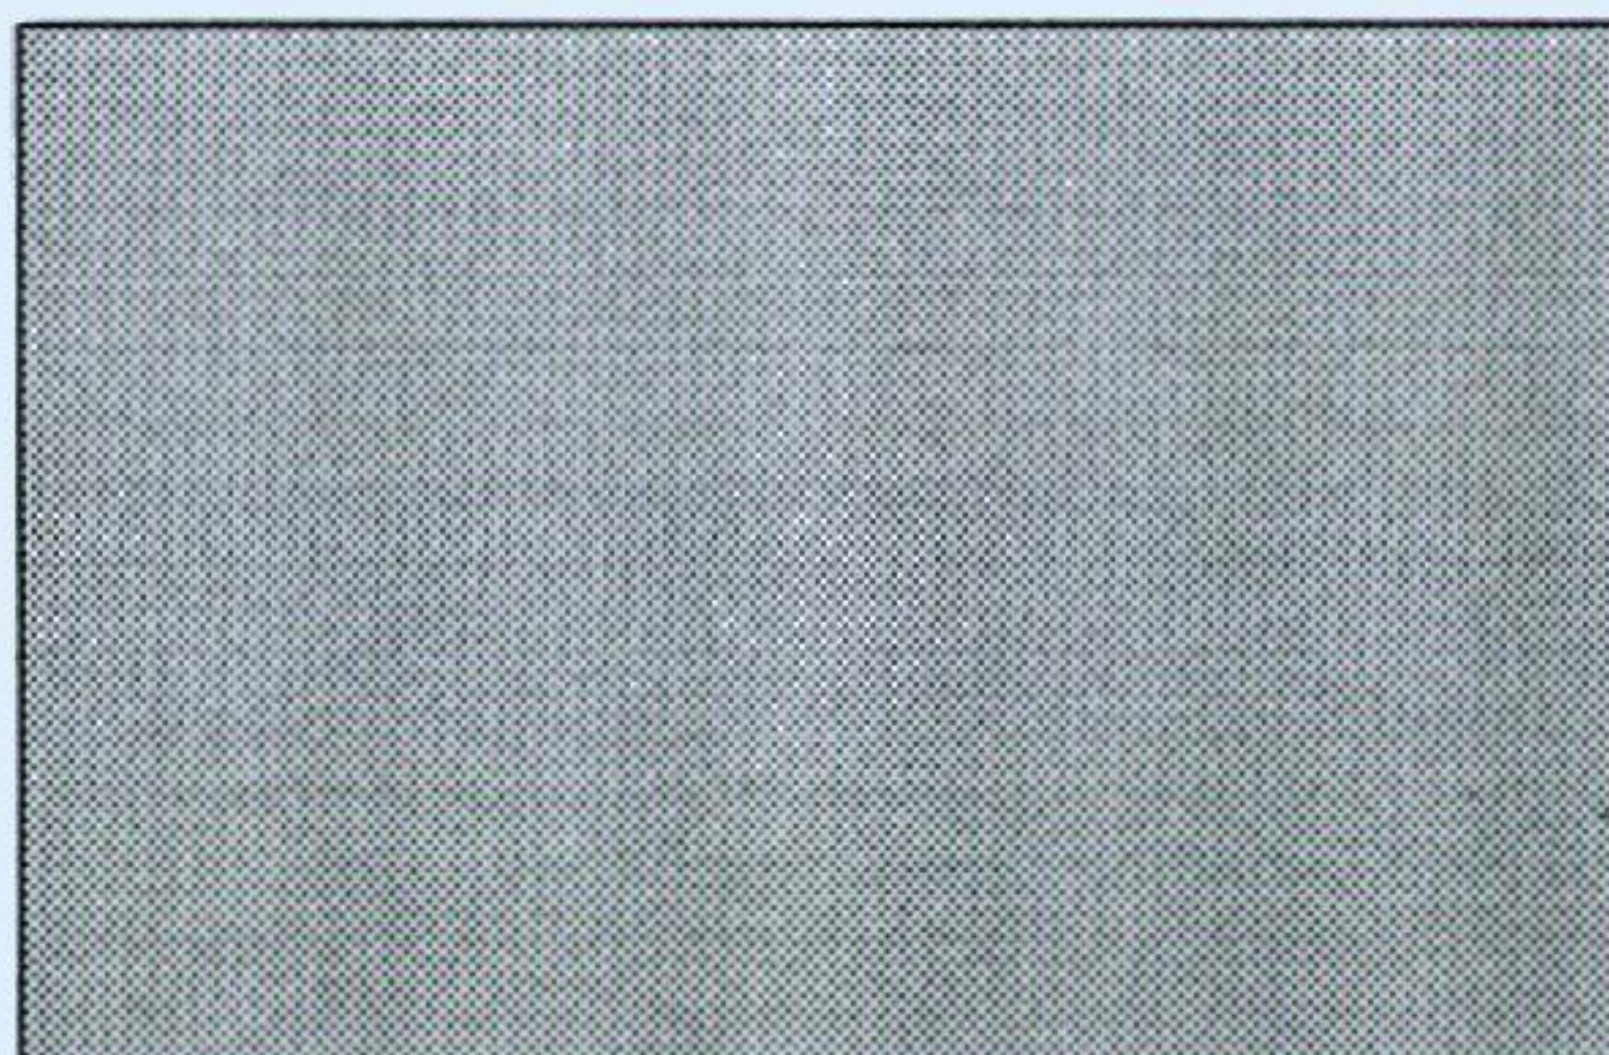
Address: Wall approx. 10m. S of The Manor
Ref No: 165
Grade: II

Wall. C17/C18. Coursed dry ironstone. Coped top. Stepped down the hillside. Included for group value.

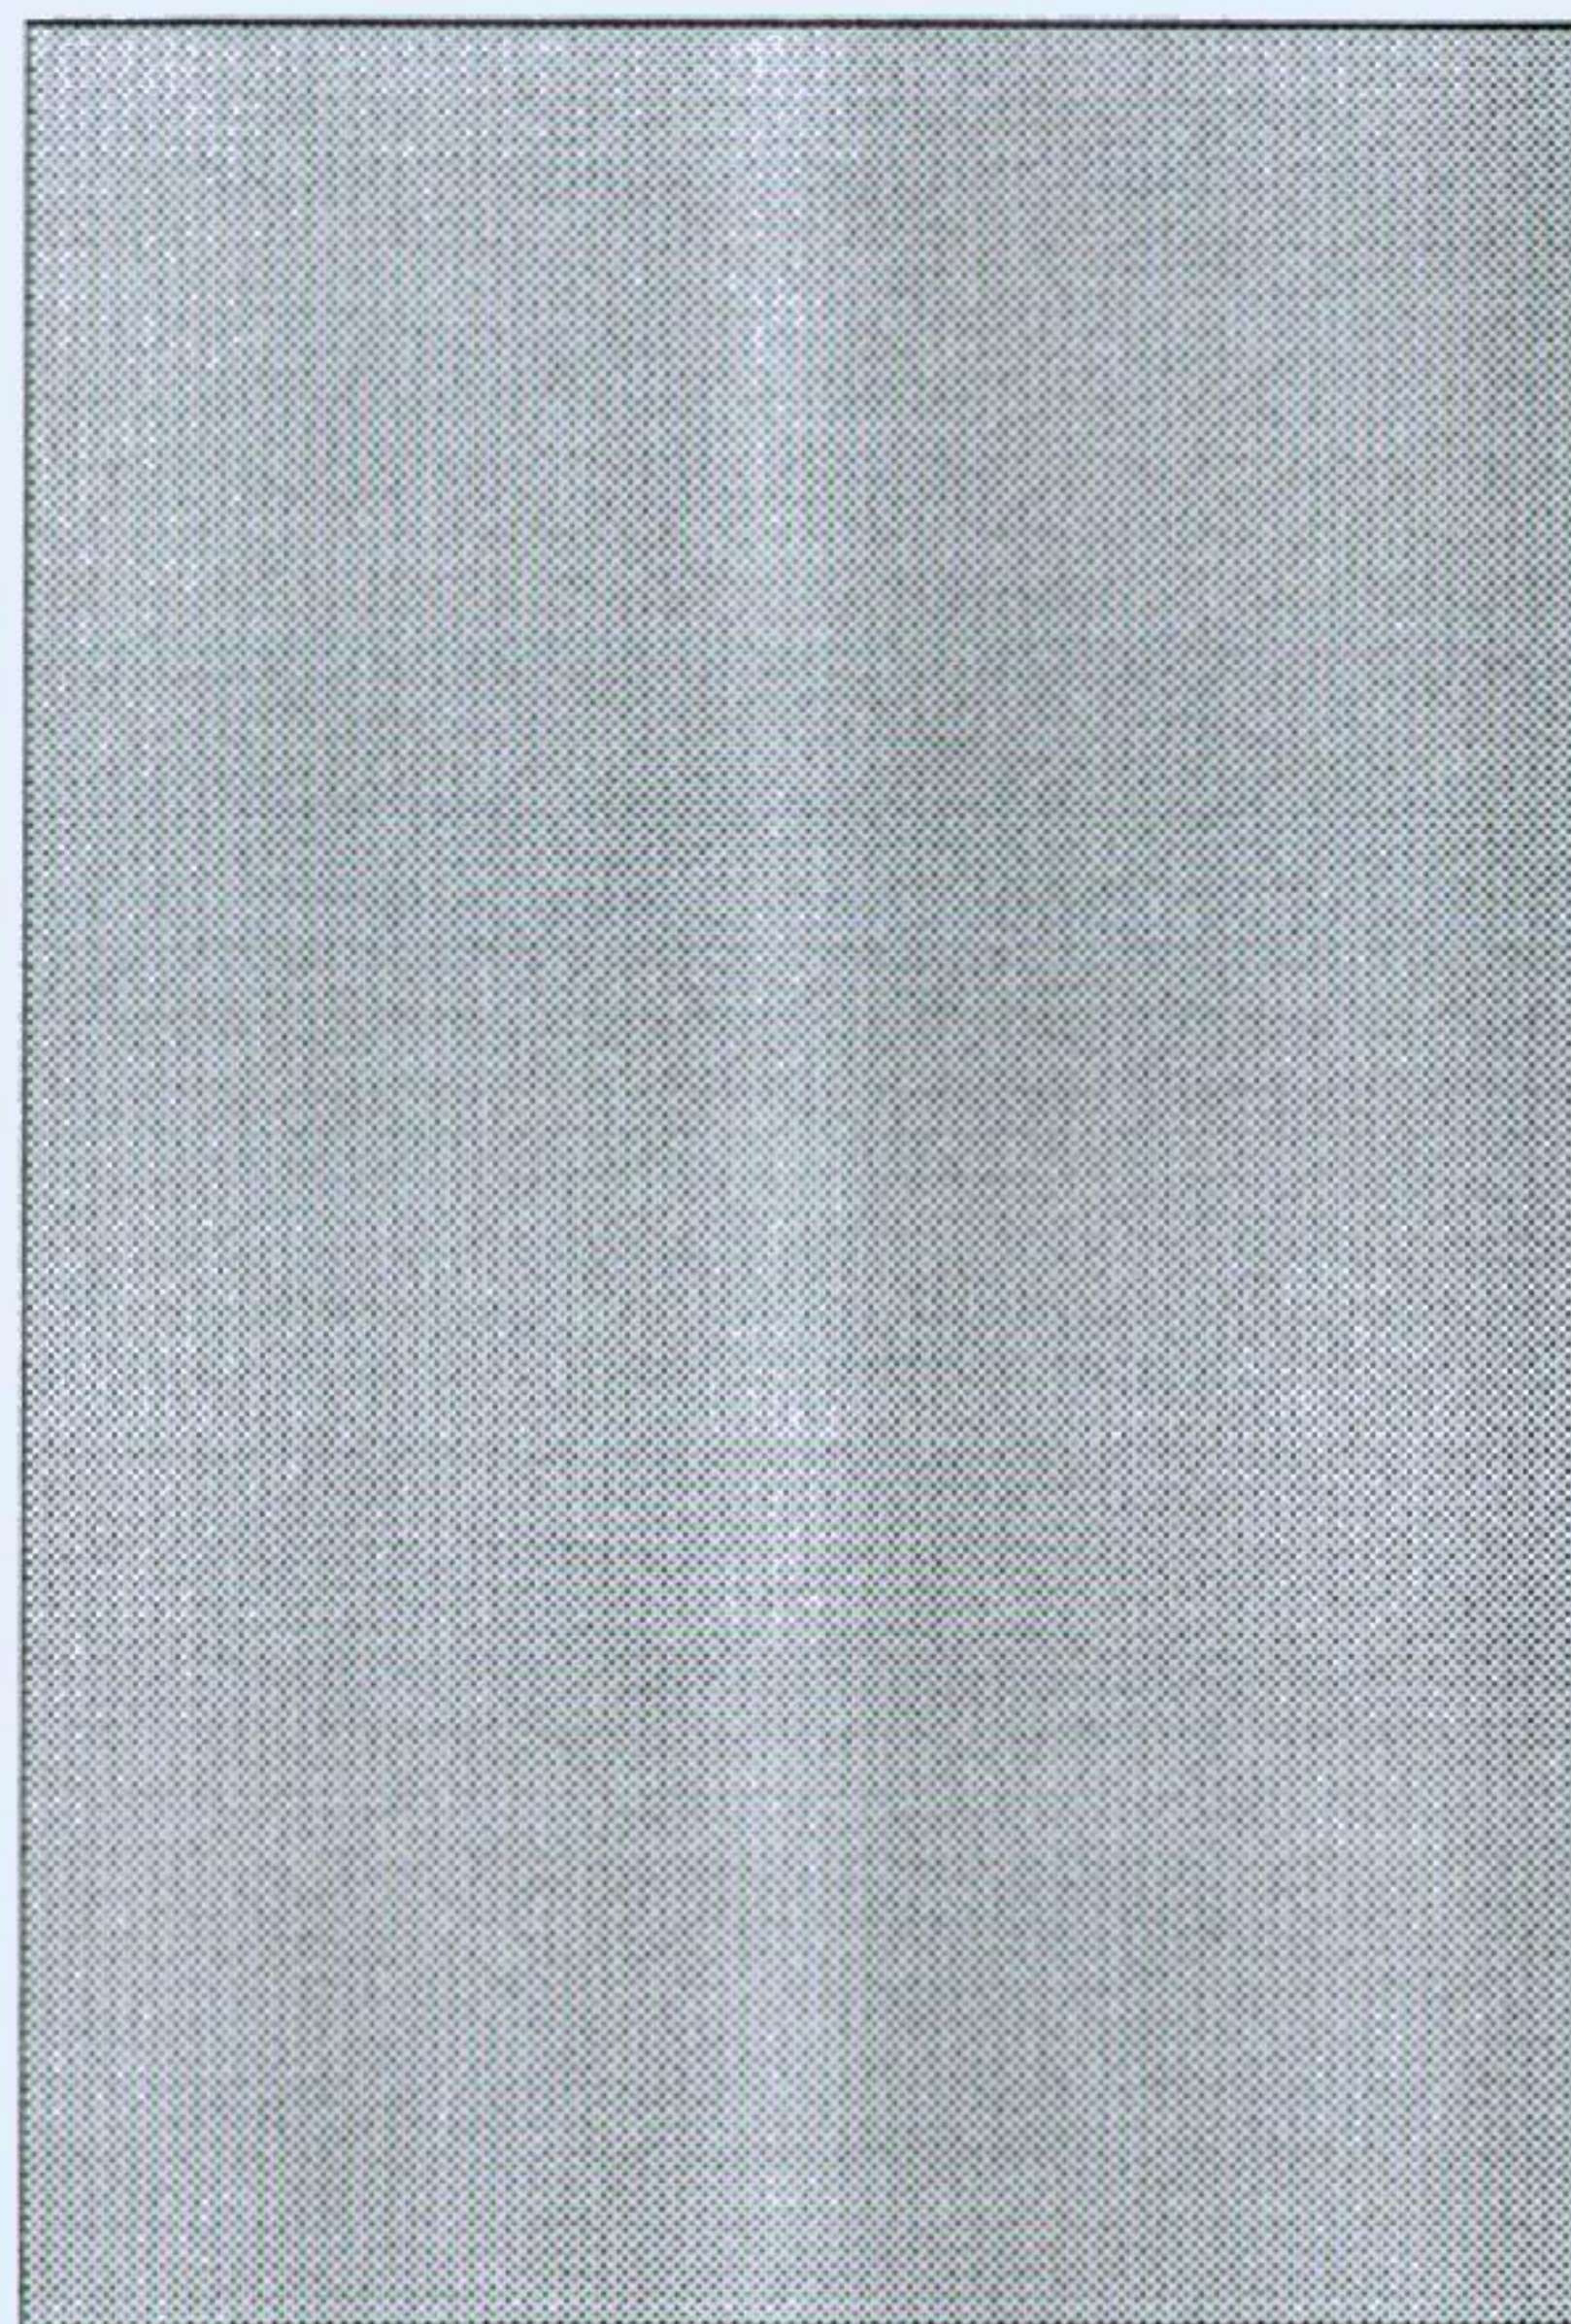
Address: Suncroft
Ref No: 169
Grade: II

Cottage, possibly formerly 2. Mid/late C18, with C19 and C20 additions and alterations. Coursed ironstone. Thatched roof; brick end stacks. 4-unit plan with gable end to road. 2 storeys; 4-window range. Entrance in second bay has plank door and open timber porch with thatched hood. Old leaded 2-light casements, and C20 casements, some leaded. Varying window levels due to steeply sloping site. Painted wood lintels. C19 addition on right, with C20 single storey addition to front. Left return side to road has C20 casements. Interior not inspected.

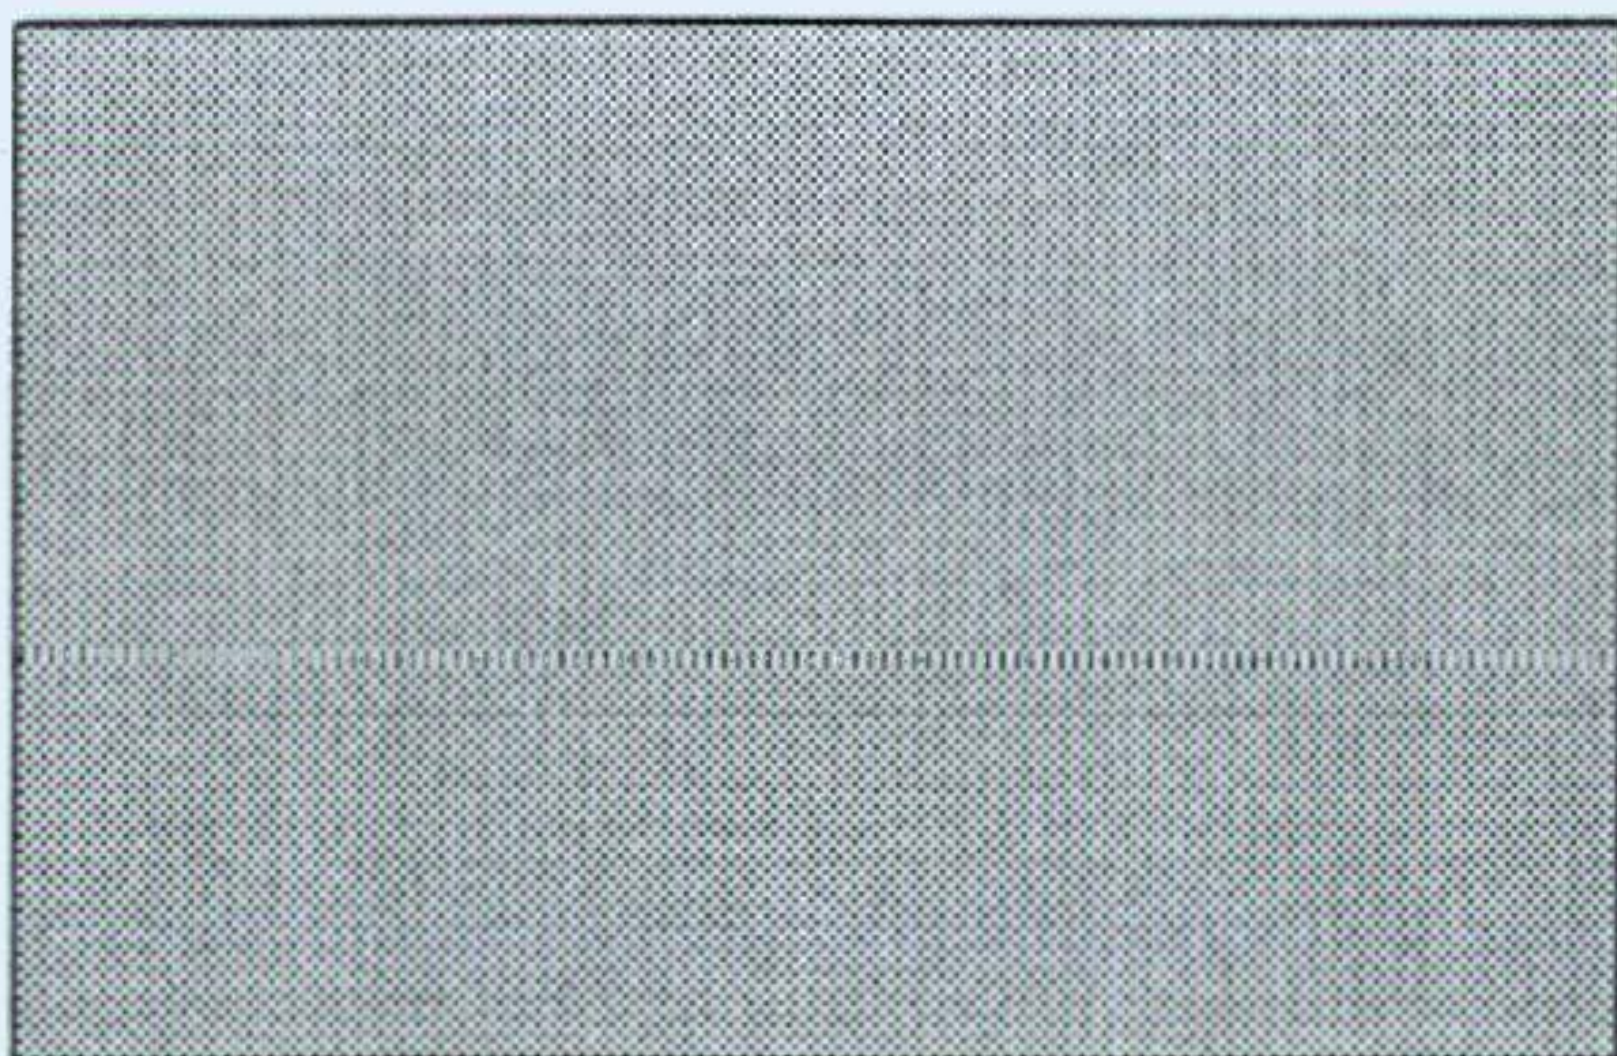
Address: Yew Tree Cottage
Ref No: 170
Grade: II

Cottage. Late C18. Coursed ironstone rubble. C20 tile roof; brick end stack to left. 2-unit plan. 2 storeys; 2-window range. Entrance to right has C20 half-glazed door and 3-light casements with horizontal glazing bars. Central casement in former doorway. 3-light window on left. Old painted wood lintels. Interior not inspected.
