***HASELOR and WALCOTE***

***Conservation Area Review***

***Draft Report - October 1997***

***for Stratford on Avon District Council***

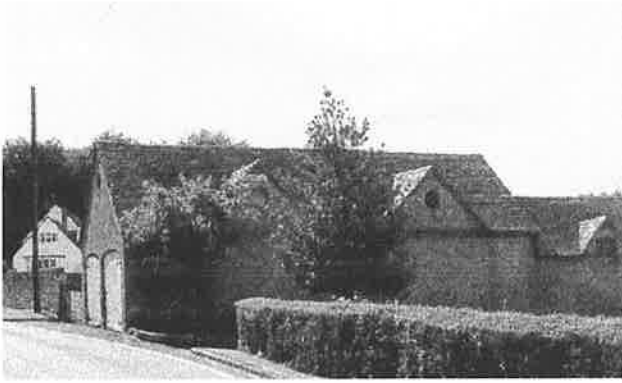
Figure 6.2a  
**HASELOR  
 IMPROVEMENTS**

4. Yard adjacent to 3 with original pavings and surrounded by attractive walls: requires renovation.
5. Inappropriate hedge species, inappropriate building form (Barnhouse Cottage): encourage planting of more substantial native hedge.

6. Renovated housing left with open, suburban looking front gardens: wall or native hedge required to define street.
7. Upton Green: hedges make access indirect and obscure wider views over valley to church. Consider landscape schemes to open up the green and bring it more into the village scene.

10. Long, dull Leylandii hedge on top of stone retaining wall. Replacement with native species would be better long term.
11. Tidying up and strengthening of hedgerows and old orchard at entrance to village.

12. Manor Farm yard and buildings in urgent need of repair / renovation / re-use.
13. Untidy hedge and adjacent paddock and farm buildings. Management would improve outlook of Orchard Corner.
