## Stratford-on-Avon District Council – Site Allocations Plan

### Heritage Impact Assessment

SHLAA Reference	BRA.15
Site Address	South of Orchard Close, Brailes
Site Capacity	Approx. 15 dwellings

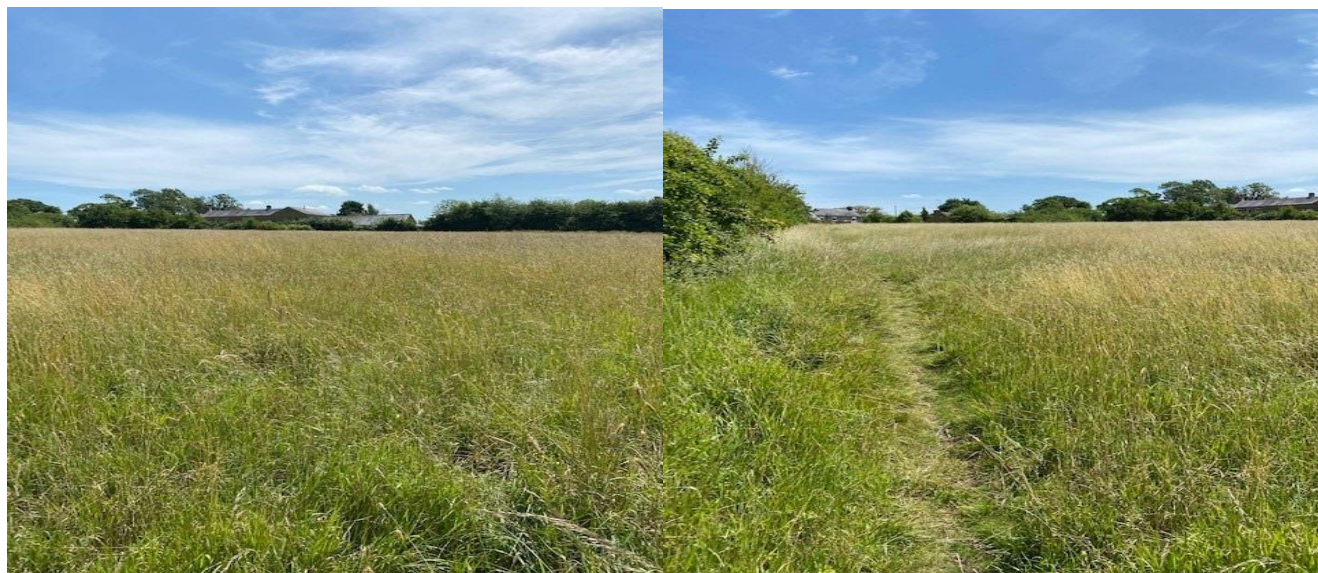
The site is approx. 1.5ha in size of grassland bounded by hedgerow and trees. The site is located at the back of Orchard Close which is an existing built up residential area. The site is extremely overgrown with grass with an 'informal' footpath which runs north west along the edge of the site. The developable area of the site is outside of the Conservation Area, however the north eastern part of the site is conterminous with the Conservation Area. There are a number of existing properties which can be seen from the site.
