## **Stratford-on-Avon District Council – Site Allocations Plan**

### **Heritage Impact Assessment**

SHLAA Reference	HALF.01
Site Address	East of Fosse Way (north), Halford
Site Capacity	Approx. 15 dwellings

SHLAA Reference	HALF.03
Site Address	North of Idlicote Road, Halford
Site Capacity	Approx. 18 dwellings

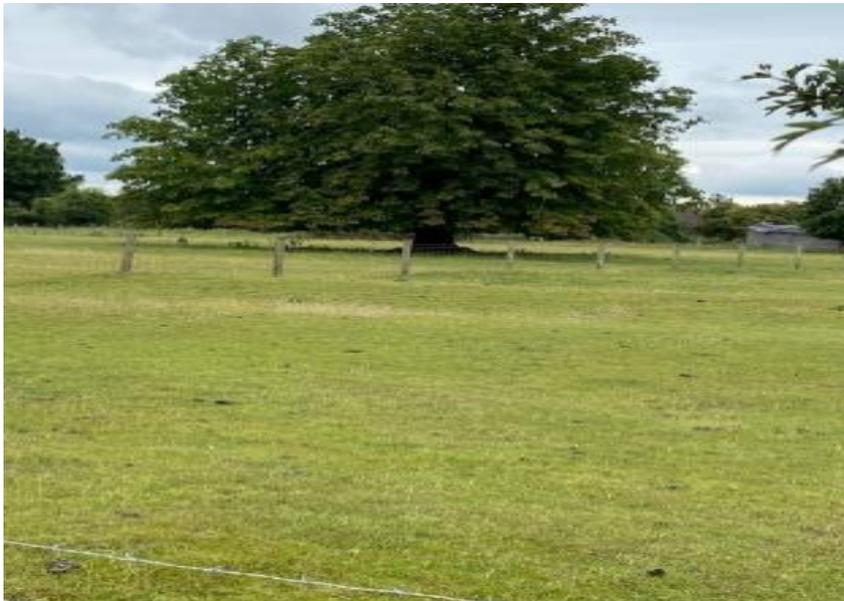
The site is a small field approx 0.8ha in size, adjacent to an existing dwelling and is currently used by sheep for grazing. It is bounded by trees and hedgerow to the west and is surrounded by a small wired fence. The site is located off the Fosse Way which runs through Halford and there is a public right of way to the north of the site which runs alongside it. Although the site is not within the Conservation Area, the western boundary is conterminous with the Conservation Area.

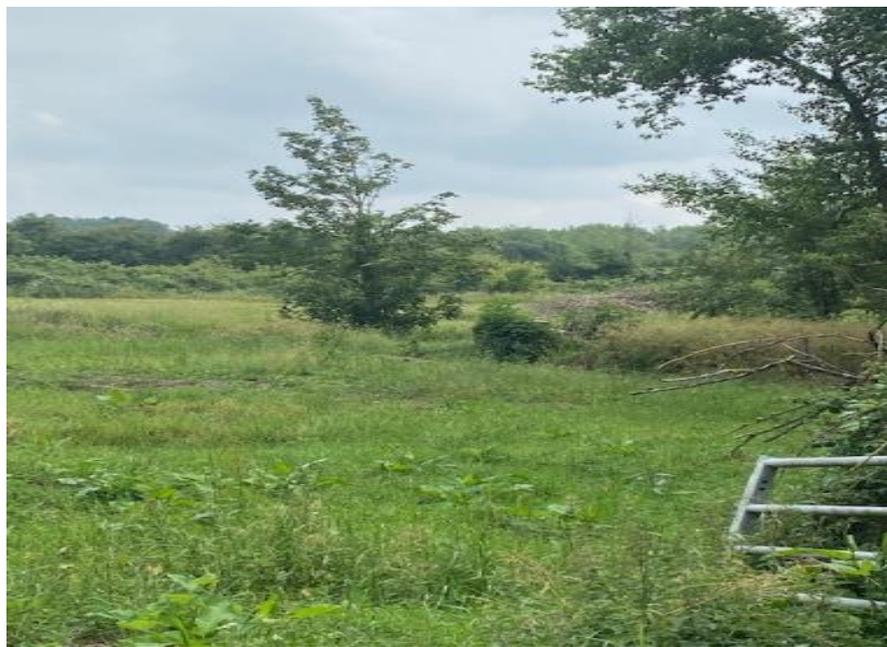
The site is approx. 1.0ha of scrubland bounded by hedgerow and trees. The site is located along Idlicote Road which is a quiet road with a number of large existing properties opposite, a couple of which are undergoing renovation. The site is not within the Conservation Area and is approx. 200m away from the boundary of the Conservation Area.

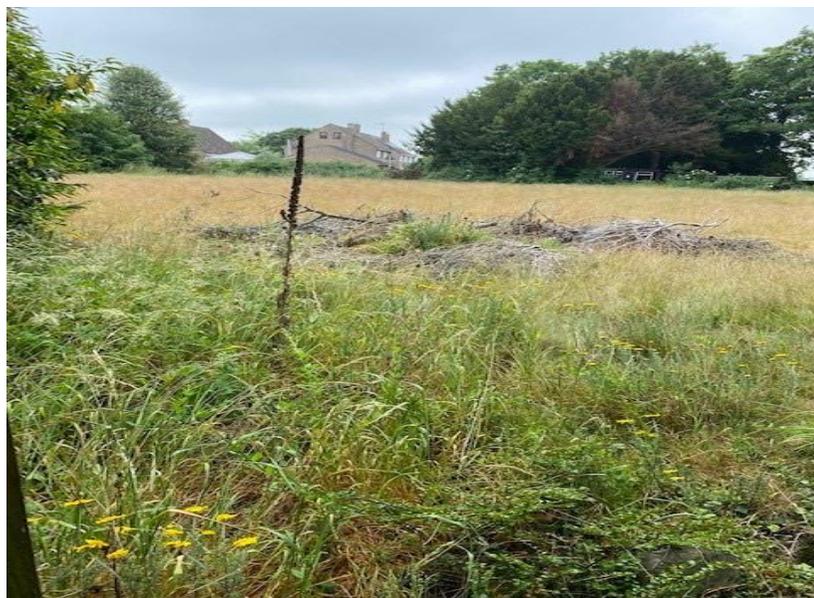
SHLAA Reference	HALF.08
Site Address	East of Fosse Way (Middle), Halford
Site Capacity	Approx. 6 dwellings

The site is approx. 0.4ha in size of grassland and is bounded by trees and hedgerow. The Fosse Way runs along the western edge of the site; however it is set back from the road. The site is opposite a Grade II listed building (Halford Bridge Inn) and is situated next to the car park belonging to the Inn. It sits wholly within the Conservation Area with several existing properties within close proximity including a garage which sells local produce.
