Stratford-on-Avon District Council – Site Allocations Plan

Heritage Impact Assessment

SHLAA Reference	LC.04
Site Address	East of Back Lane, Long Compton
Site Capacity	Approx. 10 dwellings

SHLAA Reference	LC.11
Site Address	West of Oxford Road (South), Long Compton
Site Capacity	Approx. 12 dwellings

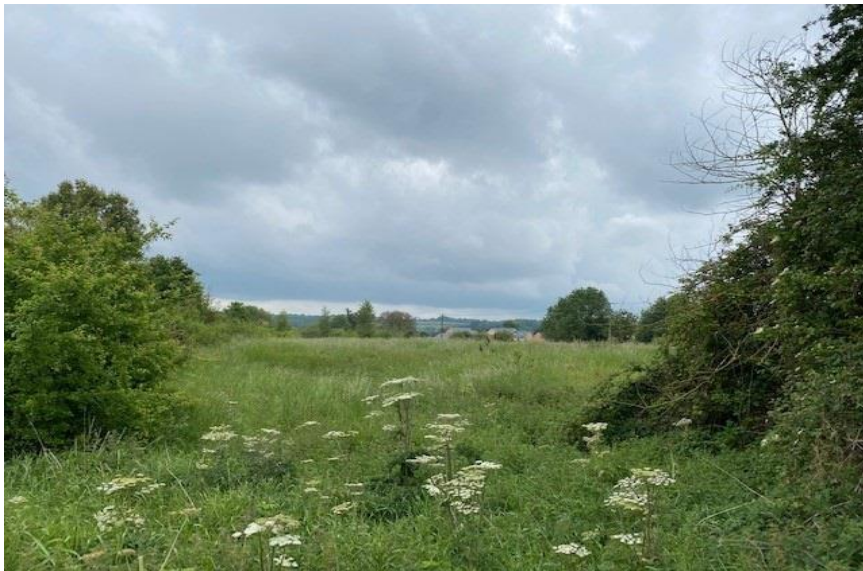
The site is a small field of semi-improved grassland bounded by mature hedgerow and trees, with some domestic fencing to parts of the southern boundary. The site is located to the east of Back Lane, between the junctions of Vicarage Lane and Broad Street. The land slopes gradually down to the north toward Nethercote Brook, which runs along the northern edge of the site. The site lies adjacent to the Long Compton Conservation Area and wholly within the Cotswolds Area of Outstanding Natural Beauty. Housing is located to the south and west, with open farmland to the north and east.

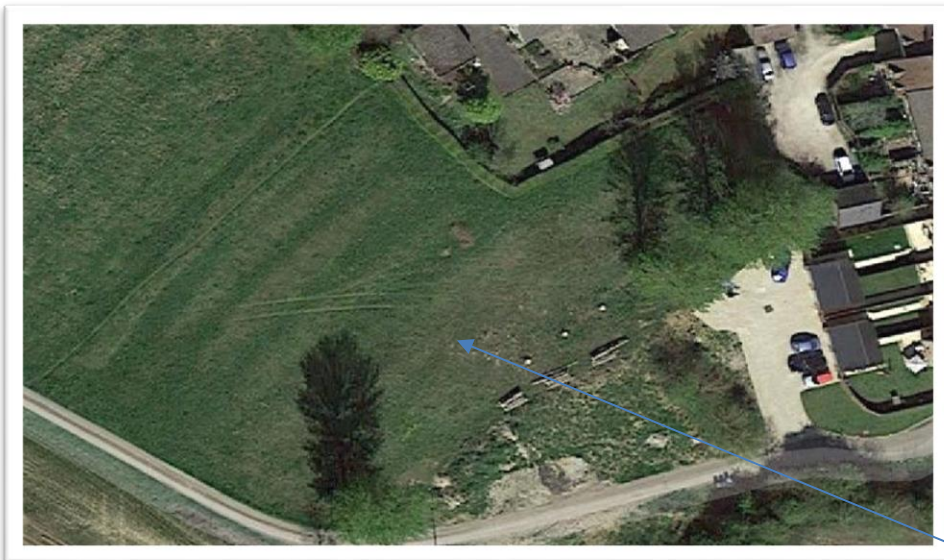
SITE 11

The site is approx. 0.8ha in size. A private drive runs along the southern edge of the site and this is the only way of access. There is rolling countryside to the south and west of the site, with a small number of existing dwellings to the eastern and northern edges of the site. The site is situated outside of the Conservation Area, however the eastern boundary is conterminous with the Conservation Area.
