Stratford-on-Avon District Council – Site Allocations Plan

Heritage Impact Assessment

SHLAA Reference	LONG.01
Site Address	East of Marton Road (north), Long Itchington
Site Capacity	Approx. 18 dwellings

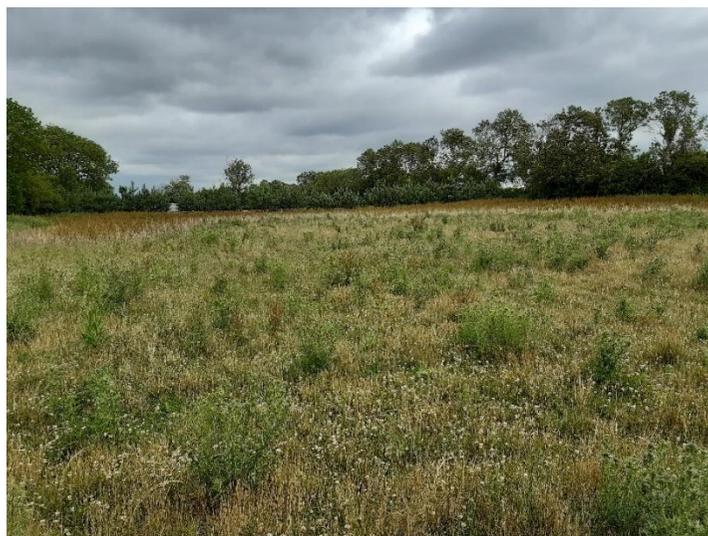
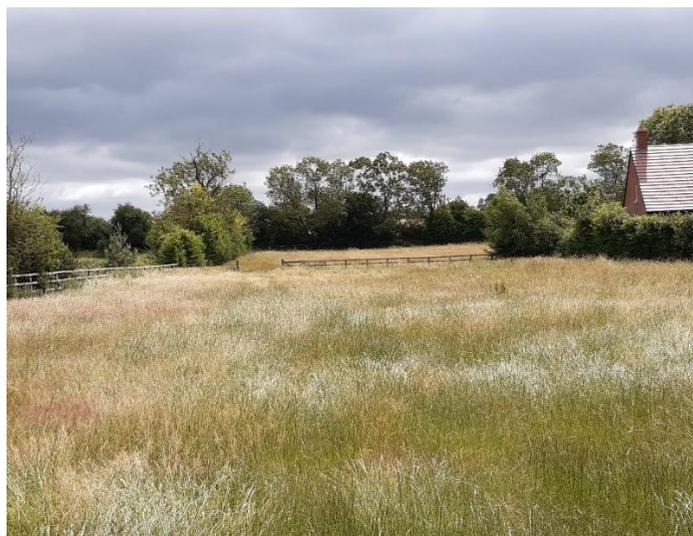
The site is made up of two adjacent land parcels. The southern half is a small field bounded by mature vegetation, with agricultural land to the east, housing to the south and west and paddock areas to the north, which make up the remainder of site LONG.01. Land levels rise to the east, throughout the site. The paddock areas are overgrown and not in use, currently. Further paddocks and agricultural land are located north of the paddock areas which form part of LONG.01.

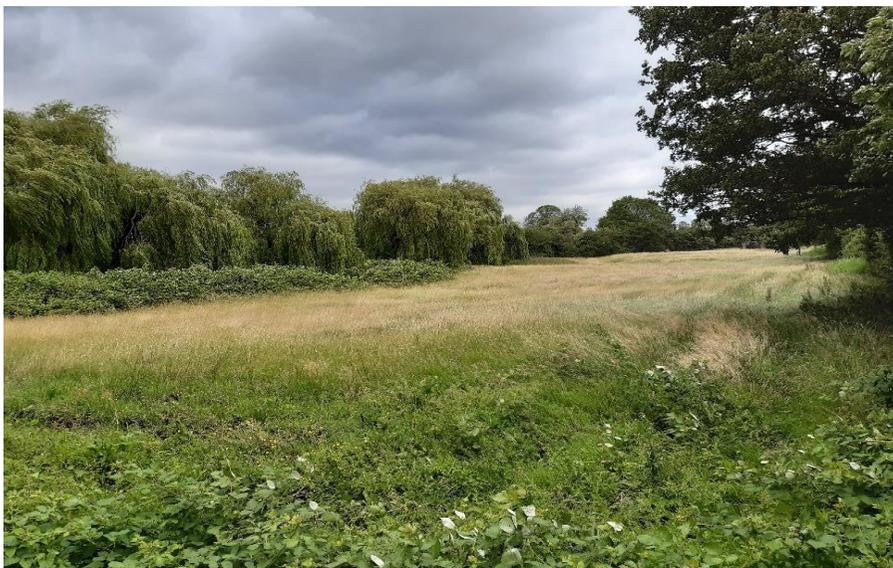
The site is a diamond shaped field on the northern periphery of the village. The land is overgrown with long grass and other vegetation. There are clear mounds and hollows throughout the site. The land is well screened due to mature trees and vegetation to all boundaries. Land levels throughout the site, with the highest point being at its northern boundary. A line of trees run through the middle of the site in a NE/SW orientation. The site is bounded by agricultural land to the north and housing to the east and south. A commercial site lies close to the site, to the west.

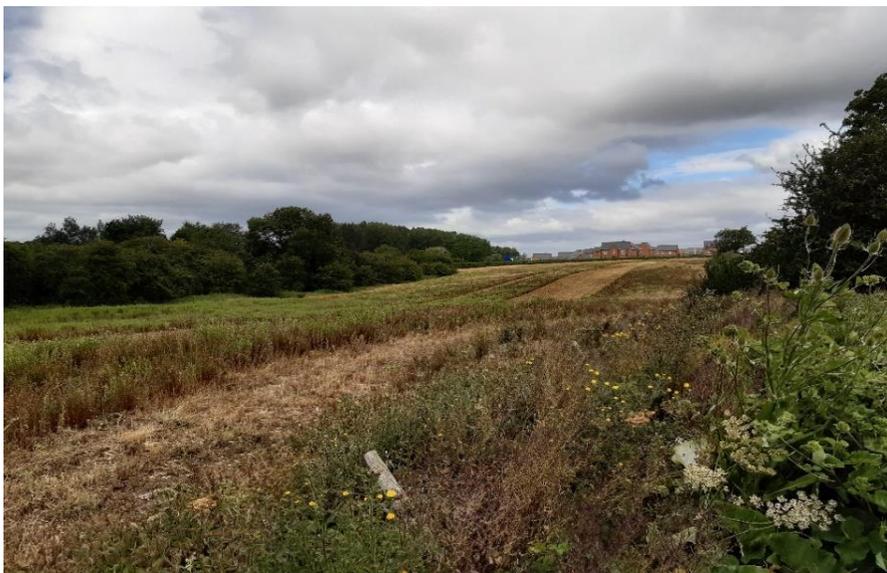
The site is a rectangular agricultural field on the eastern edge of the village. The field is a 'saddle' shape, with high ground at the east and west boundaries, with low ground in the centre of the site. The site benefits from a mature hedgerow boundary to the north and has a 'belt' of trees/mature vegetation to the east and south boundaries. Recent housing developments bound the site to the north and west. An area of scrubland lies to the east, with the Grand Union Canal running parallel with the southern boundary, in an elevated position compared to site LONG.07. The site is not located near to the Conservation Area.

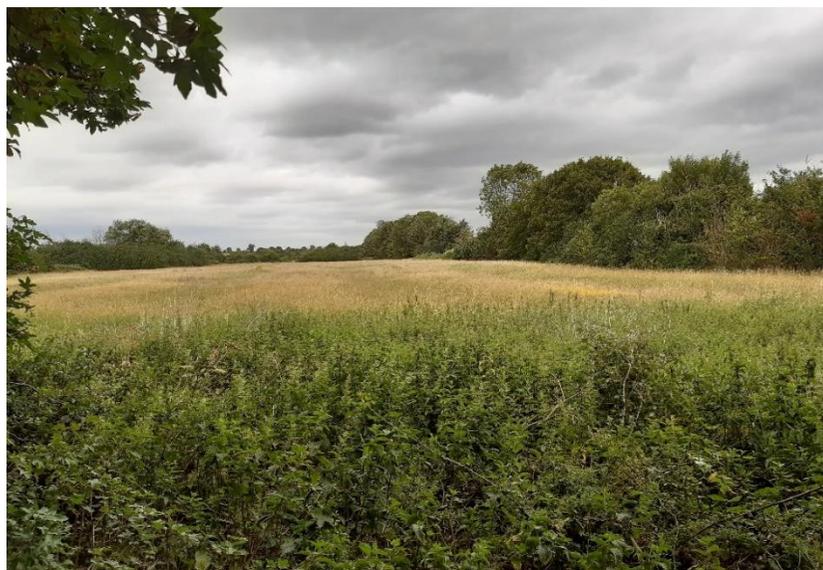
The site is part of a small rectangular shaped field on the northern edge of the village, along Leamington Road. The field is reasonably level throughout and bounded on all sides by mature hedgerow, vegetation and trees. Residential development to the east and south, with agricultural land to the west and north. The site is 150 metres from the Conservation Area, with intervening housing development. The nearest listed building is 185 metres south of the site, with an intervening housing estate. There is no scheduled monument in the vicinity of the village.

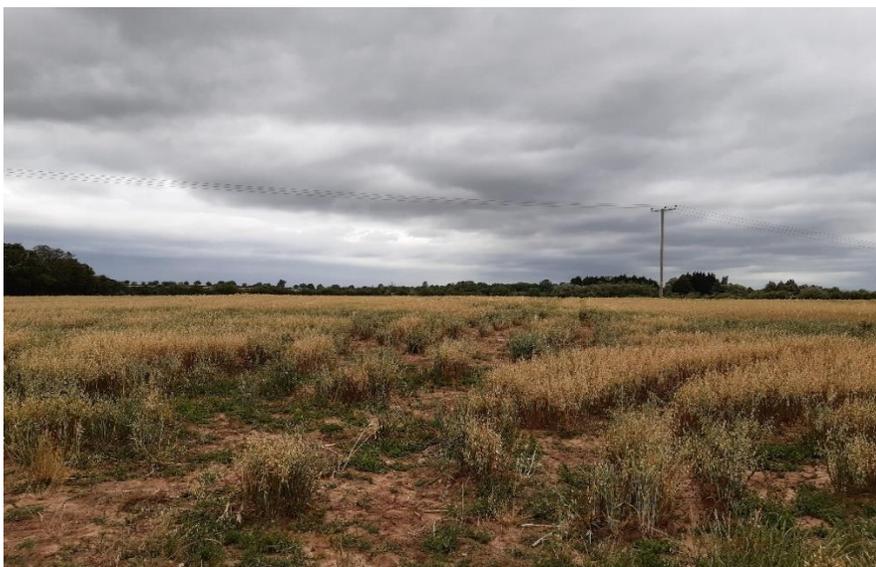
The site comprises a small paddock area adjacent to Leamington Road and the southern part of a large rectangular shaped field on the northern edge of the village. The field is reasonably level throughout and bounded on all sides by mature hedgerow, vegetation and trees. Residential development to the south, with agricultural land to the west and north and recreational land to the east. The nearest listed building is 180 metres south of the site, with an intervening housing estate. There is no scheduled monument in the vicinity of the village.

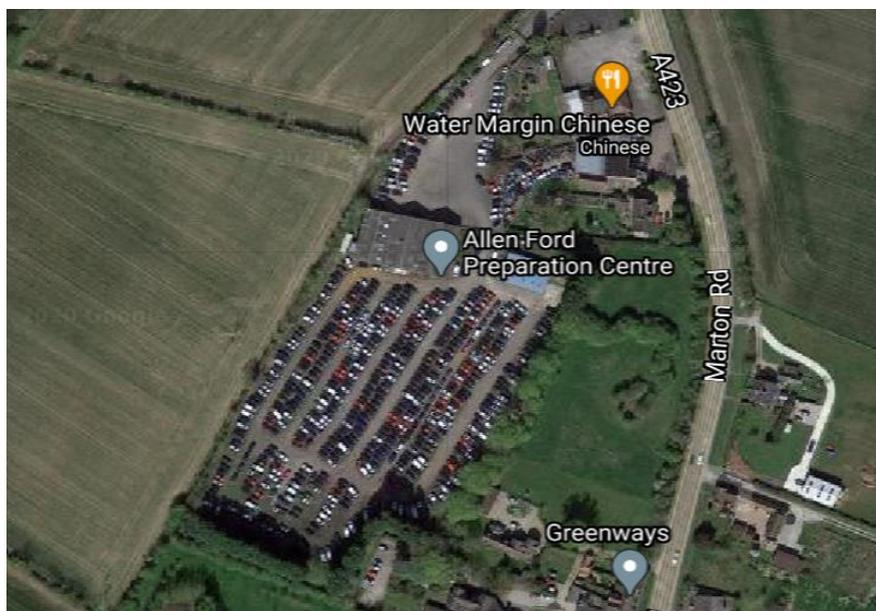
The site is entirely covered in tarmac and is occupied by a large brick industrial building with parking areas to the north and south of the building. Land slopes throughout the site, with high ground to the north and low ground to the south. The site is bounded on all sides by mature hedgerows and trees. The site lies almost half a kilometre from the Conservation Area and nearest listed building in the village. Public views of the site are limited with no nearby public footpaths and intervening buildings along Marton Road.
