Stratford-on-Avon District Council – Site Allocations Plan

Heritage Impact Assessment

SHLAA Reference	NEWB.01
Site Address	East of Stratford Road, Newbold-on-Stour
Site Capacity	Approx. 9 dwellings

SHLAA Reference	NEWB.06
Site Address	North of Moss Lane (east), Newbold-on-Stour
Site Capacity	Approx. 24 dwellings

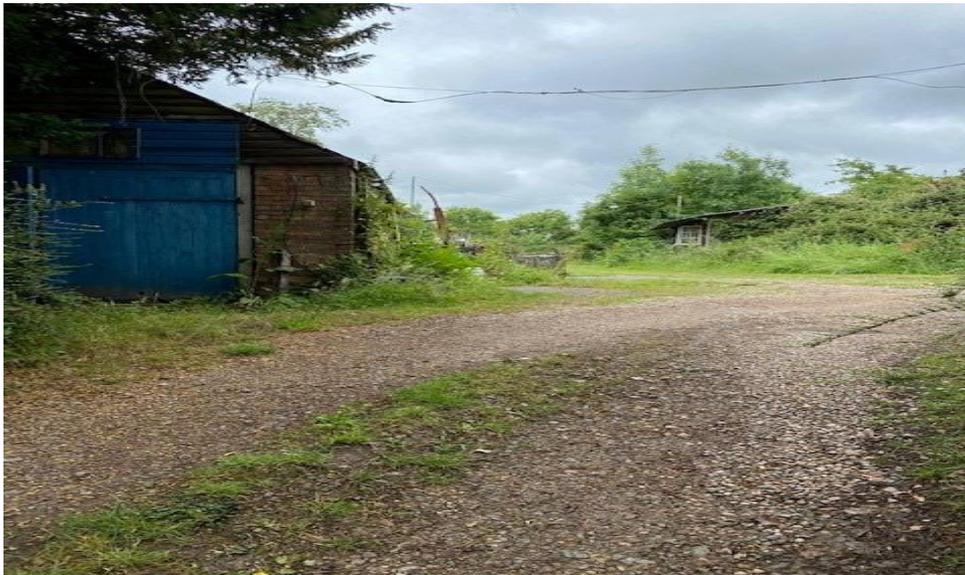
The site is approx. 0.5ha in size and situated to the east of the Stratford Road which is the main road running through Newbold on Stour. The site is overgrown with weeds and there is a redundant building surrounded by scrap metal and waste. There is a large dwelling opposite the proposed development site and a large property next to Talton Edge which is currently screened by existing trees. A listed building (South Lodge) is within close proximity to the development site with views from the rear looking towards open countryside.

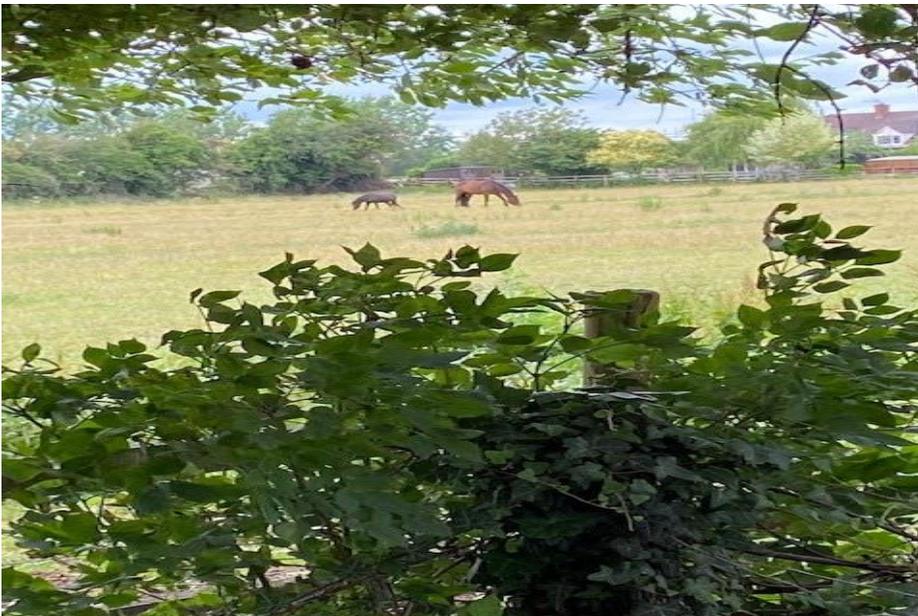
The site is approx. 1.4 ha in total, however the developable area is 0.8 ha. The site is located to the rear of the village bowling green and village hall. There is a substation adjacent to the site and several existing dwellings to the rear and in the surrounding area. The site is currently being used as a paddock with horses grazing. There are several grade II listed buildings within close proximity to the site, The Church of St David, Cob Outbuilding and Cotswold House.
