Stratford-on-Avon District Council – Site Allocations Plan

Heritage Impact Assessment

SHLAA Reference	STR.11
Site Address	East of Banbury Road, Stratford-upon-Avon
Site Capacity	Approx. 240 dwellings

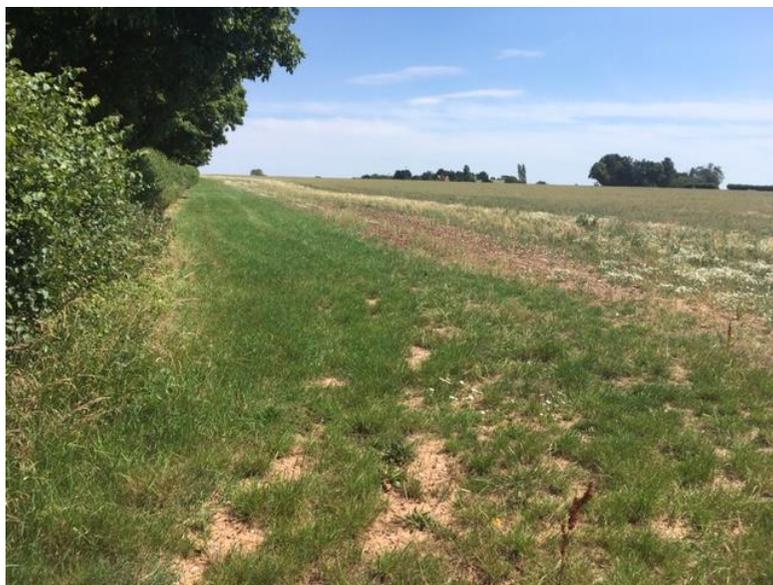
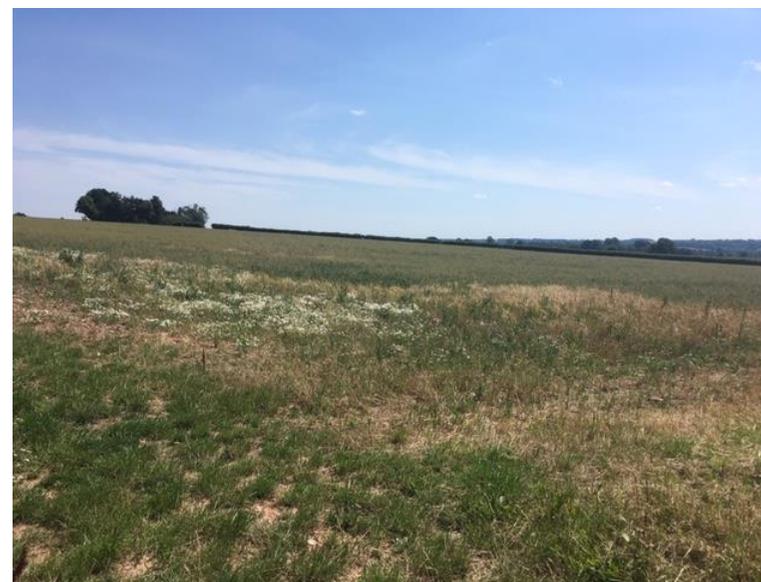
The site is formed of two large grassed arable fields, intersected by hedgerow running north to south across the middle of the site. The site is bordered by the A422 Banbury Road to the south, and by modern housing development to the west. Further crop fields are present to the north and east of the site. In terms of topography, the site rises from south to north and from east to west. Large mature hedgerow borders the site to the south. The site is not located near to any designated heritage assets.

Potential mitigation measures for identified harm	<p>Desk based assessment and potential further archaeological evaluation should be undertaken prior to any development, in line with Chapter 16 of NPPF (February 2019).</p> <p>These additional assessments would need to be undertaken as part of any planning application for the development of the site.</p>
Conclusion of harm on the heritage asset	<p>Development of this site could lead to the loss of archaeological remains of unknown significance.</p> <p>However, further archaeological evaluation work associated with a planning application for development of the site could lead to a better understanding of the historic environment.</p> <p>Conclusion on harm to heritage asset: Less than substantial harm.</p>

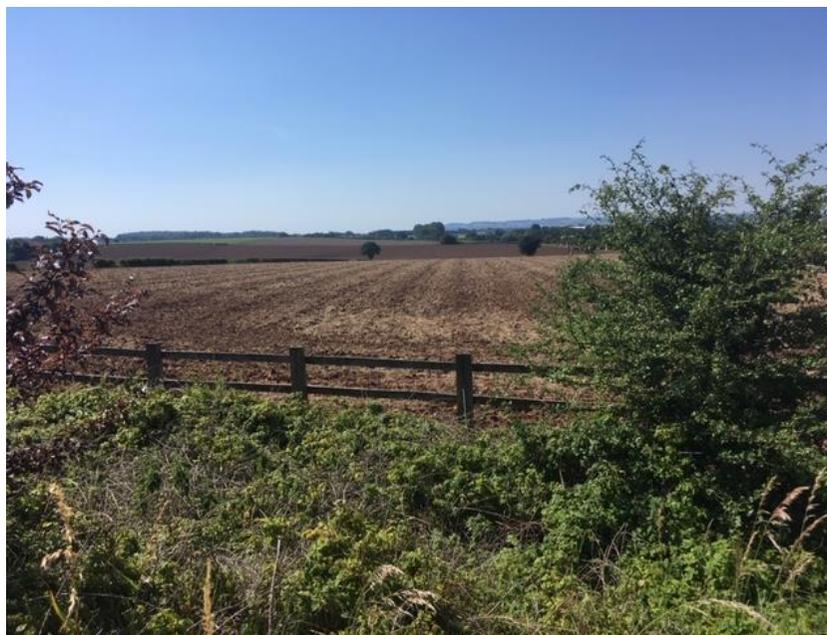
The site consists of a large ploughed agricultural field to the south of Stratford-upon-Avon. It is bordered by hedgerows to the south and east, and further ploughed fields to the north and west. The site does not contain any non-designated heritage assets, and is not within the near vicinity of any designated heritage assets.

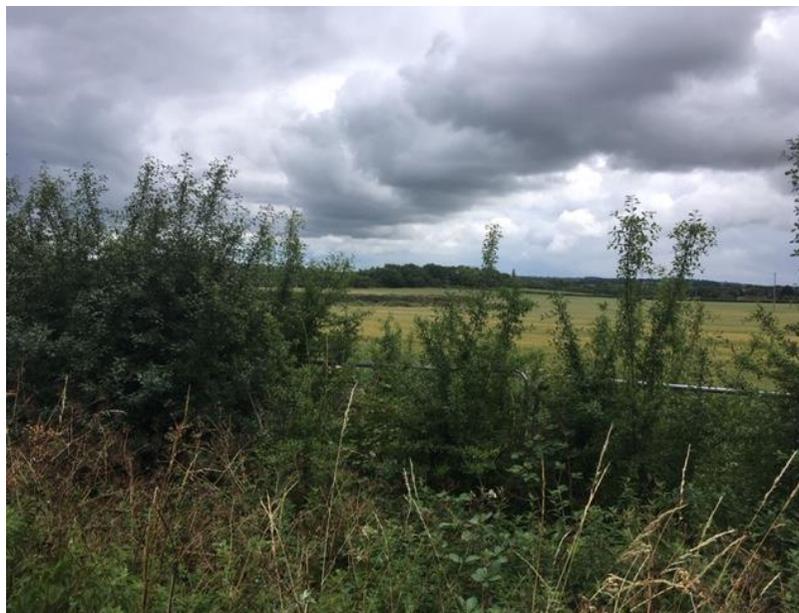
The site consists of a rectangular shaped area of farmland to the south of Stratford-upon-Avon. The site is flat in topography. The site is surrounded by hedgerows to its south-west, south-east and north-eastern boundaries, whilst to the north-west lies further ploughed field that sits adjacent to the A3400, Shipston Road. The site contains no non-designated heritage assets and the nearest designated heritage asset is the Grade II Springfield Bridge, 150 metres to the south-west of the site.

Potential mitigation measures for identified harm	No mitigation measures would be necessary, as development of the site would not have a harmful impact on the significance of the heritage asset.
Conclusion of harm on the heritage asset	<p>Due to the large (150m) distance between the site and the minimal inter-visibility between the site and the heritage asset, it is considered that no harm to the asset would be caused by development of the site.</p> <p>Conclusion on harm to heritage asset: No harm.</p>

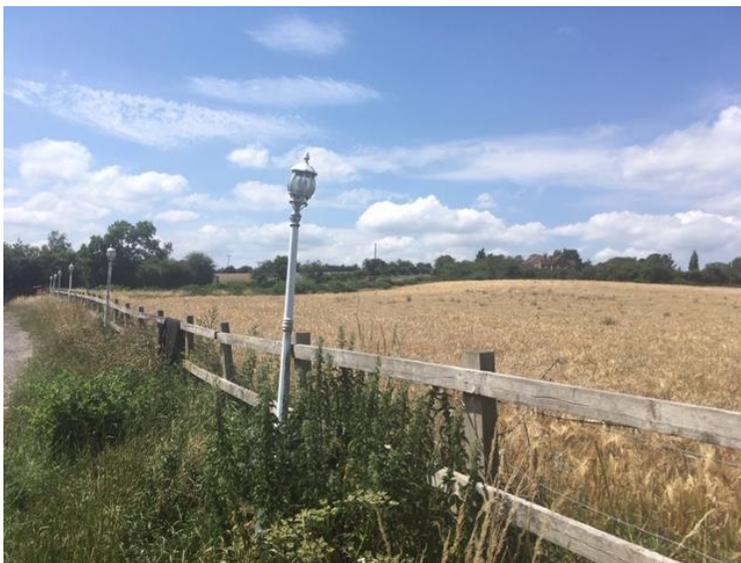
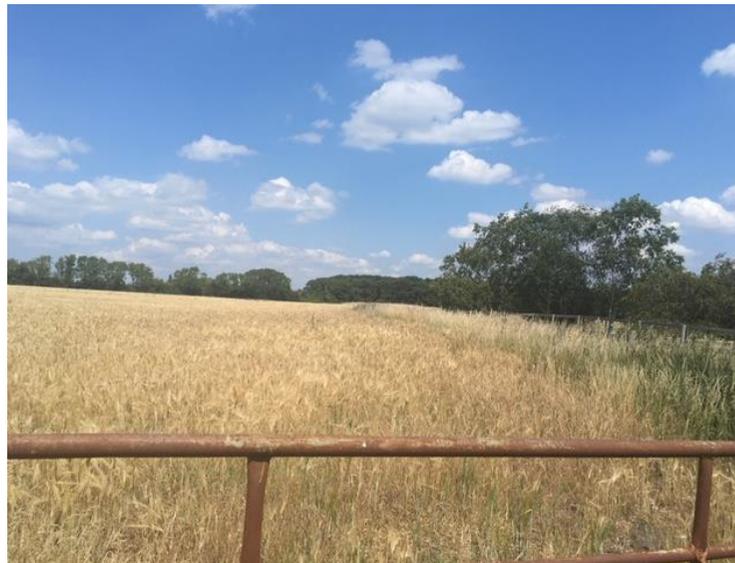
The site consists of a rectangular crop field, located to the north of Evesham Road to the south west of Stratford-on-Avon. The site is undulating in topography. It is bordered by grassed fields to the north, west and east, as well as a restaurant to the south east of the site. It is approximately 140m south of the Stratford-on-Avon Conservation Area, however, the Conservation Area is not visible due to a significant amount of mature trees and vegetation both at the northern boundary of the site and in the intervening distance between the site and the Conservation Area.

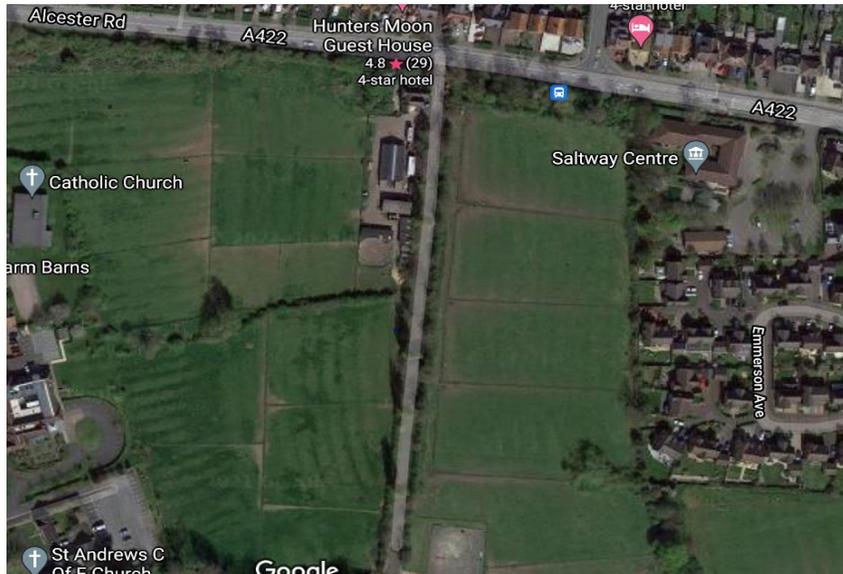
The site is a rectangular area of land, part of a larger land parcel which is currently being used as a paddock for exercising horses. The general topography of the area is flat, but the entire site includes ridge and furrow earthworks running in a north/south direction. To the north of the site is Alcester Road, which has dense vegetation preventing public views. Other site boundaries are a mixture of hedgerow, scrub and trees. To the east of the site is the Saltway Centre and residential development. To the west, open land and a lodge associated with the former Shottery Hall. The original driveway to Shottery Hall runs along the western boundary.

<p>Potential mitigation measures for identified harm</p>	<p>Development proposals would need to consider how the design and layout would address the important relationship of the Conservation Area boundary to the western edge of the site. Whilst the site is not in the Conservation Area, given the sites close proximity to it and its rural setting, consideration would need to be given to reducing the density and or overall scale of development to retain some form of buffer to the site's western boundary, as a minimum.</p>
<p>Conclusion of harm on the heritage asset</p>	<p>Sensitive site layout and design could possibly help to minimise any unacceptable detrimental impact of development on the Conservation Area. However, there would remain an impact on the setting of the Conservation Area, due to a permanent change in the character of the site through the introduction of built form.</p> <p>Development in this location would harm the setting of the Conservation Area due to its proximity to the heritage asset. Mitigation measures may be adequate to address the issue of harm to the setting of the heritage asset.</p> <p>Conclusion on harm to heritage asset: Less than substantial harm.</p>
