Aston Martin Lagonda Ltd  
Wellesbourne Distribution park,  
Unit 2 Loxley Rd, Wellesbourne,  
Warwick, CV35 9JY

**Wellesbourne Unit 8 Site Plan with  
paint booths**

Drawing No: AMLPaint-emissions-  
points\_WellesbourneUnit8\_2023

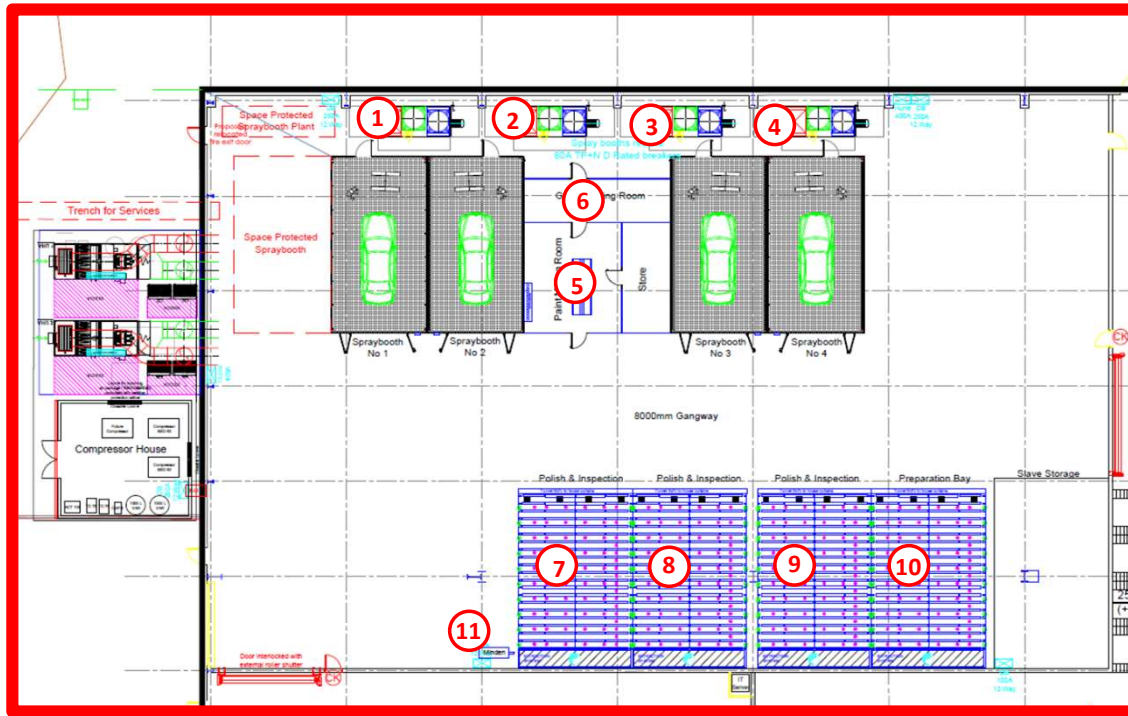
Paint spraying operations		
No	ZONE	PROCESS
1	Paint combi booth 1	2K Primer Paint, WB & SB Base Coat, 2K clear coat and Solvent
2	Paint combi booth 2	2K Primer Paint, WB & SB Base Coat, 2K clear coat and Solvent
3	Paint combi booth 3	2K Primer Paint, WB & SB Base Coat, 2K clear coat and Solvent
4	Paint combi booth 4	2K Primer Paint, WB & SB Base Coat, 2K clear coat and Solvent
5	Paint Mix Room	2K Primer Paint, WB & SB Base Coat, 2K clear coat and Solvent
6	Gun Wash Room	2K Primer Paint, WB & SB Base Coat, 2K clear coat and Solvent. Gun Wash Room contains a distillation based solvent recovery system.
7	Polish & Inspection Bay 1	Primer Sanding, Clear Coat Sanding and Polish Particulate
8	Polish & Inspection Bay 2	Primer Sanding, Clear Coat Sanding and Polish Particulate
9	Polish & Inspection Bay 3	Primer Sanding, Clear Coat Sanding and Polish Particulate
10	Polish & Inspection Bay 4	Primer Sanding, Clear Coat Sanding and Polish Particulate

11	Minden Dust Extractor	Turbine Vacuum Collector. Exhaust is over roof.
